Summary of Issues that May Need Attention

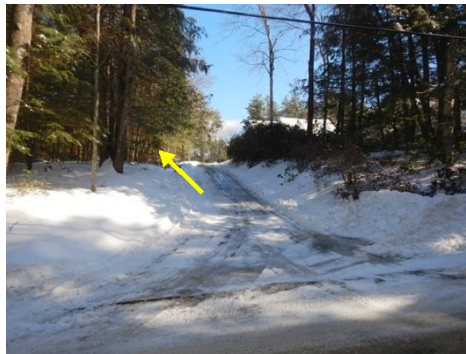
Observations: IMPROVEMENT: No address numbers visible on the property side of the road. The Fire Marshall's office advises 4" numbers on all approaches to assist emergency services quick identification of your home.

Not visible on house side of street

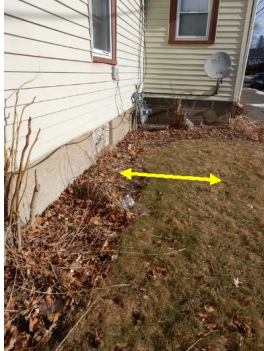
- **IMPROVEMENT:** Grade was relatively flat on the south lawn which may make it difficult to shed water away from the foundation. If excess dampness is observed in the basement, improving the perimeter grade may be necessary.

Flat on south lawn

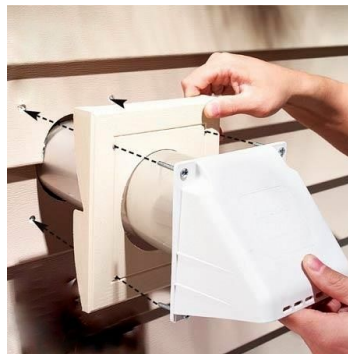
• **CORRECTION:** Some penetrations were lacking a sealant. Recommend caulking to prevent water entry and damage to the substrates and framing.

Missing sealant

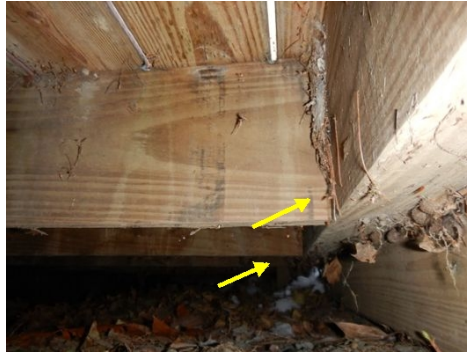
- No joist hangers present. Because of the tight assembly with the house, this did not present an immediate concern. Over time some separation is likely to occur that may require joist hangers.

No joist hangers

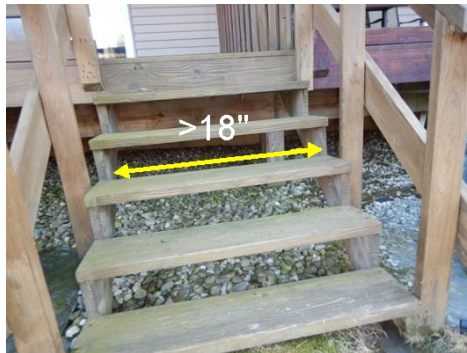
- **IMPROVEMENT:** No graspable handrail. A hand rail needs to be no larger than 2" in diameter to be easily grasped in the event of a fall. Correction needed.
- **CORRECTION:** Stair stringers were spaced more than 18 inches apart. Correction needed.
- **REPAIR:** Weak rail assembly that does not appear sufficient to withstand the requisite 200 lbs of lateral force. Repair needed.
- **CORRECTION:** Horizontal side rails present a climbing invitation to children as well as large openings through which people can slip. This type of construction is not advised. Recommend installing vertical balusters.

Widely spaced stringers

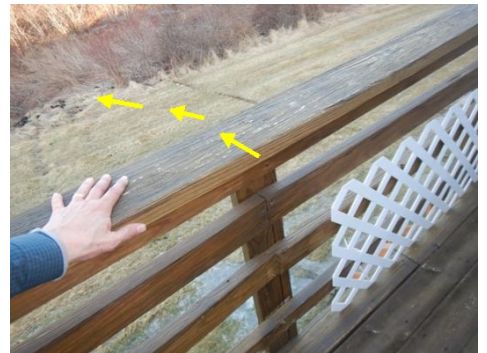
Weak rails

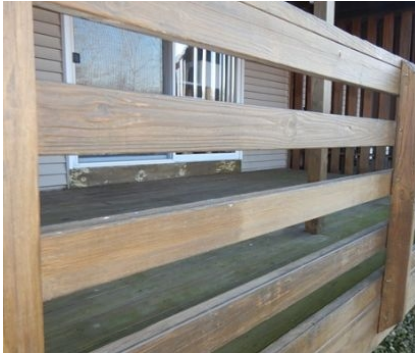
Horizontal rails

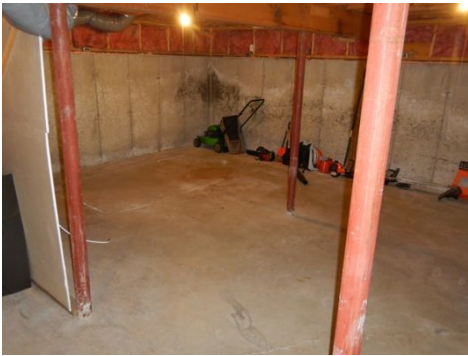
- **REPAIR:** Crack observed on the south wall that had penetrated the full depth of the wall. Repair needed. Recommend consulting a foundation crack company for sealing/patching options that will protect the foundation from water penetration, freezing and damage.

Overview

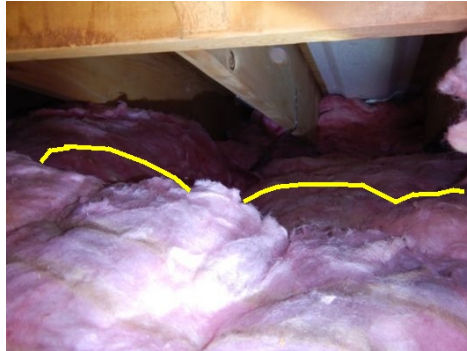
- **IMPROVEMENT:** Uneven distribution that will leave some area susceptible to heat loss. Evening out the insulation recommended.
- **IMPROVEMENT:** Scuttle insulation and air seal was not tight. Thermography revealed heat loss. Improvement needed

Uneven

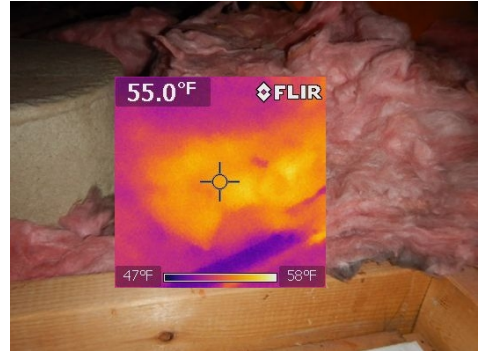
Heat loss

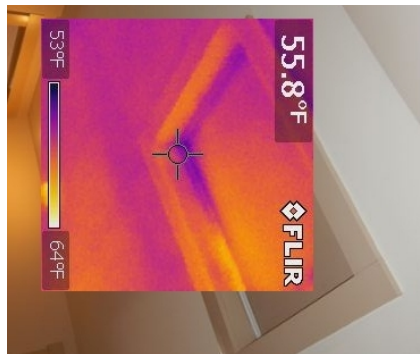
Cool points around scuttle

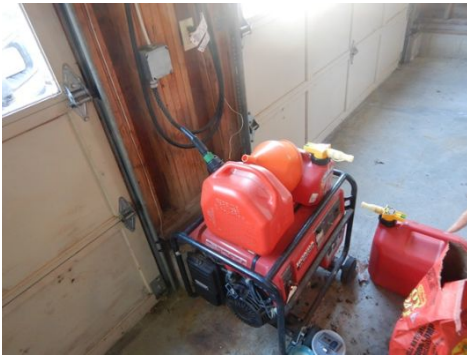
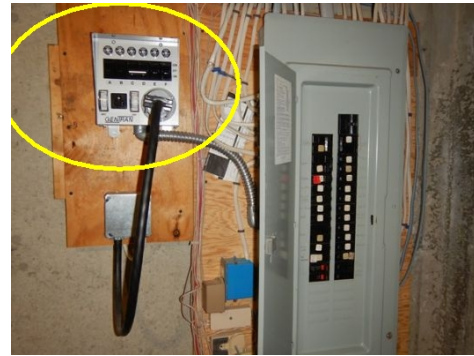
Transfer box

Observations: Generator hook ups located in the garage. , Generator transfer box in the basement, Recommend consulting the current owner, manufacturer and/or an electrician for proper operation.

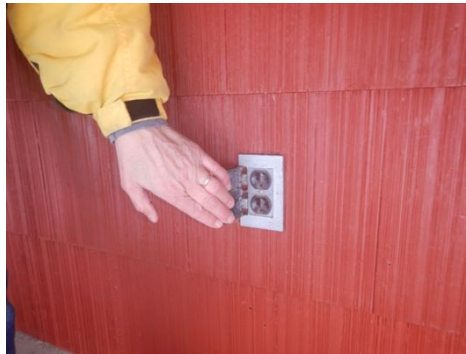
- **CORRECTION:** No GFCI protection provided. All exterior receptacles should be GFCI protected. Correction needed.

No GFCI protection

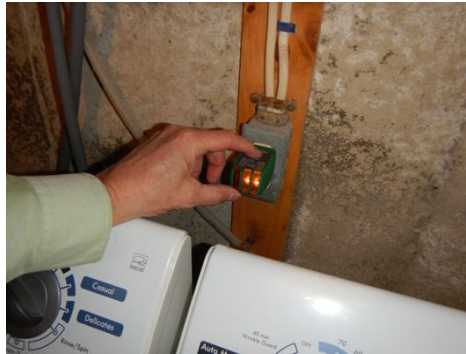
- **CORRECTION:** No GFCI protection. Installation needed.

No GFCI protection

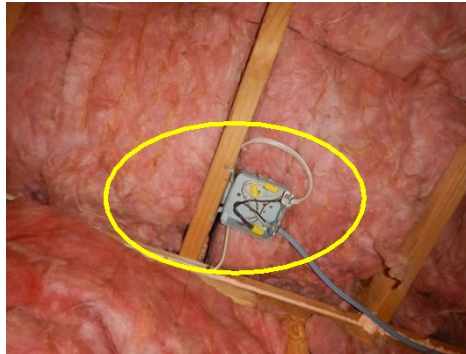
Open electrical box

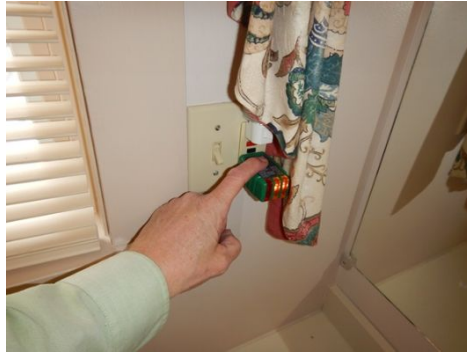
- No GFCI protection provided. All bathroom receptacles should be GFCI type for safety.

GFCI not responding

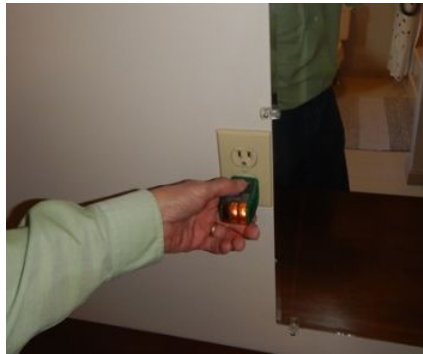
- CORRECTION: No GFCI protection provided. All bathroom receptacles should be GFCI type for safety.

No GFCI protection

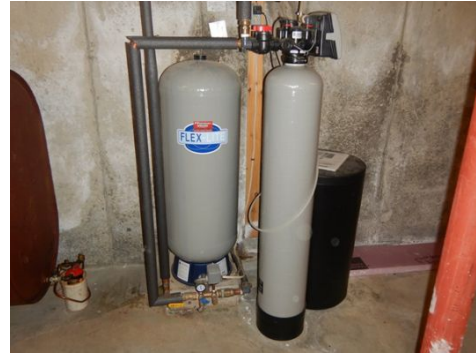
Basement well equipment

- Well head, pump, pressure tank, control switch and valves were inspected.
- Water treatment/softener system present. Recommend consulting the current owner for clarification of its purpose and maintenance.

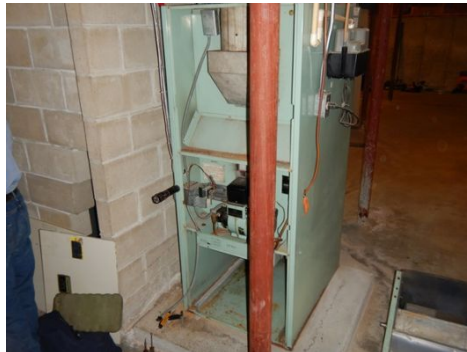
Heating plant

- It is advisable to have the heating system cleaned and inspected by an HVAC service company before moving into the house. This will assure safe and efficient operation.
- The furnace was older, but in fair, functional condition. It may not be as efficient as would be expected with today's energy demands. Consideration and plans may want to be given to replacement.
- DOE Home Energy Score Rating: 70% efficiency

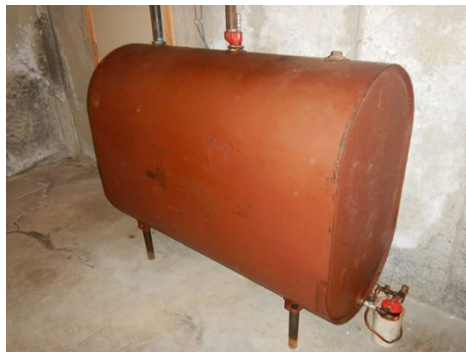
Basement oil tank

- Oil tank, fill & vent pipes and feed pipe / filter inspected
- This is a visual inspection only and not a ultrasound study of the tank. Oil tanks tend to rust from the inside out, often hiding deterioration. It may be advisable to obtain an ultrasound evaluation to confirm its integrity.
- Fuel supply line was above the floor and not in contact with it, in accordance with the Mass. D.O.E. September 2011 regulations.

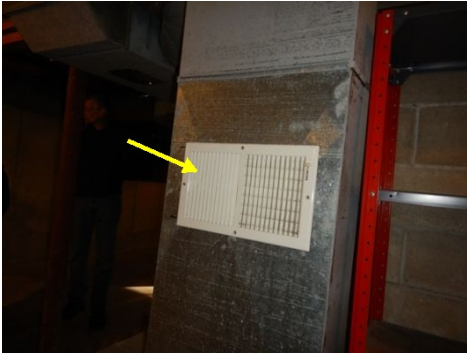
- Insulated and uninsulated areas
- A return register had been cut into the basement return duct. Be sure to keep this closed to maintain balance in the system, as well as to prevent drawing basement mildew and dust into the living areas.
- **IMPROVEMENT:** Duct joints were not sealed. The EPA estimates 20% to 30% of the air that moves through a duct system is lost due to leaks, holes, and poorly connected seams. This will reduce the efficiency of the heating system. Recommend sealing the joints and voids in the ducts.

Keep closed

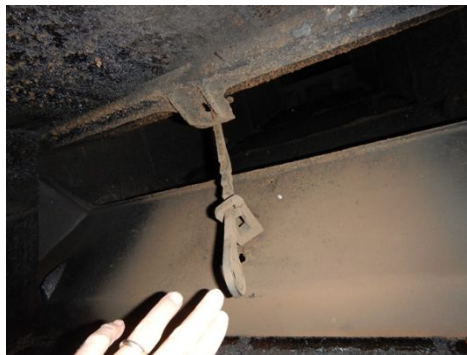
- **REPAIR:** The damper was out of alignment. Repair/adjustment needed.
- **MAINTENANCE:** Creosote accumulation was present. Cleaning needed before using to be assured of safe operation.

Damper out of alignment

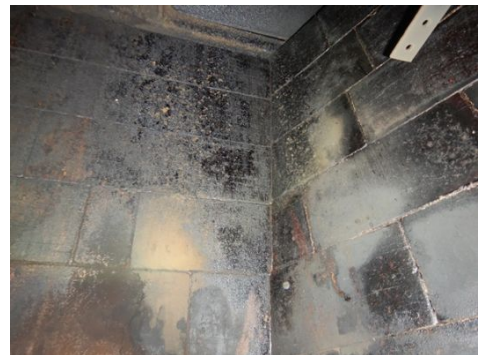
Creosote accumulation

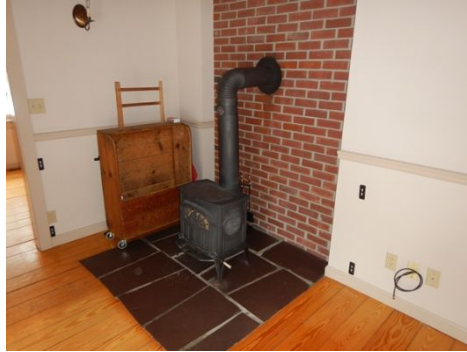
Wood Stove

- Clearance from combustible material was at least the customary 18"
- It is recommended to confirm proper installation and permitting with the local building department.
- It is always advisable to have a chimney sweep evaluate and clean the chimney system to assure there is no debris accumulation or other issues that might compromise the safe and efficient operation of the wood stove.

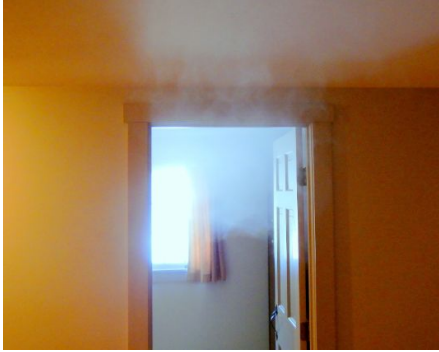
- **REPAIR:** The was not operating. Steam was easily accumulating in the bathroom and rolling into the hallway. Repair needed.
- **CORRECTION:** Tightly louvered exhaust cover. These constrict air flow and offer no backdrafting damper. Replacement needed.

Steam drafting into hallway

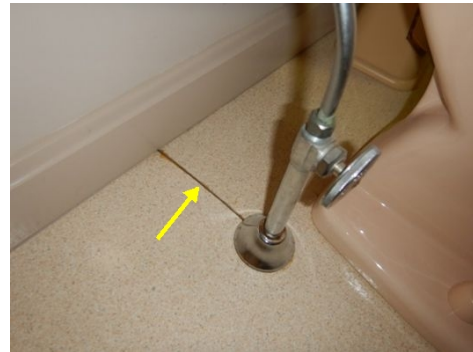
Lifting seam
