## VICTORIA HILL DEPRECIATION REPORT

**THE OWNERS  
STRATA PLAN BCS 1676  
14 East Royal Avenue  
NEW WESTMINSTER, BC**

**INSPECTION DATE: MARCH 2015**

**ACE FILE NUMBER: # 15702**

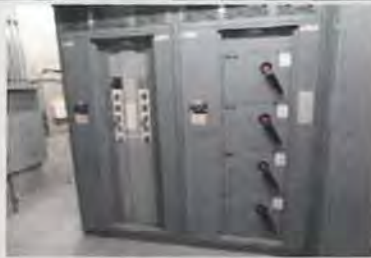
Switchgear Unit									
Item # :	4.1.2 Square D 3000 A

<table><tr> <td>Year Installed:</td><td>2005</td></tr><tr> <td>Condition</td><td>Good</td></tr></table>

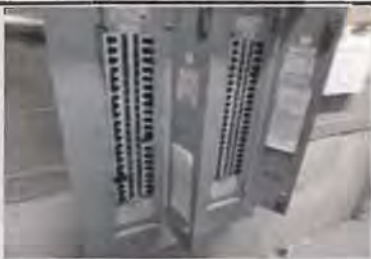
Breaker Panels									
Item # :	4.1.3 Generic Breaker Panels

<table><tr> <td>Year Installed:</td><td>2005</td></tr><tr> <td>Condition</td><td>Good</td></tr></table>

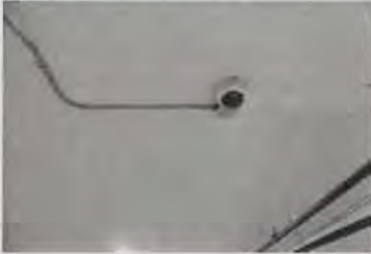
Video Surveillance System									
Item # :	4.1.6								
14 Surveillance Cameras

<table><tr> <td>Year Installed:</td><td>2005</td></tr><tr> <td>Condition</td><td>Good</td></tr></table>

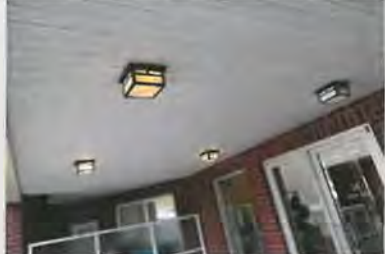
Common Area Exterior Lights									
Item # :	4.2.1								
General

<table><tr> <td>Year Installed:</td><td>2005</td></tr><tr> <td>Condition</td><td>Good</td></tr></table>

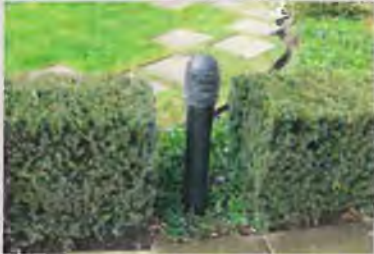
Common Area Exterior Light Posts									
Item # :	4.2.2								
General

<table><tr> <td>Year Installed:</td><td>2005</td></tr><tr> <td>Condition</td><td>Good</td></tr></table>

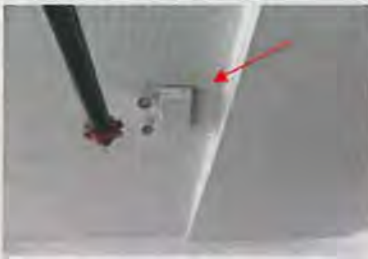
Item # : 4.2.5		<b>Emergency Light Battery Packs</b>	
		Standard

Comments: Service Through Operating Budget. Replace Batteries Every 5 Years.			
Year Installed:		Mixed	
Condition		Good	
Estimated Life Remaining		30 Years +	
Estimated Replacement Cost		See Comment Above

The building is equipped with emergency lighting powered through a battery back-up system. Batteries should be replaced every 5 years. These components are recommended to be serviced through the Operating Budget.

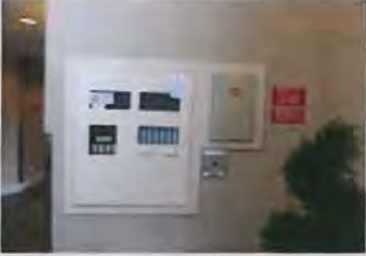
<b>Fire Monitoring Station Annunciator</b>	
Item # :	7.2.1
Mircon

Year Installed: 2005 Condition: Good Estimated Replacement Cost: Operating Budget Item

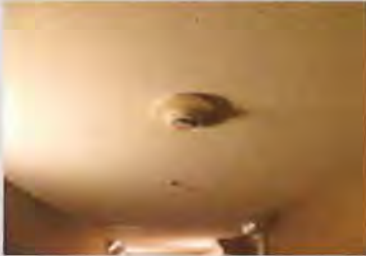
<b>Smoke/Heat Detectors</b>	
Item # :	7.2.4
Hard Wired

Year Installed: 2005 Condition: Good Estimated Life Remaining: Mixed Estimated Replacement Cost: Operating Budget Item

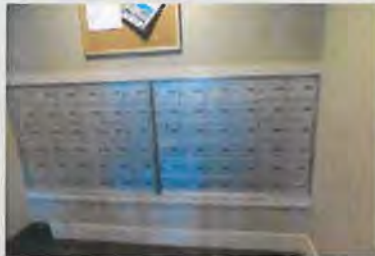
Item # :	8.2.9	<b>Mailbox Unit</b>
		72 Box Stainless Steel Unit

Year Installed: 2005		
Condition: Good		
Estimated Replacement Cost: Operating Budget Item

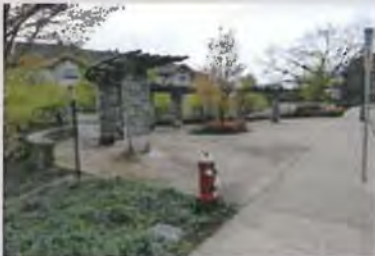
Item # :	8.3.1	<b>Pergola Architectural Feature at Street Front</b>
		Metal Pergola, Stone Pillars with Benches and Concrete Surround

Year Installed: 2005		
Condition: Good		
Estimated Life Remaining: 30 Years +

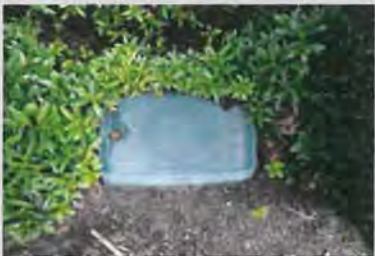
Item # :	8.3.4	<b>Irrigation System</b>
		Automated System

Year Installed: 2005		
Condition: Good		
Estimated Replacement Cost: Operating Budget Item

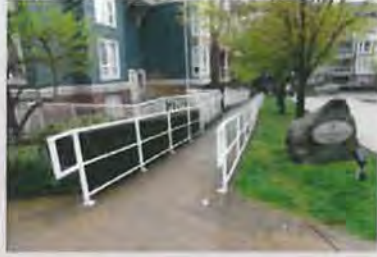
Item # :	8.3.7	<b>Exterior Hand Rails</b>
		Metal Railing at Walkways

Comments:		
Year Installed:	2005	
Condition	Good	
Estimated Life Remaining	30 Years +

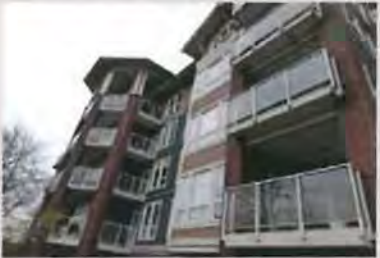
Item # :	8.3.8	<b>Balconies Guardrail Assemblies</b>
		Aluminum Guardrail Assemblies

Comments:		
Year Installed:	2005	
Condition	Good	
Estimated Life Remaining	30 Years +
