**Report:** wells2northstar

**Confidential Inspection Report**  
**123 Anywhere Lane**  
**Nantucket, MA 02554**

**August 4, 2021**

**Prepared for: Sample Customer**

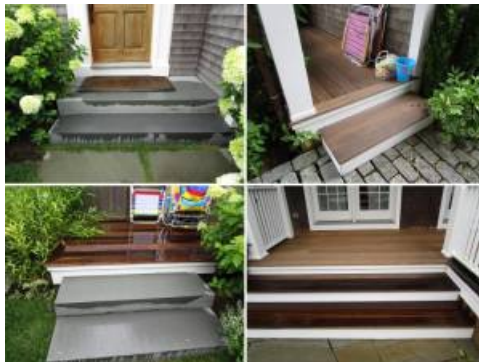
Blue Stone Steps to Wood decking, Pressure treated side steps & stoop with no handrail. Pressure treated wood steps & stoop at the deck, but no handrail.

- Missing footings
- Wood stringers are in Earth contact. (Note: Even treated lumber is conducive for decay or pest infestation).
- The wood support posts are not mechanically fastened to the footings to prevent movement.

Analysis: The above listed problems are part of the means of egress from the dwelling and must be maintained in a safe and functional condition to prevent personal injury to anyone using the entrance. **URGENT** safety repairs are needed.

Recommendation: You should ask a licensed and insured contractor to further investigate the entrances and to provide a cost estimate for repairs or replacement **NOW**, in order to determine the impact on your budget. All repairs should be done in accordance with the requirements of the building code.

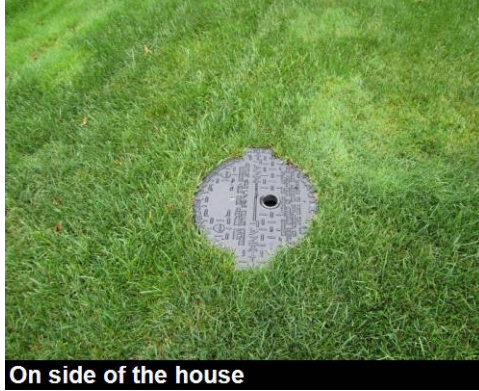
On side of the house

TYPE:  
Observation: The home has an outside buried propane tank and copper piping leading into the home.

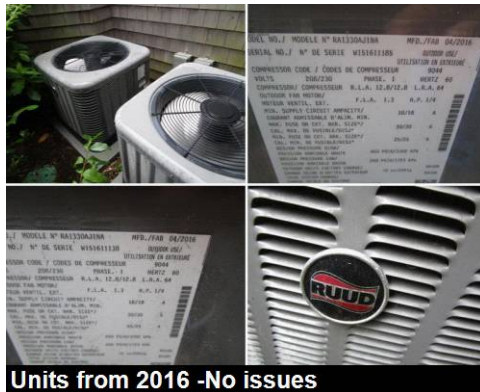
Brand: Ruud  
 Model: RA1330AJINA  
 Serial: W151611185 and W151611138  
 Est. age: 2016

**Units from 2016 -No issues**

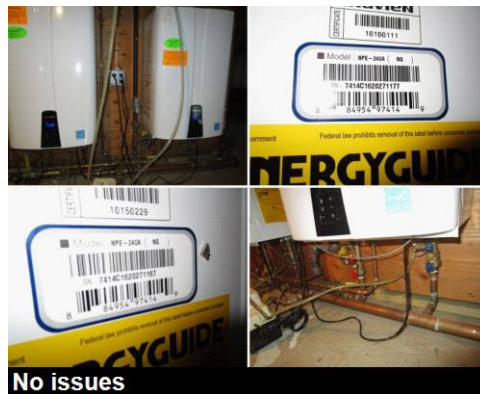
Brand: Navien  
 Model: NPE-240A  
 Serial: 7414C1620271177 and 7414C1620271167

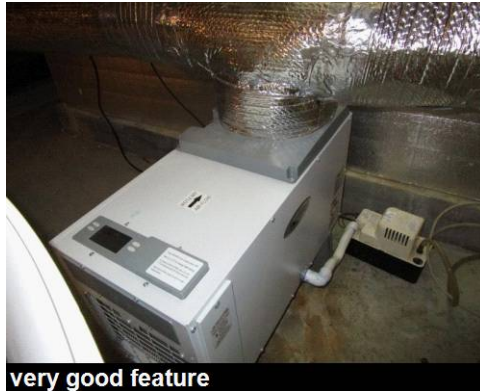
Observation: A Whole house dehumidifier is present in the basement.

very good feature

Recommendation: I advise that you ask the owner if the basement has had moisture problems, if the dehumidifier is necessary and how often it is used.

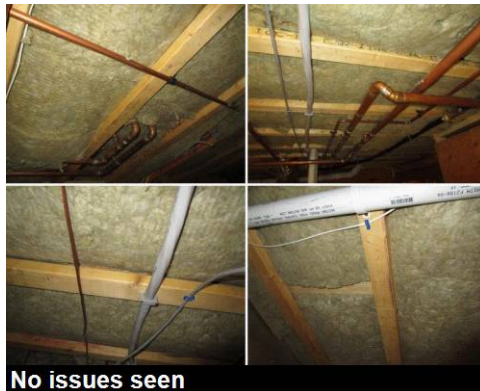
Wood sills, beam, joists, headers and subfloor.

No issues seen

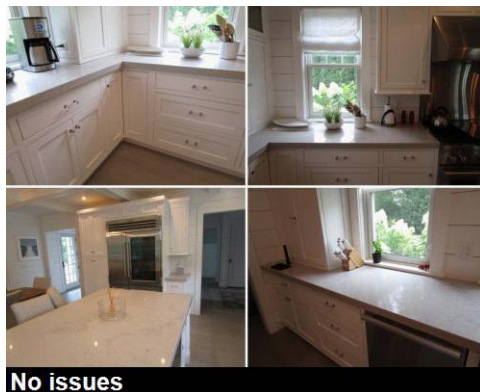
\* **FUNCTIONAL.** Observation: I inspected a **representative number** of cabinets and did not observe any evidence of problems where **readily accessible** and **observable** at time of inspection.  
 (Note: The inspector did not inspect every cabinet and is not required to move stored goods to evaluate the inside of cabinets. After the owner has moved out and prior to passing, you should inspect the interior of all cabinets for potential hidden defects not documented in this report.)

No issues

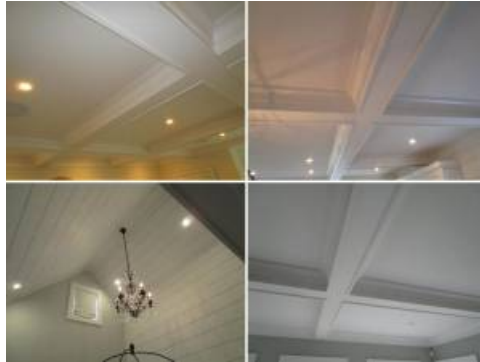
Wood in areas.

Recommendation: If any problems are suspected, then you should hire a specialist to remove ceiling materials to provide access for further inspection.

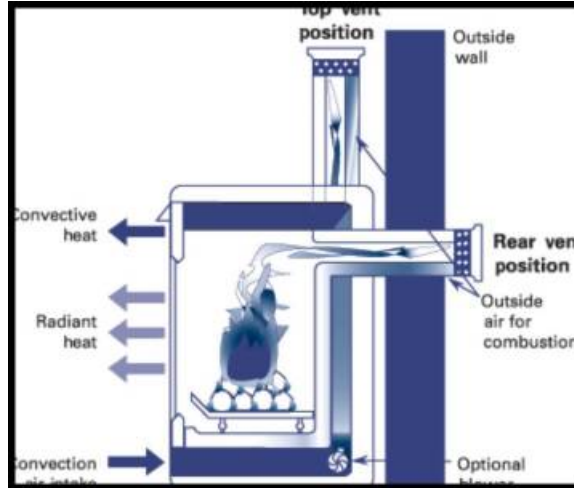
Analysis: A gas fireplace is a positive feature in the home, but it is also one more appliance whose function and maintenance requirements you should understand.

Recommendation: You should ask the owner if he / she can demonstrate the use of the gas fireplace, if the owners manual is available and when the fireplace was last serviced by a professional.
