Test Report For:
SPIG Industries, LLC
SGET End Terminal

TESTED TO:
Manual for Assessing Safety Hardware (MASH 2016)
Test 3-30

TEST REPORT NUMBER:
TR-P38034-01-NC

REPORT DATE:
August 20, 2018

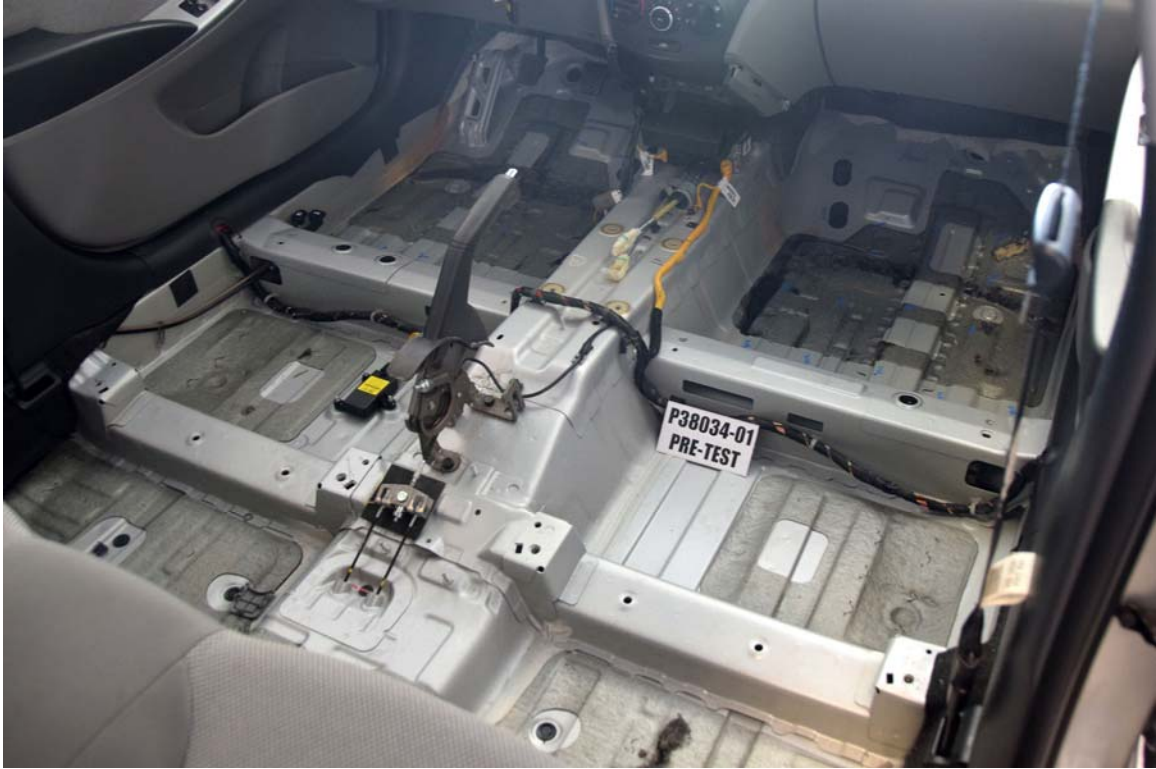
FIGURE 54. Post-Test Passenger Side Occupant Compartment

The vehicle's damage was concentrated at its front end. The front bumper beam was crushed at its center and pushed back into the radiator. The radiator and its support were deformed. The hood was deformed and the sheet metal was separated at the right-front side. The bumper fascia and right headlight were also damaged. The occupant compartment was not penetrated and the deformation limits were not exceeded.
