Test Report For:  
**SPIG Industries, LLC**  
**SGET End Terminal**

TESTED TO:  
**Manual for Assessing Safety Hardware (MASH 2016)**  
**Test 3-32**

TEST REPORT NUMBER:  
**TR-P38107-01-NC**

REPORT DATE:  
**August 20, 2018**

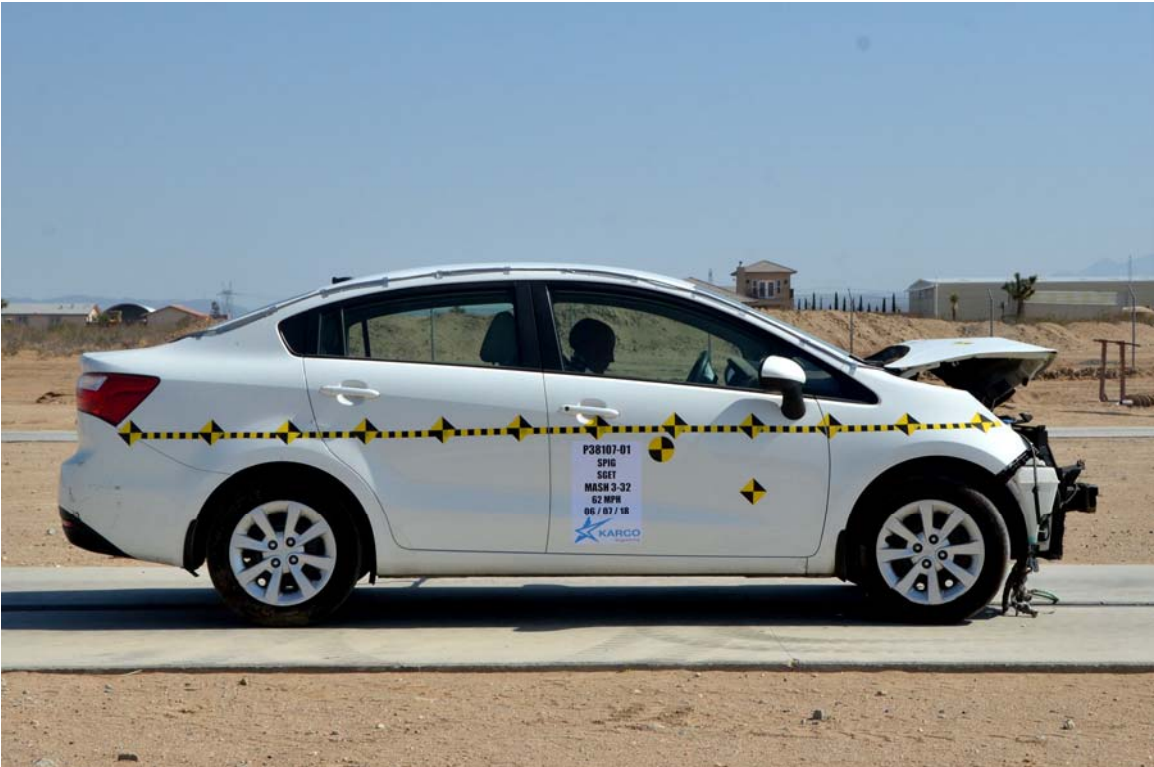
FIGURE 46. Post-Test Right View of Test Vehicle

The vehicle's damage was concentrated at its front end. The front bumper beam was crushed at its center and pushed back into the radiator. The radiator and its support were crushed. The hood was deformed and the sheet metal was separated at the right side. The bumper fascia and right headlights were also damaged. The occupant compartment was not penetrated and the deformation limits were not exceeded.
