Test Report For:  
**SPIG Industries, LLC**  
**SGET End Terminal**

TESTED TO:  
**Manual for Assessing Safety Hardware (MASH 2016)**  
**Test 3-32**

TEST REPORT NUMBER:  
**TR-P38107-01-A**

REPORT DATE:  
**August 20, 2018**

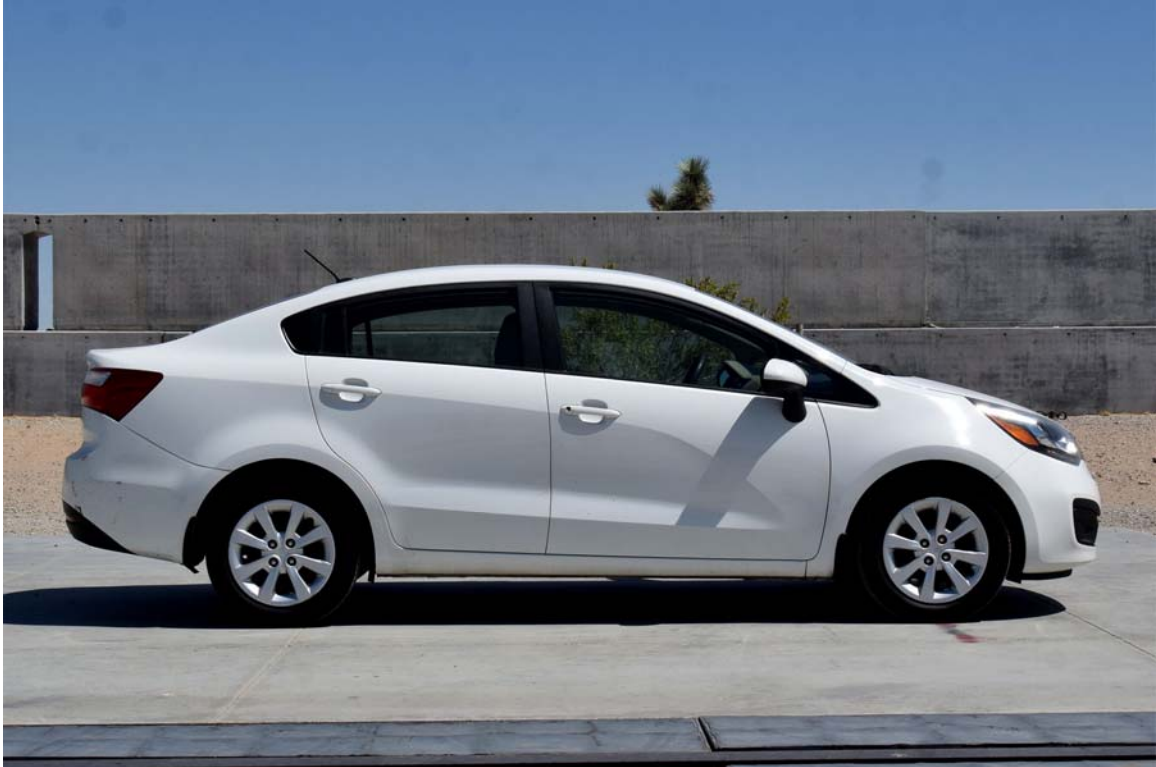
FIGURE 44. Post-Test Right Front  $\frac{3}{4}$  View of Test Vehicle

The vehicle's damage was concentrated at its front end. The front bumper beam was crushed at its center and pushed back into the radiator. The radiator and its support were crushed. The hood was deformed and the sheet metal was separated at the right side. The bumper fascia and right headlights were also damaged. The occupant compartment was not penetrated and the deformation limits were not exceeded.
