Test Report For:  
**SPIG Industries, LLC**  
**SGET End Terminal**

TESTED TO:  
**Manual for Assessing Safety Hardware (MASH 2016)**  
**Test 3-35**

TEST REPORT NUMBER:  
**TR-P38032-01-A**

REPORT DATE:  
**August 20, 2018**

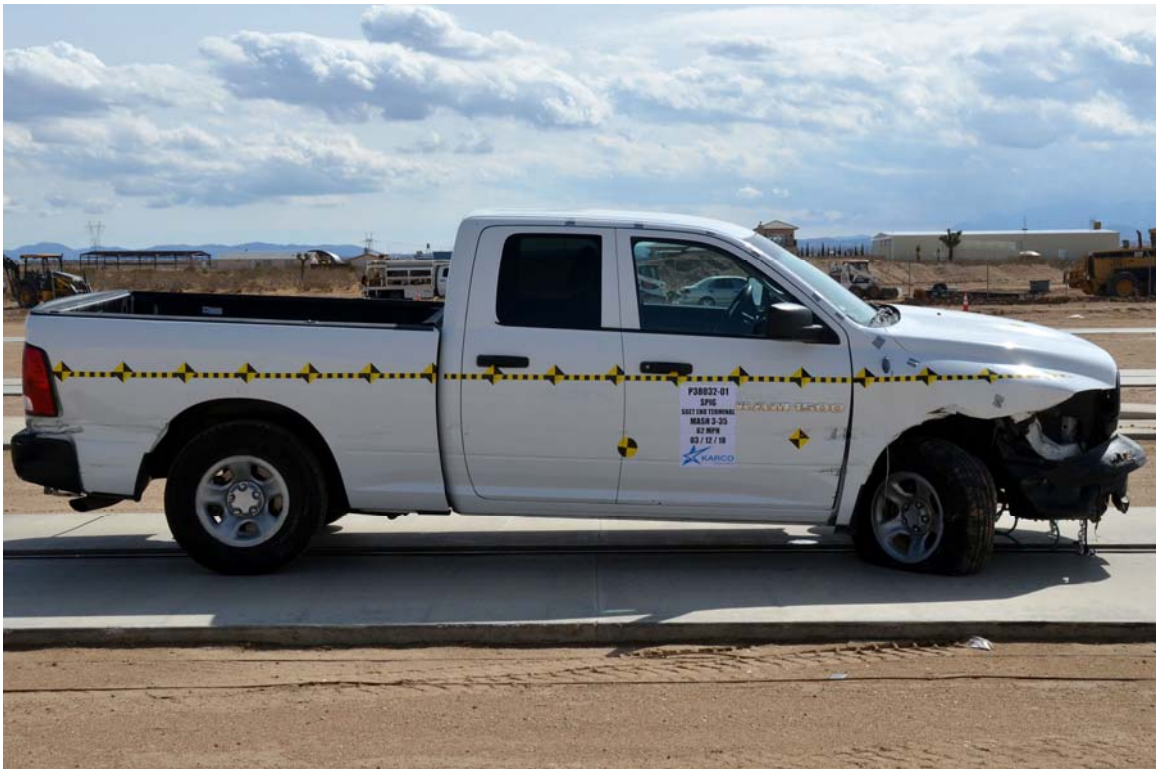
FIGURE 46. Post-Test Right View of Test Vehicle

The vehicle's damage was concentrated at its front-right side. The subframe assembly behind the quarter panel was deformed. The lower control arm was bent and the tire was punctured. The side of the front bumper was deformed inward and was lodged behind the front wheel. The front quarter panel, both doors and bedside were damaged. The front head light was detached and the grill was damaged. The occupant compartment was not penetrated and the deformation limits were not exceeded.
