Test Report For:
SPIG Industries, LLC
SGET End Terminal

TESTED TO:
Manual for Assessing Safety Hardware (MASH 2016)
Test 3-37b

TEST REPORT NUMBER:
TR-P38033-01-NC

REPORT DATE:
August 17, 2018

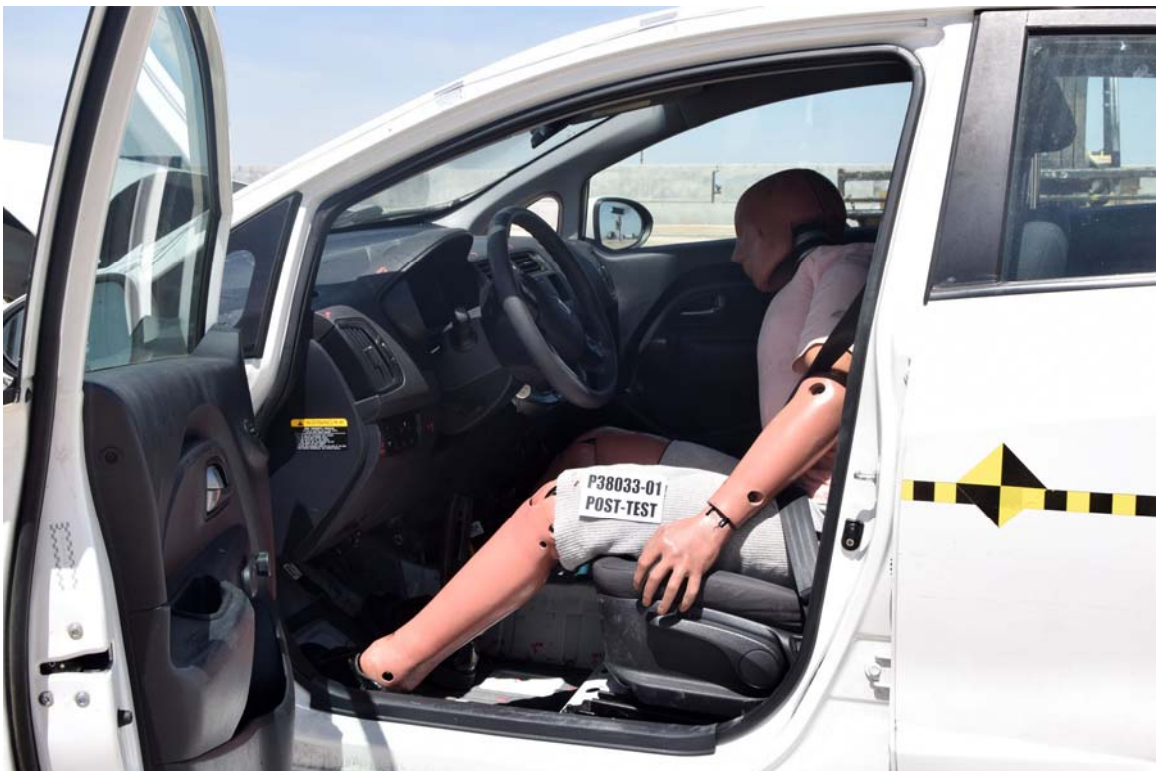
Within the engine compartment the radiator, radiator support, and driver side crush rail were damaged. The engine shifted slightly rearward. The front driver side tire was flattened as a result of the impact. The occupant compartment was not penetrated and the deformation limits were not exceeded.

FIGURE 50. Post-Test Driver Side Occupant Compartment
