Test Report For:
SPIG Industries, LLC
SGET End Terminal

TESTED TO:
Manual for Assessing Safety Hardware (MASH 2016)
Test 3-31

TEST REPORT NUMBER:
TR-P38108-01-B

REPORT DATE:
September 22, 2022

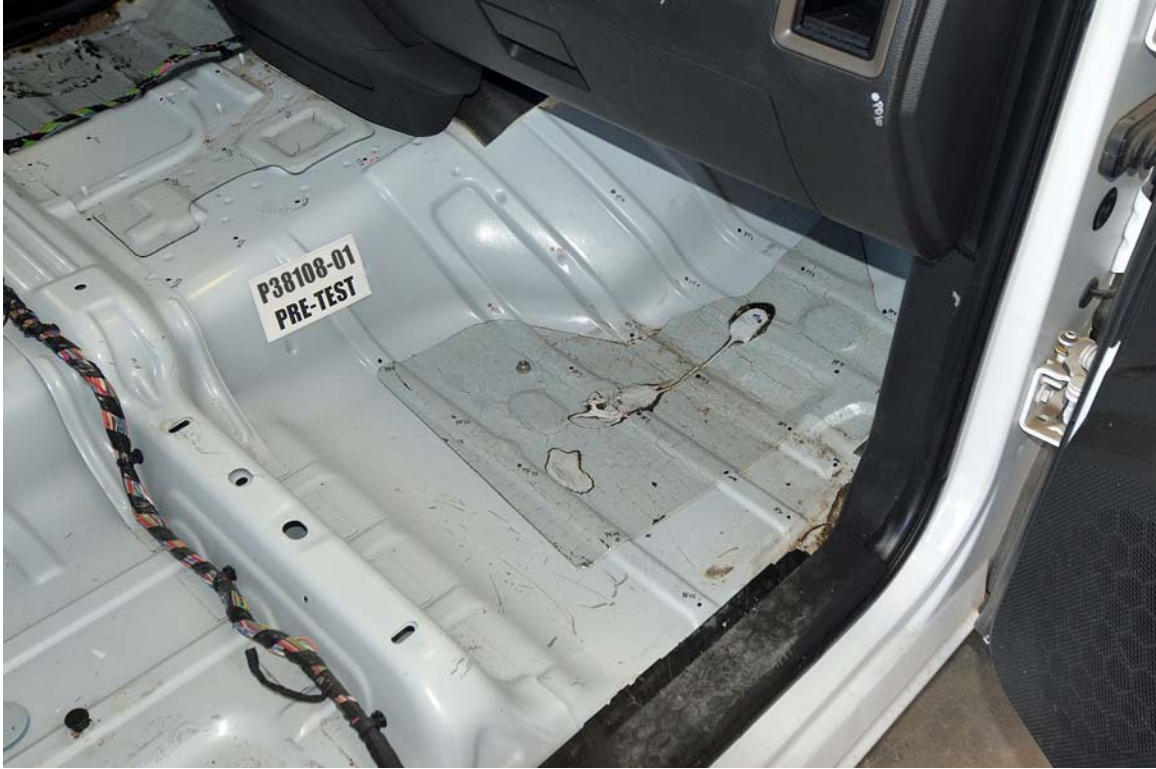
FIGURE 54. Post-Test Passenger Side Occupant Compartment
