# Property Inspection Report

Report Prepared By: Clarence Livingstone, License 4457

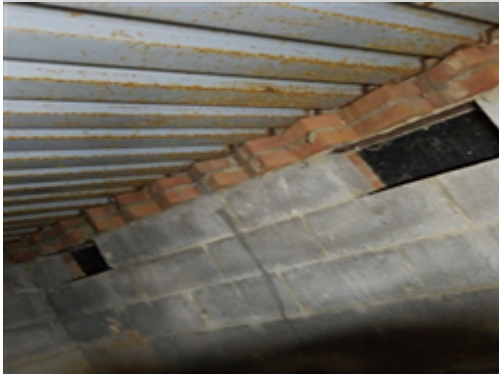
**(A3 - 5.1 ) Porch**

Crawl space under porch does not have vapor barrier installed and vents are closed. As a result, corrugated porch support can deteriorate over time due to excess moisture. Contact a specialist in crawl space systems.

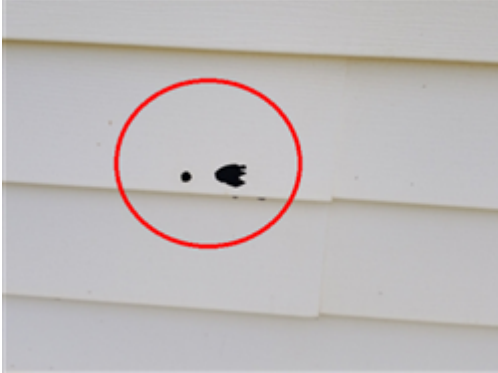
#### **(B1 - 5.1 ) Main House Front**

There is a hole in the siding on the front porch and at the back of the house. Deterioration can result in water penetration which can result in structural damage. A licensed general contractor should be consulted to repair all visible damage and check the home for possible areas of hidden damage.

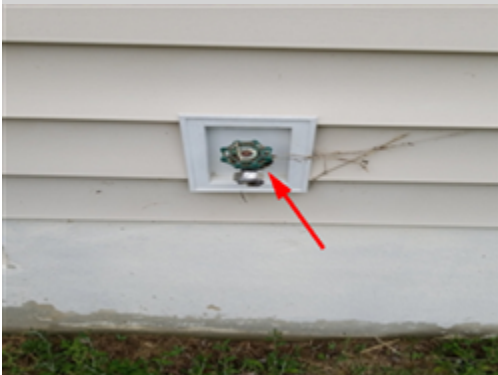
##### (D1 - 3.1 ) Exterior faucets

All Faucets are loose and are missing anti-siphon values.

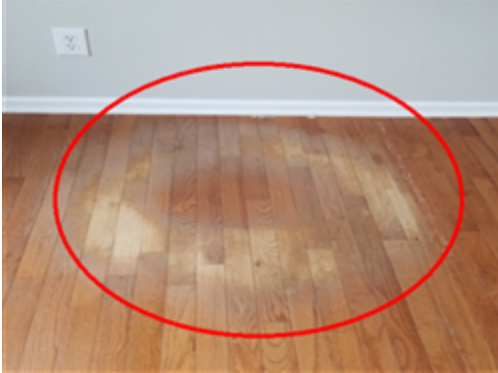
**(H1 - 1.1 ) Formal Living**

Laminated flooring needs refinishing

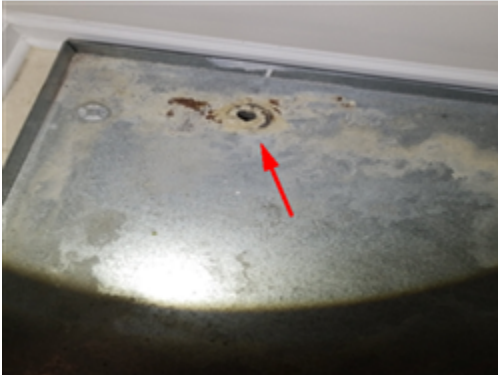
**(H1 - 2.1 ) Laundry**

The Washer/Dryer overflow pan needs further evaluation and repair; the following concerns were noted at the time of the inspection:

1. Water overflow can damage first floor ceiling

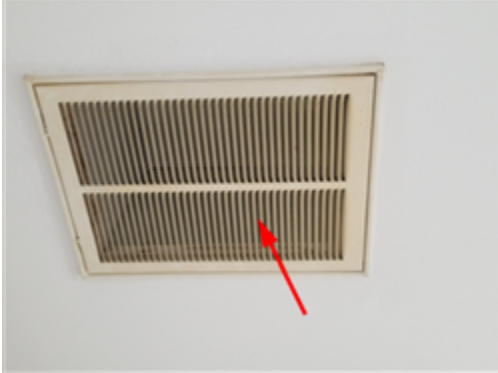
**(H1 - 7.1 ) Hall**

Filter is missing from ceiling air return grill.

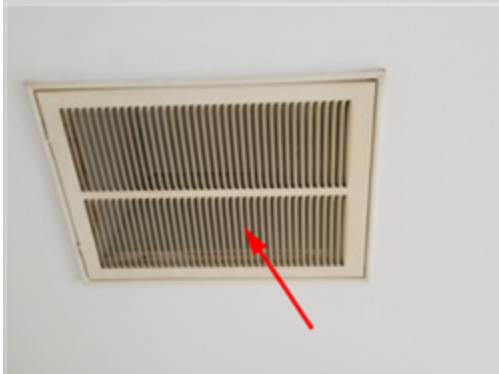
**(H1 - 9.1 ) Family Room**

Filter is missing from ceiling air return grill.

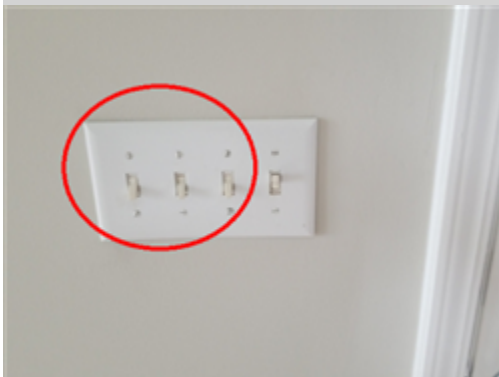
**(H1 - 10.1 ) Family Room**

Inspector was not able to identify the light switch appliances during inspection - not able to identify the use of the switches.

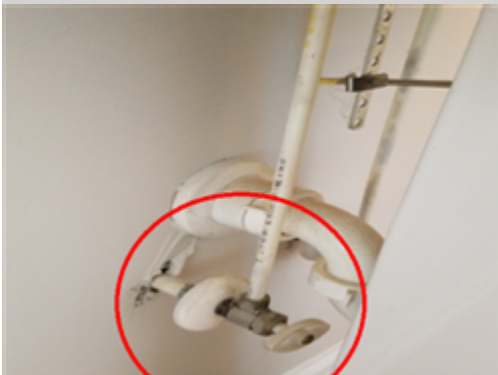
**(H3 - 2.1 ) Bathroom #1**

Water supply lines are loose. This condition can result in water leaking into the wall areas. A licensed plumbing contractor should be consulted for a complete evaluation and to make necessary repairs.

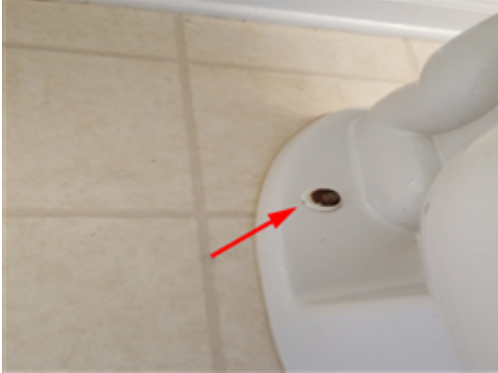
##### (H3 - 5.1 ) Bathroom #2

Rusted toilet flange bolt (typical of all) toilets. Loose flange will causes the toilet to rocks and not secure to the floor. Movement of the toilet can result in leaks and damage. A licensed plumbing and general contractor should be consulted for evaluation and repair.

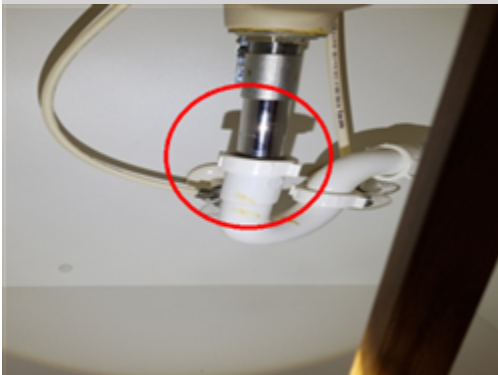
##### (H3 - 7.1 ) Bathroom #2

Sink tail pipe does not align with p-trap. This could result in water leakage. Moisture is present on pipe. A licensed plumbing contractor should be consulted for a complete evaluation and to make necessary repairs.

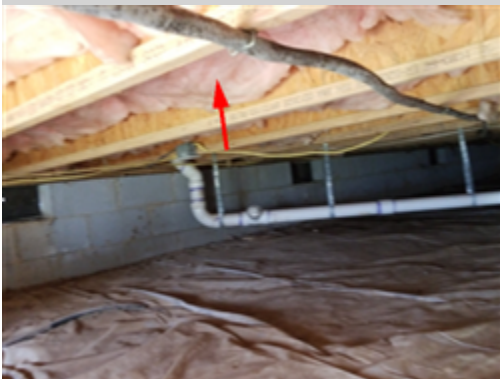
**(I1 - 2.1 ) Crawl Space: Main House**

R-19 Insulation
