Property Visit

Prepared on behalf of Example Lettings Ltd

123 Preview Street
Sample City
London
AB1 2CD

January
18th 2025
10:30

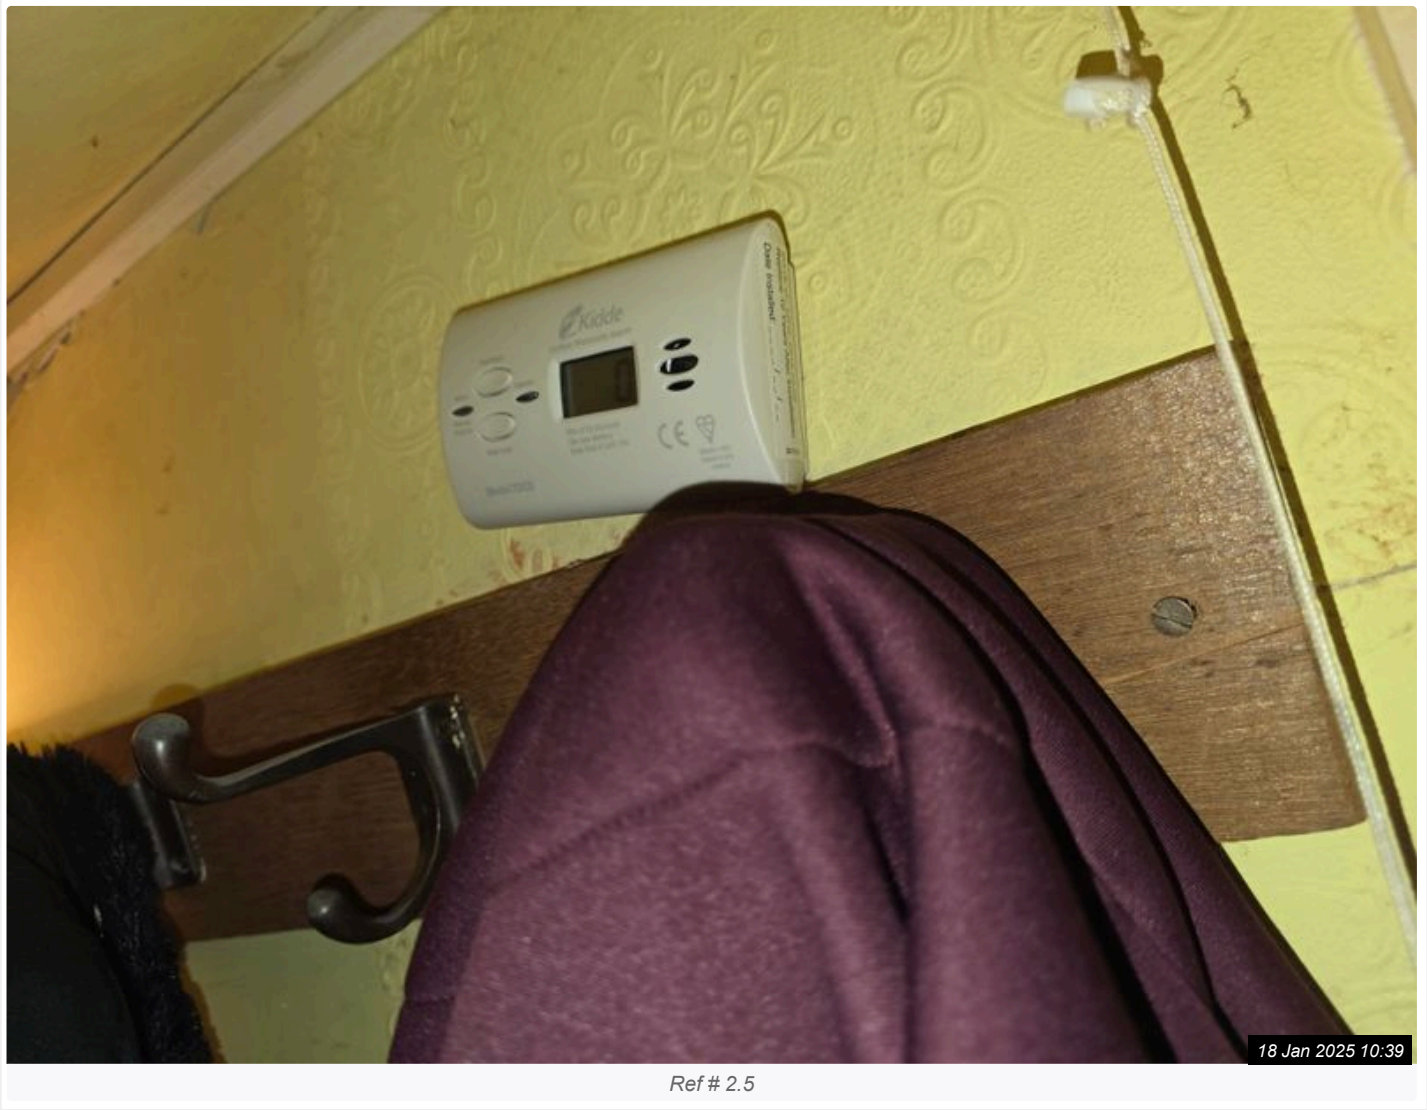
Carbon Monoxide Alarm	Understairs cupboard entrance hall wall ground floor	Alarm tested for power only, audible alarm noted	Replacement date 06-11-2022
