# Inventory & Schedule of Condition

Prepared on behalf of Example Lettings Ltd

123 Preview Street  
Sample City  
London  
AB1 2CD

**September**  
**13th 2024**

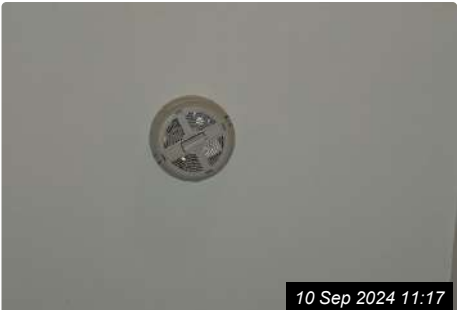
| Ref | Name | Location | Answer | Further information |
|---|---|---|---|---|
| 4.4<br> | Smoke Alarm | Entrance Hall ceiling | <b>Test Result</b><br>Unable to test due to height,<br>tested for power, Light<br>showing | <b>Replacement date</b> |

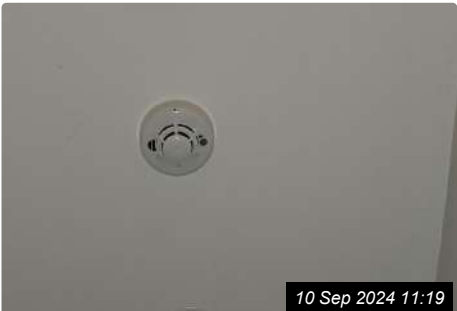
| Ref | Name | Location | Answer | Further information |
|---|---|---|---|---|
| 4.5<br> | Smoke Alarm | Entrance Hall Ceiling ground floor | <b>Test Result</b><br>Unable to test due to height,<br>tested for power; Light<br>showing | <b>Replacement date</b> |

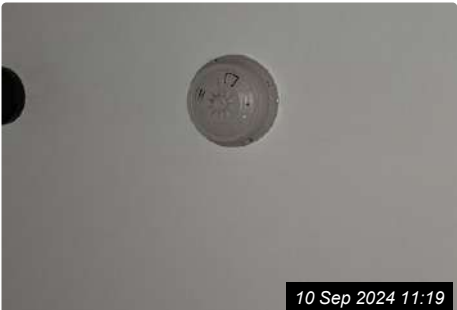
| Ref | Name | Location | Answer | Further information |
|---|---|---|---|---|
| 4.6<br> | Heat Alarm | Kitchen Ceiling ground floor | <b>Test Result</b><br>Unable to test due to height,<br>tested for power; Light<br>showing | <b>Replacement date</b> |

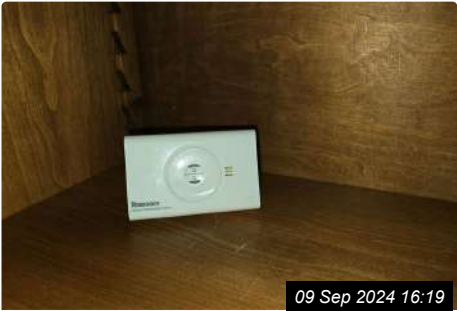
| Ref | Name | Location | Answer | Further information |
|---|---|---|---|---|
| 4.7<br> | Carbon Monoxide Alarm | Reception room 1 on units ground floor | <b>Test Result</b><br>Alarm tested for power only,<br>audible alarm noted | <b>Replacement date</b> |

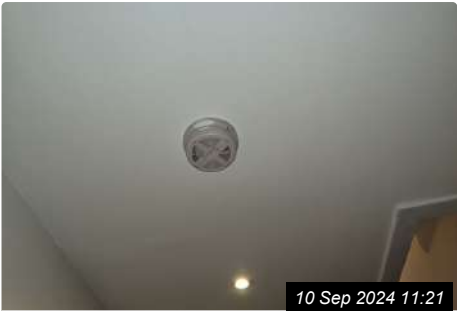
| 4. ALARMS (CONT.) | | | | |
|---|---|---|---|---|
| 4.9 | Smoke Alarm | Landing Ceiling basement level | <b>Test Result</b><br>Unable to test due to height, tested for power; Light showing | <b>Replacement date</b> |

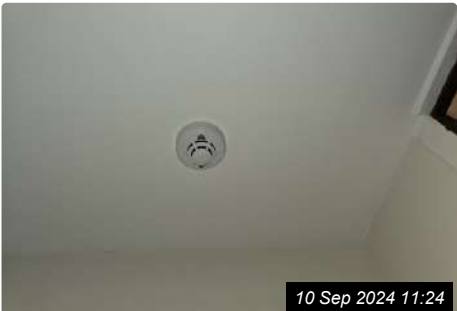
| 4. ALARMS (CONT.) | | | | |
|---|---|---|---|---|
| 4.10 | Smoke Alarm | Landing Ceiling basement level | <b>Test Result</b><br>Unable to test due to height, tested for power; Light showing | <b>Replacement date</b> |

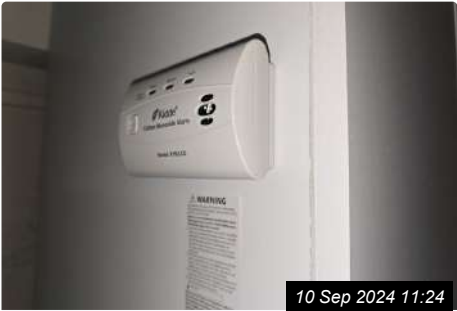
| 4. ALARMS (CONT.) | | | | |
|---|---|---|---|---|
| 4.11 | Carbon Monoxide Alarm | Utility on units basement level | <b>Test Result</b><br>Alarm tested for power only, audible alarm noted | <b>Replacement date</b> |

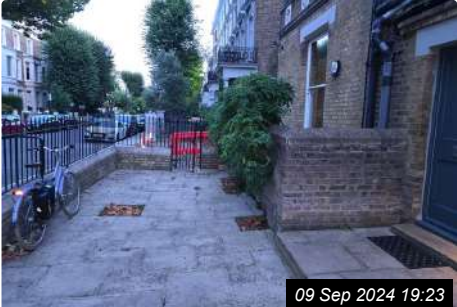
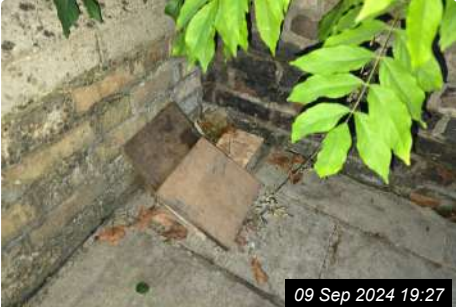
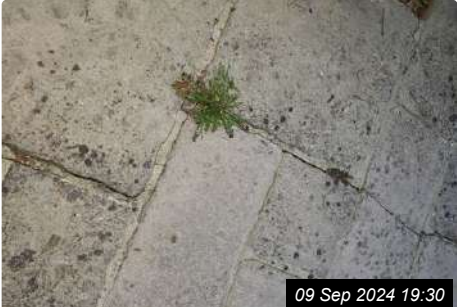
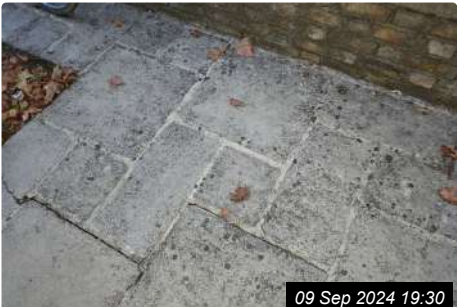
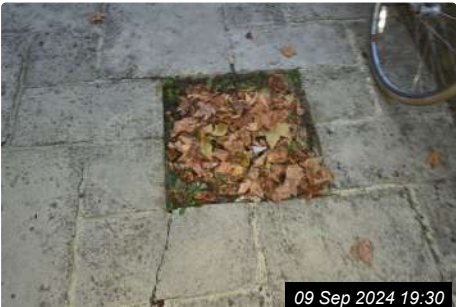
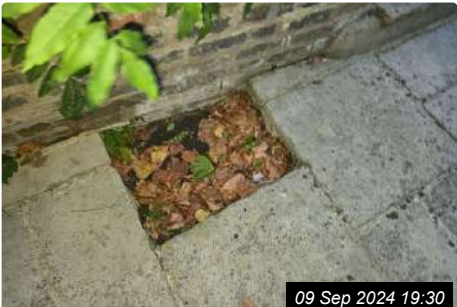
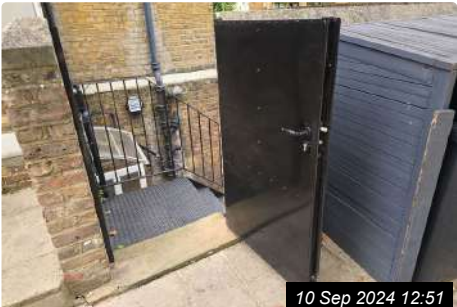
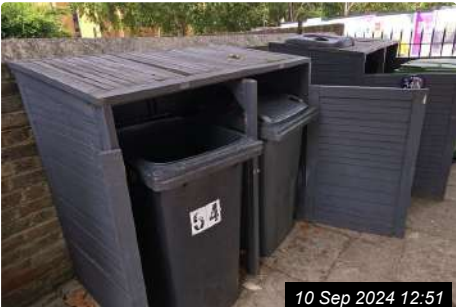
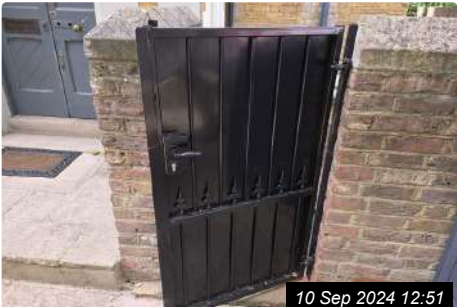
| 5. EXTERIOR FRONT | | | |
|---|---|---|---|
| 5.1<br> | Front garden | Courtyard style front garden with light Stone Paving and step with further paving to match leading to front door | Some Leaf debris too paving;<br>Two missing paving slams;<br>Minor weed growth between paving in parts<br>Loose paving to right hand side on ground |

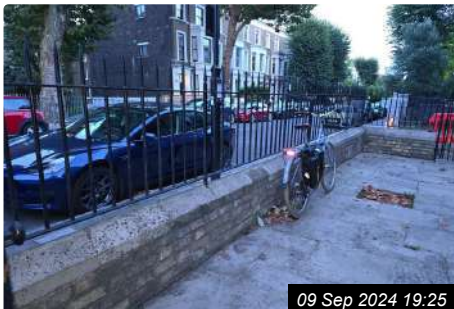
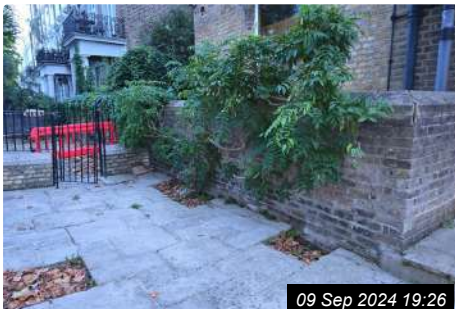
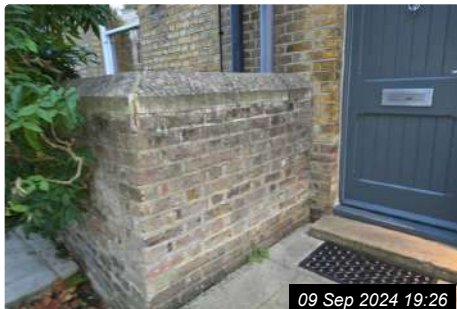
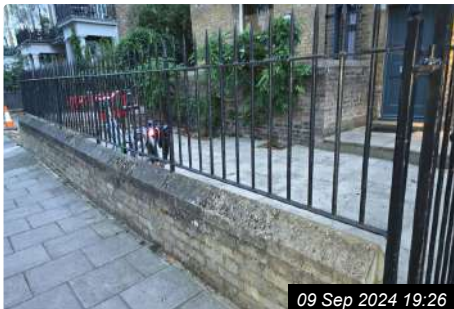
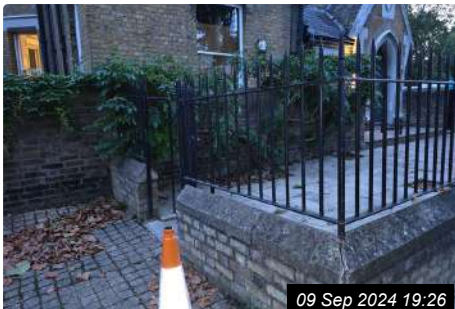
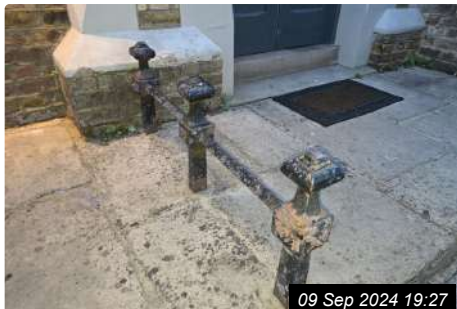
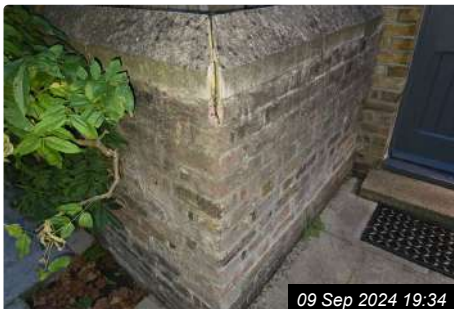
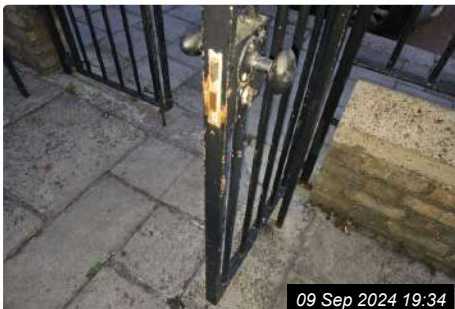
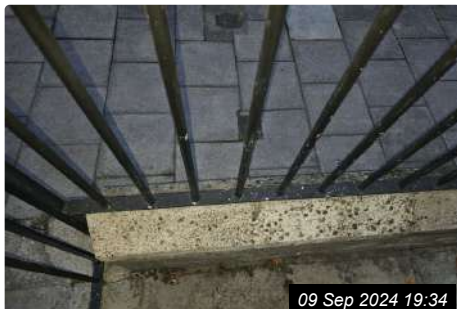
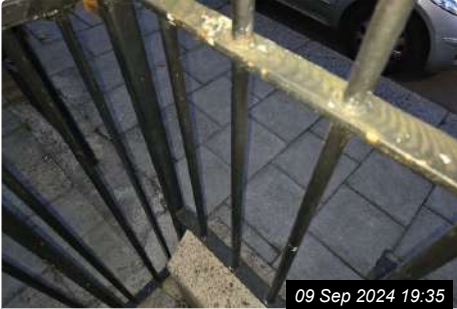
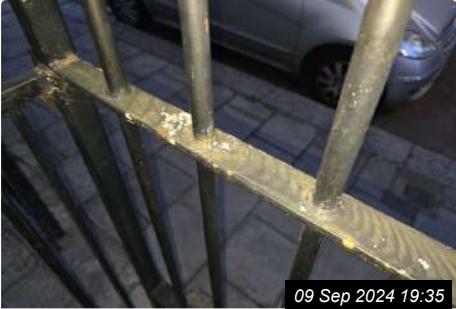
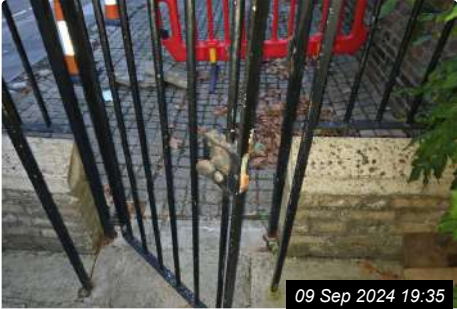
| 5. EXTERIOR FRONT (CONT.) | | | |
|---|---|---|---|
| 5.2<br> | Boundaries | <p>1- Light brown exposed brick wall with cement moulded coping and black metal fencing to top of front and right-hand side when exiting front door<br/>Black metal double Gate to front left hand side<br/>Single black metal gate to right hand side boundary</p> <p>2- Rear boundary is exposed brick wall with cement moulded coping to top</p> <p>3- Left hand side boundary is black metal ornate low fencing</p> | <p>Some signs of wear to fencing;<br/>Moss growth to walls, especially coping;</p> <p>1- Intact<br/>Some rust to Gates</p> <p>2- Rear boundary has crack to right hand side corner</p> <p>3- Surface wear to metal</p> |

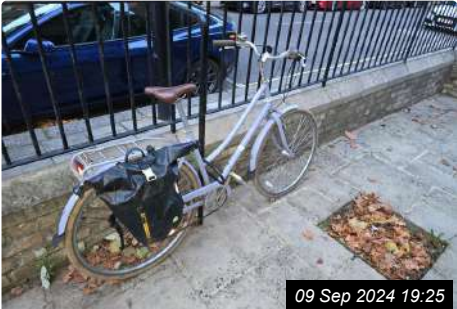
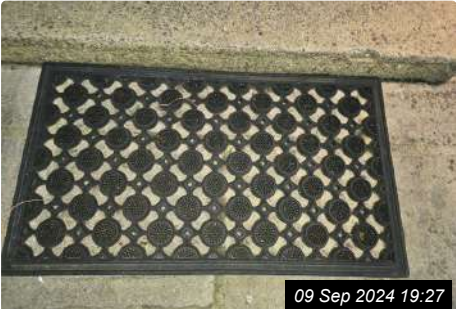
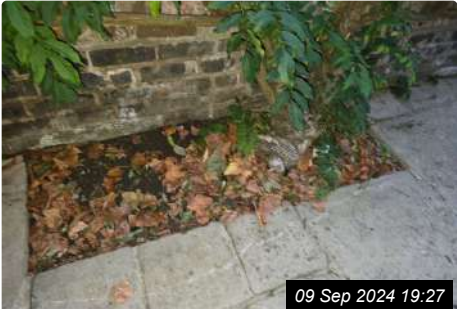
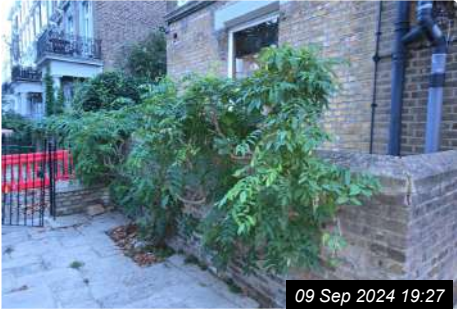
| 5. EXTERIOR FRONT (CONT.) | | | |
|---|---|---|---|
| 5.3 | Addition items/<br>Information | Push bike attached to metal fencing support of front boundary;<br><br>Black patterned rubber entry mat<br><br>Mature shrub planted against rear boundary | Unincluded item<br><br>Good condition; some signs of use<br><br>Good condition; seasonal growth |

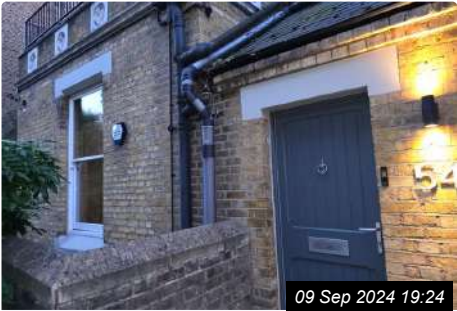
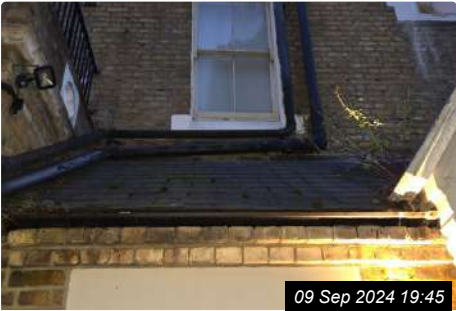
| 5. EXTERIOR FRONT (CONT.) | | | |
|---|---|---|---|
| 5.4 | Front face | Exposed brick exterior with molded cement lintels and molded patterning;<br><br>Greystone roof tiles and black plastic guttering;<br><br>One exterior sash window | Brickwork appears in a good condition;<br>Wire clip to Upper right side of front door;<br>Two white plastic rule plugs to right-hand side of black plastic bracket<br><br>Guttering has plant to growth<br>Moss to roofing tiles |

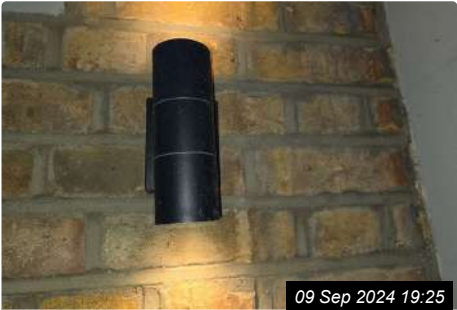
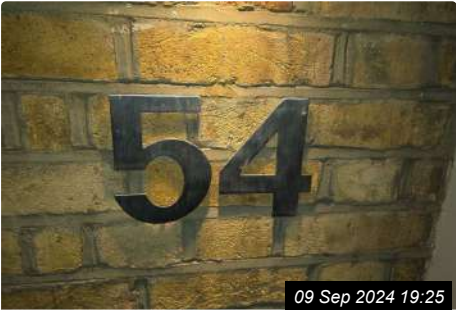
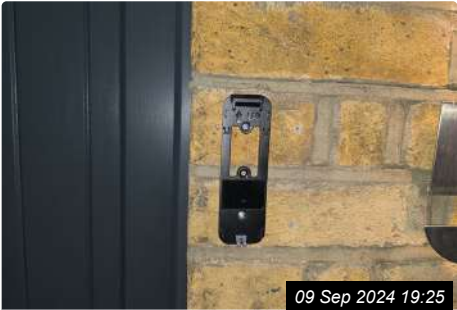
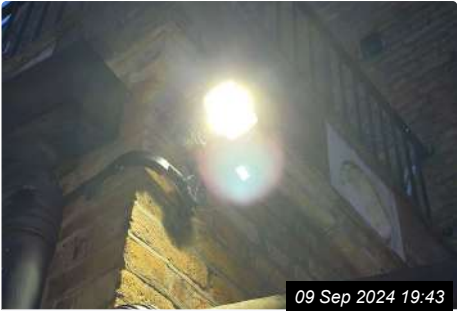
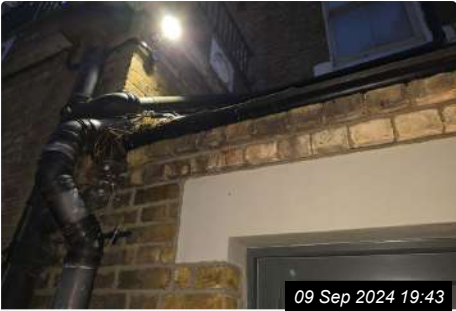
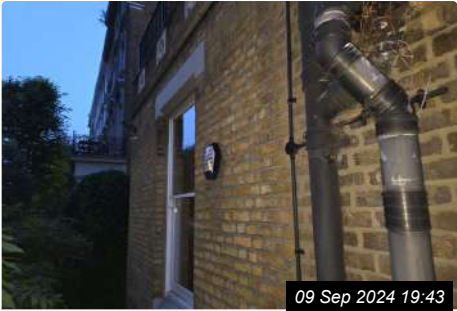
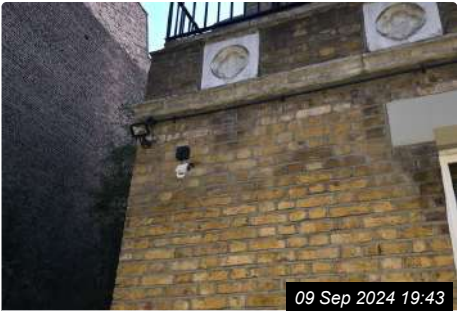
| 5. EXTERIOR FRONT (CONT.) | | | |
|---|---|---|---|
| 5.5<br> | Additional items/<br>Information | <p>Black blue and white plastic security cover;</p> <p>2 Black and clear sensor lights;</p> <p>White camera</p> <p>Black metal light fixture with two spotlights</p> <p>Brushed grey metal numerals five and four</p> <p>Black plastic wall mounted bracket</p> | <p>Numerals intact; dirt and minor marking/ rust to surface</p> <p>Light is in a good working order with dirt and cobwebs to exterior</p> <p>Doorbell bracket has dirt to surface</p> <p>Alarm cover appears in good condition; untested</p> <p>Sensor light closest to door works; appears in a good condition</p> <p>Sensor light to left hand side corner appears to be not working</p> <p>Camera untested</p> |

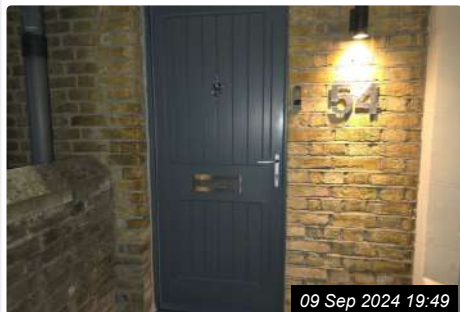
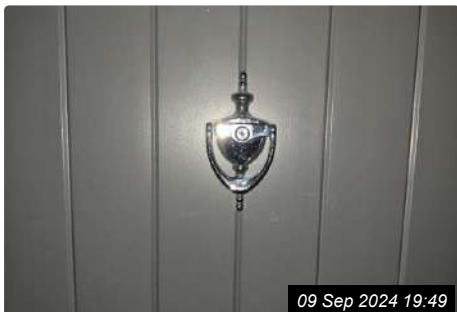
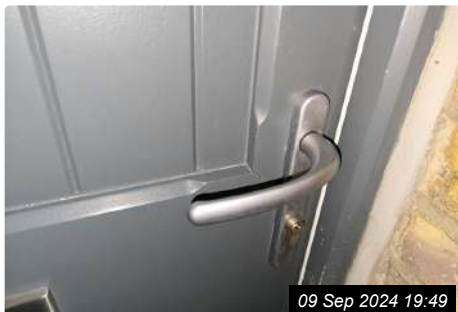
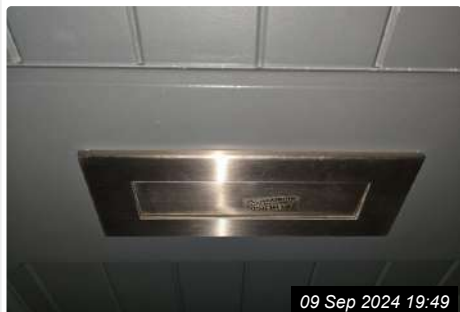
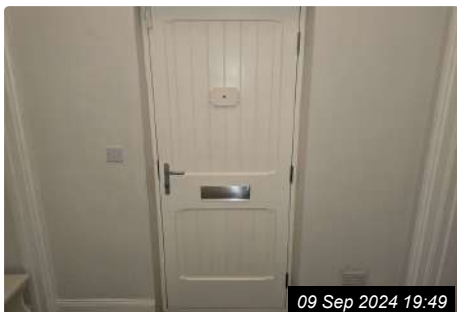
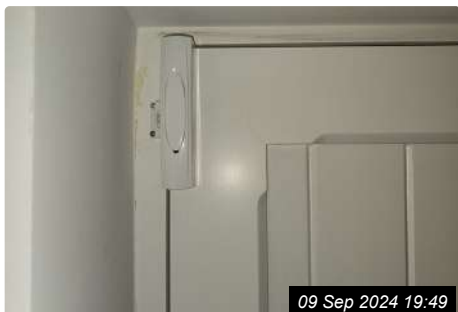
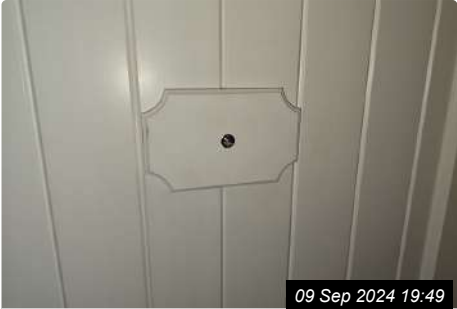
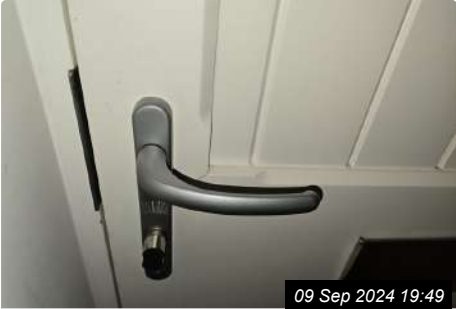
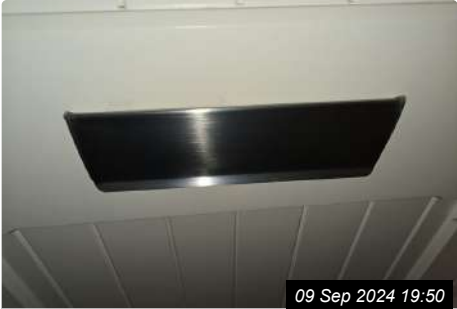
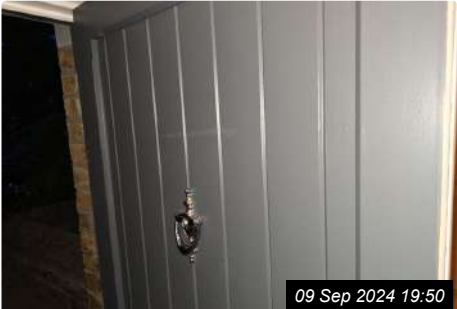
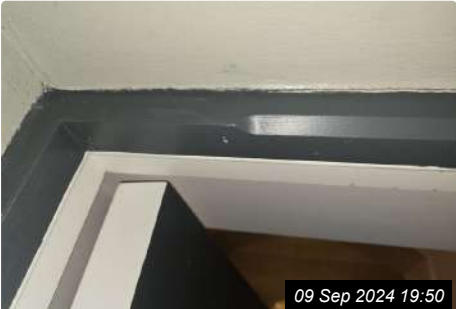
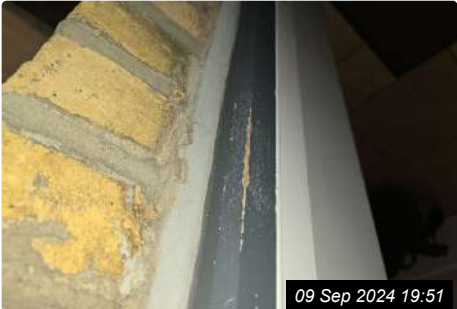
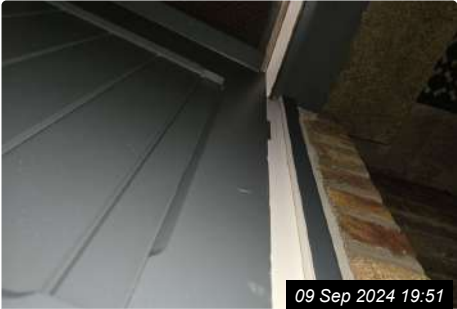
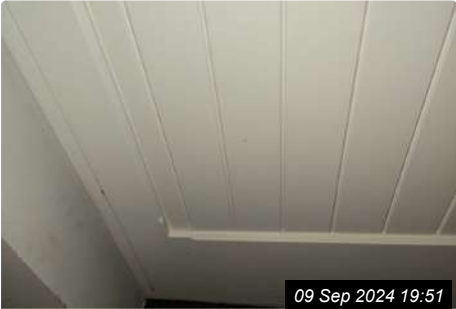
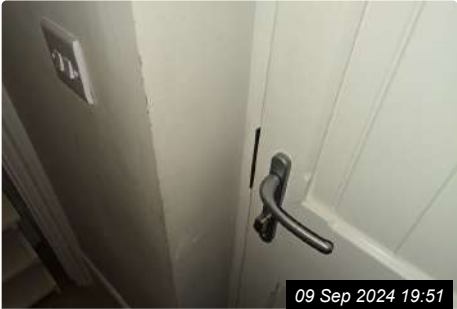
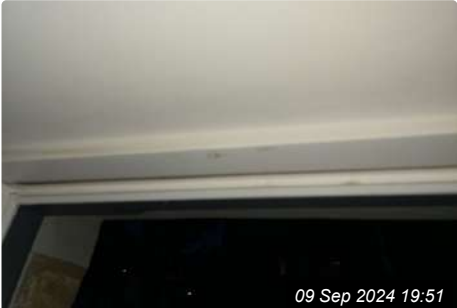
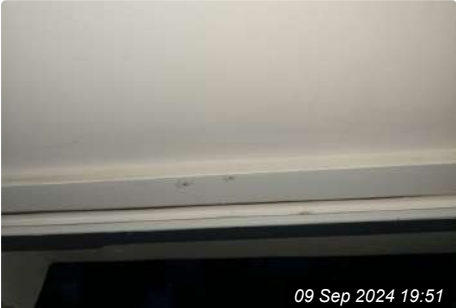
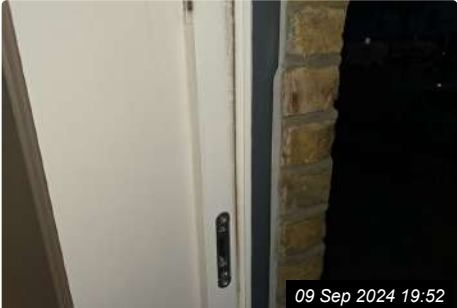
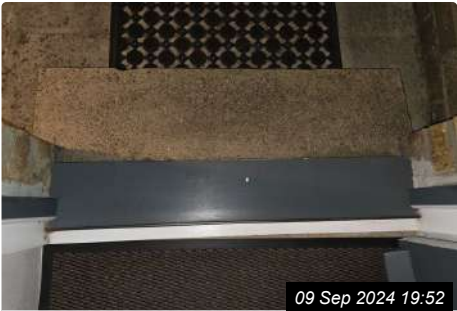
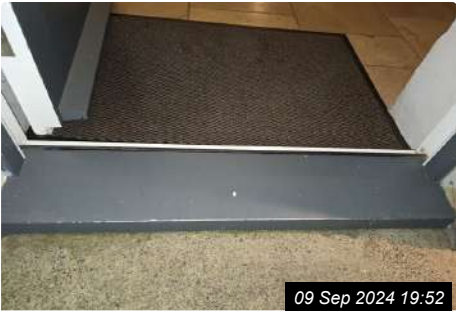
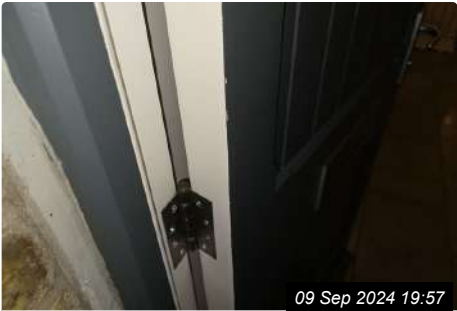
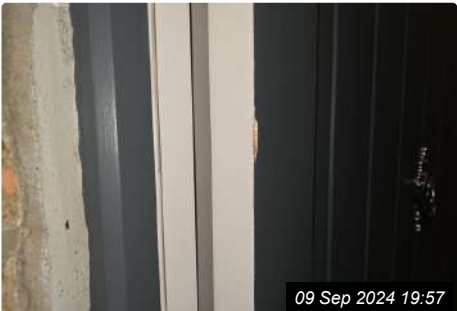
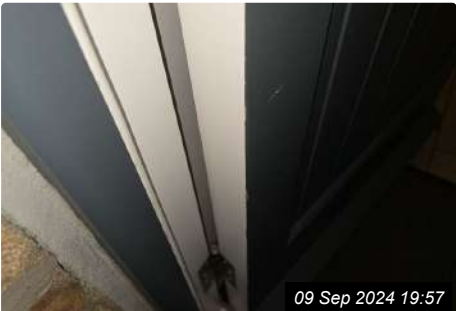
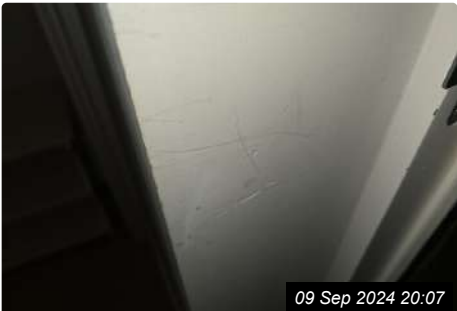
| 6. ENTRANCE HALL (CONT.) | | | |
|---|---|---|---|
| 6.1<br>📷 | Door/ Frame/<br>Threshold | <p>Door: Blue composite panel door with grey metal furniture; including: knocker with viewer, door handle with yellow lock and letterbox</p> <p>Interior: interior is white with white plastic security fitting, wooden plaque with viewer cover, handle with some twist lock and letterbox</p> <p>Frame: blue painted wooden to exterior and white painted wooden to interior with white plastic receiver to top left and three grey metal strike plates</p> <p>Threshold: blue painted to exterior and white painted to interior</p> | <p>Door exterior: Minor dust exterior chipping to left-hand side closing edge; minor marking to lower left-hand ; Mark to mid upper level; otherwise in good condition</p> <p>Door knocker has minor dirt and pitting/ corrosion to metal</p> <p>Door handle is in good working order with minor marking to handle</p> <p>Letterbox has very minor smudge marks and light scratching two surface and advising sticker stuck to Middle</p> <p>Interior: good condition; small crack to upper paneling lower left and right hand side corner</p> <p>Blackening to edges of viewer batten;</p> <p>Handle has very minor marking to surface;</p> <p>Letterbox in good working order</p> <p>Frame exterior has where to right hand side mid and some dirt and degrees to corners; interior has dark residue to Upper right hand side corner; chipping to corner near Two lower strike plates; otherwise in good condition</p> <p>Threshold is in a good condition consistent with use; where to exterior and interior top edges</p> <p>Chipping to corner of interior reveal left hand side and scratch marks to mid-level</p> |

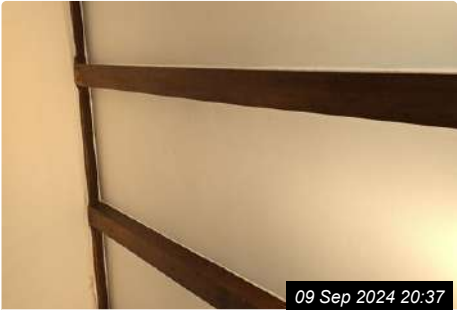
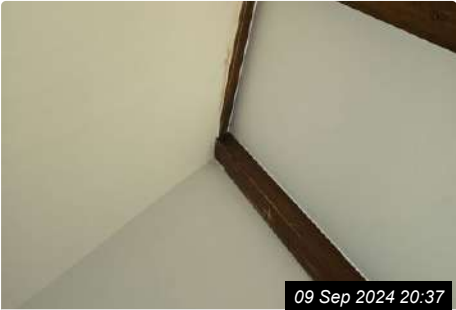
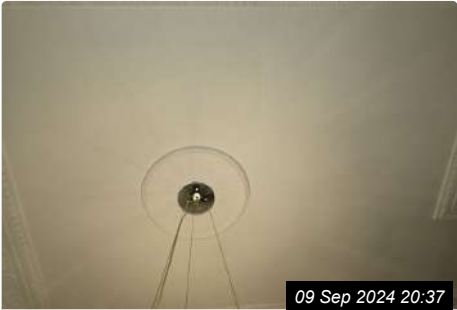
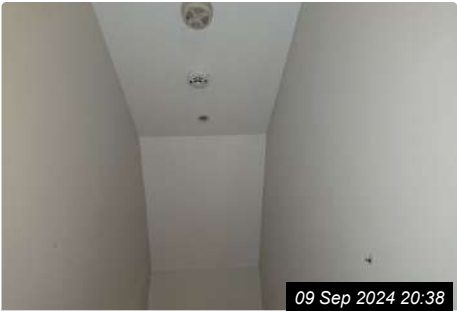
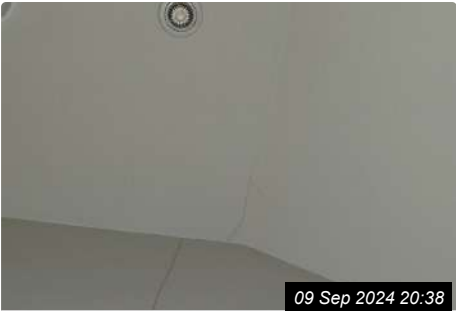
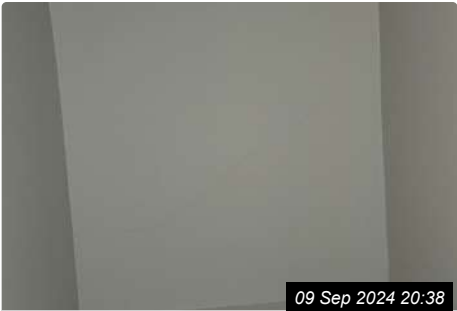
| 6. ENTRANCE HALL (CONT.) | | | |
|---|---|---|---|
| 6.2<br> | Ceiling | Smooth white painted with ornate coving; when entering there are wooden beams and there is one feature mould to the second section | In a good condition and intact; cracking two section near WC |

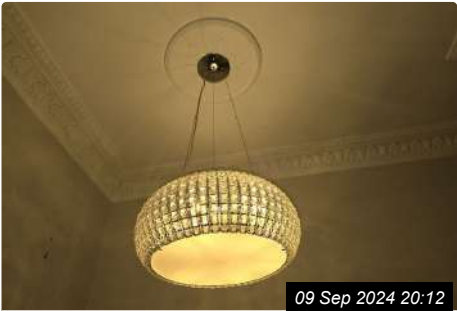
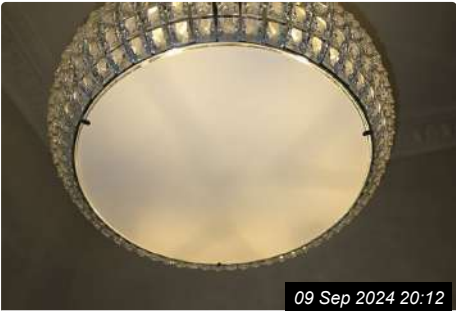
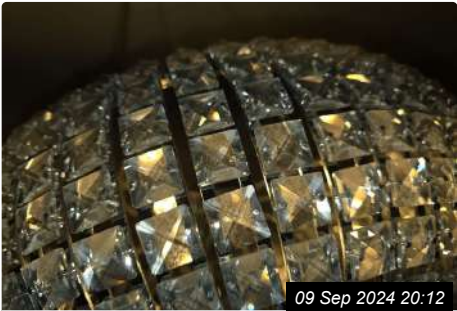
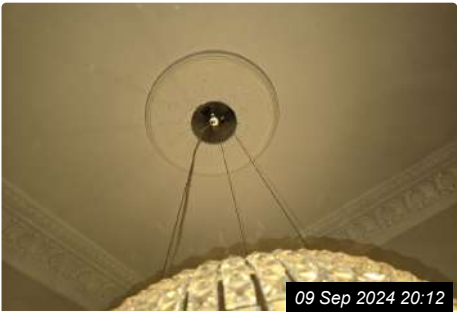
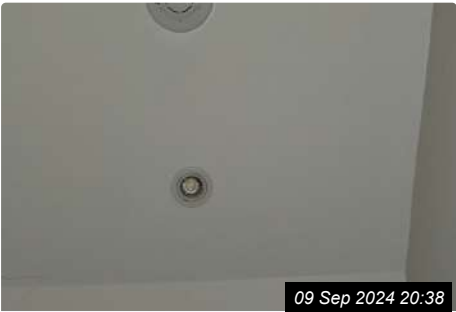
| 6. ENTRANCE HALL (CONT.) | | | |
|---|---|---|---|
| 6.3 | Lighting | <p>Play glass pyramid shaped shade with opaque glass circle two bottom with three grey chords and grey ceiling rose</p> <p>Single insets spotlight with white plastic surround</p> | <p>In working order; some dirt and dust to interior of clear glass otherwise appears in good condition</p> <p>Appears to be not working or switch not located</p> |

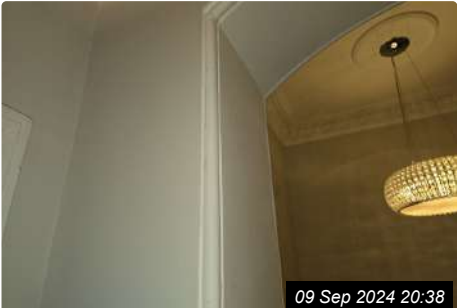
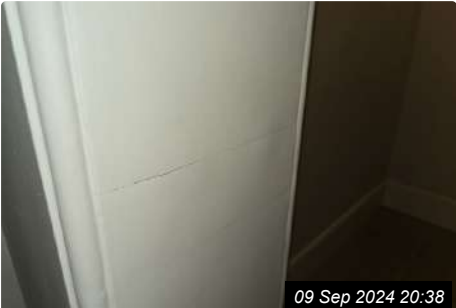
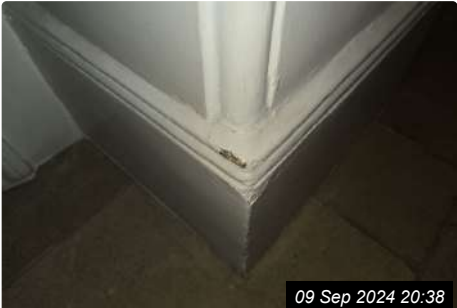
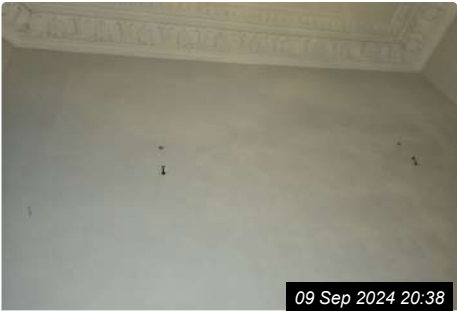
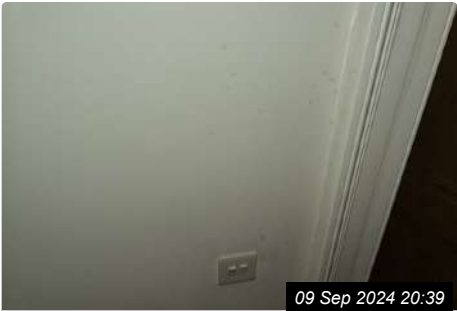
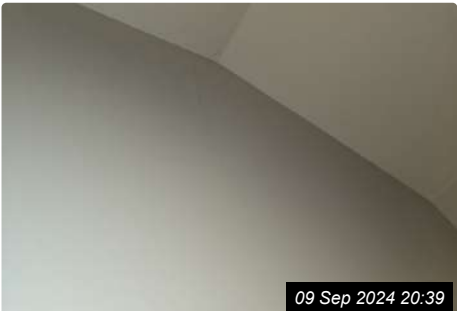
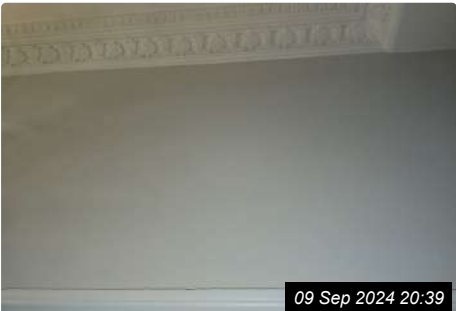
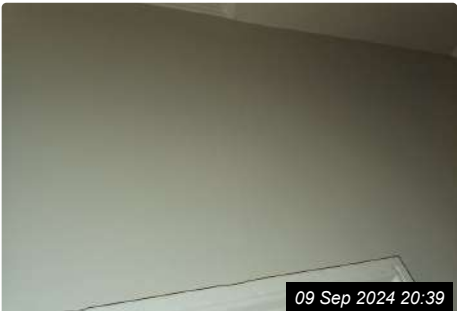
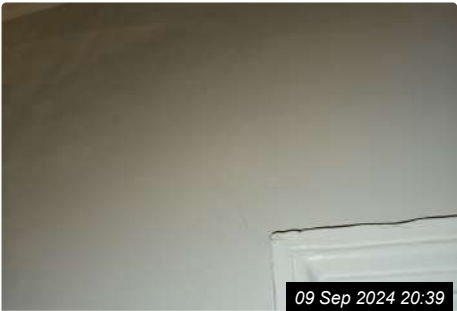
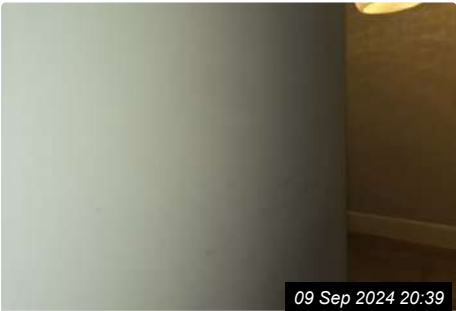
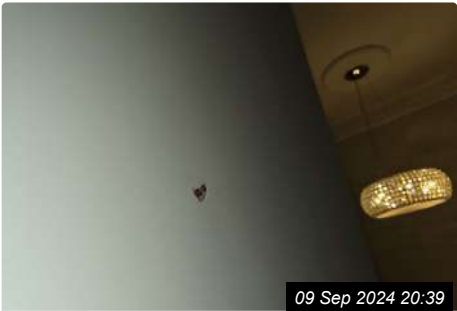
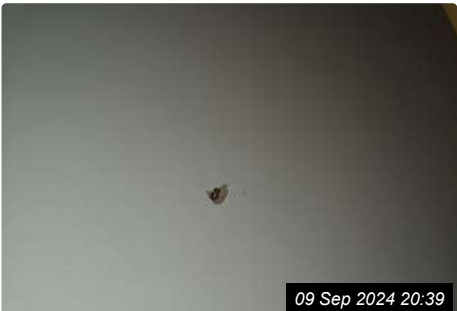
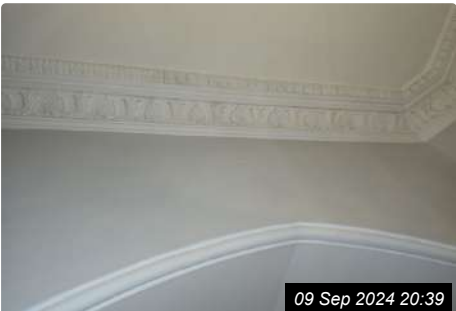
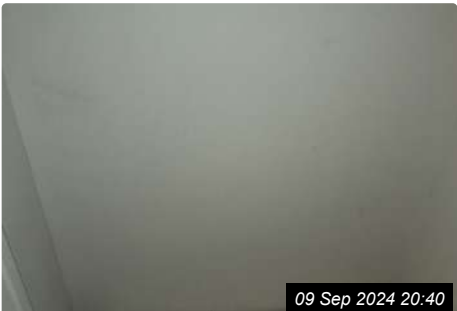
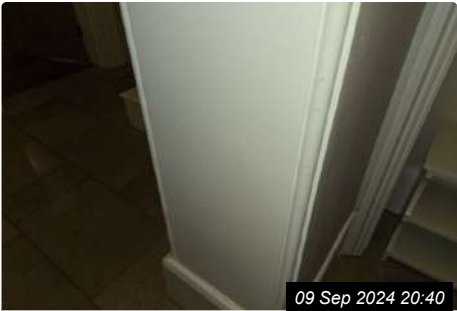
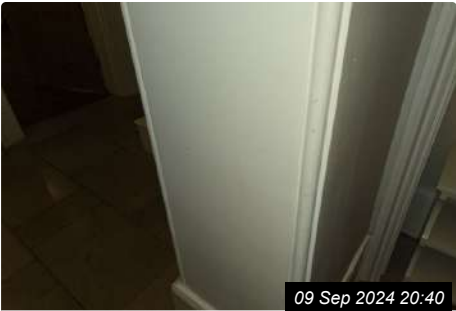
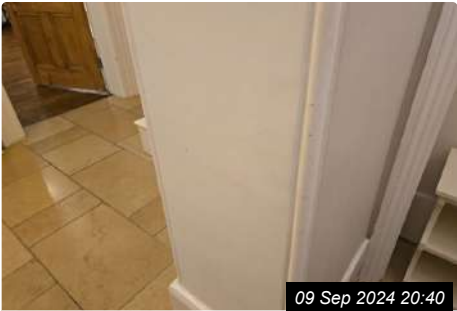
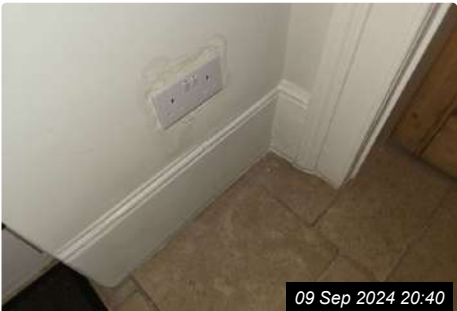
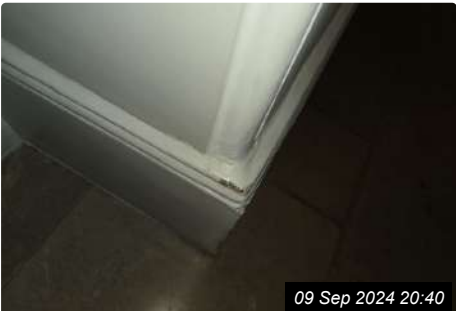
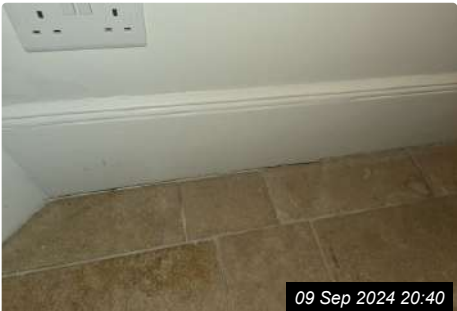
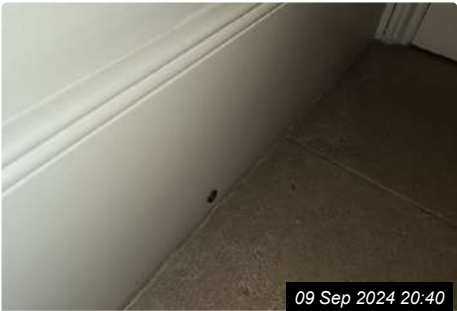
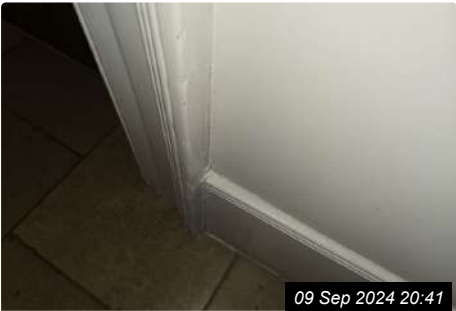
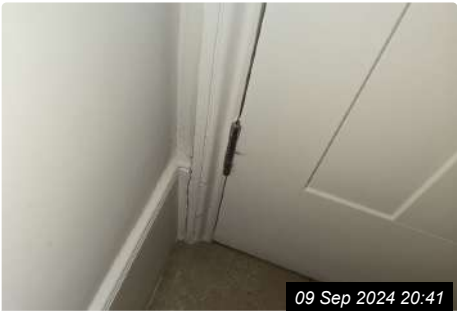
| 6. ENTRANCE HALL (CONT.) | | | |
|---|---|---|---|
| 6.4<br> | Walls / Skirting | <p>Smooth off white painted walls</p> <p>Smooth white painted moulded Arch</p> <p>White painted wooden frame to right hand side upon entry</p> <p>White painted high profile wooden skirting where's wooden utility cover to right hand side wall</p> | <p>Generally in a good condition;</p> <p>Watermarks to right-hand side running running from the top of the wooden beams</p> <p>Minor cracking to upper level left hand side of Arch and mid-level; line marking to right hand side mid to lower level; wall above arch far side some cobwebs</p> <p>Left hand side wall: Two protruding screws to upper level and two holes; some discolouration and marking throughout right hand side</p> <p>Far wall: some marking around light switch; stain mid-level left hand side; minor cracking to Upper left-hand side and upper right-hand side of door frame to living room; cracking to right hand side; light staining two right hand side of wall lower level</p> <p>Right hand side wall: ferry minor marking above toilet door frame; mid level marking to right hand side of stairs; screw protruding and damage to plaster to Upper right hand side of entrance to stairs; marking mid to a level in recess near door</p> <p>Rear wall: Cracking to the upper left-hand side of front door discoloration mid to low level to left-hand side of front door; signs of damage and low quality repair to wall surrounding socket to right-hand side of front door</p> <p>Skirting: crack to seal at bottom to left hand side; painted over defects; crack to right hand side of kitchen door frame and left-hand side of water closet door frame minor marking two left-hand side light chipping to corners on right hand side; marking and surface chipping slash cracking to utility cover surface damage to left hand side near corner of skirting on archway as you enter; broken door stop to left hand side of water closet entrance</p> |

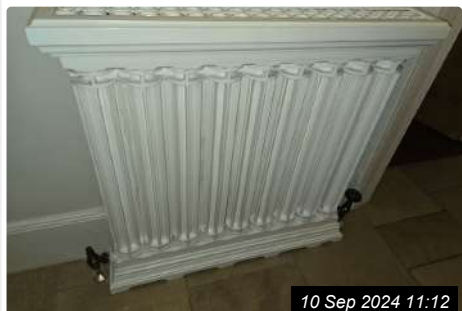
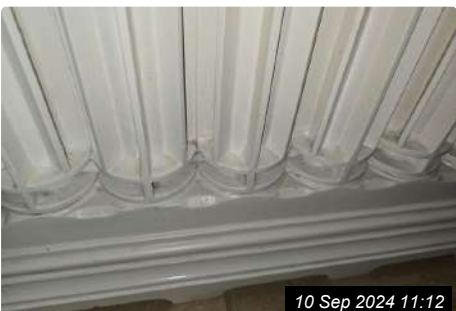
| 6. ENTRANCE HALL (CONT.) | | | |
|---|---|---|---|
| 6.5 | Heating | White metal ornate patterned radiator | Light dirt and discoloration to front; otherwise appears in good condition |

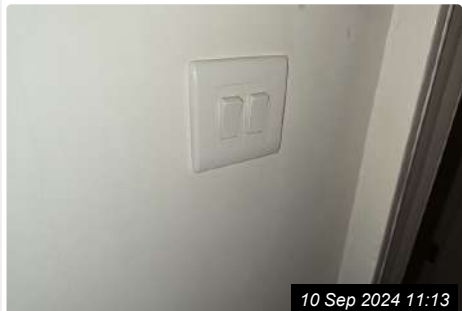
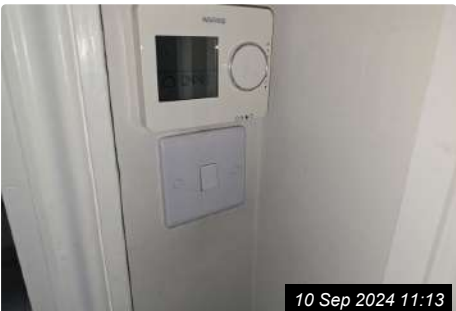
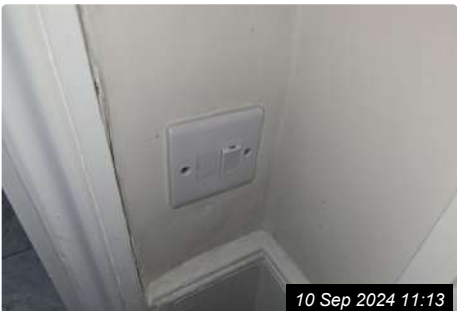
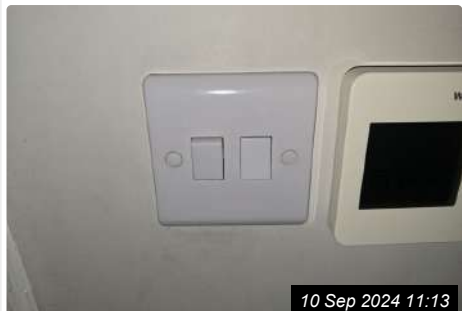
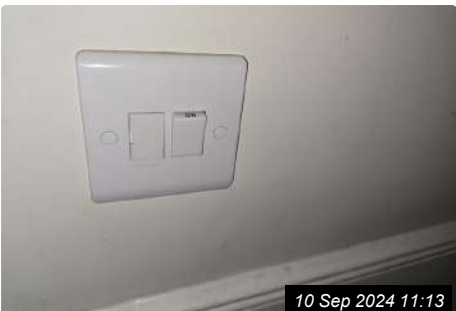
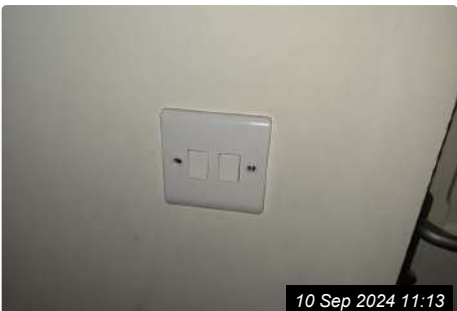
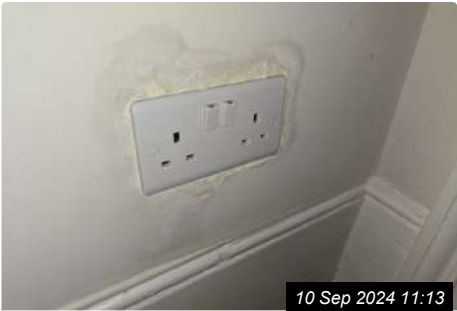
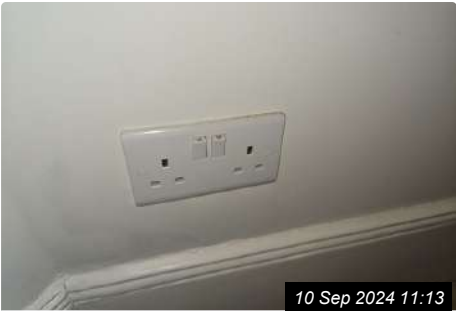
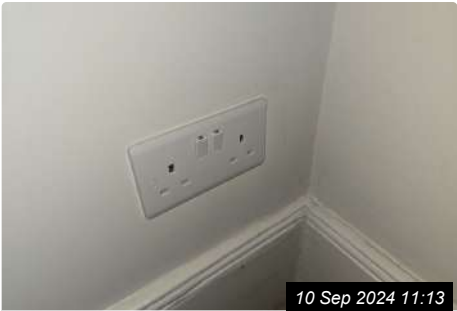
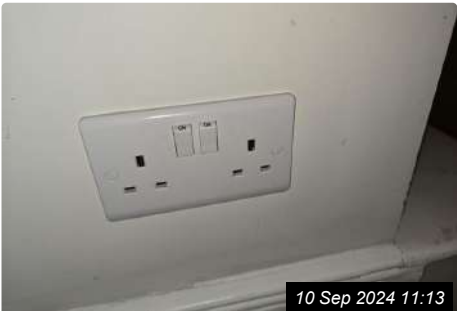
| 6. ENTRANCE HALL (CONT.) | | | |
|---|---|---|---|
| 6.6 | Switches / Sockets | White plastic:<br>Three Double light switches<br>Single light switch<br>Two fuse switches<br><br>4 double plug sockets | Light switches in good working order<br><br>Fuse switches and sockets appear in good condition |

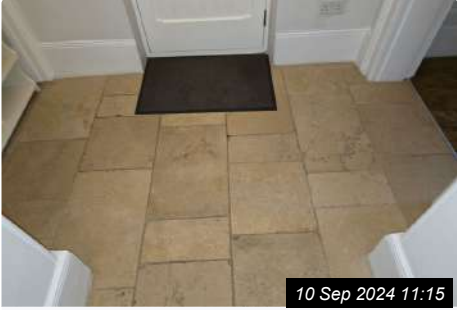
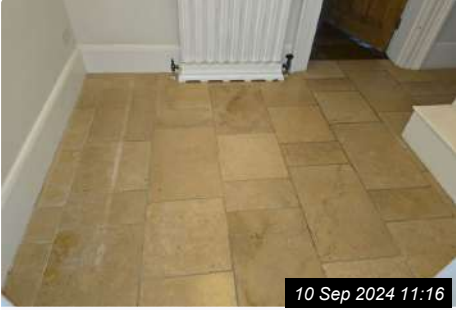
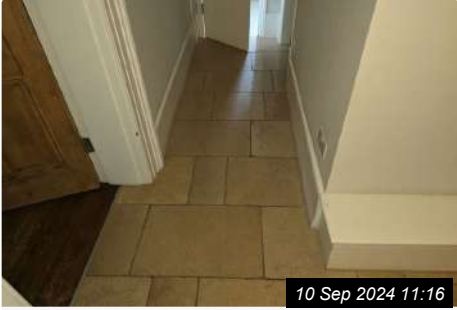
| 6. ENTRANCE HALL (CONT.) | | | |
|---|---|---|---|
| 6.7 | Flooring | Light brown stone tiling with light brown grouting | In a good condition with signs of use and minor defects in places |

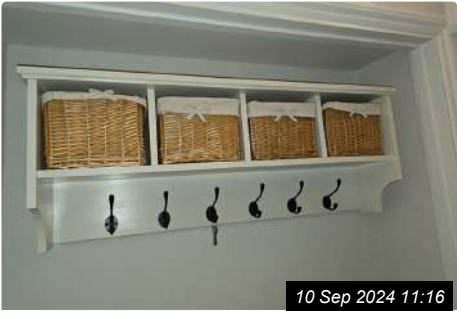
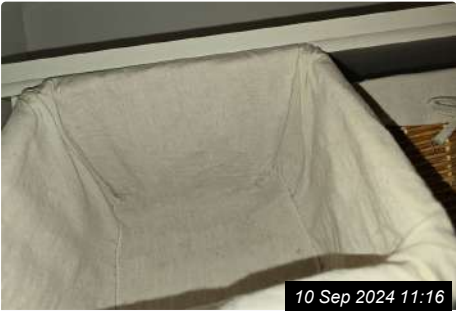
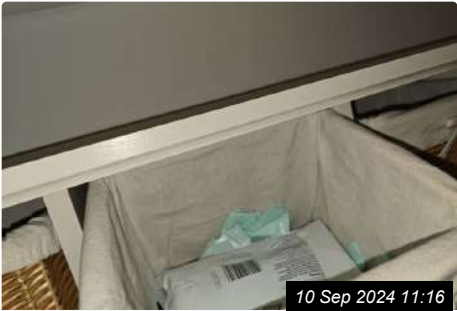
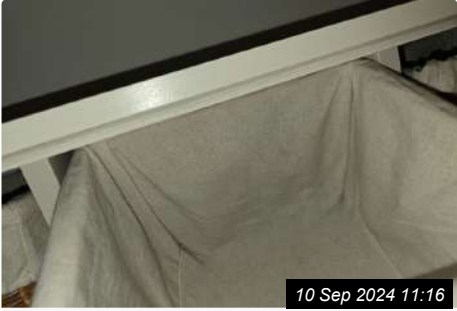
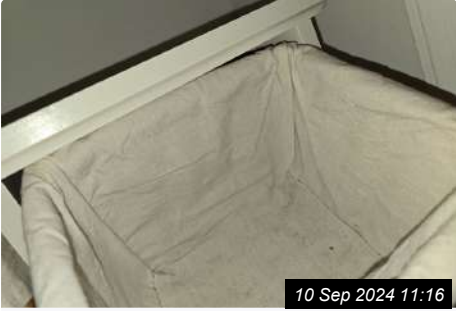
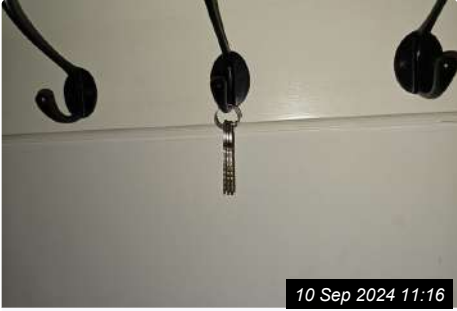
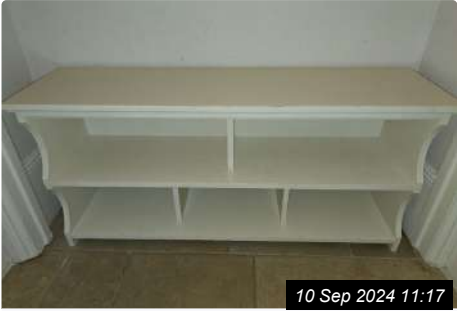
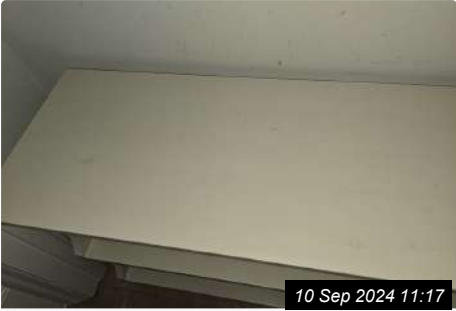
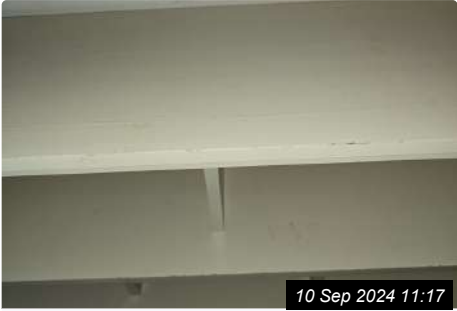
| 6. ENTRANCE HALL (CONT.) | | | |
|---|---|---|---|
| 6.8 | Furnishings | <p>White wooden wall mounted units with four Brown wicker baskets with off-white material insects and 6 black metal hooks to bottom</p> <p>White wooden shoe rack with five compartments and one shelf</p> | <p>A good condition intact; minus signs of use; dirt to Interiors of with the inserts; items left in middle left-hand side insert; three keys to gym room hanging on hook</p> <p>Intact; signs of use; light marking throughout; chipping to leading edges</p> |

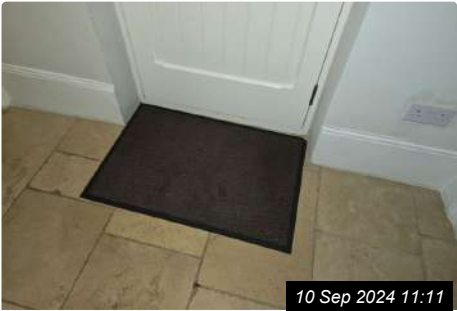
| 6. ENTRANCE HALL (CONT.) | | | |
|---|---|---|---|
| 6.9 | Additional items | 2 Off white plastic warm up heating controls<br><br>Black and brown material and black rubber entry mat | Very minor dust / residue to tops; tested for power; appear good condition<br><br>Signs of use but in a reasonable condition |

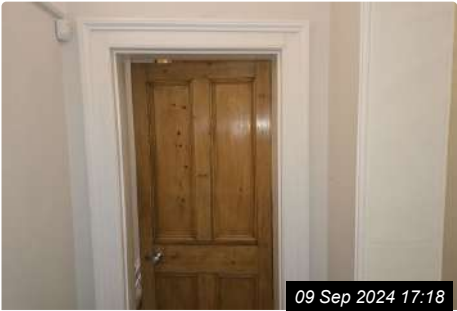
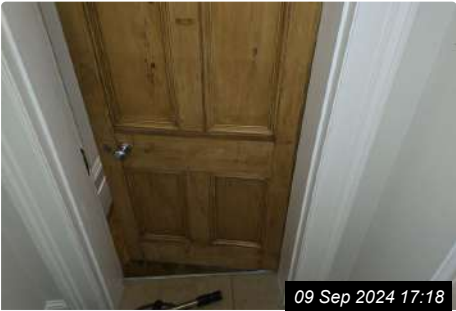
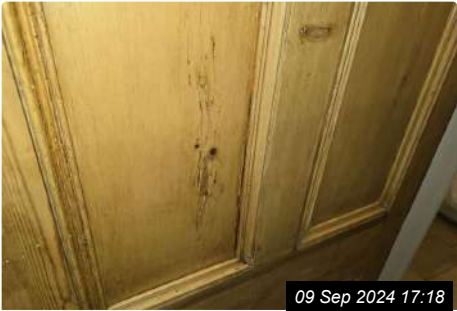
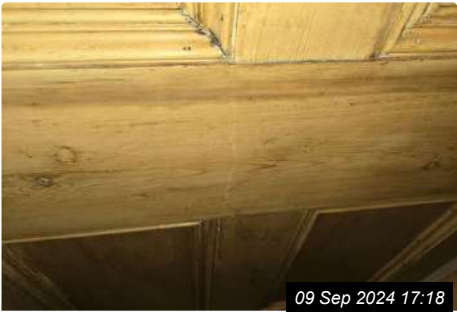
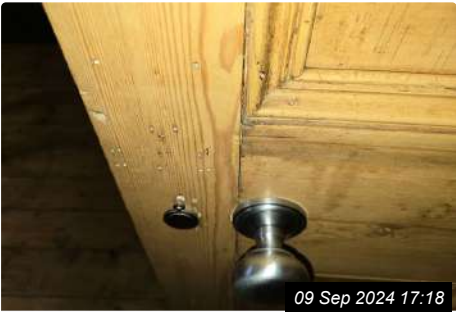
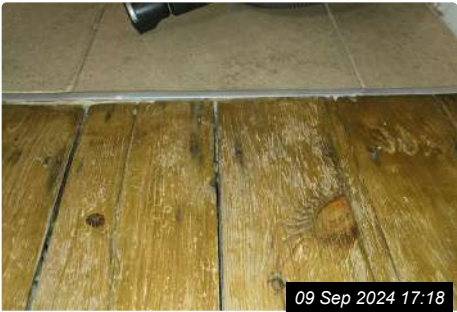
| Ref | Name | Description | Condition |
|---|---|---|---|
| 7.1<br>📷 | Door/ Frame/<br>Threshold | <p>Door: Brown wooden four panel door with Gray metal furniture including: two handles and two mortice lock covers</p> <p>Reverse: to match</p> <p>Frame: White painted wooden frame; grey metal strike plate</p> <p>Threshold: grey metal transverse strip</p> | <p>Door: Signs of age; surface damage to left hand side up a panel and to middle of door some marking and pitting to exterior and interior; handles and lock covers in very good condition</p> <p>In working order</p> <p>Frame: in good condition; painted over defects</p> <p>Threshold: lifted from room flooring; slightly bent in places; condition consistent with use</p> |
