# Inventory & Schedule of Condition

Prepared on behalf of Example Lettings Ltd

123 Preview Street  
Sample City  
London  
AB1 2CD

**September**  
**13th 2024**

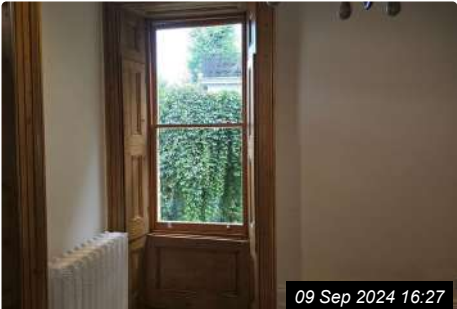
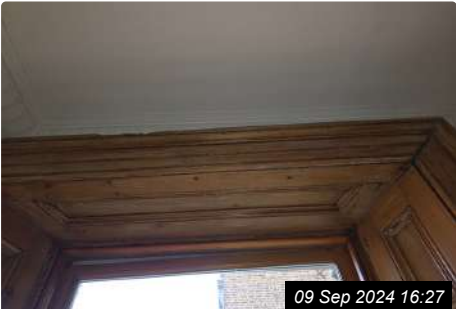
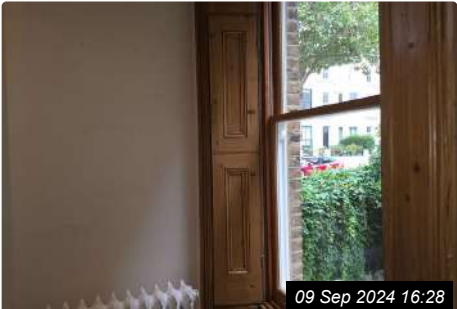
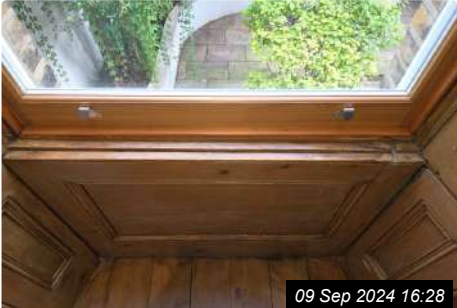
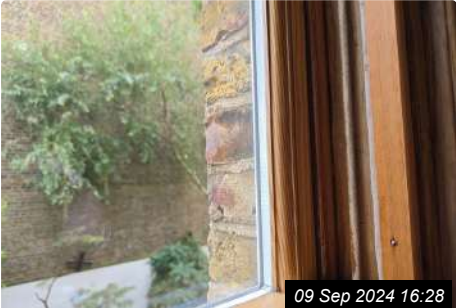
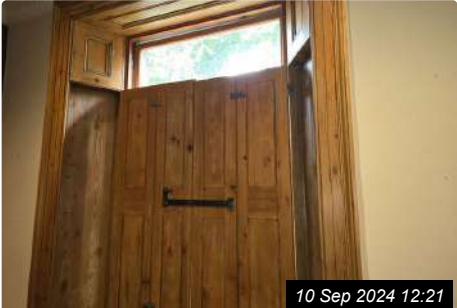
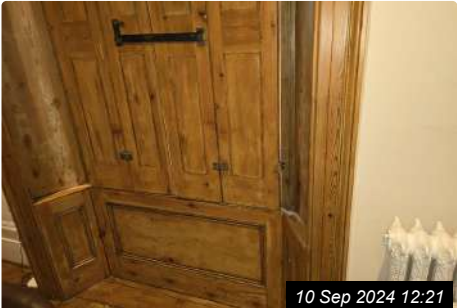
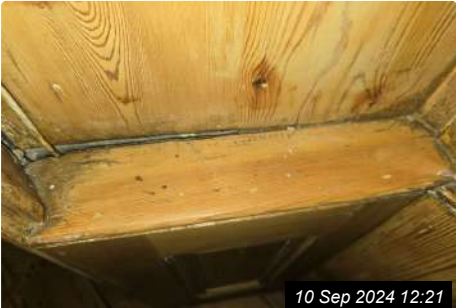
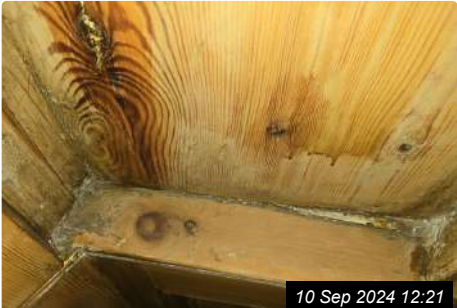
| 7. RECEPTION ROOM 1 (CONT.) | | | |
|---|---|---|---|
| 7.2<br> | Window(s) / Sill | <p>Window 1: Brown wooden frame sash window with two cleared glass panes and two Chrome Effect metal locks and handles; Brown wooden reveals to match</p> <p>Shutter 1: Brown wooden folding shutter with dark metal furniture; with wooden panelling below</p> <p>Window 2: Brown wooden frame sash window with two cleared glass panes and two Chrome Effect metal locks and handles; Brown wooden reveals to match</p> <p>Shutter 2: Brown wooden folding shutter with dark metal furniture; with wooden panelling below</p> | <p>Window 1: in good condition with some dirt to pains and Cobbs webbing to middle right-hand side; in working order</p> <p>Shutter 1: right hand side shatter does not shut properly; signs of age and use deep gouging to top of wooden panel at bottom generally indents scratches repair holes and where two surface</p> <p>Window 2: working order; signs of age; dirt and marking to window pain interior in places; window frame has damaged to lower right hand side</p> <p>Shutters 2: Shutters in working order; do not stay in alcoves when open</p> |

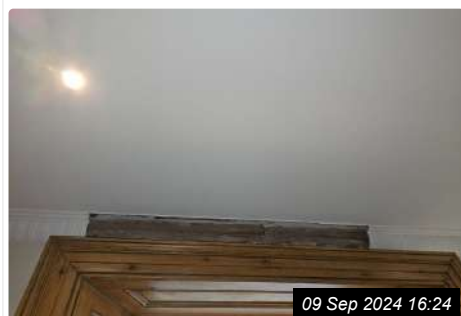
| 7. RECEPTION ROOM 1 (CONT.) | | | |
|---|---|---|---|
| 7.3 | Ceiling | Smooth white painted with ornate coving and moulding to center | In good condition; section of coving missing above window to left hand side |

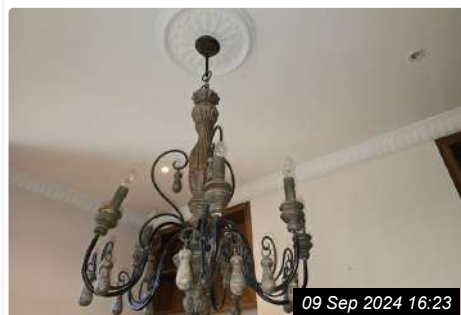
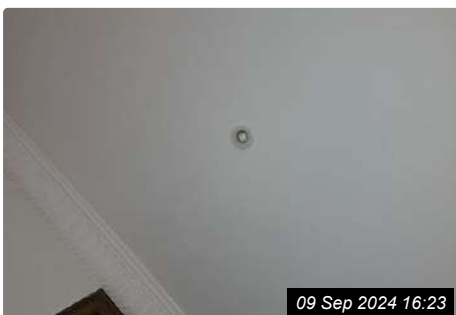
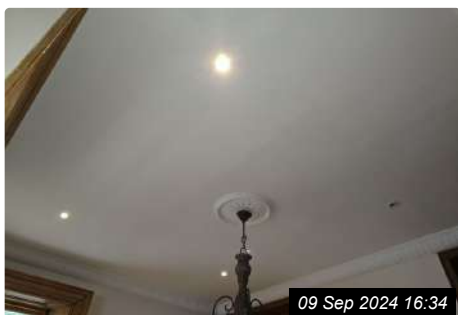
| 7. RECEPTION ROOM 1 (CONT.) | | | |
|---|---|---|---|
| 7.4<br> | Lighting | <div>Large black metal and dark brown wooden chandelier to center</div> <div>4 inset spotlights with white plastic surrounds</div> | <div>Chandelier is not working; appears intact</div> <div>Spotlights in good working order other than right hand side upon entry not working</div> |

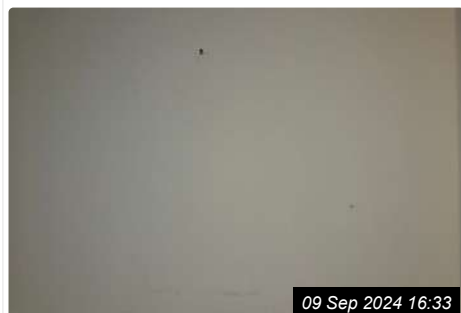
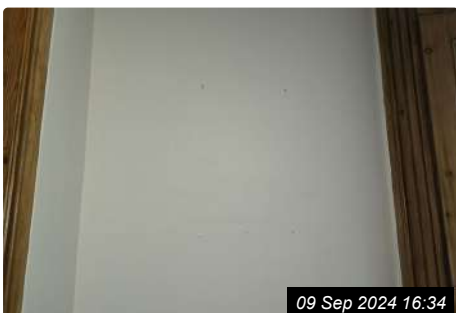
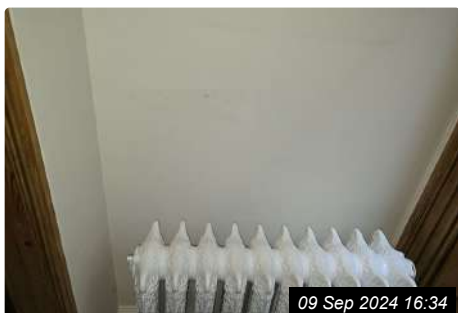
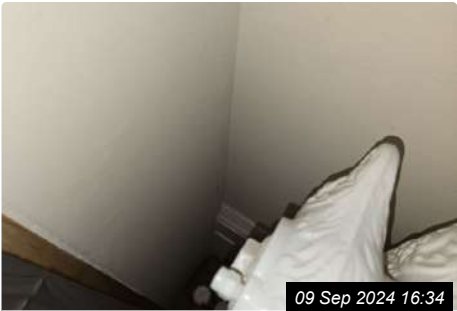
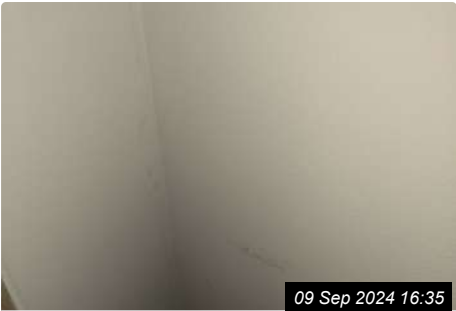
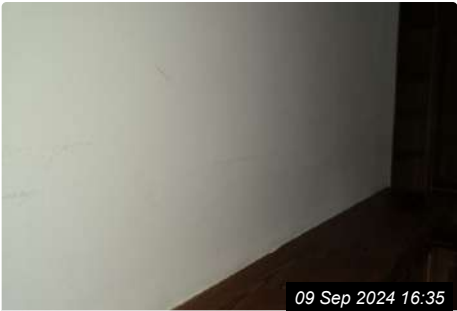
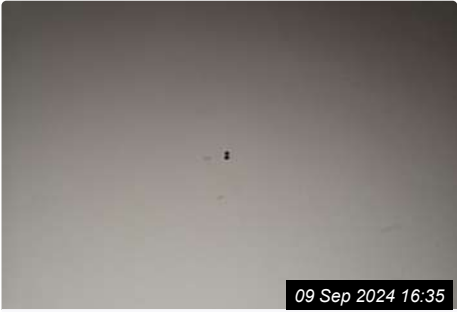
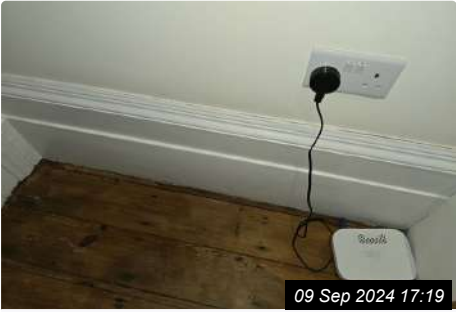
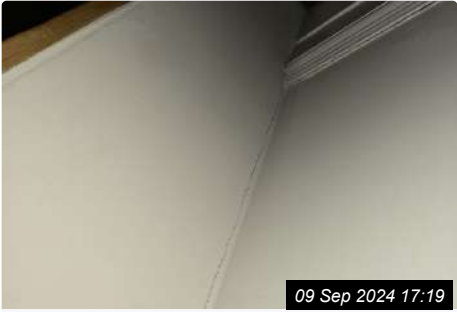
| 7. RECEPTION ROOM 1 (CONT.) | | | |
|---|---|---|---|
| 7.5<br> | Walls / Skirting | <div>Smooth white painted walls</div> <div>High profile white wooden skirting</div> <div>Grey metal and black plastic door stop</div> | <div>Left hand side wall: marking to mid level; single protruding nail to mid-level left hand side; four nails protruding to mid-level to right hand side; cracking to left hand side of ornate radiator with surface damage</div> <div>Far wall: cracking to right hand side of window reveal; Mark to mid-level right hand side of window</div> <div>Right hand side wall: marking to low level; crack to left hand side; screw protruding to Middle upper level; marking above fireplace mid to high level</div> |

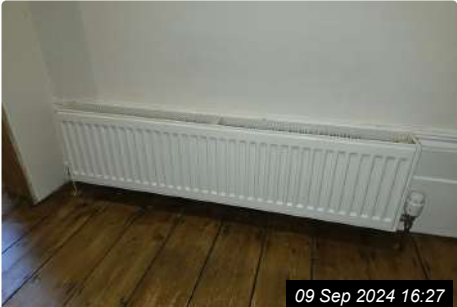
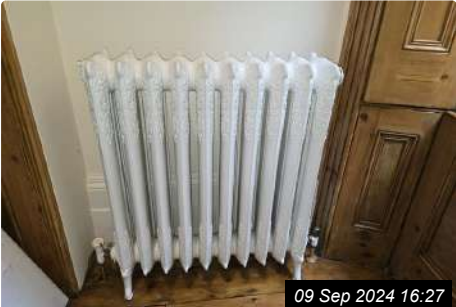
| 7. RECEPTION ROOM 1 (CONT.) | | | |
|---|---|---|---|
| 7.6 | Heating | White metal ornate radiator<br><br>White metal panel radiator | Untested<br>Both appear in good condition |

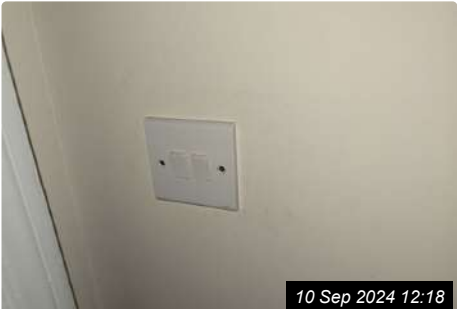
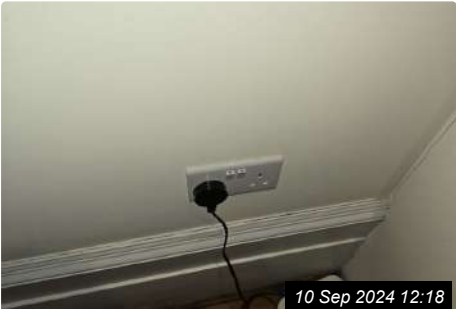
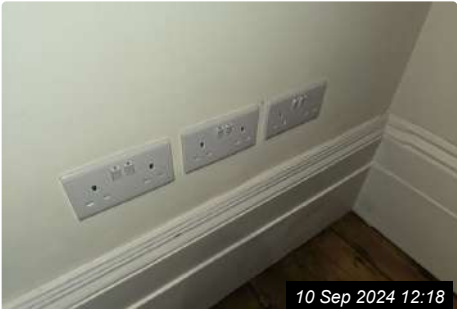
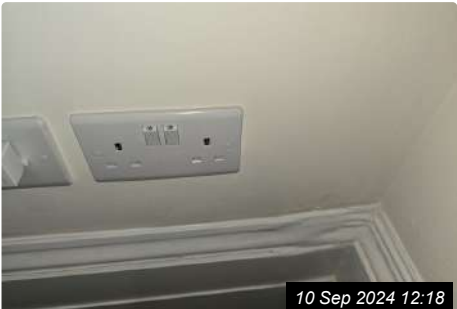
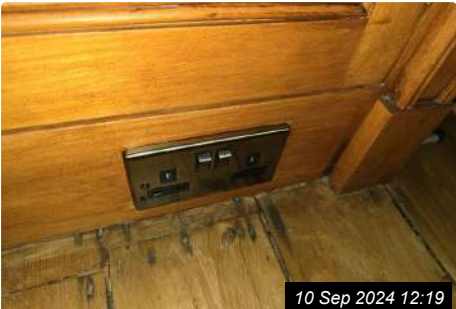
| 7. RECEPTION ROOM 1 (CONT.) | | | |
|---|---|---|---|
| 7.7 | Switches / Sockets | White plastic double switch<br><br>Five white plastic double sockets<br><br>Grey metal and black plastic double socket | Switch in working order<br><br>Sockets untested; appear in good condition |

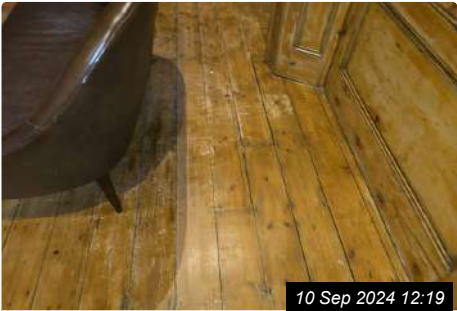
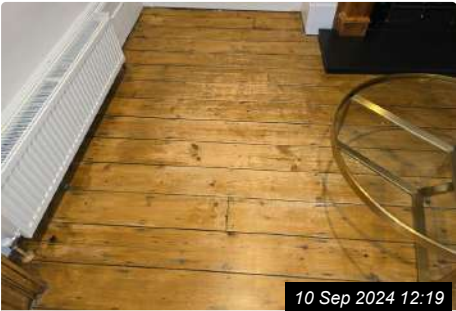
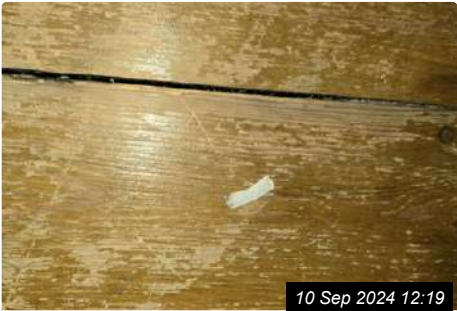
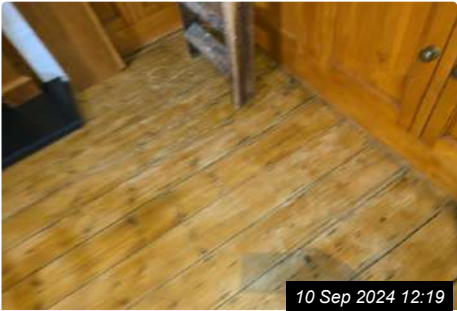
| 7. RECEPTION ROOM 1 (CONT.) | | | |
|---|---|---|---|
| 7.8<br> | Flooring | Brown wooden floorboards | Intact; where to traffic areas especially edges; signs of age |

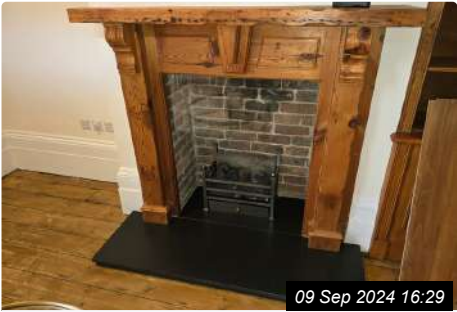
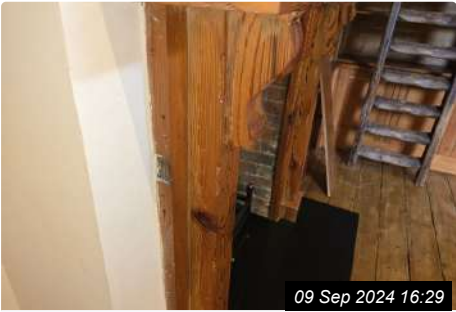
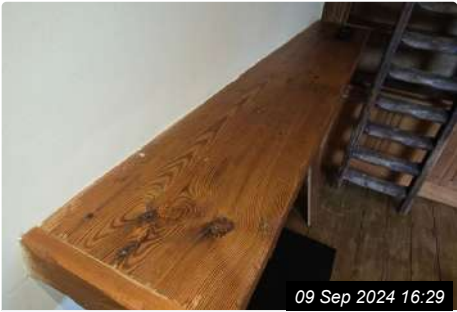
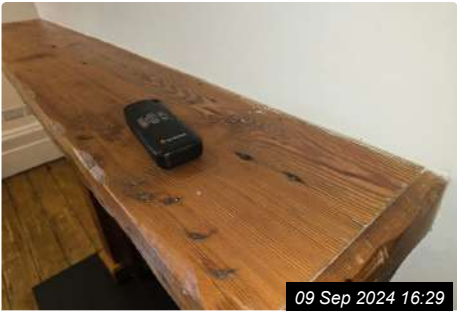
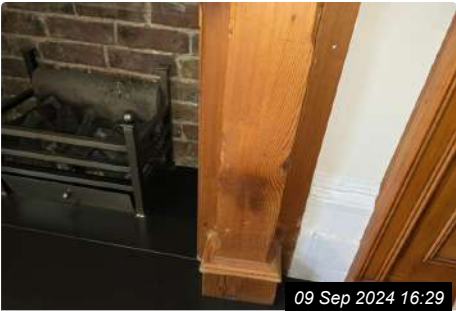
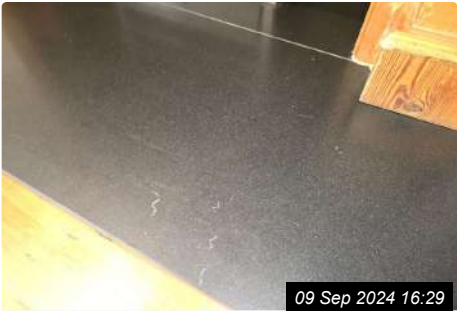
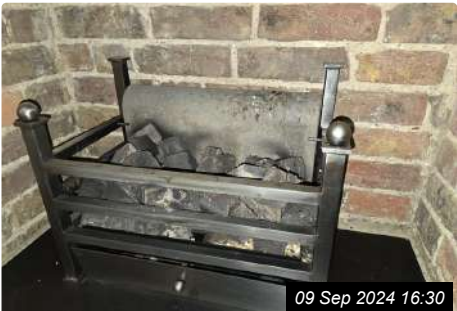
| 7. RECEPTION ROOM 1 (CONT.) | | | |
|---|---|---|---|
| 7.9<br> | Fireplace | Brown wooden surround and mantle; interior is brickwork; Hearth is Black Stone fire basket is grey metal withdraw to bottom and contains black charcoal | Untested<br>Appears in good condition consistent with use and age; dents and holes to Mantle; where two surface of surround; residue to rear of fibre basket; minor debris to hearth; surface scratches to near right hand side of hearth<br>Black plastic New – Flame remote on top of mantle |

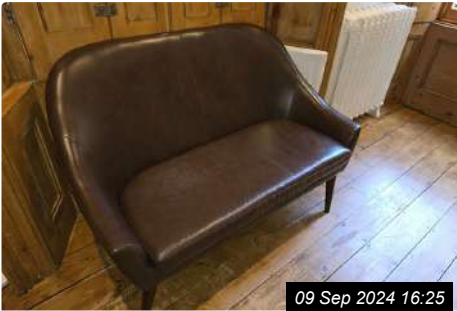
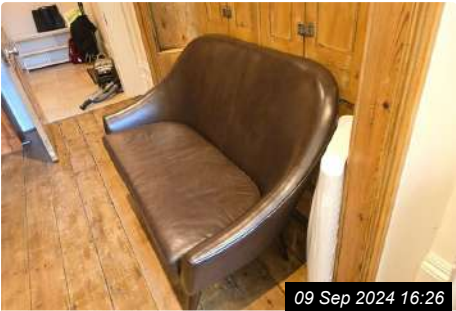
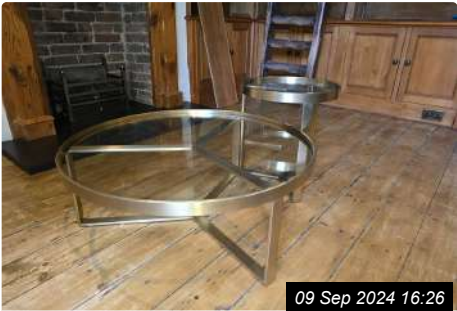
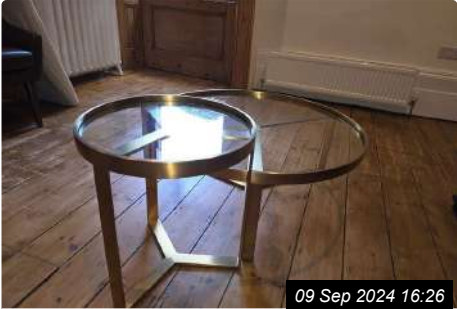
| 7. RECEPTION ROOM 1 (CONT.) | | | |
|---|---|---|---|
| 7.10<br> | Furnishings | <p>Seating: Brown leather effect sofa with brown wooden legs</p> <p>Tables: brushed brass circular framed two-part coffee table with clear glass tops</p> <p>Units: Brown wooden unit with single shelf</p> <p>Four part unit; Brown wooden with 15 shelves and three cupboards with six doors and six brass knobs</p> <p>Cupboards contain one shelf</p> <p>Ladder: Brown wooden book ladder</p> | <p>Seating: is in a good condition with some signs of use</p> <p>Tables: in very good condition; in good clean order</p> <p>Units: signs of age; good condition consistent with use</p> <p>Minor surface damage and marking in areas; pin protruding to right-hand side nearest to door frame; you white plastic utility box in left-hand side cupboard appears to have broken wires; various items inside left hand side and right-hand side cupboard; unable to inspect middle cupboard due to ladder position</p> <p>Ladder: heavy signs of age; where to surface; appears intact; condition consistent with use</p> |

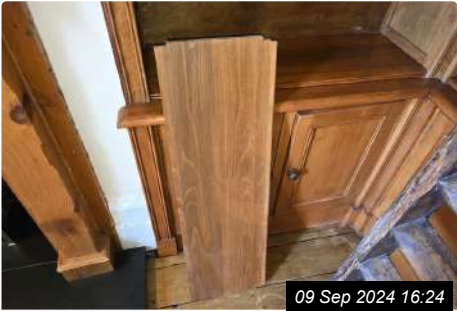
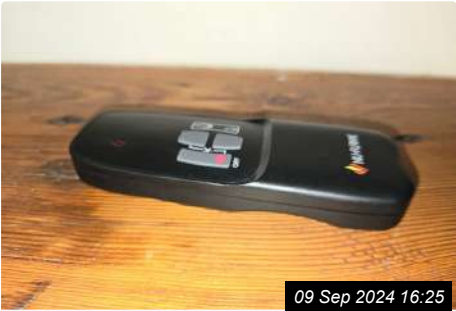
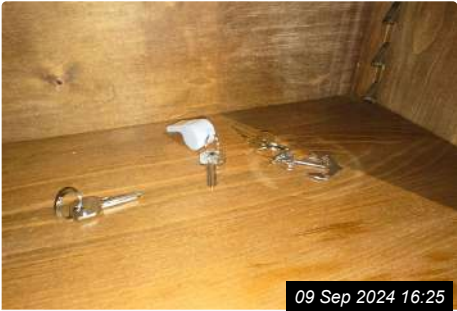
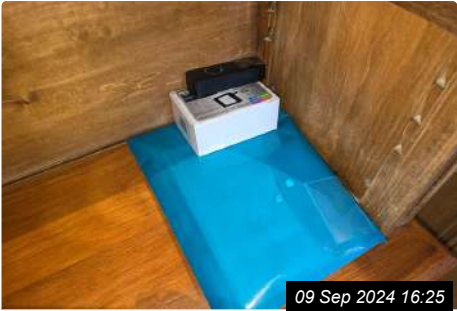
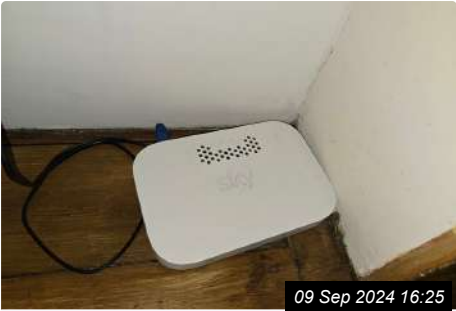
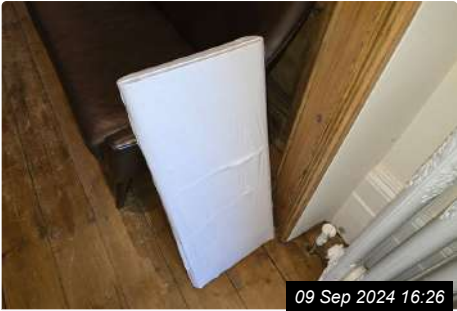
| 7. RECEPTION ROOM 1 (CONT.) | | | |
|---|---|---|---|
| 7.11 | Additional items | <div>White plastic internet modem</div> <div>White plastic wrapped item</div> <div>Brown wooden board; assumed shelving</div> <div>Turquoise booklet and doorbell with cardboard box</div> <div>Three Yale style keys and one white whistle key ring and one Gray metal anchor keyring</div> | <div>Tested for power</div> <div>Unknown item</div> <div>Appears intact</div> <div>Doorbell appears new; cardboard box is empty; blue folder contains manuals</div> |

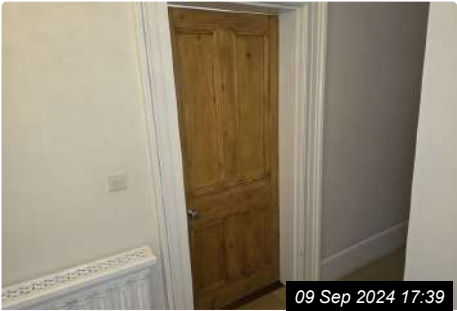
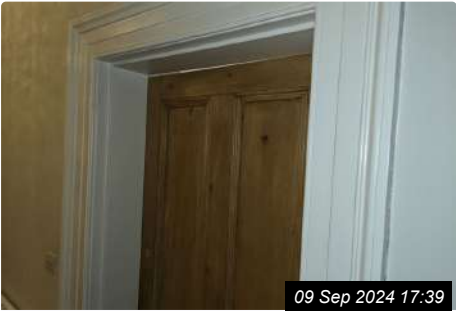
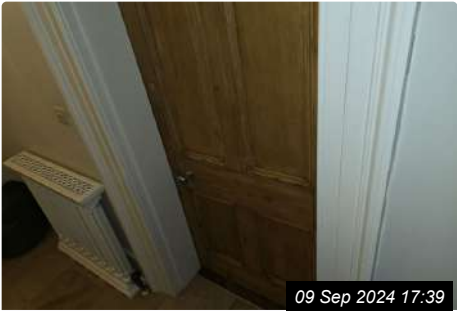
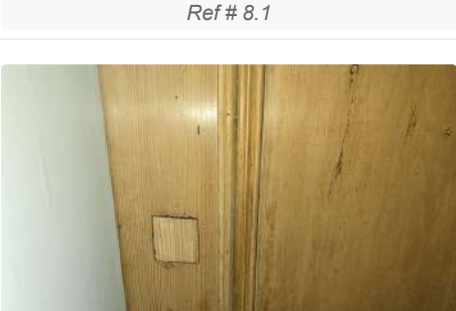
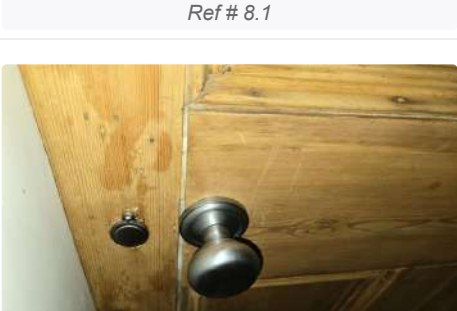
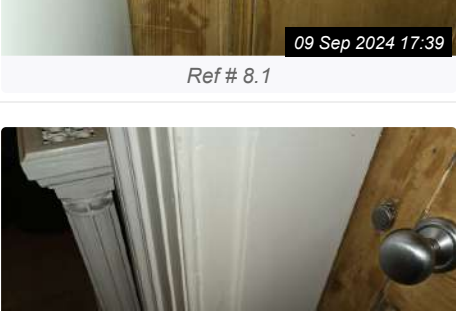
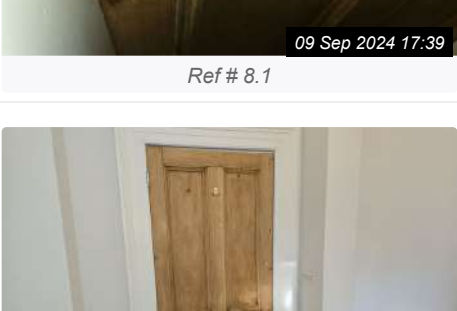
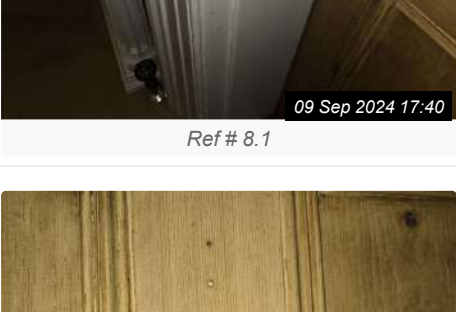
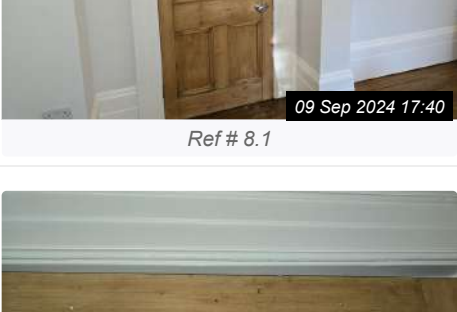
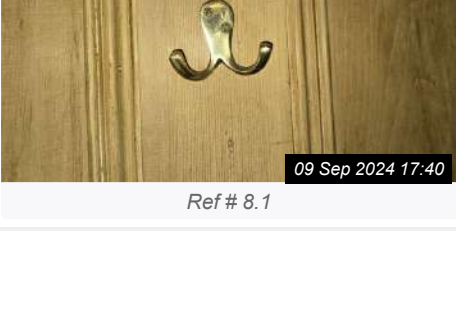
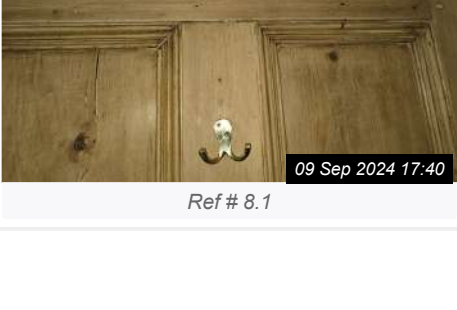
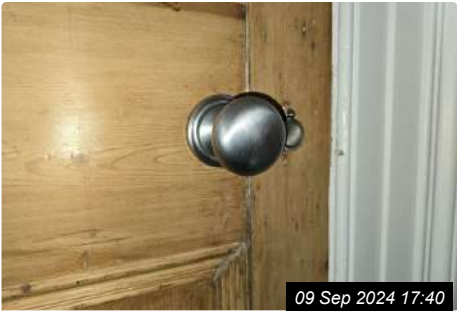
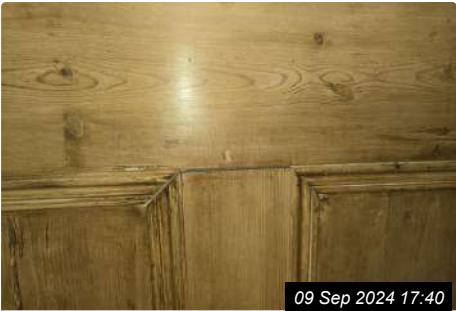
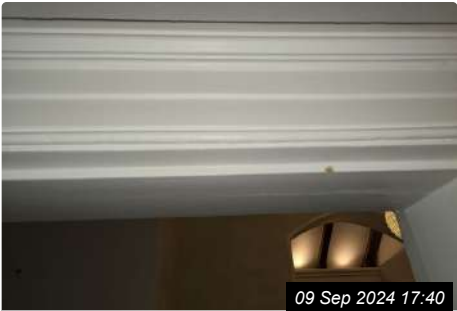
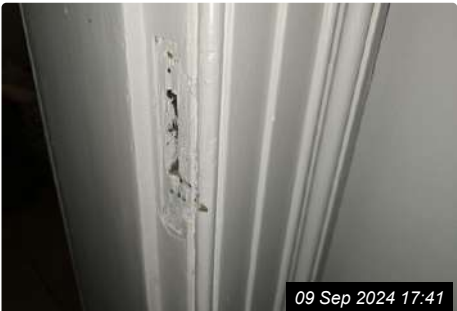
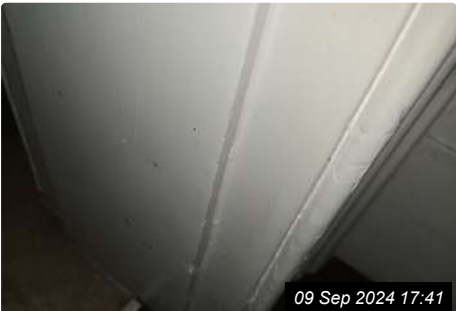
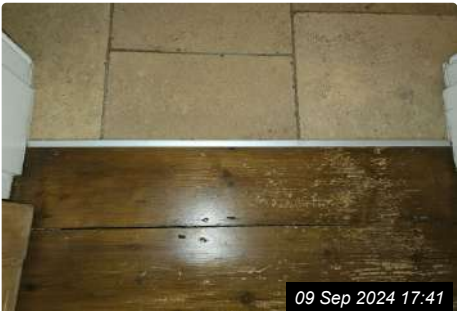
| 8. RECEPTION ROOM 2 (CONT.) | | | |
|---|---|---|---|
| Ref # 8.1 | 09 Sep 2024 17:39 | | |

| Ref | Name | Description | Condition |
|---|---|---|---|
| 8.1<br>📷 | Door/ Frame/<br>Threshold | <p>Door: Brown wooden four panel door with Gray metal furniture including: two handles and two mortice lock covers</p> <p>Reverse: to match; brass double hook to top</p> <p>Frame: White painted wooden frame</p> <p>Threshold: grey metal transverse strip</p> | <p>Door: Signs of age and use; repaired Square to left hand side; pinholes to mid-level Centre; discoloration to mid-level left-hand side; door handle and lock cover in good condition; all in working order</p> <p>Reverse: filled holes to top; and surface damage to upper hand side; small area of damage to Middle; line scratch to left hand side middle; minor marking and discoloration throughout</p> <p>Frame: exterior is in generally good clean condition with chip to lower right hand side and minor chipping to lower left hand side; painted over defects</p> <p>Interior: chip to Upper right-hand side; chip near bottom of strike plate fitting area; strike plate not present</p> |

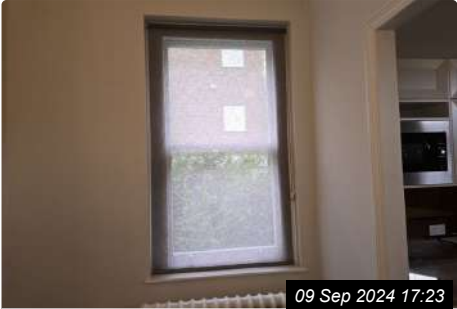
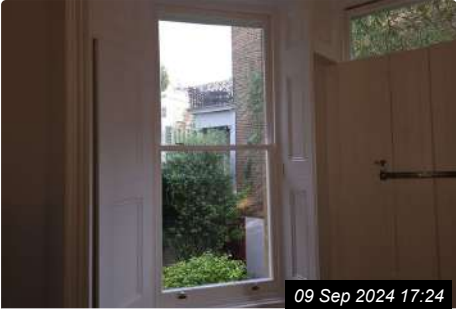
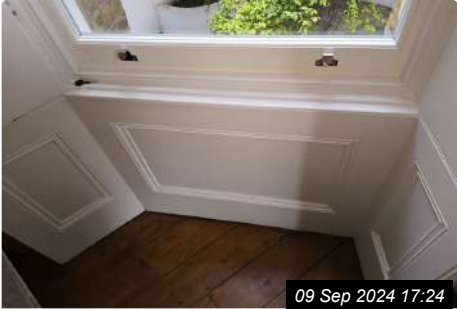
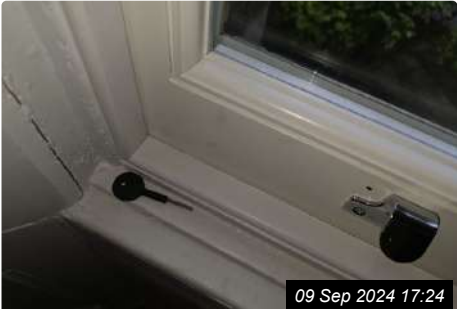
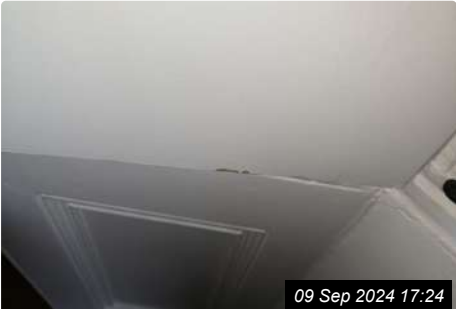
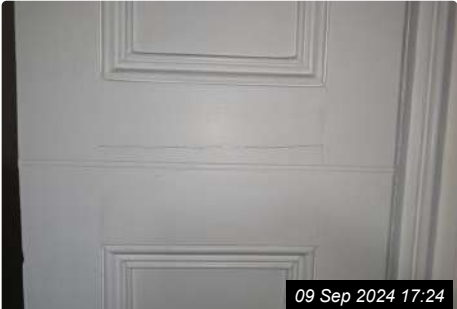
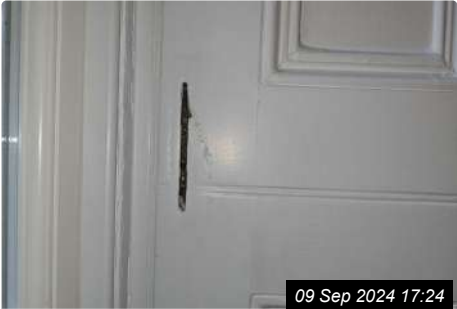
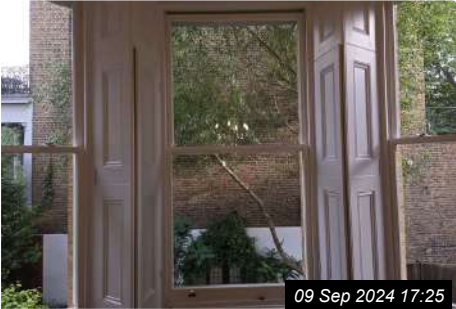
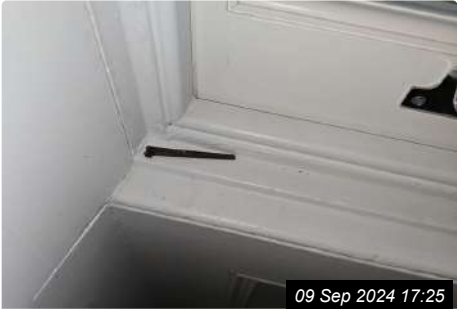
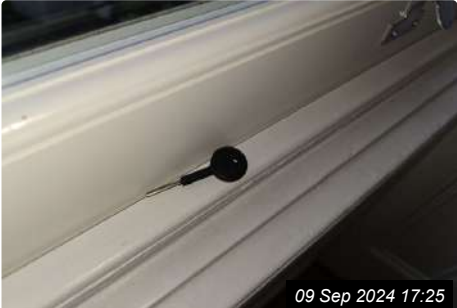
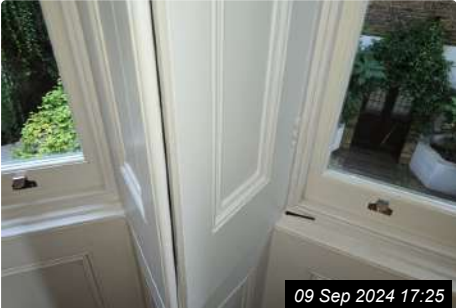
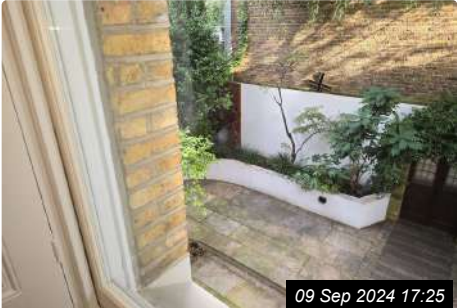
| 8. RECEPTION ROOM 2 (CONT.) | | | |
|---|---|---|---|
| Ref # 8.2 | Ref # 8.2 | Ref # 8.2 | <p>09 Sep 2024 17:23</p> |

| Ref | Name | Description | Condition |
|---|---|---|---|
| 8.2<br> | Window(s) / Sill | <p>Left hand side wall:</p> <p>Window 1: White wooden framed sash window with two cleared glass panes and two Chrome Effect metal locks and handles; White wooden reveals to match</p> <p>Shutter 1: White wooden folding shutter with dark metal furniture; with white wooden panelling below</p> <p>Window 2: White wooden framed sash window with two cleared glass panes and two Chrome Effect metal locks and handles; White wooden reveals to match</p> <p>Shutter 2: White wooden folding shutter with dark metal furniture; with white wooden panelling below</p> <p>Window 3: White wooden framed sash window with two cleared glass panes and two Chrome Effect metal locks and handles; White wooden reveals to match</p> <p>Shutter 3: White wooden folding shutter with dark metal furniture; with white wooden panelling below</p> <p>Far wall:</p> <p>Window 4: white wooden framed sash window with 2 Clare glass paints and two chroma effects metal locks and handles;</p> <p>Sill 4: White painted wooden sill</p> <p>Blind 4: Grey material roller blind with grey metal beaded cord</p> <p>Window 5: white wooden framed sash window with 2 Clare glass paints and two chroma effects metal locks and handles;</p> <p>Sill 5: White painted wooden sill</p> <p>Blind 5: grey material roller blind with grey metal beaded cord</p> | <p>All windows in good condition for age and use;</p> <p>Some cobwebs present in places;</p> <p>painted over defects;</p> <p>Signs of age;</p> <p>Dirt to pane exteriors;</p> <p>Some light surface damage in areas</p> |

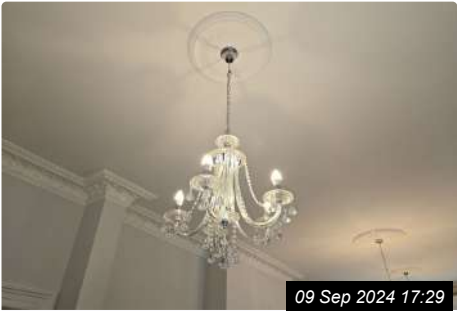
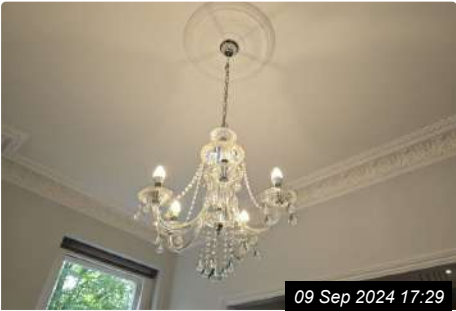
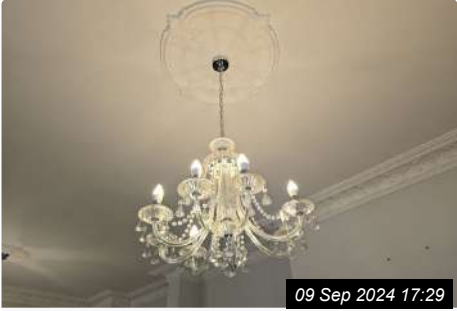
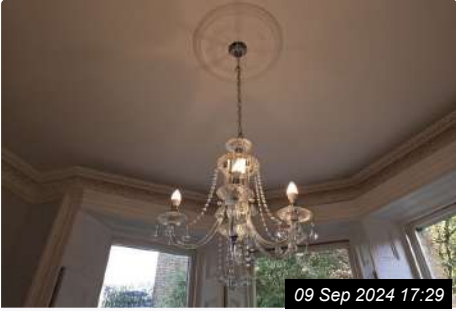
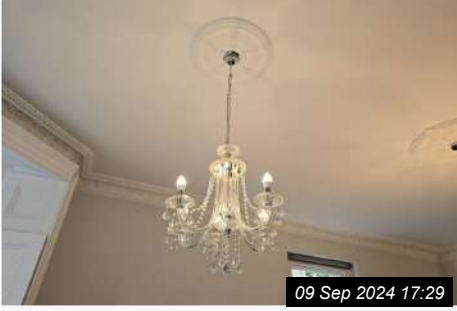
| 8. RECEPTION ROOM 2 (CONT.) | | | |
|---|---|---|---|
| 8.4 | Lighting | Three clear glass ornate chandeliers with 8 bulbs and Chrome Effect chain and ceiling rose | All are intact;<br>All are in good clean condition<br>All are in good working order |

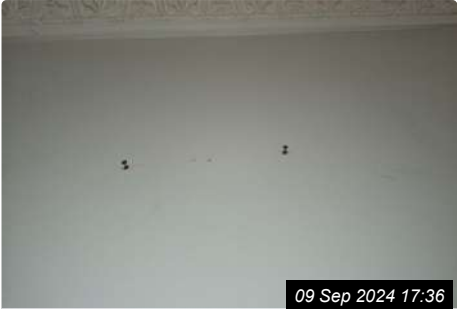
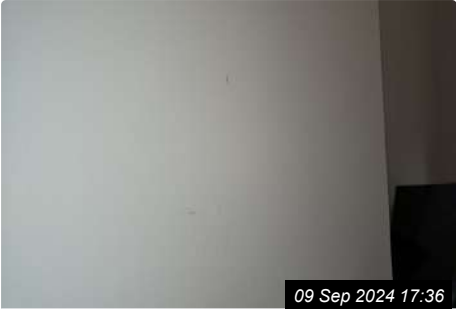
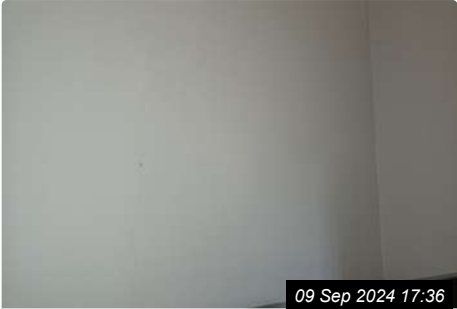
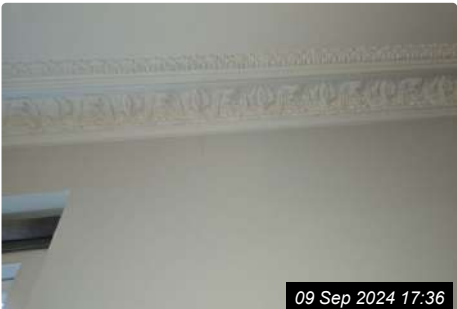
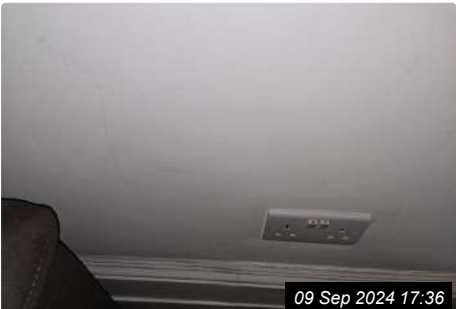
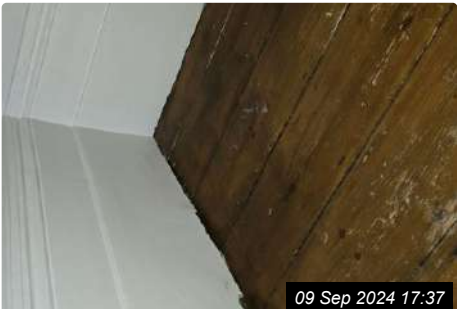
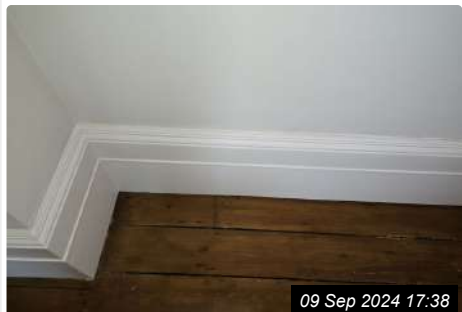
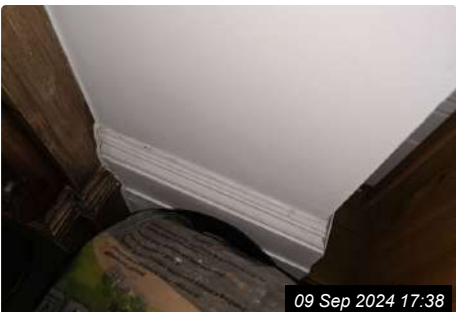
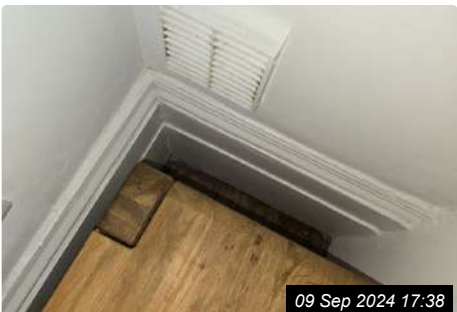
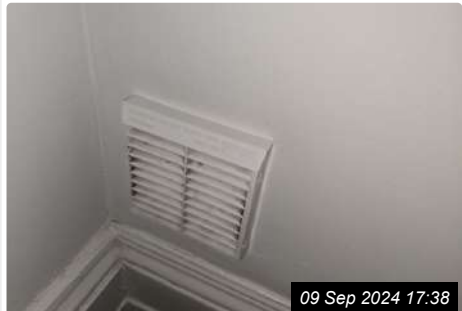
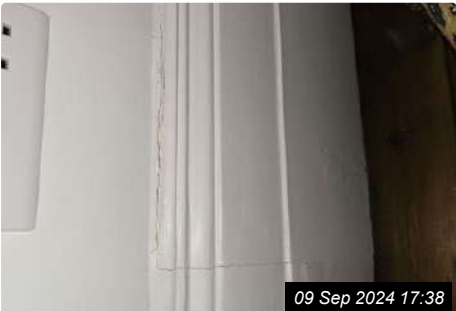
| 8. RECEPTION ROOM 2 (CONT.) | | | |
|---|---|---|---|
| 8.5<br> | Walls / Skirting | Smooth white painted walls<br><br>High profile white painted wooden skirting | Generally in good condition<br><br>Left hand side wall: White plastic air brick to lower left-hand side;<br>Painted cover to upper right-hand side<br><br>Far wall: Cracking to upper level to right hand side of window 4;<br>Minor marking to lower right hand side of sill 4;<br>Light marking to lower levels places;<br>Crack to Upper and lower left-hand side of window 5<br><br>Right hand side wall: Light cracking to join with bottom of coving<br><br>Rear wall: marking and light discolouration to protruding part of wall to left hand side upon entry;<br>Minor light marking to low level;<br>Marking mid to upper level above fireplace with two protruding screws<br><br>Skirting: generally in good condition with painted over defects<br>Gap with flooring in places;<br>Cracking to top and join to bottom right hand side of window 4;<br>Marking to lower left-hand side of window 5;<br>Peeling/damage to paint to lower left-hand side of kitchen entrance frame;<br>Damage to bottom, to the right-hand side of kitchen entrance frame;<br>Chipping to corners to right hand side of entrance;<br>Cracking to join with fireplace right hand side |

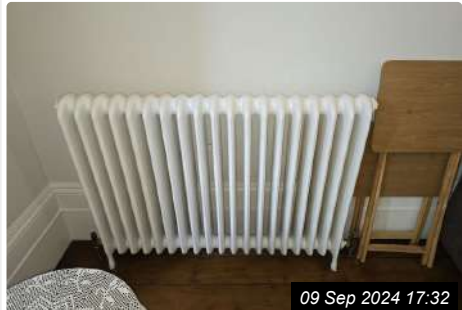
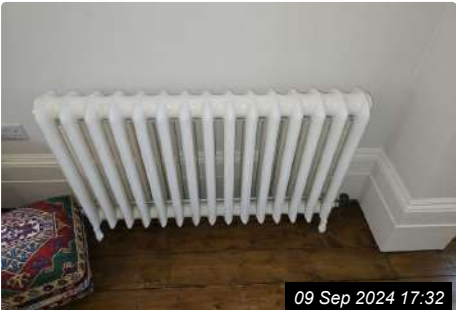
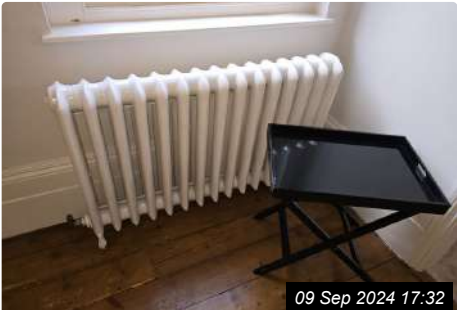
| 8. RECEPTION ROOM 2 (CONT.) | | | |
|---|---|---|---|
| | Ref # 8.6 | <br>09 Sep 2024 17:32 | Ref # 8.6 |

| 8. RECEPTION ROOM 2 (CONT.) | | | |
|---|---|---|---|
| 8.6<br> | Heating | Three white metal column radiators to far wall | All appear in good condition<br>Untested<br>Signs of age<br>Minor chipping to surface of left hand side radiator |

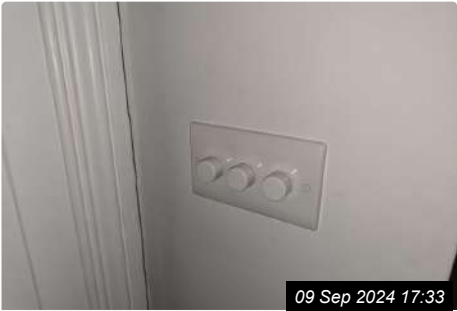
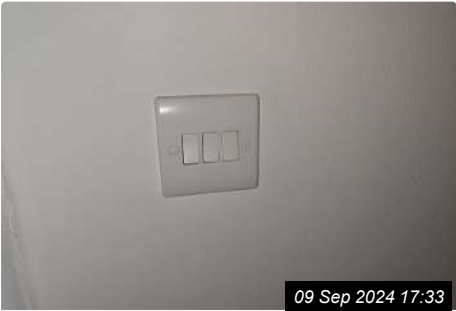
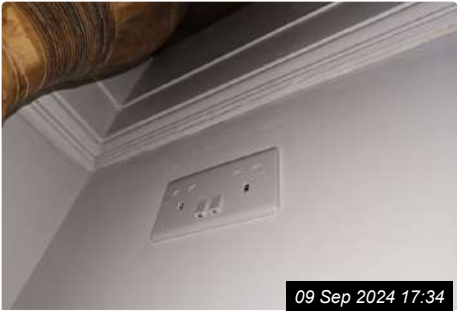
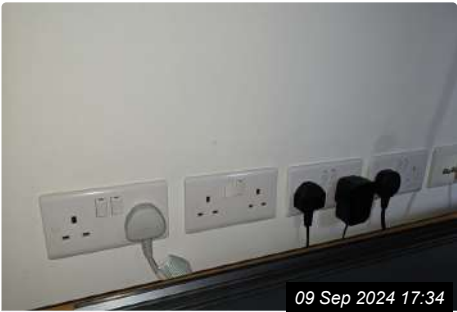
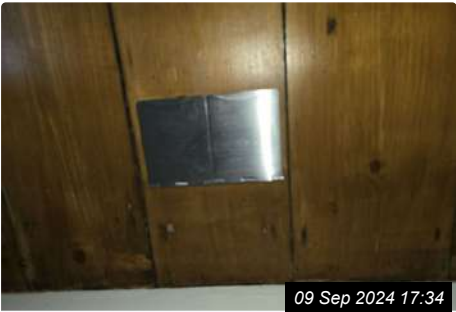
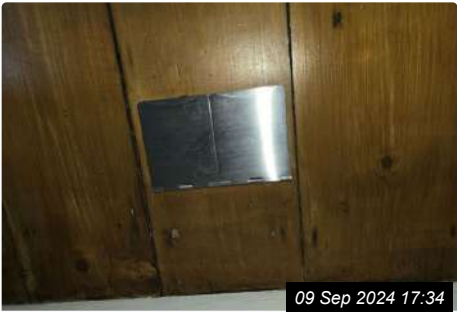
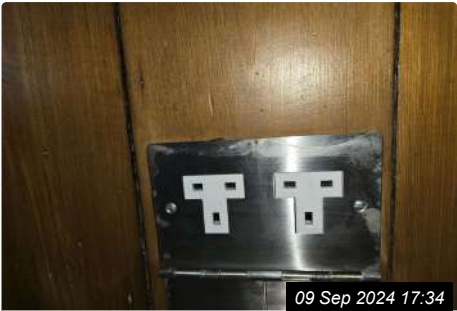
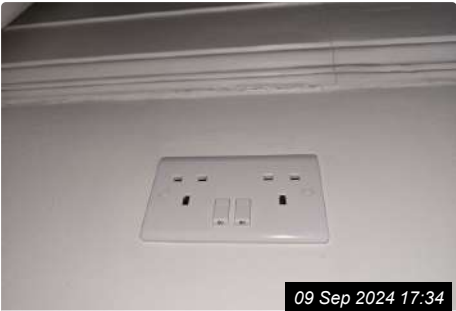
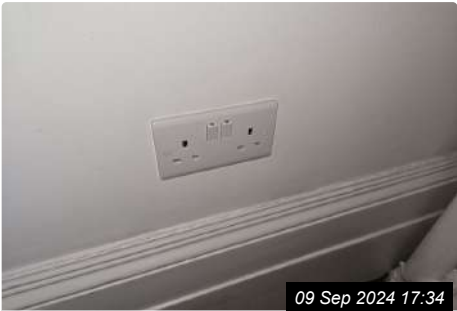
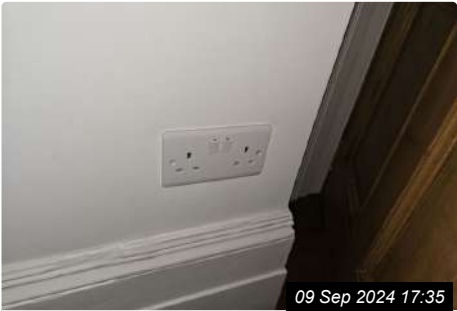
| 8. RECEPTION ROOM 2 (CONT.) | | | |
|---|---|---|---|
| 8.7 | Ref # 8.7 | <br>09 Sep 2024 17:33 | Ref # 8.7 |

| 8. RECEPTION ROOM 2 (CONT.) | | | |
|---|---|---|---|
| 8.7<br> | Switches / Sockets | White plastic:<br><br>Triple dimmer switch<br>Triple light switch<br><br>8 Double sockets<br><br>2 Grey metal and white plastic floor mounted sockets | In good working order<br><br>Untested; appear in good condition |

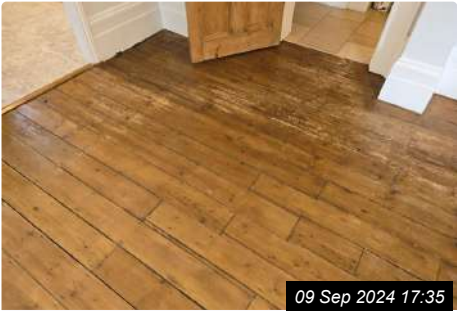
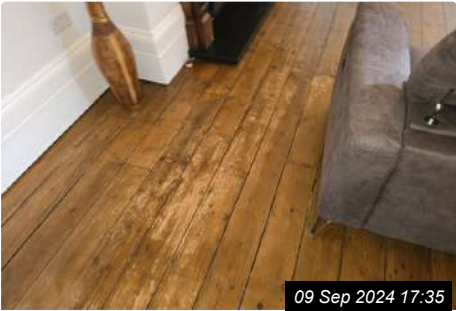
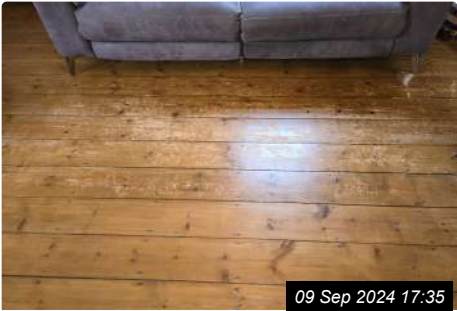
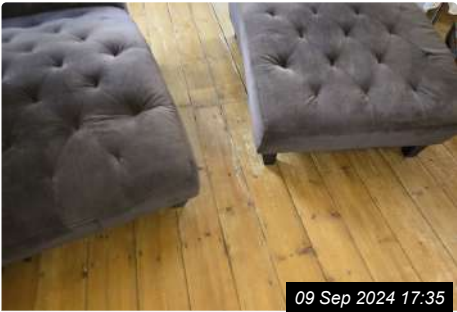
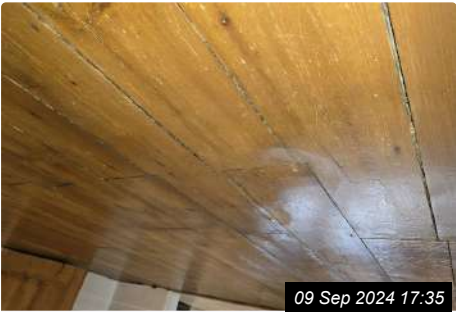
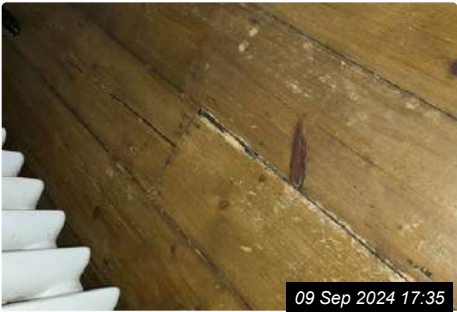
| 8. RECEPTION ROOM 2 (CONT.) | | | |
|---|---|---|---|
| 8.8<br> | Flooring | Brown wooden floorboards | Surface where two traffic areas;<br>Some surface scratching and chipping<br>Signs of age and use |

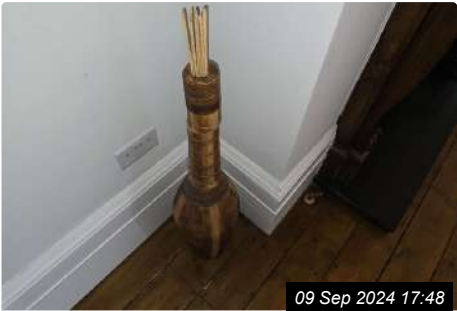
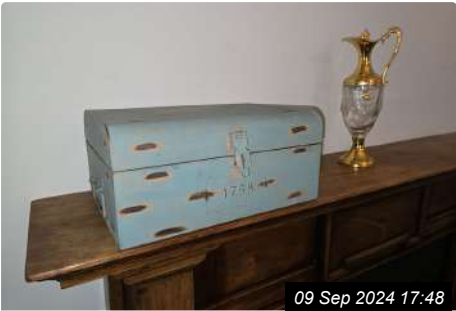
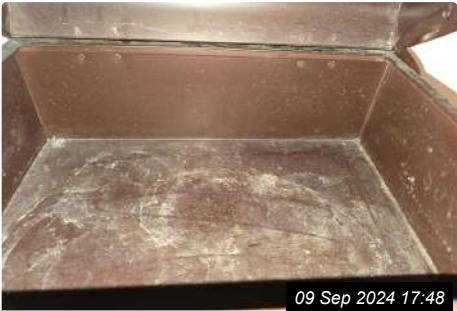
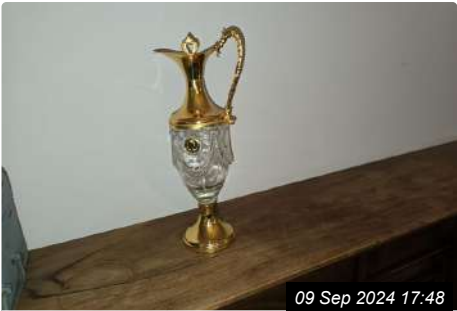
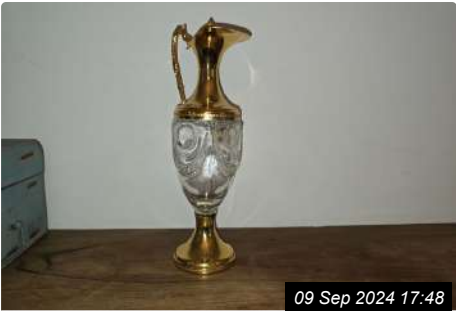
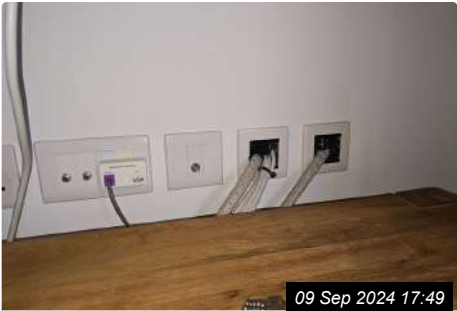
| 8. RECEPTION ROOM 2 (CONT.) | | | |
|---|---|---|---|
| 8.9 | Additional items | <p>Brown ceramic vase with brown sticks inside</p> <p>Turquoise exterior metal box with numerals "1768"; interior is brown metal</p> <p>Gold effect metal and clear glass ornate decanter</p> <p>White plastic:<br/>Utility cover with two grey metal ports and two shutter ports<br/>Utility cover with single grey metal Port<br/>2 White plastic cover with black interior cable ties</p> | <p>Two cracks two stem of vase</p> <p>In working order;<br/>Patches of surface wear to exterior<br/>Dirt to interior;<br/>Signs of age</p> <p>Intact; appears in good condition<br/>Pitting and surface wear to metal parts in places</p> <p>Untested; all appear in good condition<br/>White plastic utility insert to right hand side of first cover</p> |

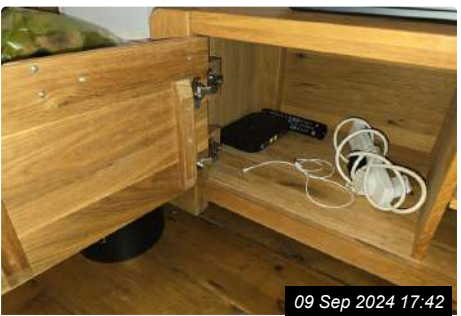
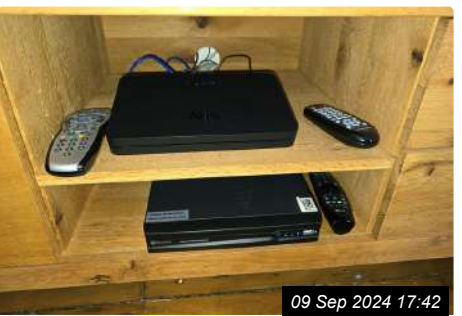
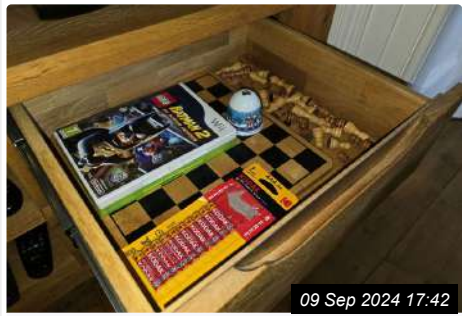
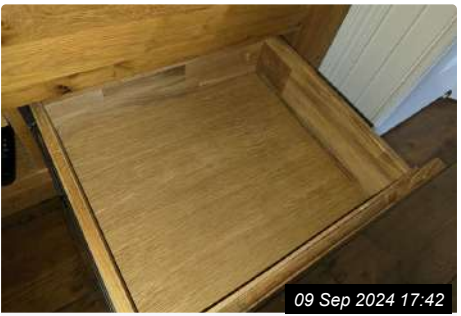
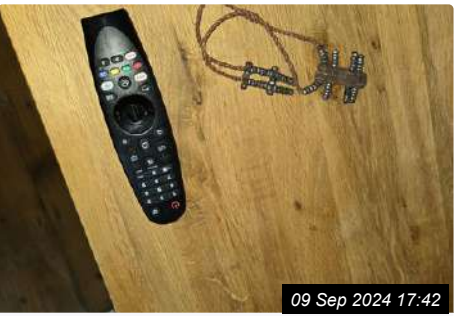
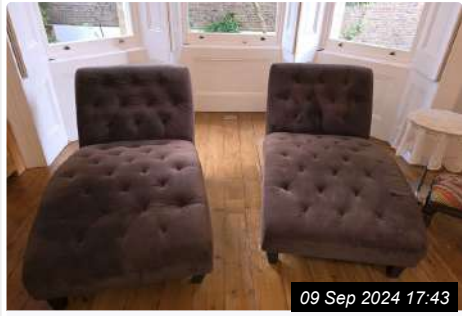
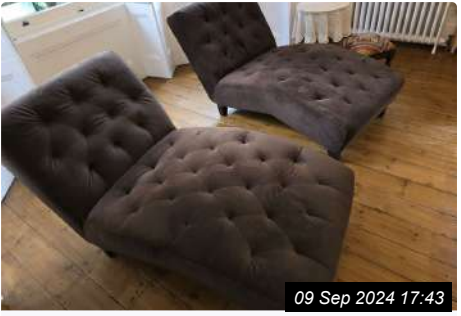
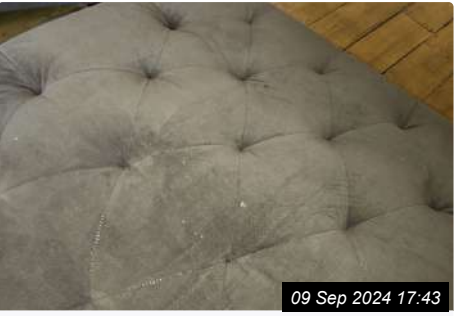
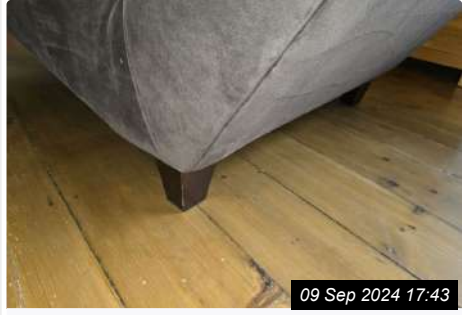
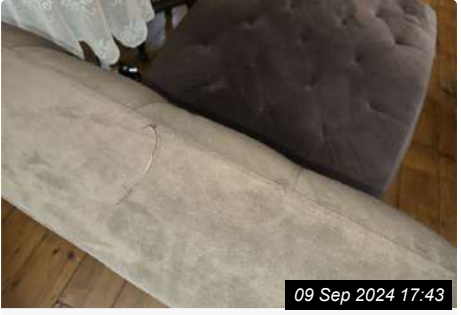
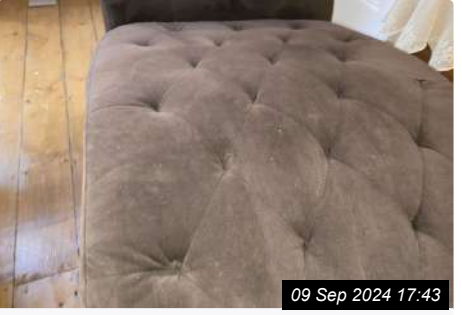
| 8. RECEPTION ROOM 2 (CONT.) | | | |
|---|---|---|---|
| Ref # 8.10 | | <div>09 Sep 2024 17:42</div> | <div>09 Sep 2024 17:42</div> |

| 8. RECEPTION ROOM 2 (CONT.) | | | |
|---|---|---|---|
| 8.10 | Furnishings | <p>Brown wooden TV unit</p> <p>Cupboard with single door to left-hand side</p> <p>One shelf to middle contains:</p> <p>Two drawers to the right-hand side</p> <p>2 Brown material Chesterfield style chaise lounges with brown wooden legs</p> <p>2 Dark brown wooden footstool with colourful decorated cushion top</p> <p>Brown wooden table top with chrome Effect metal base and off-white doily to top</p> <p>2 Small light brown wooden folding tables</p> <p>2 Grey material electric sofas with chroma effect metal legs</p> <p>Small black wooden folding table</p> | <p>Good condition consistent with use; Black plastic remote and grey metal brown cord and brown stone item to top contains: Black plastic utility box; Black plastic remote control; White plastic four plug extension lead with two items plugged in; One white apple USB charger</p> <p>Contains: One grey and black plastic remote One black plastic "Sky" Box; Two black plastic remote</p> <p>Contains: Various entertainment items</p> <p>Intact; minor marking to seats; fire label not seen</p> <p>Table is intact and in a good condition; doily has very minor signs of use</p> <p>Both stools are in very good condition; fire label not seen</p> <p>Good condition; taller table has brown cord tied to left-hand side leg</p> <p>In very good condition<br/>Minor smudging two chrome parts<br/>Tested for power<br/>Fire labels present</p> <p>Intact; chipping to surface throughout</p> |
