# Inventory & Schedule of Condition

Prepared on behalf of Example Lettings Ltd

123 Preview Street  
Sample City  
London  
AB1 2CD

**September**  
**13th 2024**

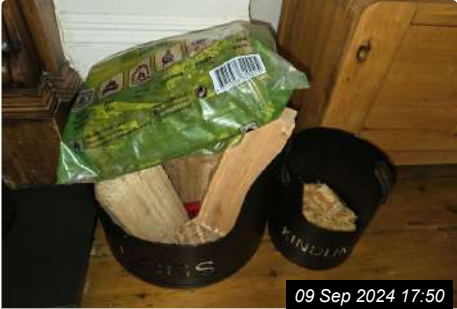
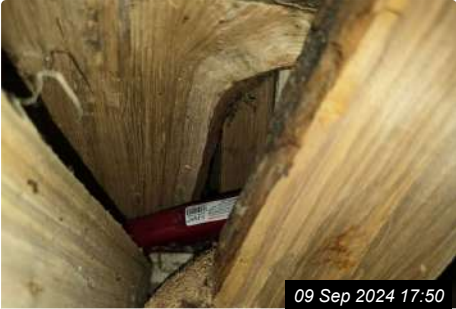
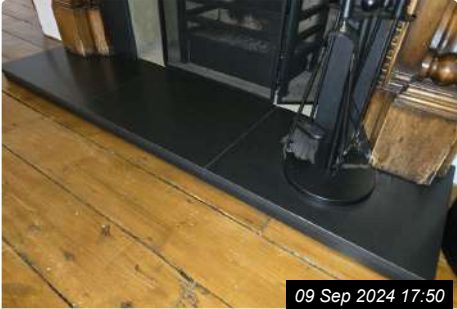
| 8. RECEPTION ROOM 2 (CONT.) | | | |
|---|---|---|---|
| 8.11<br>📷 | Fireplace | <p>Brown wooden mantle and surround; black stone inner surround and hearth with clear glass pane to top; cement and exposed brick interior; black metal fire basket with draw to bottom</p> <p>Black metal framed with matching mesh fireguard</p> <p>Black metal four part fire utensil set and stand oh</p> | <p>Generally in a good condition</p> <p>Mantal As signs of age; wear to tops: heavy wear/ chipping / light damage to bottom left and right hand sides</p> <p>Interior condition is consistent with use; some debris to base</p> <p>Residue to rear of fibre basket</p> <p>Fireguard is intact; small scratch to right hand side of Center panel; minus signs of use</p> <p>All present and in working order; some white residue to tool ends</p> |

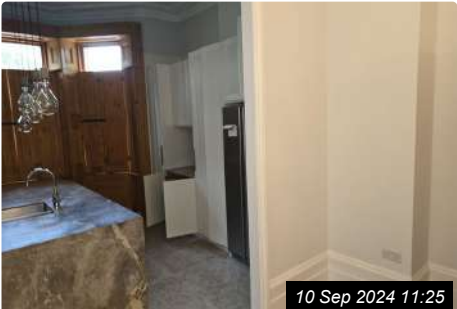
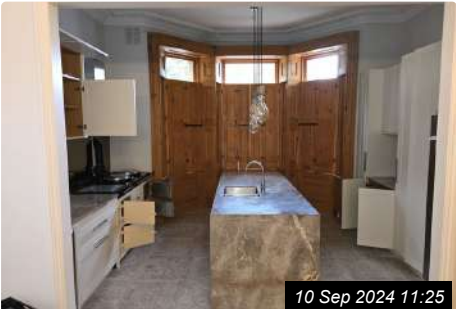
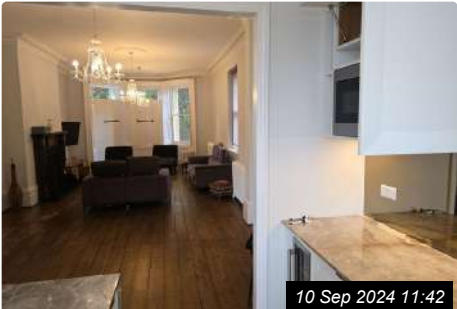
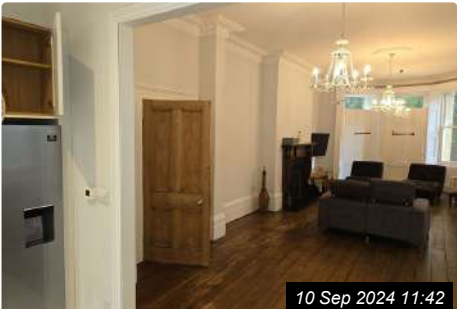
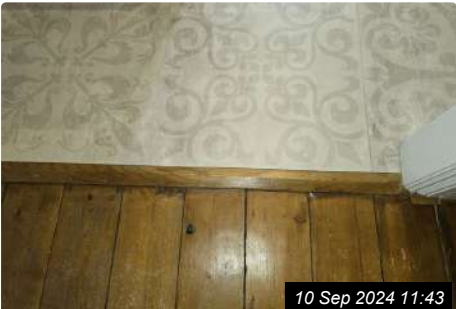
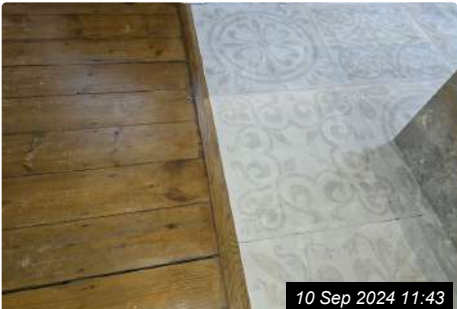
| Ref | Name | Description | Condition |
|---|---|---|---|
| 9.1<br>📷 | Door/ Frame/<br>Threshold | Large white painted wooden frame<br><br>Brown wooden transverse strip | Some marking mid to low level semicolon<br>cracking two interior right and left-hand side and<br>right hand side exterior<br><br>Consistent with use |

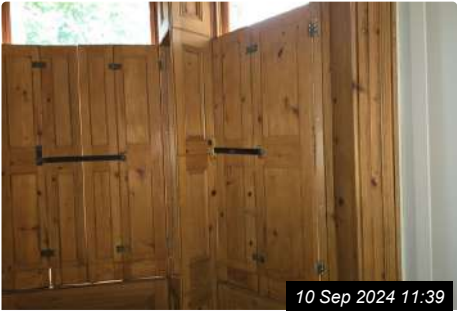
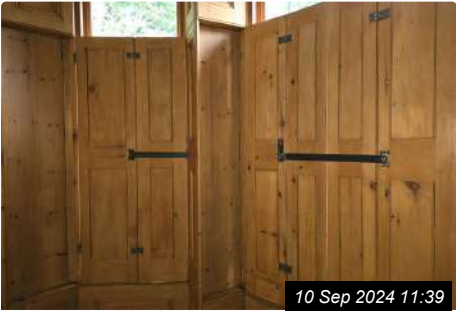
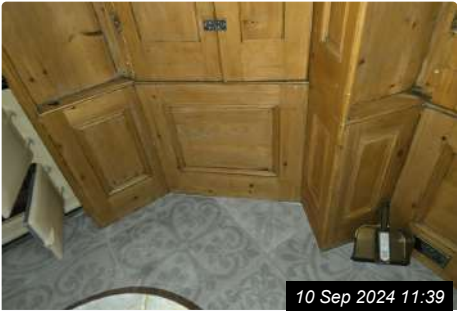
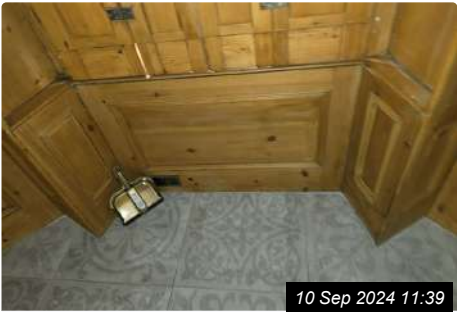
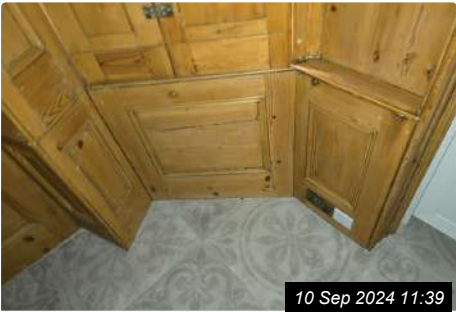
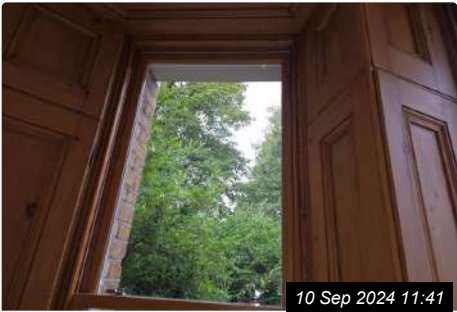
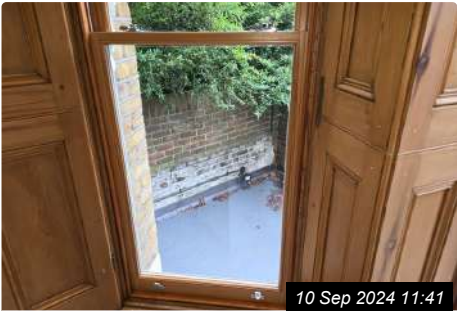
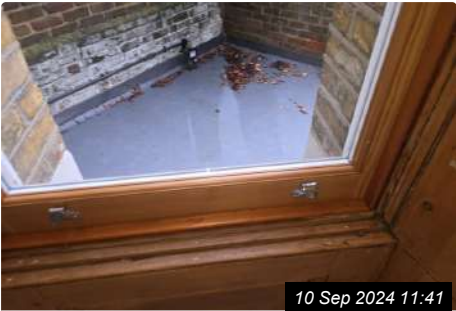
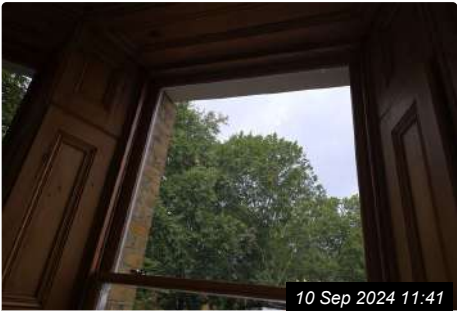
| 9. KITCHEN (CONT.) | | | |
|---|---|---|---|
| <div>9.2</div> <div></div> | Window(s) / Sill | <p>Window 1: Brown wooden frame sash window with two cleared glass panes and two Chrome Effect metal locks and handles; Brown wooden reveals to match</p> <p>Shutter 1: Brown wooden folding shutter with dark metal furniture; with wooden panelling below</p> <p>Window 2: Brown wooden frame sash window with two cleared glass panes and two Chrome Effect metal locks and handles; Brown wooden reveals to match</p> <p>Shutter 2: Brown wooden folding shutter with dark metal furniture; with wooden panelling below</p> <p>Window 3: Brown wooden frame sash window with two cleared glass panes and two Chrome Effect metal locks and handles; Brown wooden reveals to match</p> <p>Shutter 3: Brown wooden folding shutter with dark metal furniture; with wooden panelling below</p> <p>4 black plastic and grey metal keys</p> | <div>10 Sep 2024 11:25</div> <div>Ref # 9.1</div> |

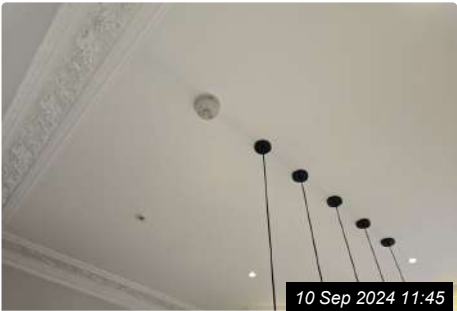
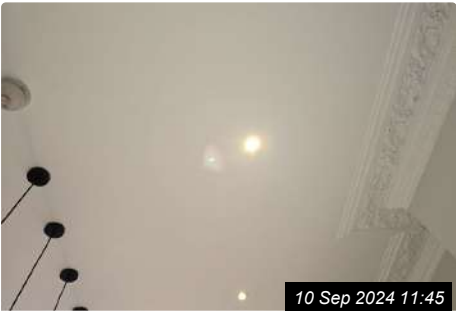
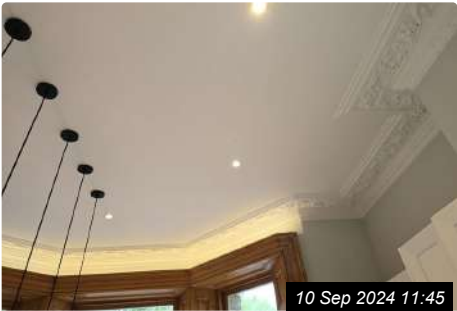
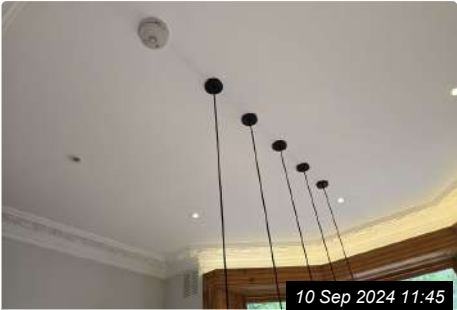
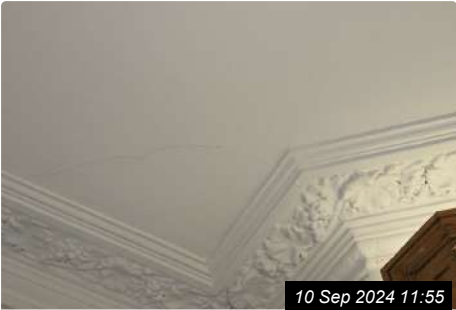
| 9. KITCHEN (CONT.) | | | |
|---|---|---|---|
| 9.3 | Ceiling | Smooth white painted with ornate coving | In a good condition with minor cracking two far left hand side |

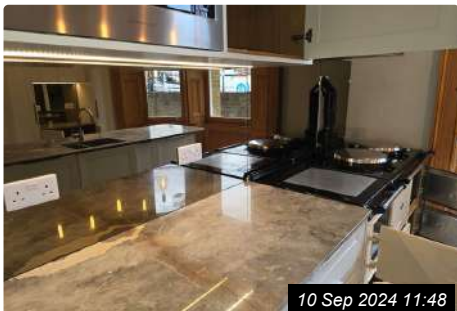
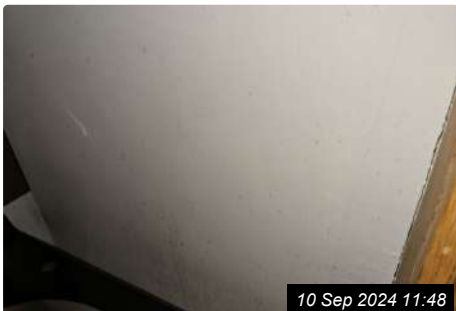
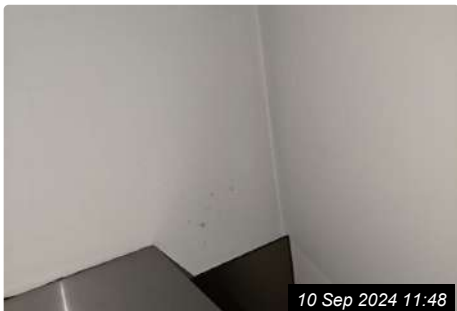
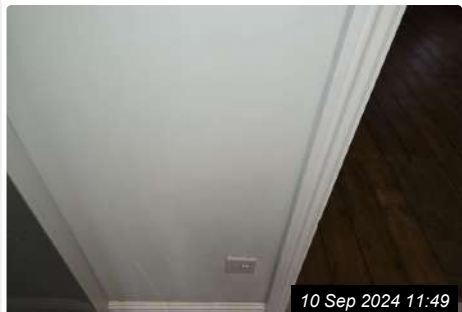
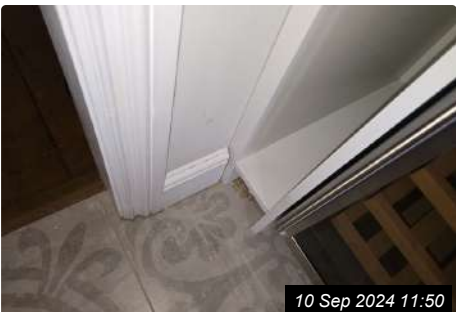
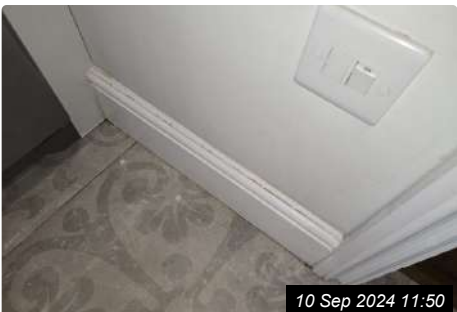
| 9. KITCHEN (CONT.) | | | |
|---|---|---|---|
| 9.5<br> | Walls / Skirting | Smooth off white painted walls glass with tinted mirror panels to Middle left-hand side walls | Some minor smudging to mirrored parts |
| | | | Drip marking and marking around cooking area<br>Marking to lower levels right hand side upon entry |
| Skirting is chipped to top; painted over defects | | | |

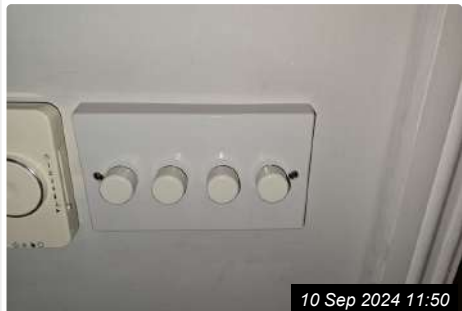
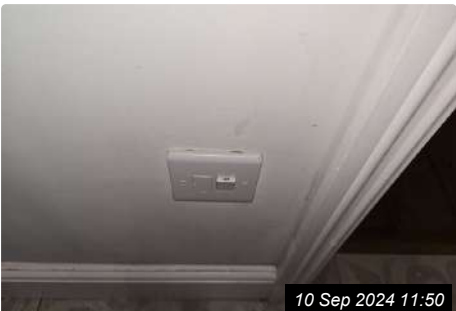
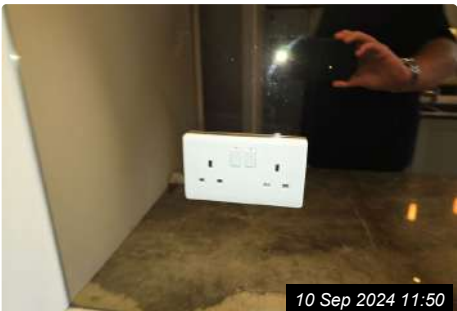
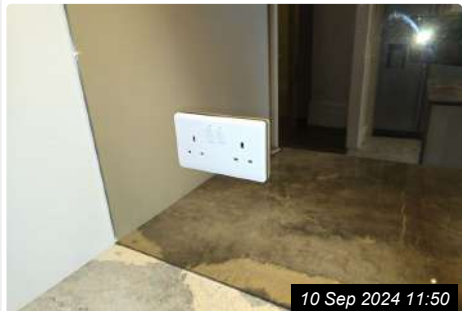
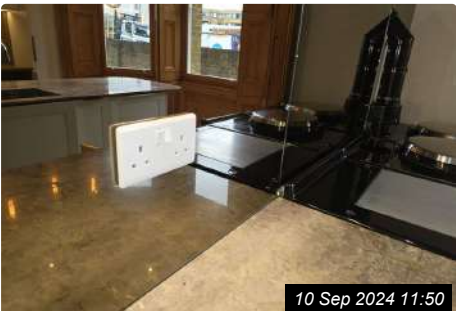
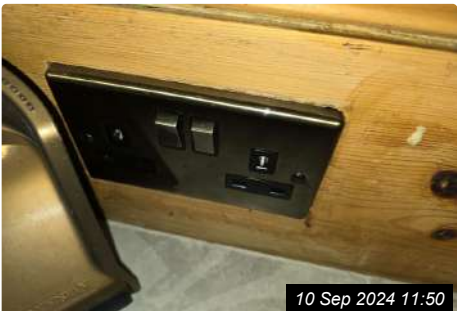
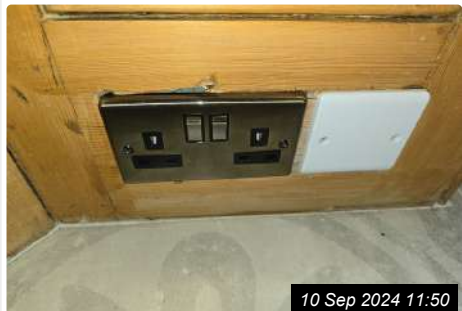
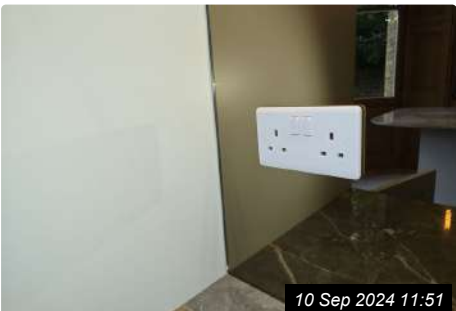
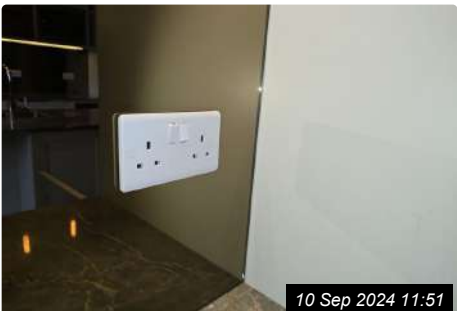
| 9. KITCHEN (CONT.) | | | |
|---|---|---|---|
| 9.6 | Switches / Sockets | <div>White plastic:</div> <div>Quadruple dimmer switch</div> <div>Single fuse switch</div> <div>4 Double sockets</div> <div>2 grey metal and black plastic double sockets</div> | <div>In working order</div> <div>Sockets untested</div> |

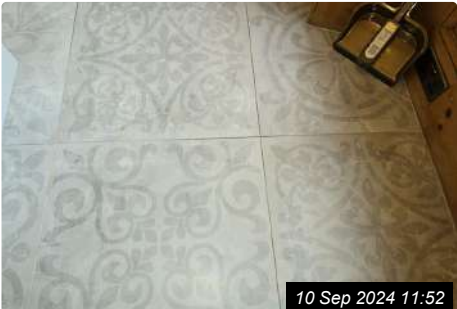
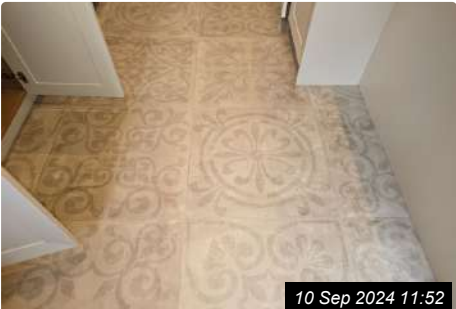
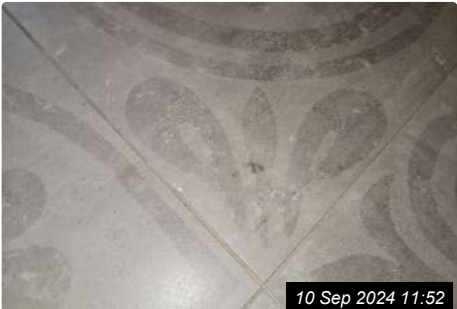
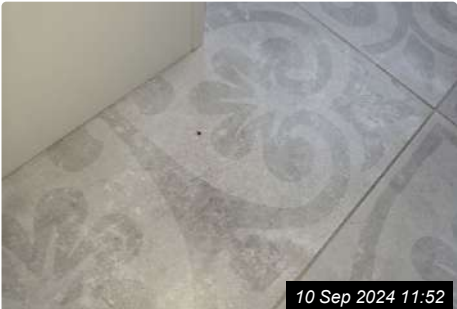
| 9. KITCHEN (CONT.) | | | |
|---|---|---|---|
| 9.7<br> | Flooring | Grey patterned square tiles with grey grout | Good condition with some surface Ware and minor debris; intact |

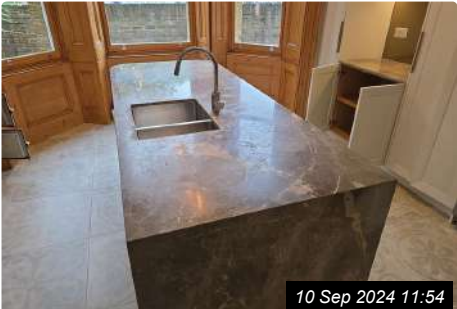
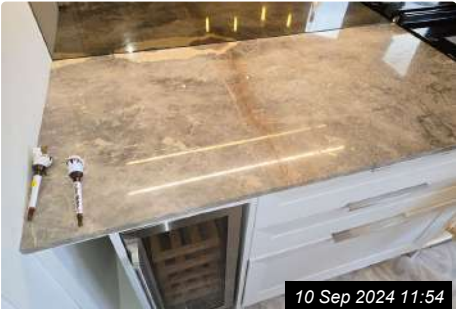
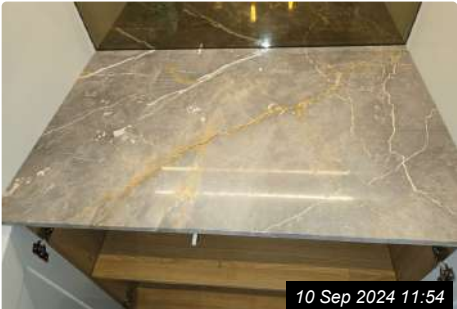
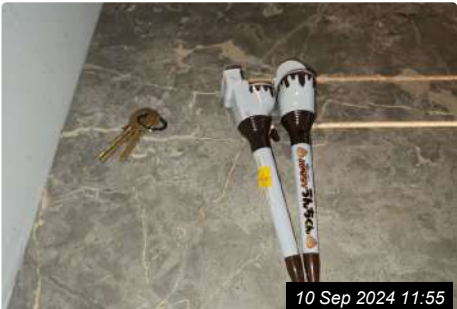
| 9. KITCHEN (CONT.) | | | |
|---|---|---|---|
| 9.8<br> | Work tops | Grey marble worktops<br><br>Grey marble worktop to center Island<br><br>Two brass Yale keys | All in a good condition;; intact: island has residue and marking throughout<br><br>Two plastic items on left hand side worktop |

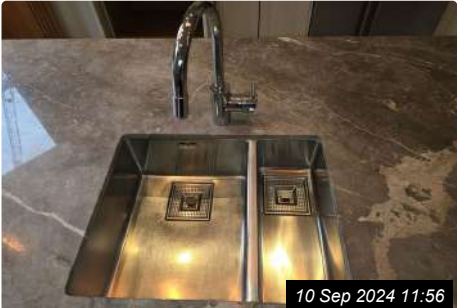
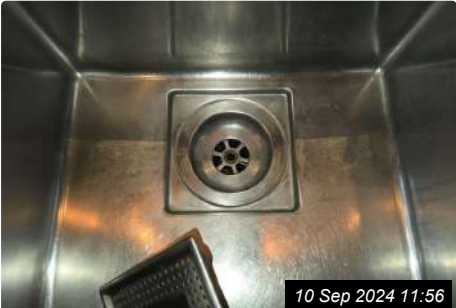
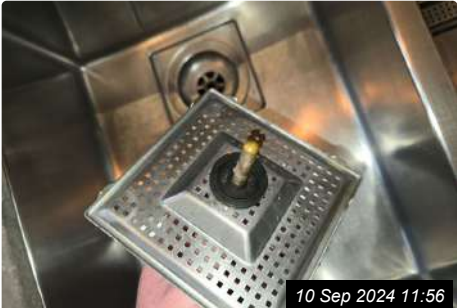
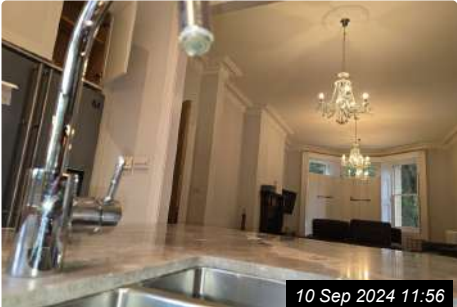
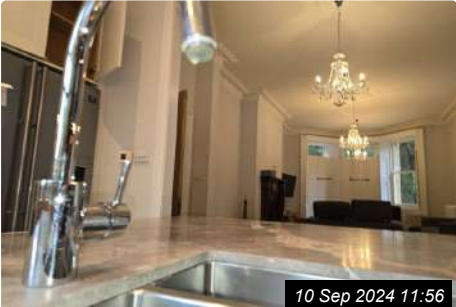
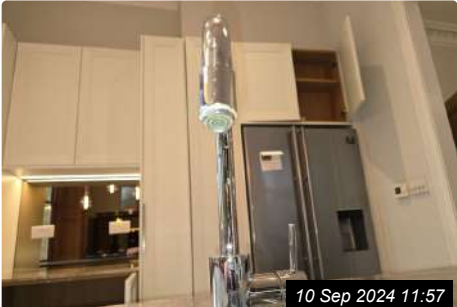
| 9. KITCHEN (CONT.) | | | |
|---|---|---|---|
| <div>9.9</div> <div>📷</div> | Sink | Grey metal two-part sink with two square drain catches and chroma effect metal mixer tap and spout | In good working order; mostly clean; lime scale too tap about |

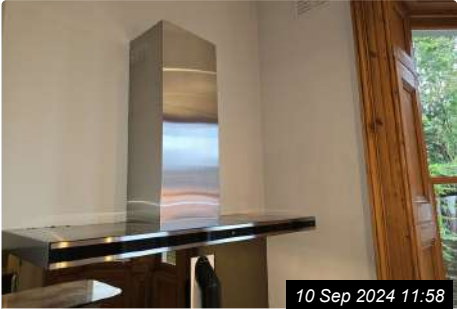
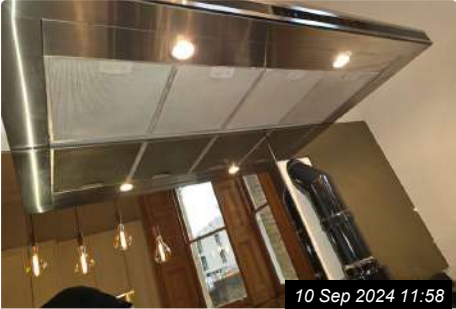
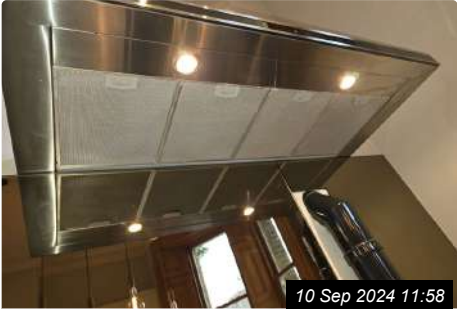
| 9. KITCHEN (CONT.) | | | |
|---|---|---|---|
| <div>9.10</div> <div>📷</div> | Extractor hood | Grey metal and black plastic cover with four part filter and two lights | Clean; in good working order |

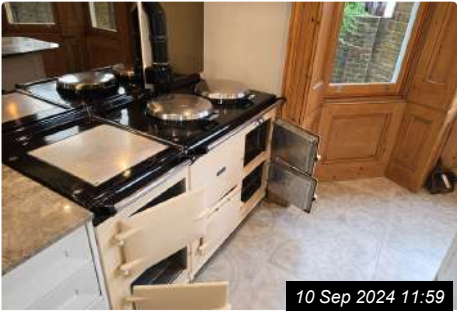
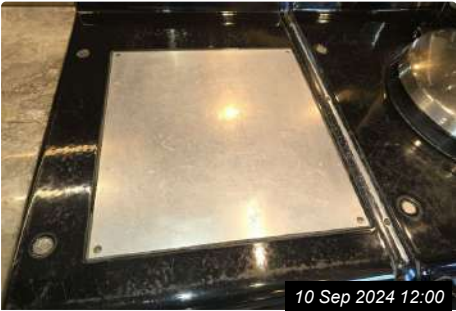
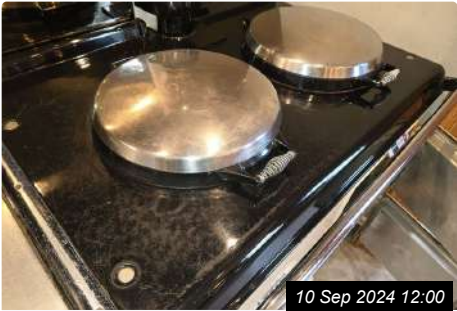
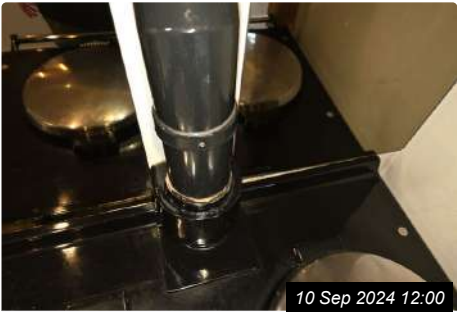
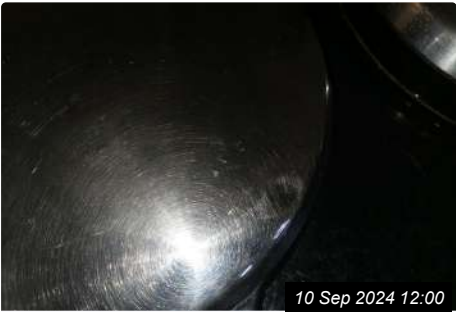
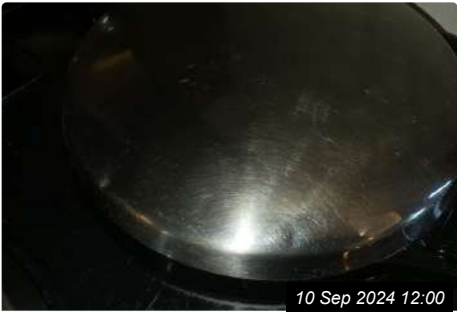
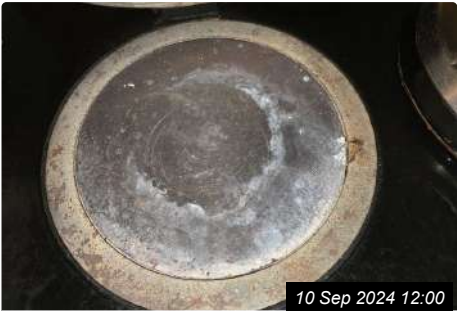
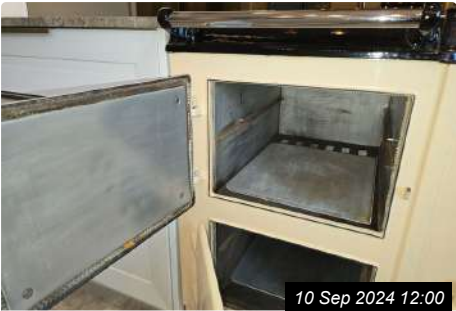
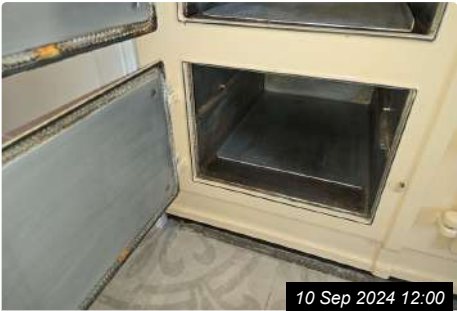
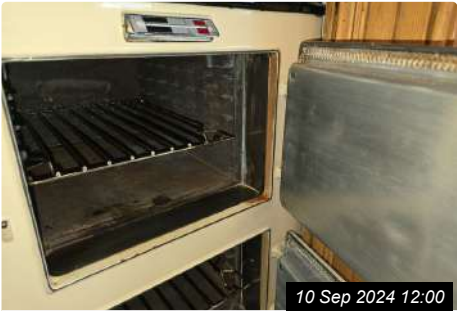
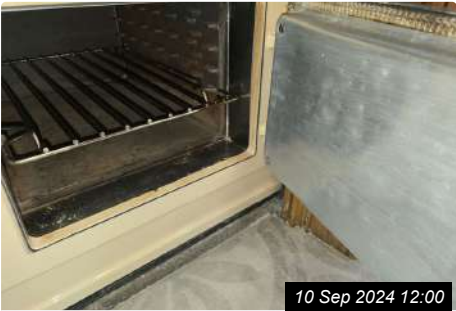
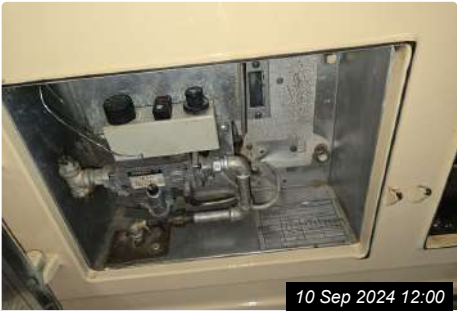
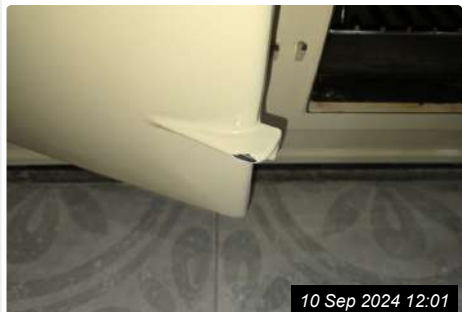
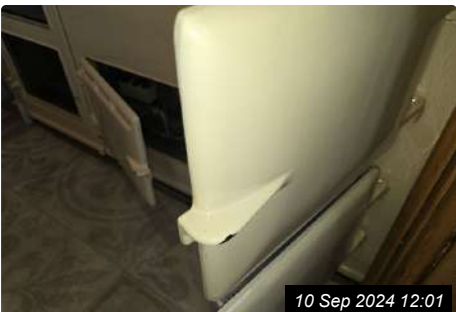
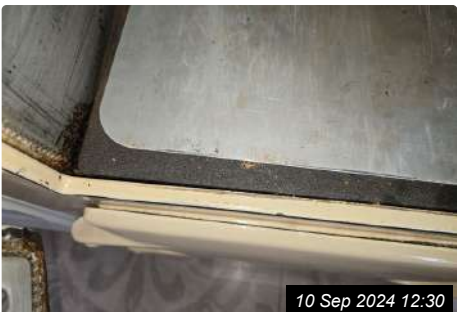
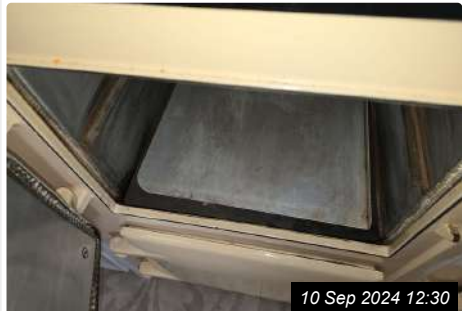
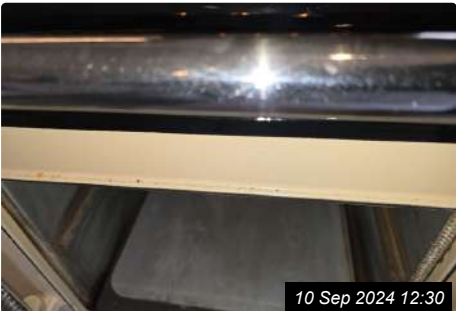
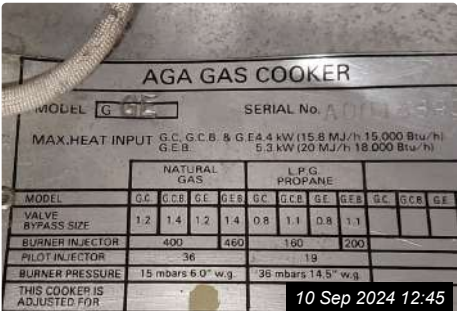
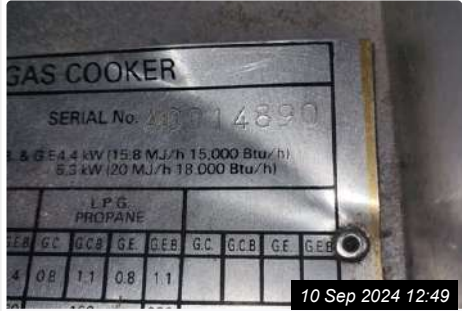
| 9. KITCHEN (CONT.) | | | |
|---|---|---|---|
| <div>9.11</div> <div>📷</div> | Aga | <p>Cream and black metal/ ceramic with Chrome Effect metal handrails and grey metal cover to top left hand side</p> <p>Black metal flue to rear</p> <p>Two grey and black metal hob covers</p> <p>Five doors to front</p> <p>Grey metal interiors with two grey metal wire shelves to right hand side</p> | <p>Wear to top; signs of use to interior compartments; untested; appears in working order</p> <p>Denting to hob covers; surface damage to door handles</p> |

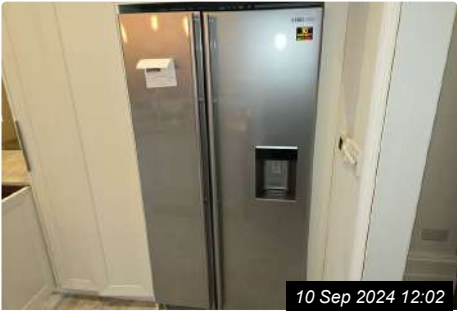
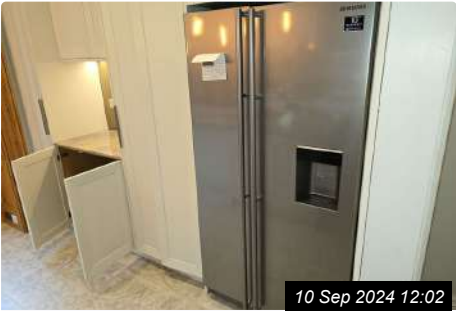
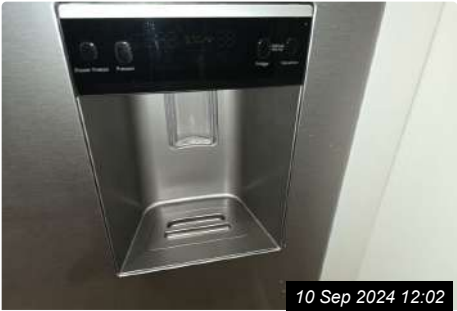
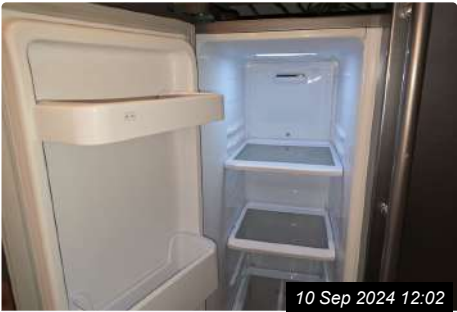
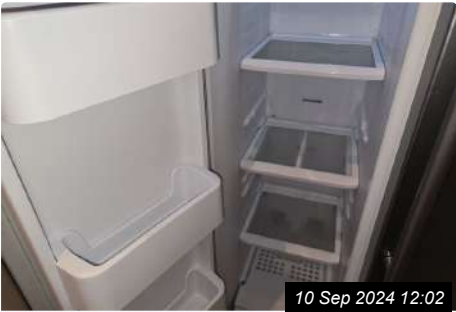
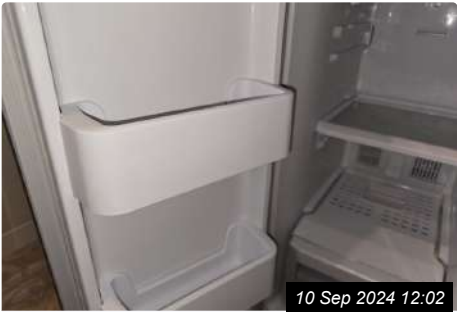
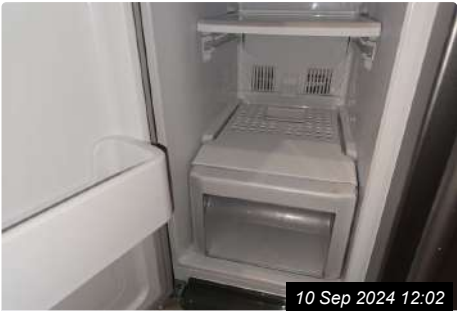
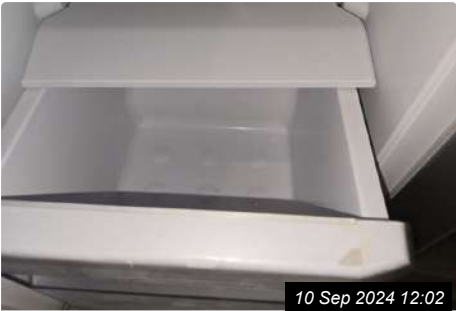
| 9. KITCHEN (CONT.) | | | |
|---|---|---|---|
| 9.12<br> | Fridge/ freezer | <p>Grey black and clear plastic "Samsung" with water dispenser</p> <p>Freezer interior left: 5 white plastic shelves two door;<br/>Body contains four clear glass and white plastic shelves and one clear and white plastic drawer</p> <p>Fridge interior right: The door has four white plastic shelves, which has a clear plastic cover;<br/>water dispenser mechanism to middle<br/>Body contains five clear glass and white plastic shelves and to clear and white plastic drawers</p> | <p>Not cleaned to a professional standard</p> <p>In working order</p> <p>Items left to fridge interior</p> <p>Dirt and residue two bottom draw of fridge<br/>Damage to Upper level of fridge door handle</p> |

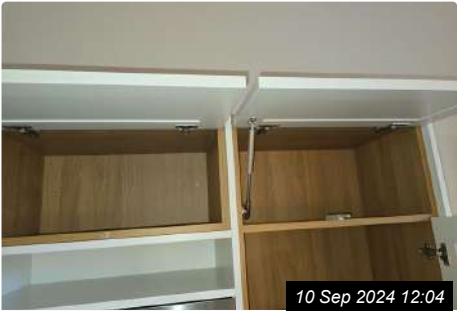
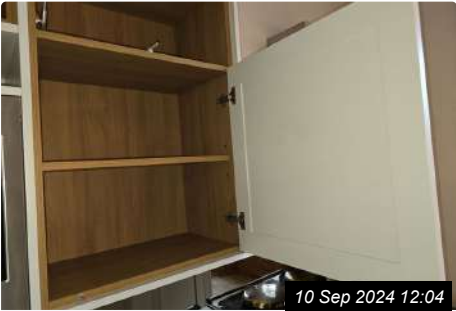
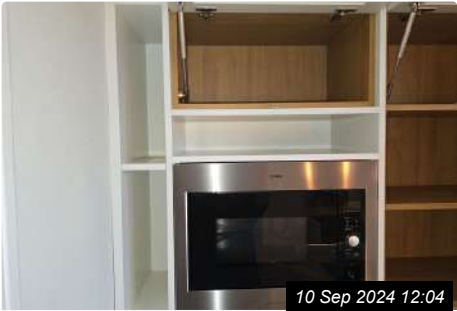
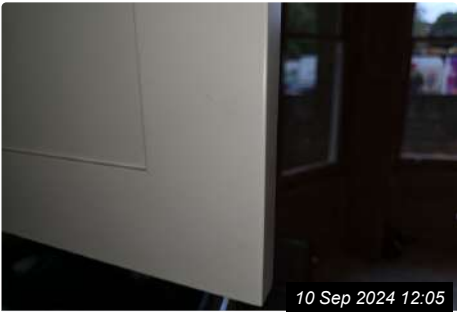
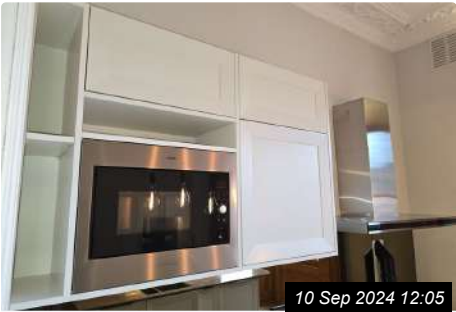
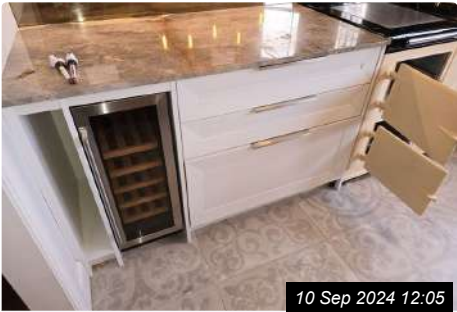
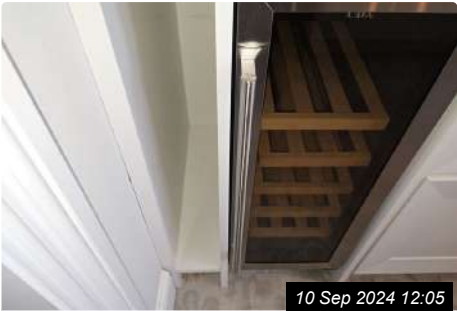
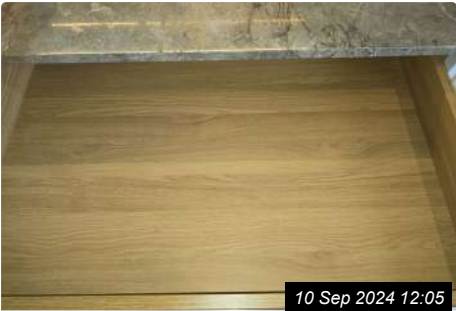
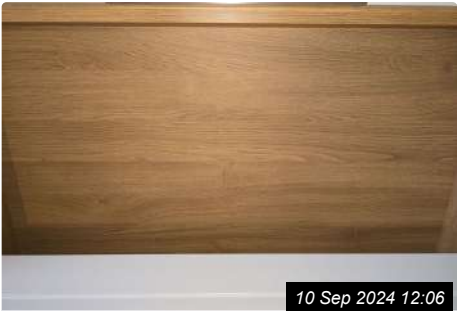
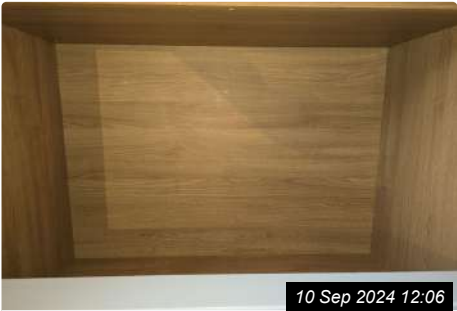
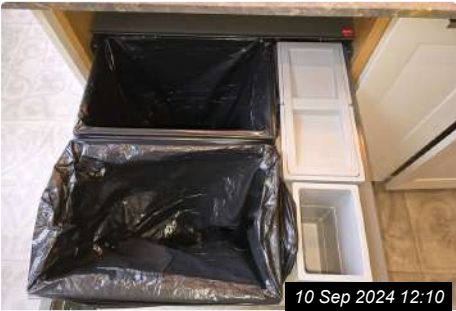
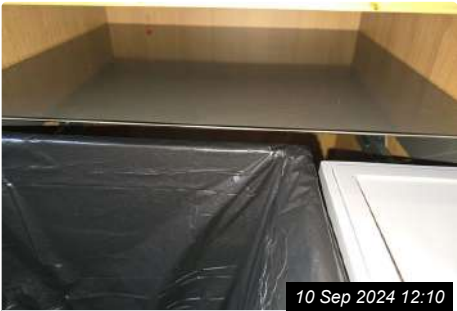
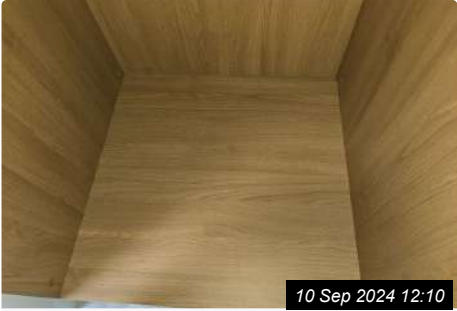
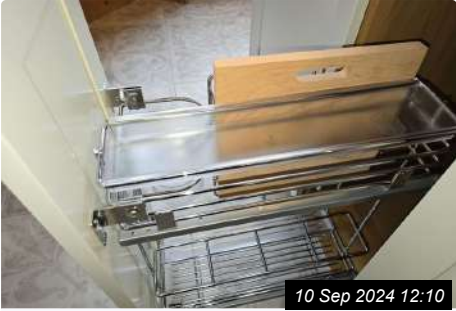
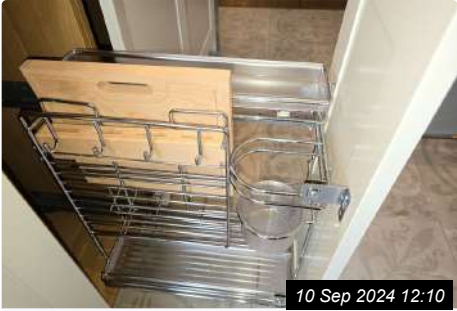
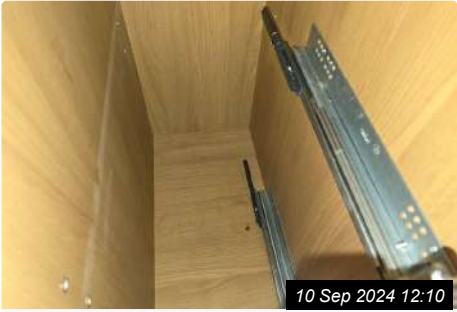
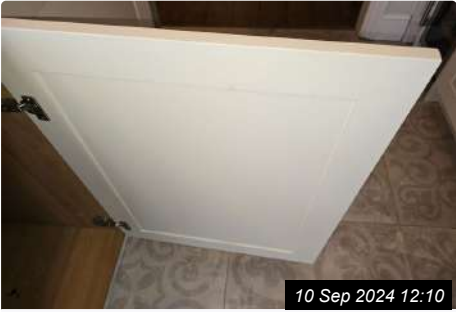
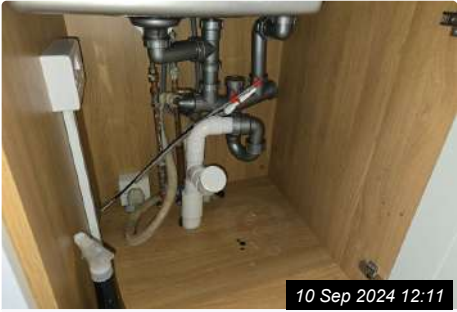
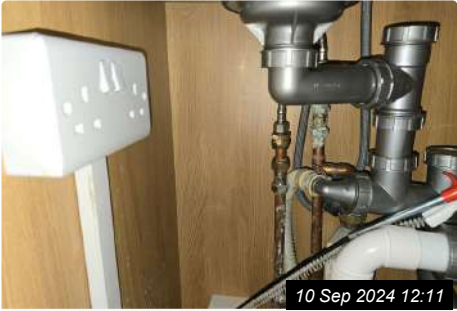
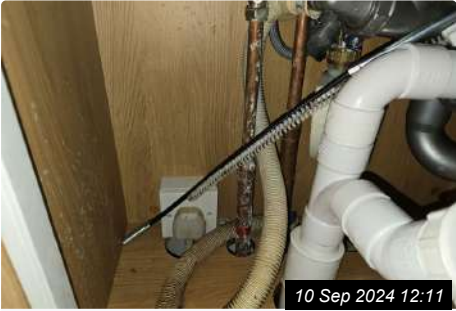
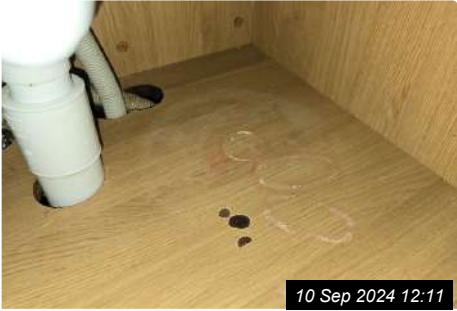
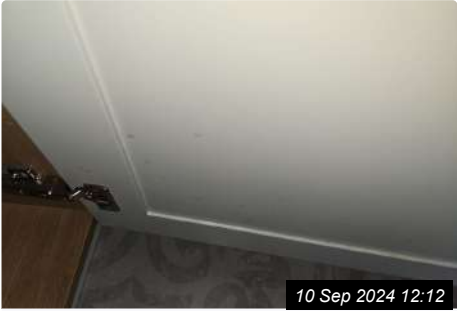
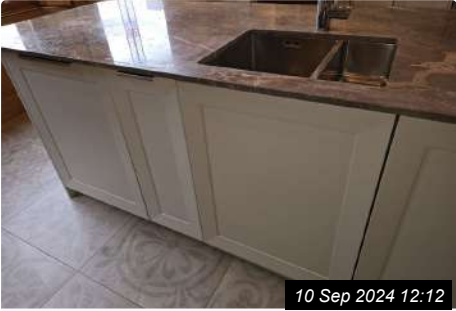
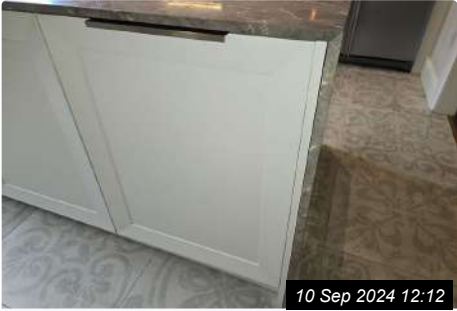
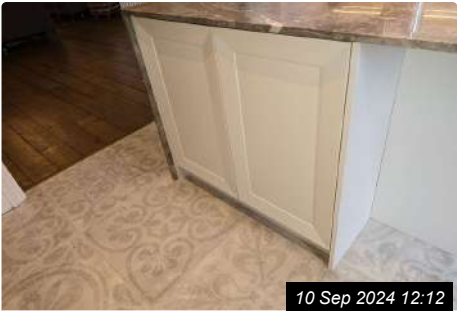
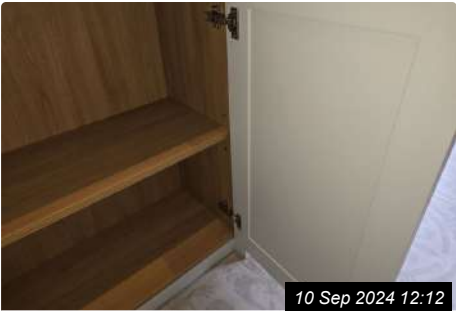
| 9. KITCHEN (CONT.) | | | |
|---|---|---|---|
| 9.14 | Units | <p>White laminate units with grey metal handles and brown wood effect interiors</p> <p>Left hand side wall:<br/>Upper- Oneself to left-hand side: one open fronted section to Middle;<br/>Three push to open cupboards with brown wood effect interiors; lower right-hand side cupboard contains one shelf<br/>Lower- open fronted storage section two left hand side<br/>Three drawers with brown wood effect interiors</p> <p>Centre Island:<br/>Left hand side - one pull out draw with grey metal frame and for light grey plastic bins<br/>Pull out draw with various clear plastic brown wooden and grey metal wire storage<br/>Single push to open with brown wood effect interior and one single and one double white plastic socket<br/>Right hand side - double door covered with brown wood effect interior and one shelf</p> <p>Right hand side wall:<br/>Pull out unit with five clear and opaque glass and chrome effect metal trays and grey metal frame<br/>Two door push to open unit with two shelves<br/>Two door pushed to open unit with single shelf<br/>Pull out unit with five clear and opaque glass and chrome effect metal trays and grey metal frame<br/>Shallow unit with seven shelves<br/>Two door push to open unit with single shelf and seven single white plastic fuse switches</p> | <p>In a good condition with some minor signs of use<br/>Some dust to door exterias and light marking two door interiors</p> <p>Damage to right hand side interior bottom of under sink unit; drain rods present</p> <p>Debris to interior of pull out drawers with multiple shelves</p> <p>Light debris to interior of shallow shelves</p> <p>Light bulbs left to top left hand of unit above fridge freezer</p> |

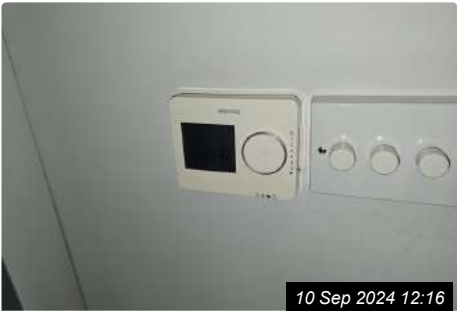
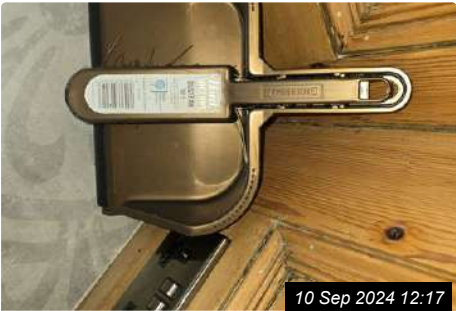
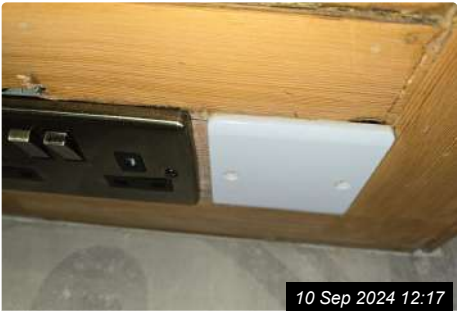
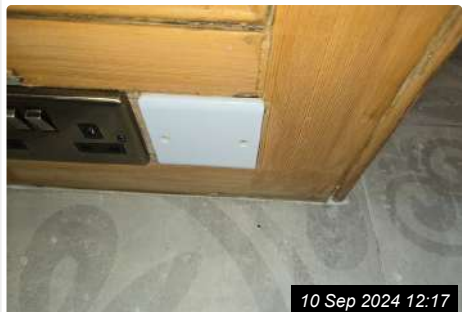
| 9. KITCHEN (CONT.) | | | |
|---|---|---|---|
| 9.15 | Ref # 9.15 | 10 Sep 2024 12:16 | |

| 9. KITCHEN (CONT.) | | | |
|---|---|---|---|
| 9.15 | Additional items | Off-white plastic warm-up thermostatic control<br>Brown plastic dustpan and brush<br>White plastic electrical cover | Tested for power; appears in good condition<br>Signs of use<br>Condition consistent with use |

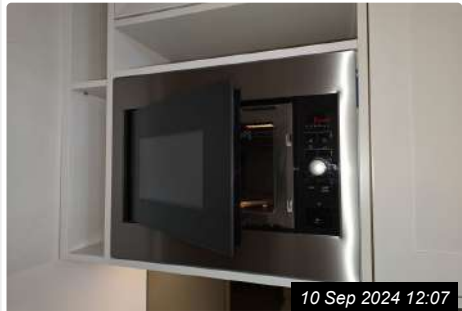
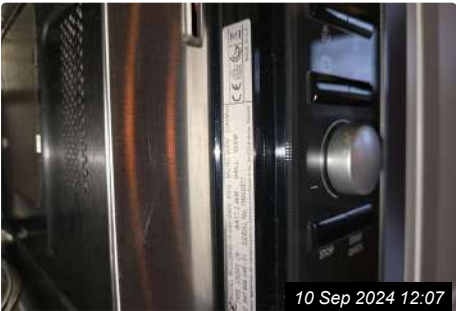
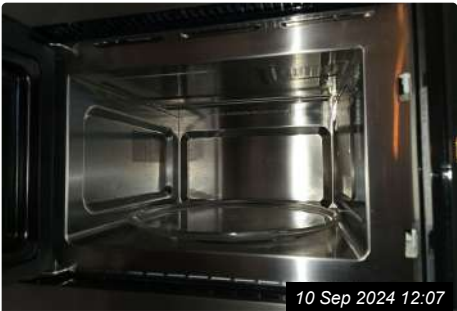
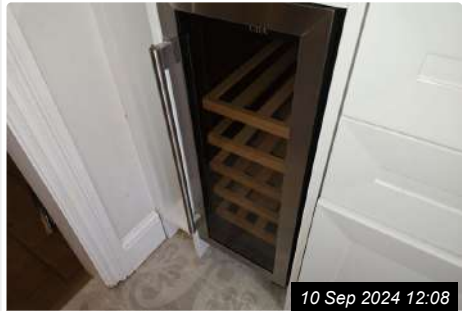
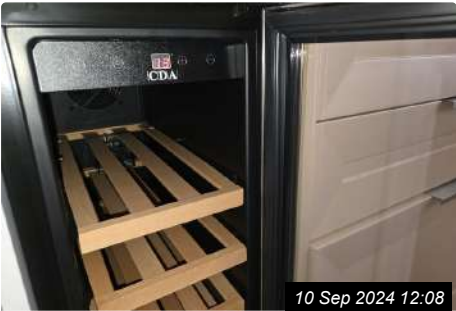
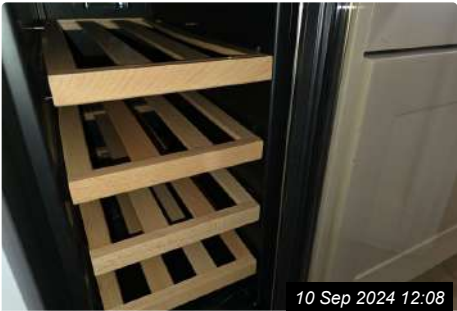
| 9. KITCHEN (CONT.) | | | |
|---|---|---|---|
| 9.16 | Small appliances | <p>Grey metal and clear and black glass AEG microwave with grey metal interior and clear glass rotating plate</p> <p>Grey and black metal, clear glass and black plastic wine fridge with brown wooden shelves</p> | <p>Tested for power; signs of use; appears in good clean condition</p> <p>Tested for power; dust top of door; in good condition</p> |

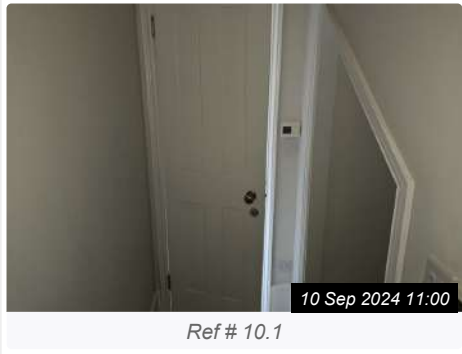
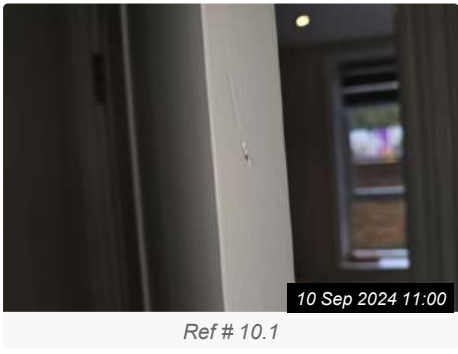
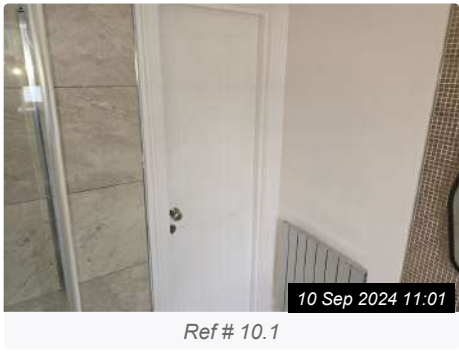
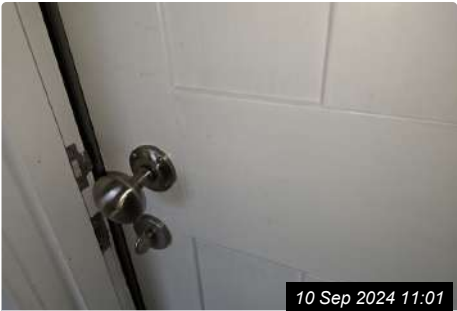
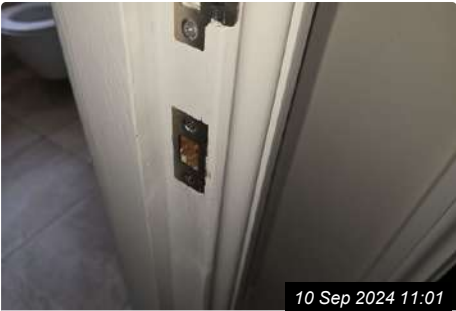
| Ref | Name | Description | Condition |
|---|---|---|---|
| 10.1<br>📷 | Door/ Frame/<br>Threshold | <p>Door: White wooden four panel door with grey metal furniture including: two handles and thumbtwist lock</p> <p>Frame: White painted wooden frame; two grey metal strike plate</p> <p>Threshold: grey metal transverse strip</p> | <p>Good condition with minor surface damage to closing hedge upper level<br/>Some marking to interior left-hand side</p> <p>Minor Mark mid-level right hand side; otherwise in good condition; some cracking to bottom of lower strike plate</p> <p>Condition consistent with use</p> |

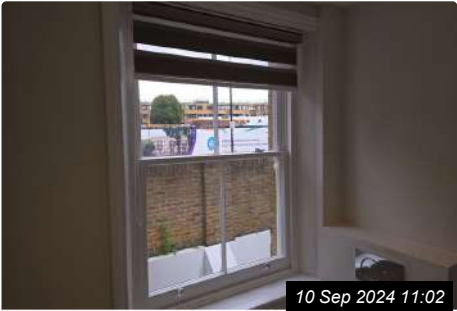
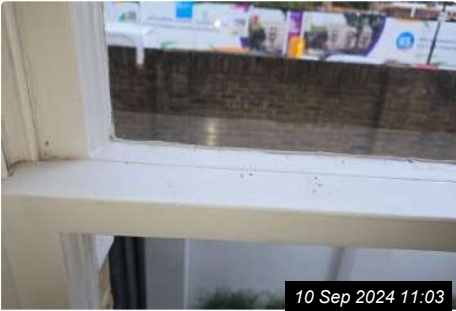
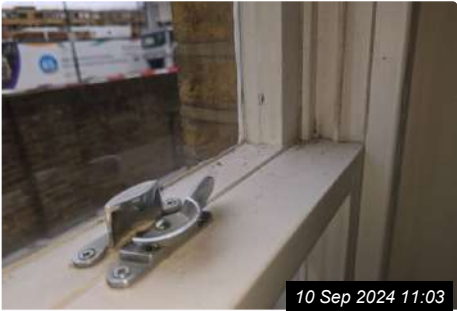
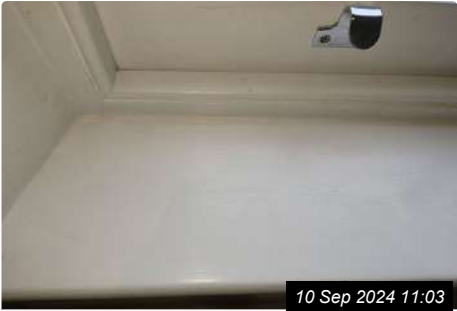
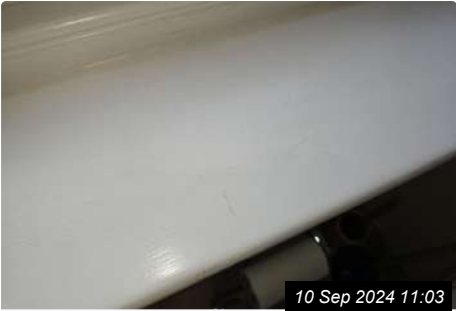
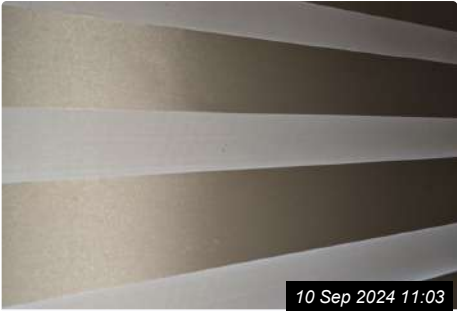
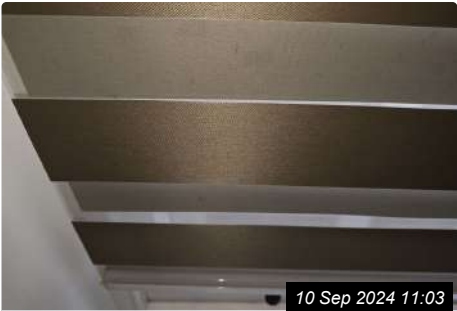
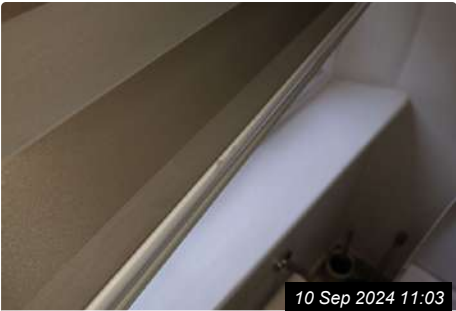
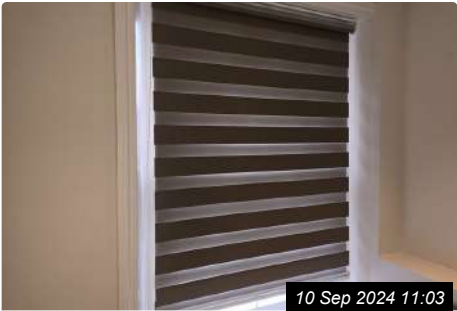
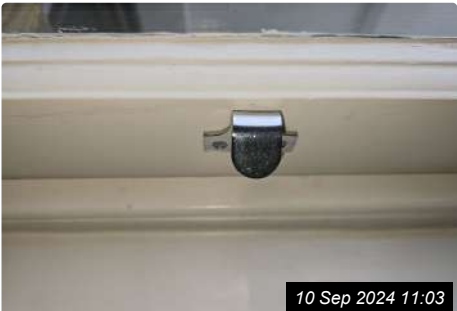
| 10. WATER CLOSET (CONT.) | | | |
|---|---|---|---|
| 10.2 | Window(s) / Sill | <p>White wooden framed sash window; four cleared glass panes; one chrome effect lock and two handles</p> <p>White painted wooden sill</p> <p>Grey and clear mesh roller blind with white plastic and white plastic beaded cord</p> | <p>Window is in good working order with some watermarks and to panes; dust and paint cracking to middle of sash window frame and dust to tops of handles</p> <p>Generally good condition with minor marking throughout and one chip two left-hand side of leading edge</p> <p>Minor dirt to blind and plastic and piece</p> <p>No cord present</p> |

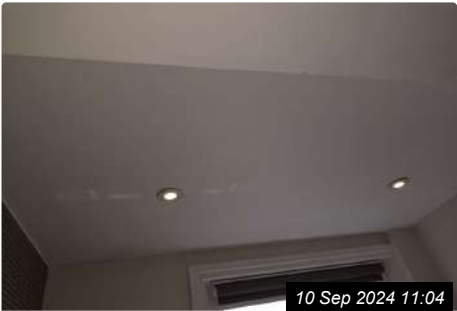
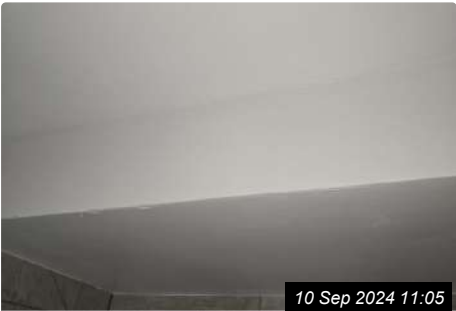
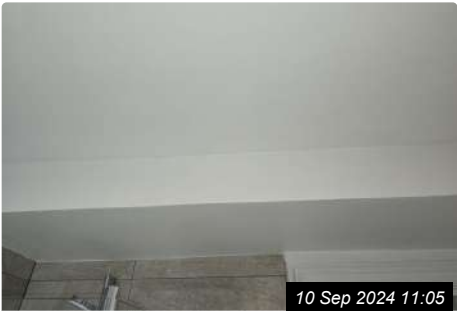
| 10. WATER CLOSET (CONT.) | | | |
|---|---|---|---|
| 10.3 | Ceiling | Smooth white painted | Generally good condition with paint flaking to corner above shower area |

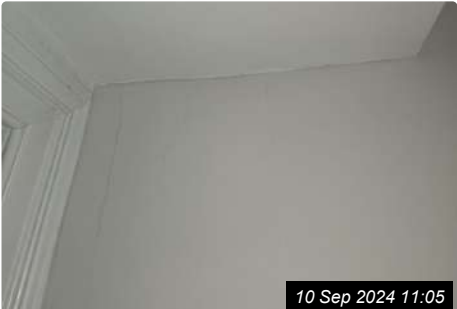
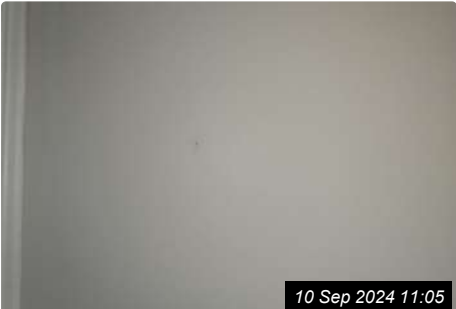
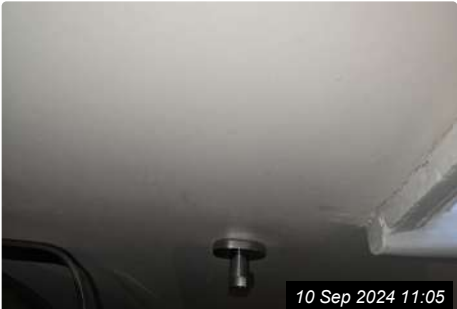
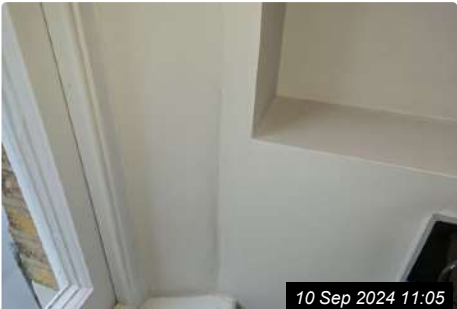
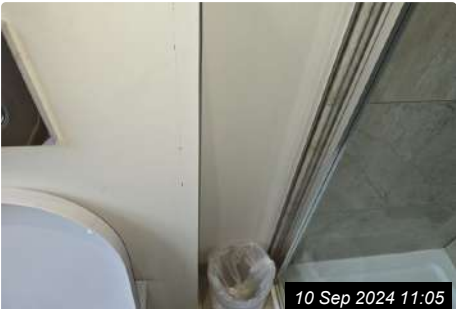
| 10. WATER CLOSET (CONT.) | | | |
|---|---|---|---|
| 10.5<br> | Walls / Skirting | <p>Walls: Off white smooth painted<br/>Small copper mosaic style tiles to left hand side<br/>Grey and brown stone effect rectangular tiles to right-hand side with chroma effect edging<br/>Red/brown stone shelf to left hand side of rear wall</p> <p>Skirting to match flooring</p> | <p>Good condition; minor cracking and places<br/>Minor Mark mid-level to left-hand side upon entry</p> <p>Crack between wall and skirting Too Far Side</p> |
