# Inventory & Schedule of Condition

Prepared on behalf of Example Lettings Ltd

123 Preview Street  
Sample City  
London  
AB1 2CD

**September**  
**13th 2024**

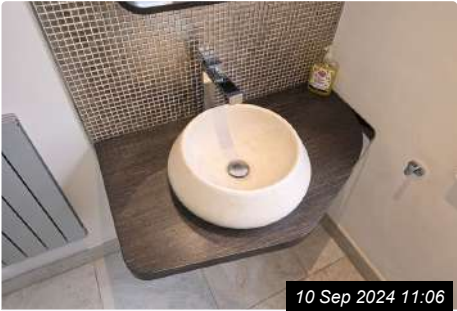
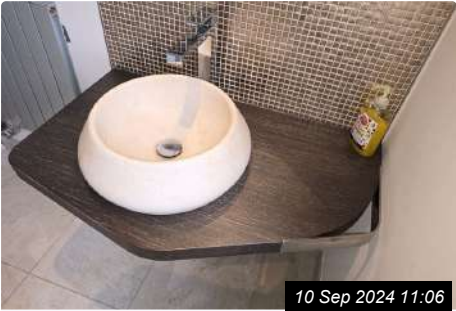
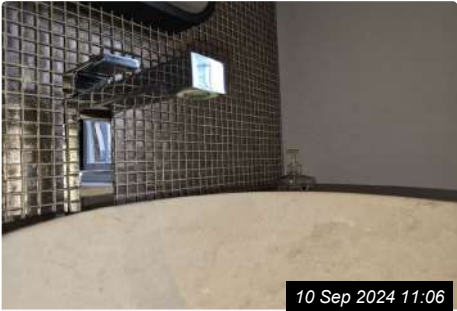
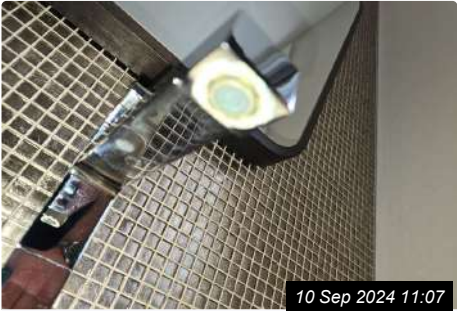
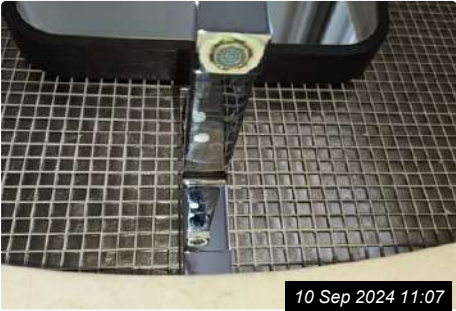
| 10. WATER CLOSET (CONT.) | | | |
|---|---|---|---|
| 10.9 | Basin | Light brown stone with Chrome Effect push button plug and mixer tap<br><br>Brown wood effect laminate worktop with metal chroma effect strip to right hand side | All in good working order<br>Limescale to tap spout<br><br>Over painting to worktop and some tarnishing/ smudging too chrome strip |

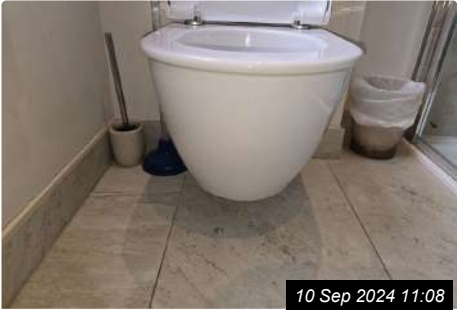
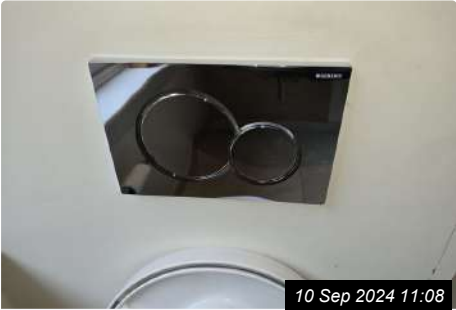
| 10. WATER CLOSET (CONT.) | | | |
|---|---|---|---|
| 10.10<br>📷 | Toilet | White ceramic hidden system toilet with white plastic seat and lid and Chrome Effect plastic two button flush | Good clean condition; in good working order |

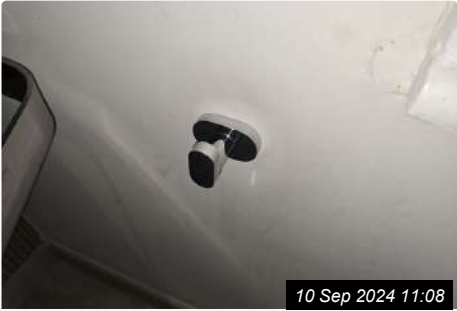
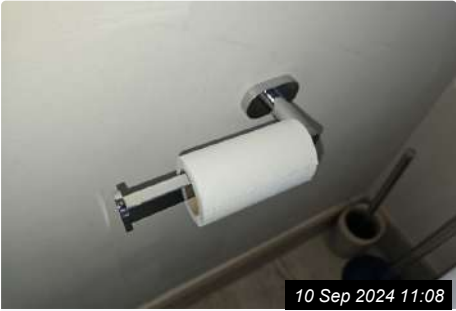
| 10. WATER CLOSET (CONT.) | | | |
|---|---|---|---|
| 10.11<br>📷 | Accessories | Brown laminate frame with glass mirror to front<br><br>Chrome Effect handtowel holder and toilet roll holder | In good condition with light smudge marks |

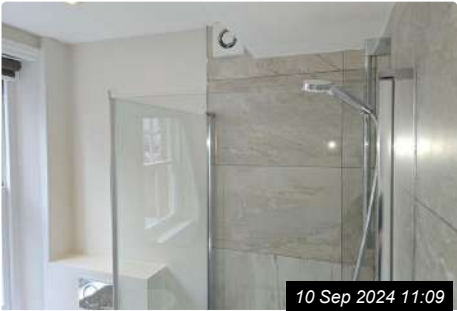
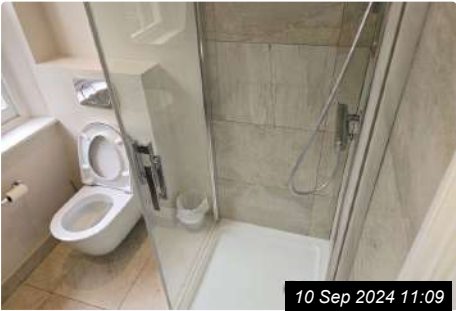
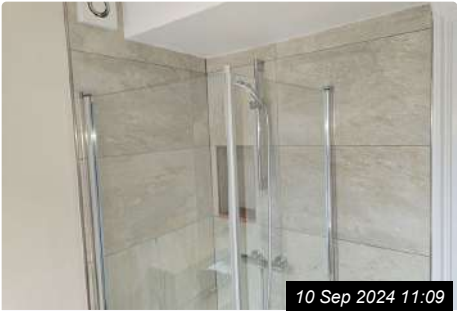
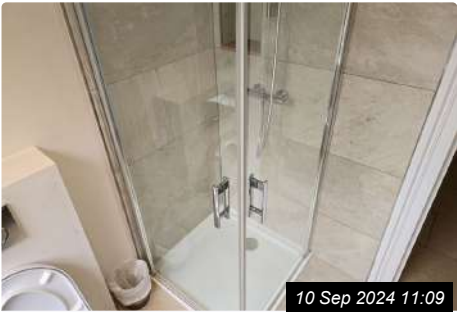
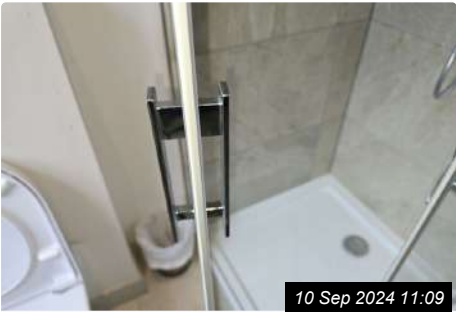
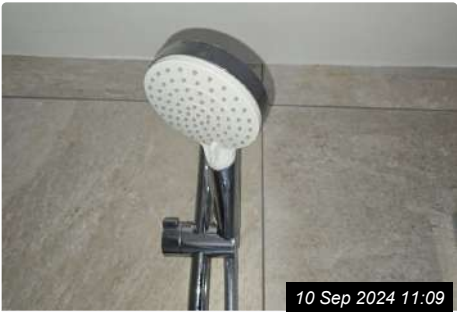
| 10. WATER CLOSET (CONT.) | | | |
|---|---|---|---|
| 10.12<br>📷 | Shower unit/ area | Chrome Effect frame and two handles with two clear glass door panes<br><br>Shower unit is Chrome Effect plastic and metal with white plastic shower head plate where's hose and controls too match<br><br>White composite shower tray with Chrome Effect drain cover | Untested<br><br>Signs of use; good clean condition with some watermarks to Chrome<br><br>Some minor debris too shower tray |

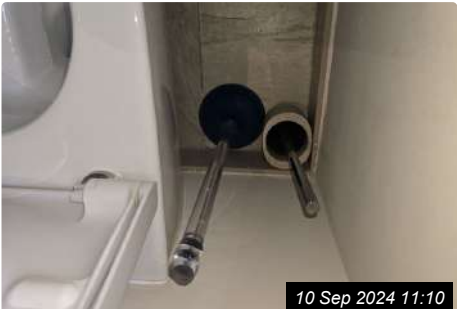
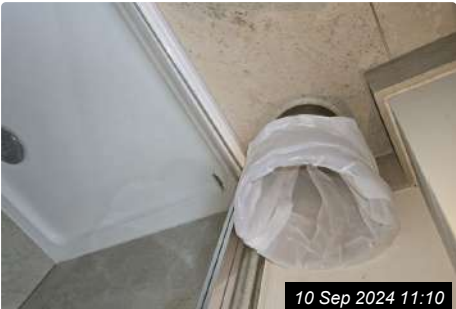
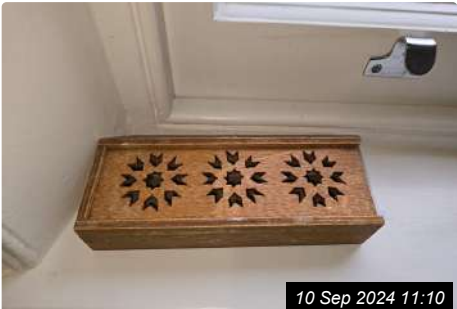
| Ref | Name | Description | Condition |
|---|---|---|---|
| 10.13<br> | Additional items | <div>One Chrome Effect and black plastic toilet brush with light brown stone holder</div> <div>Clear plastic and black rubber plunger</div> <div>Coloured clear plastic bin</div> <div>Wooden box with patterned sliding top</div> | Signs of use; untested |

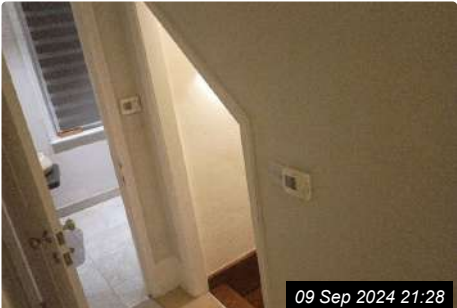
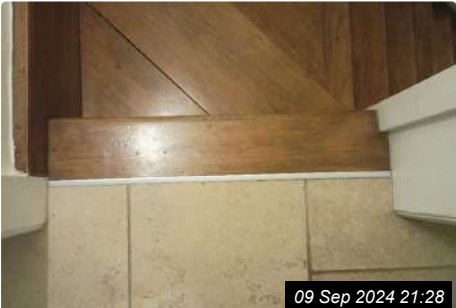
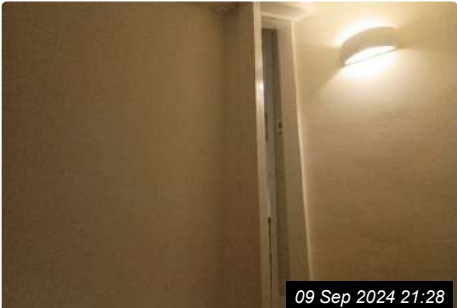
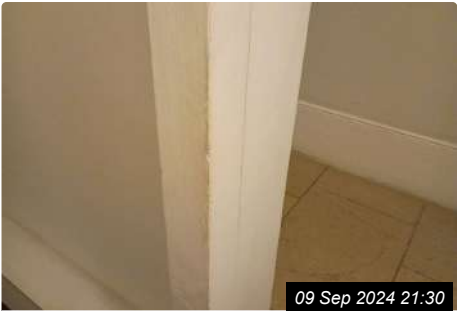
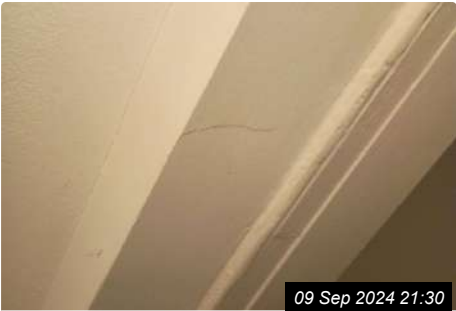
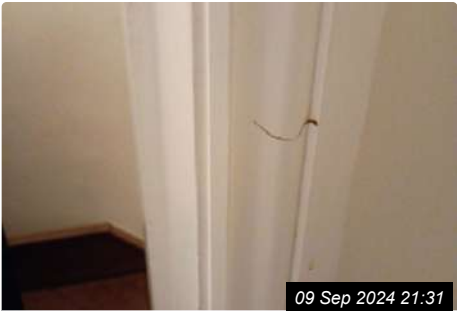
| Ref | Name | Description | Condition |
|---|---|---|---|
| 11.1<br>📷 | Door/ Frame/<br>Threshold | Wooden white painted door frame<br><br>Treated wood threshold<br><br>Brushed metal traverse strip | Painted over defects<br><br>Chips to paint<br><br>Some light scuffing<br><br>Wear to lip of threshold |

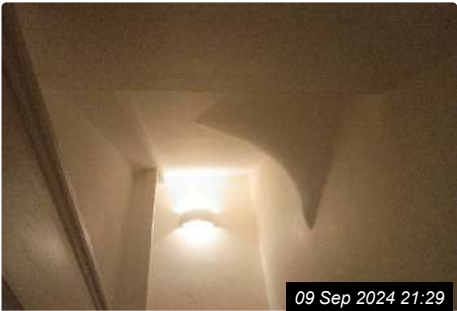
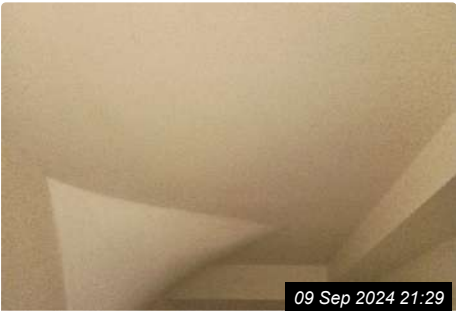
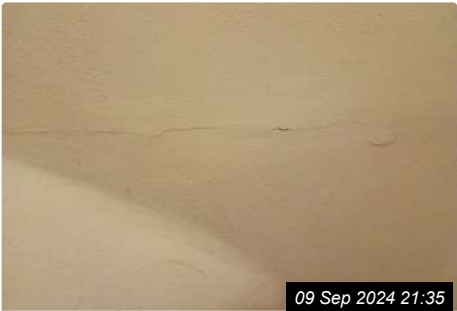
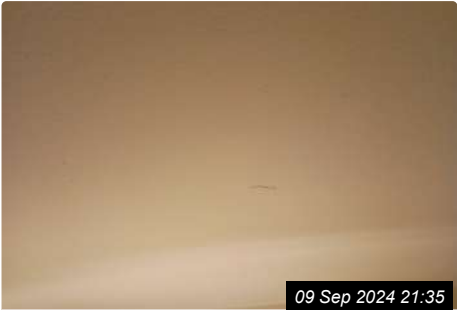
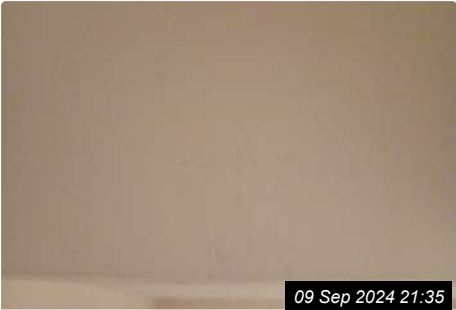
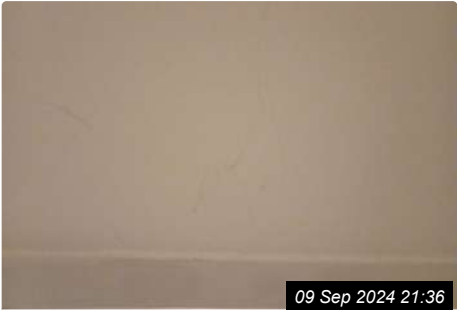
| 11. STAIRS/ LANDING (BASEMENT) (CONT.) | | | |
|---|---|---|---|
| 11.2 | Ceiling | Smooth white painted ceiling | Some nail and settlement cracks in paint on stairway |

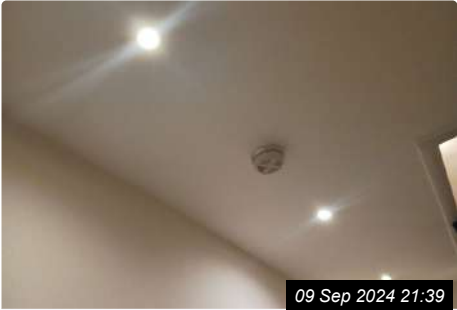
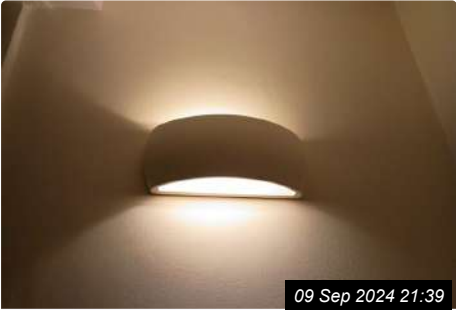
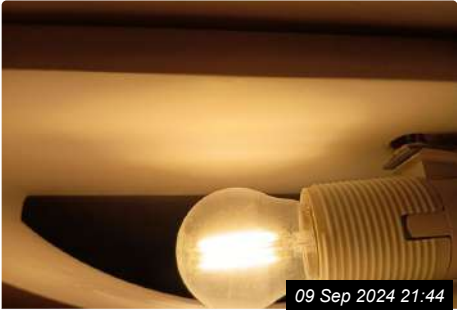
| 11. STAIRS/ LANDING (BASEMENT) (CONT.) | | | |
|---|---|---|---|
| 11.3 | Lighting | white surround inset spotlights X3<br><br>X1 single bulb wall mounted ceramic unit | Tested and working<br><br>Good condition |

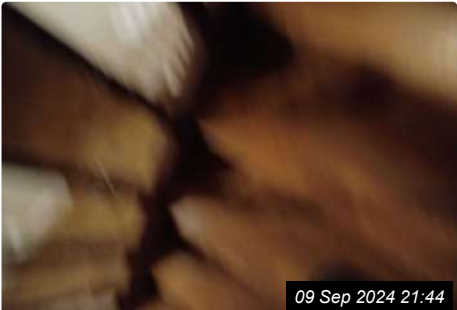
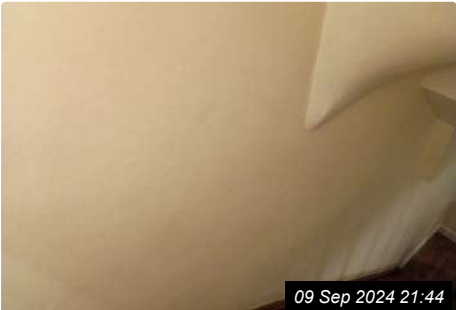
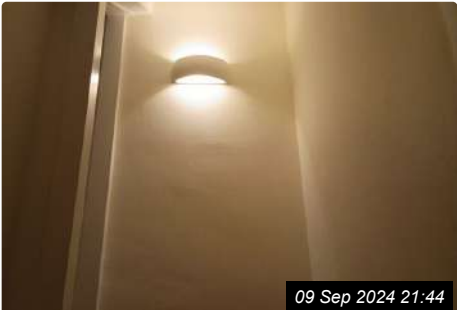
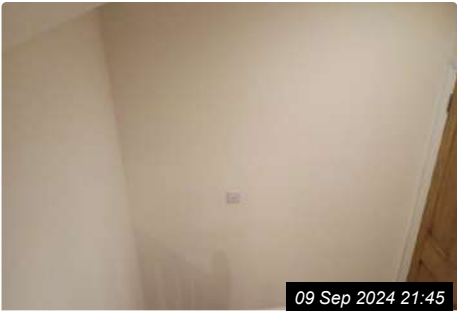
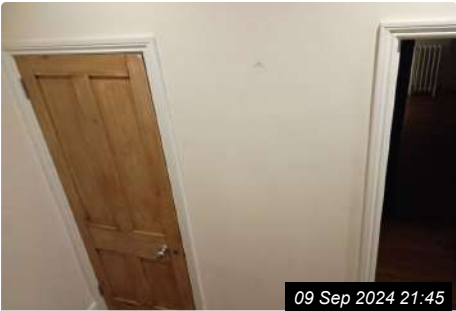
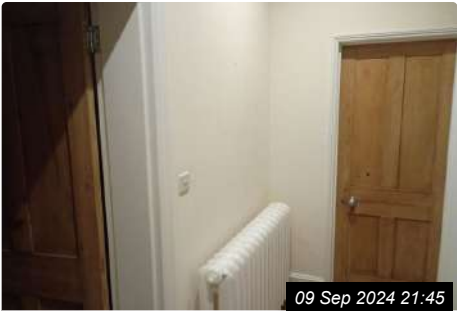
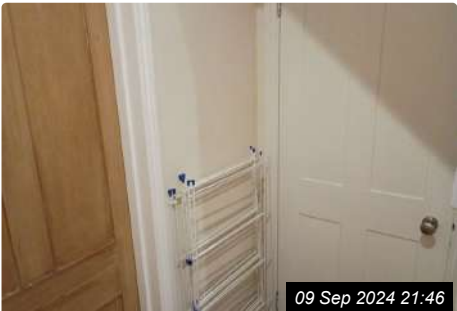
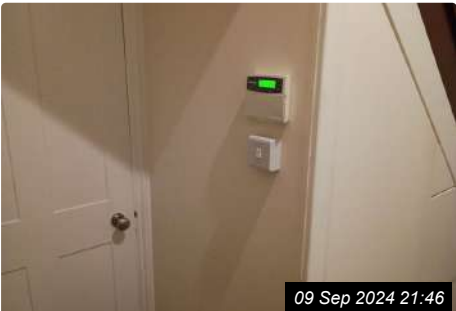
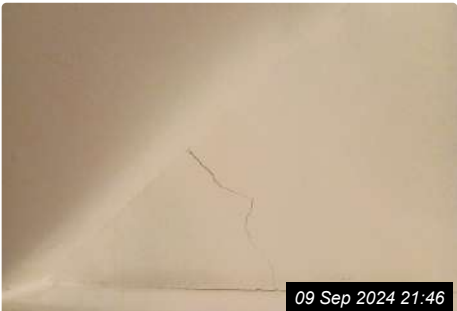
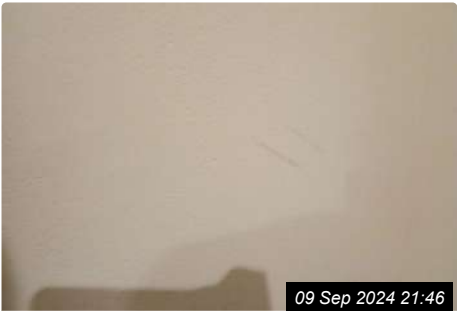
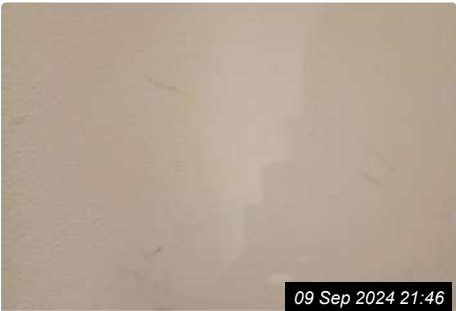
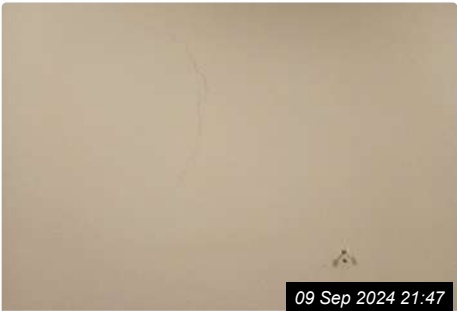
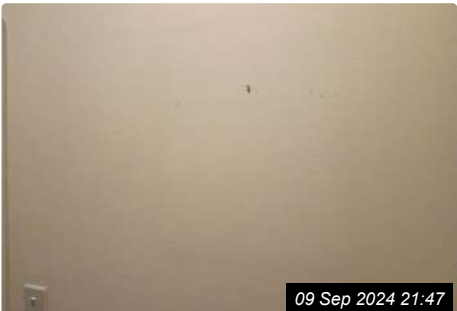
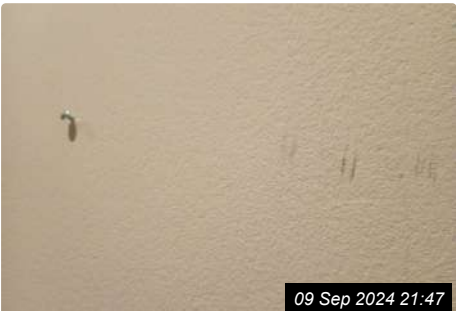
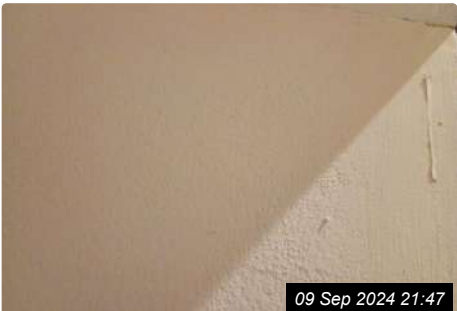
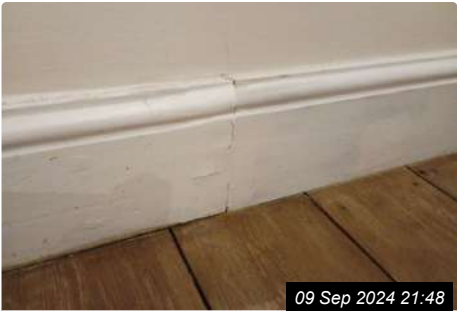
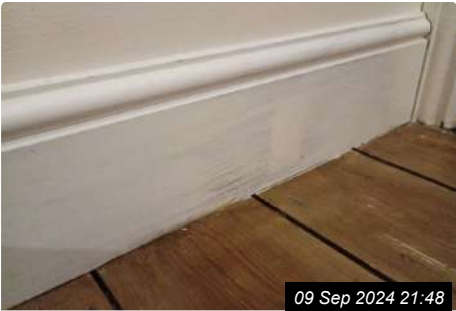
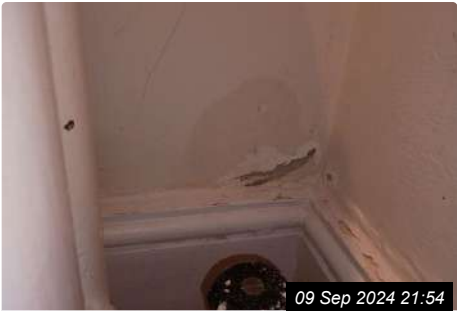
| 11. STAIRS/ LANDING (BASEMENT) (CONT.) | | | |
|---|---|---|---|
| 11.4 | Walls / Skirting | Off white painted walls<br><br>Wooden white painted skirting boards | Some scuffing<br><br>Some settlement cracks<br><br>Nails for paintings<br><br>Weathering left by picture frame<br><br>Painted over defects on skirting boards<br><br>Patch of paint missing behind radiator |

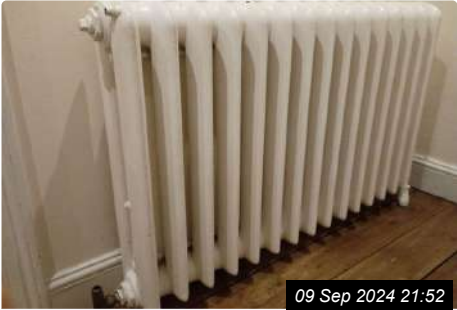
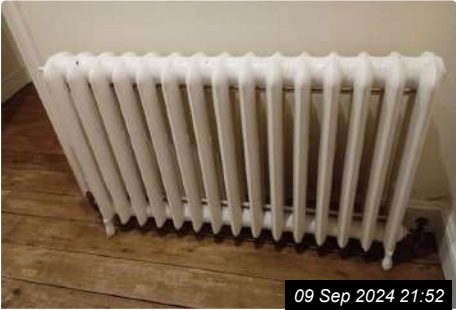
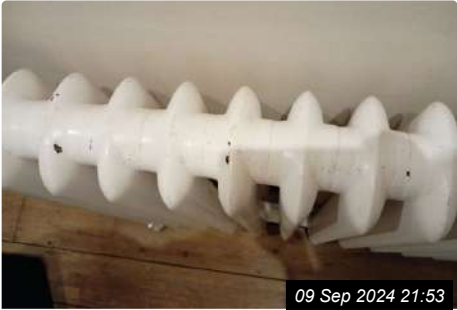
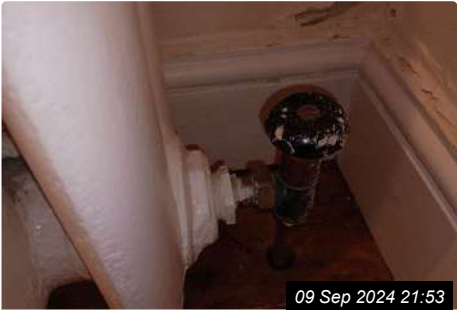
| 11. STAIRS/ LANDING (BASEMENT) (CONT.) | | | |
|---|---|---|---|
| 11.5 | Heating | Large iron white painted vertical bar radiator with ornate feet | Paint chipping on top<br><br>Scuff marks to top |

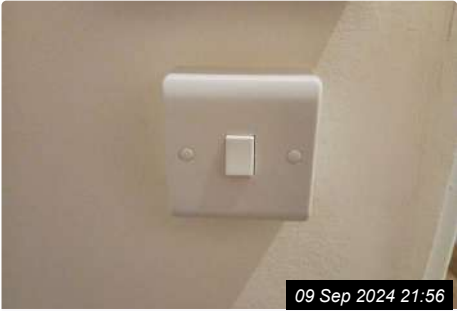
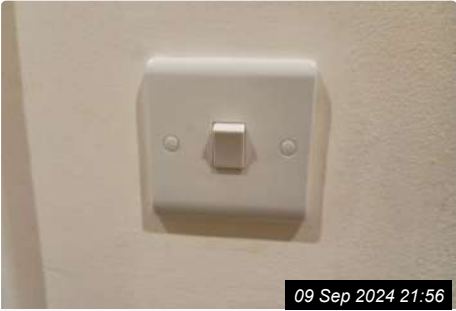
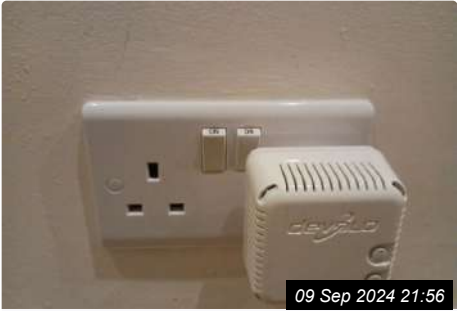
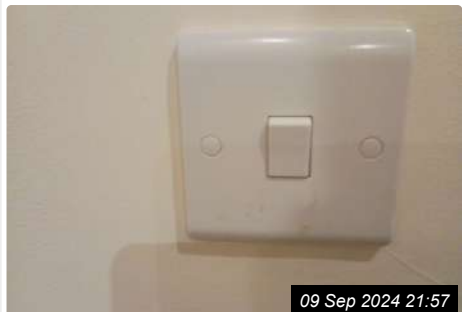
| 11. STAIRS/ LANDING (BASEMENT) (CONT.) | | | |
|---|---|---|---|
| 11.6 | Switches / Sockets | White plastic switch x3<br><br>White plastic double socket x1 | All in good, working order |

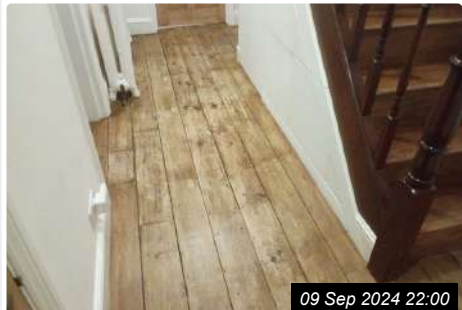
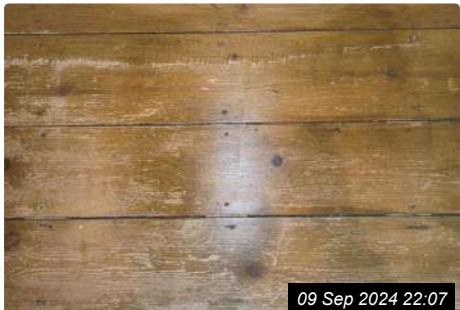
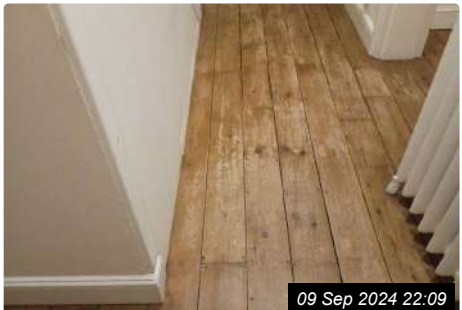
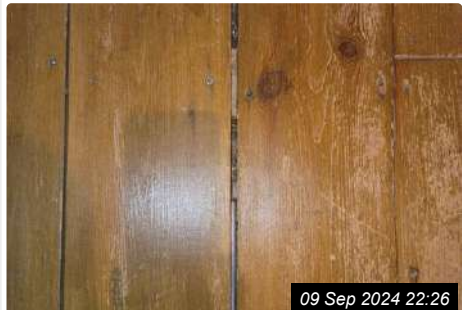
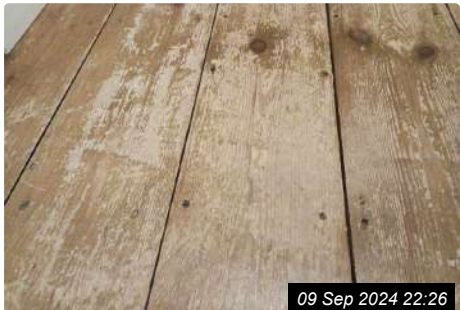
| 11. STAIRS/ LANDING (BASEMENT) (CONT.) | | | |
|---|---|---|---|
| 11.7 | Flooring | Treated Wood panel floorboards with some filled some exposed fixing screws | Signs of use and age<br><br>Some gaps in between floorboards |

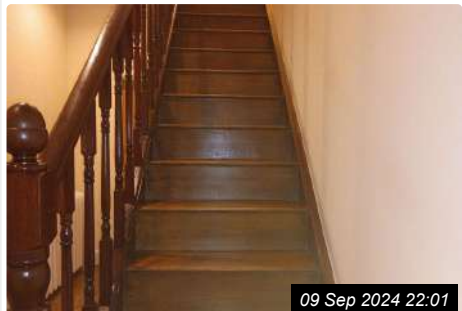
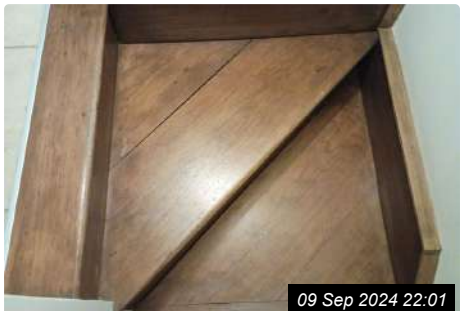
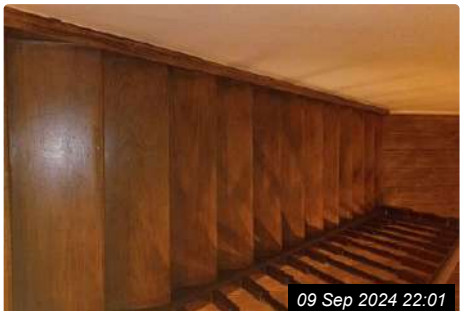
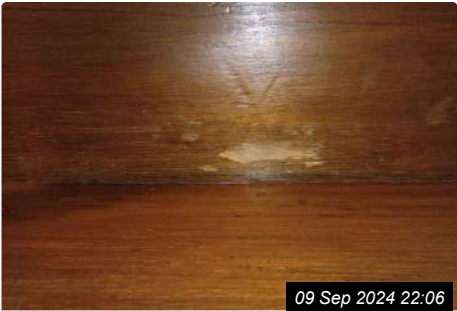
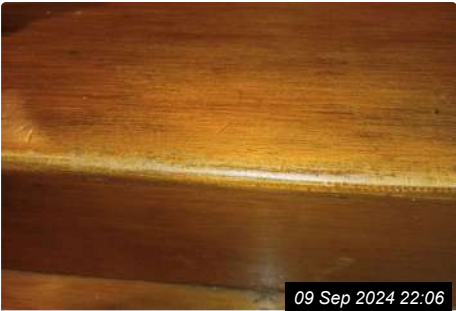
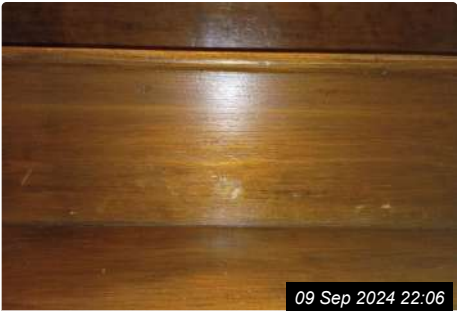
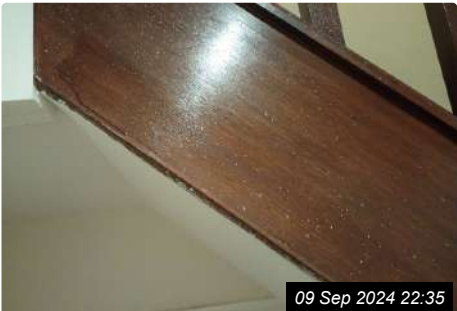
| 11. STAIRS/ LANDING (BASEMENT) (CONT.) | | | |
|---|---|---|---|
| 11.8 | Staircase | Wooden treated wood stairs with roughly 8mm lip on each tread | Signs of age and use to lip of stair treads<br><br>Some weathered marks on uprights of treads<br><br>Paint splatters to running board on staircase |

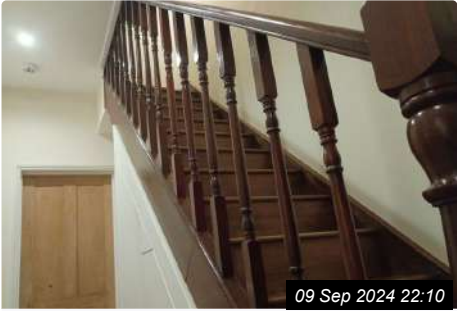
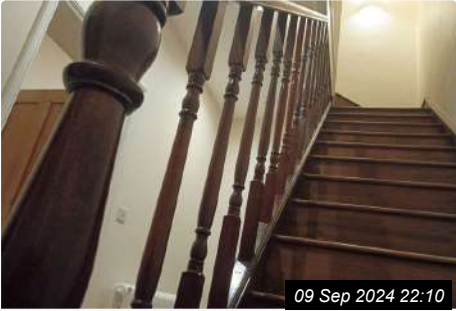
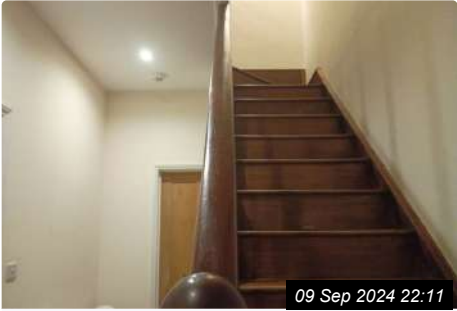
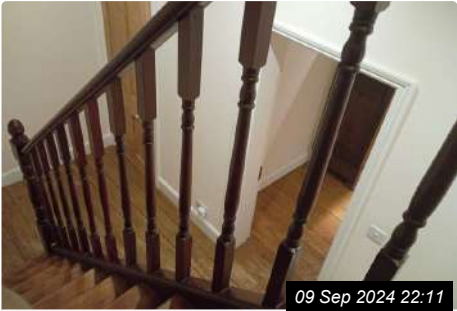
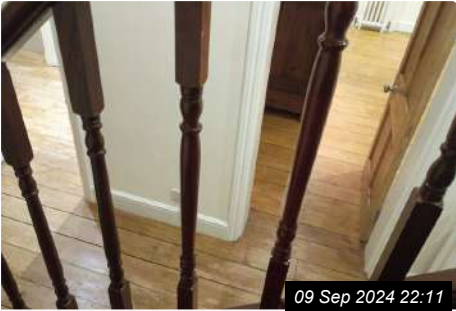
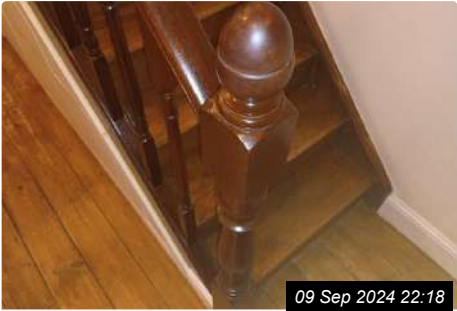
| 11. STAIRS/ LANDING (BASEMENT) (CONT.) | | | |
|---|---|---|---|
| 11.9 | Bannister/handrail | Wooden vanished handrail and spindle with acorn newlpst cap | <p>X2 of the bannister spindles are upside down with a different redder varnish</p> <p>Some varnish defects to spindles</p> <p>Songs of use and age to handrail</p> |

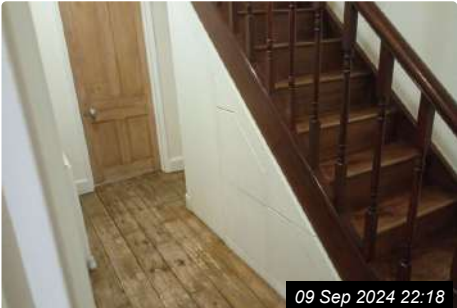
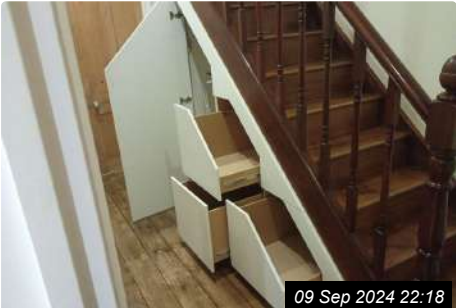
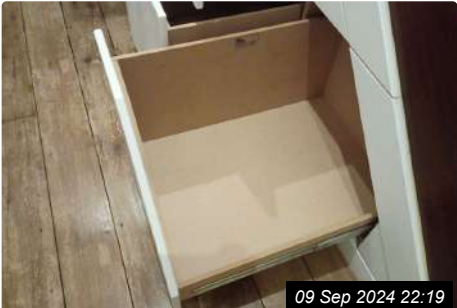
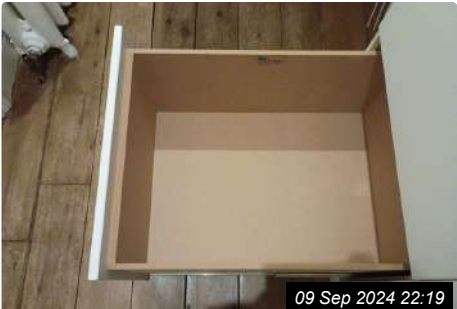
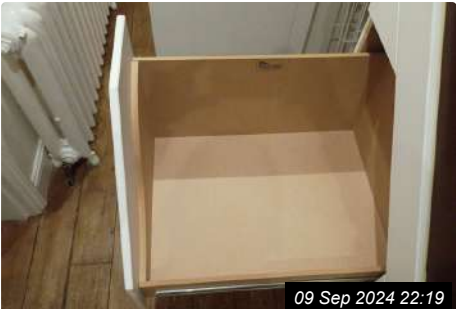
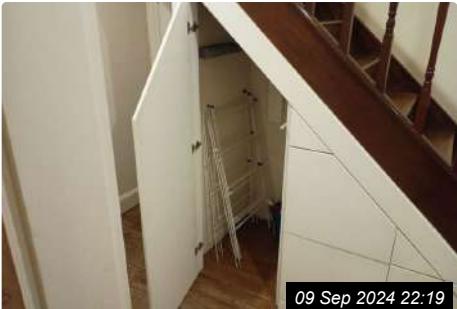
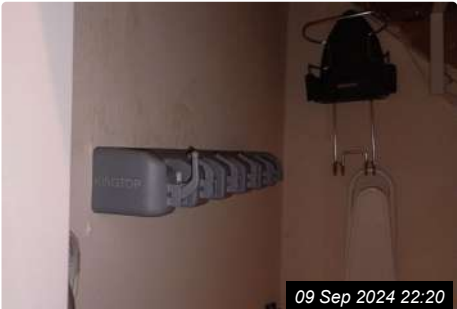
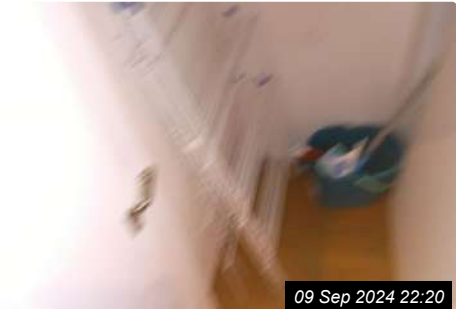
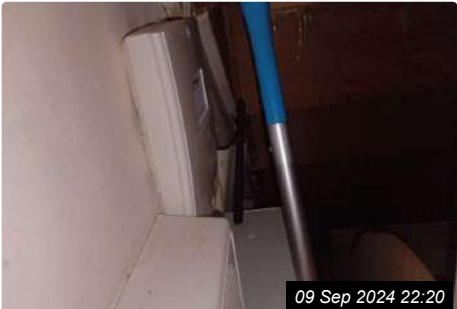
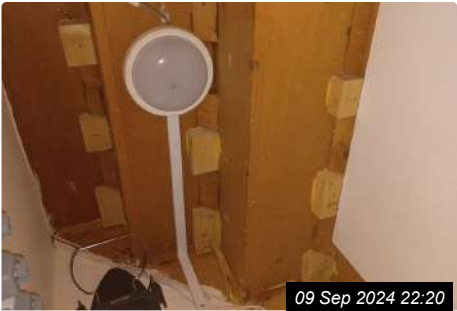
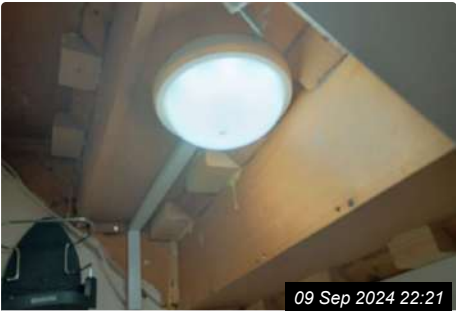
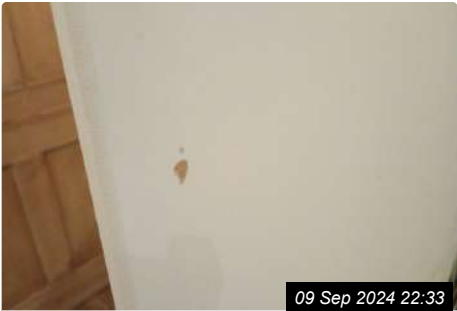
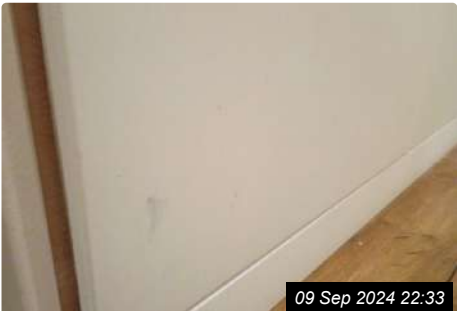
| 11. STAIRS/ LANDING (BASEMENT) (CONT.) | | | |
|---|---|---|---|
| 11.10<br> | Cupboard unit | <p>X3 sliding panel draws with white painted ply wood front and MDF inside</p> <p>X1 cupboard with white painted ply wood door containing following:<br/>X9 drying racks<br/>Bucket and mop<br/>Broom rack mounted on wall<br/>Iron rack mounted on wall<br/>Miniature ironing board</p> <p>Plastic surround Cresnet light with plastic lens</p> | <p>Minor scuffing to lower half of sliding draws</p> <p>Chip in paint to inside of cupboard door</p> <p>Light is tested and working</p> |

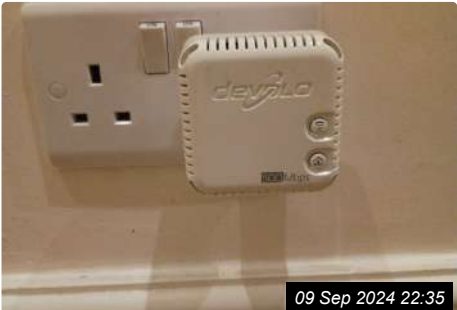
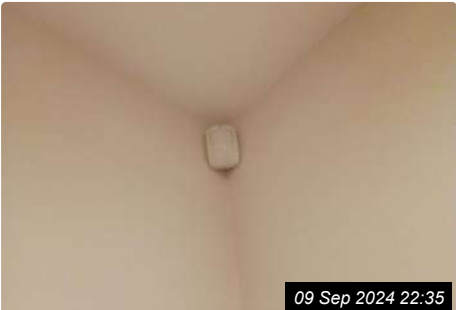
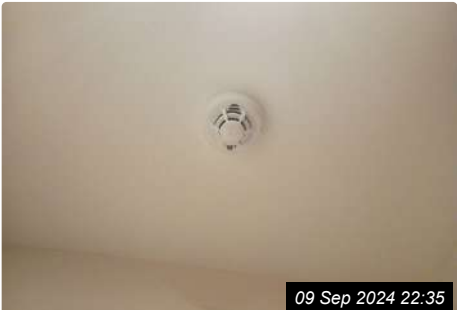
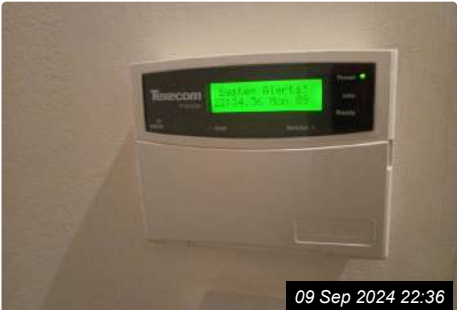
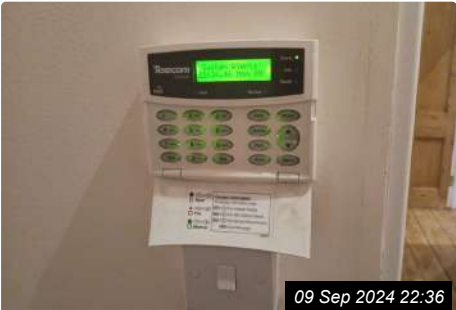
| 11. STAIRS/ LANDING (BASEMENT) (CONT.) | | | |
|---|---|---|---|
| 11.11 | Additional items | X1 Devolo router hub<br>X1 alarm sensor<br>X1 smoke alarm<br>X1 Texecom alarm panel interface | All appears in good condition |

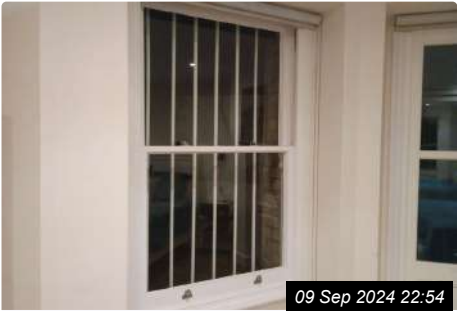
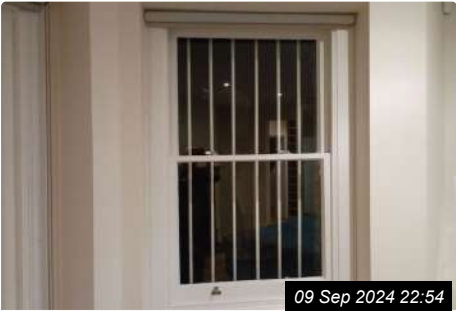
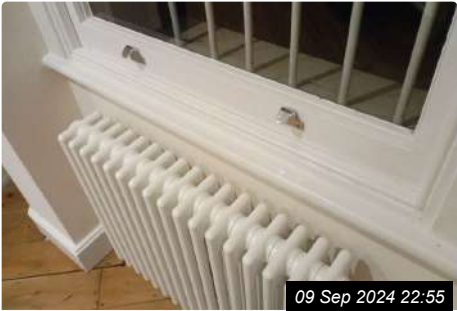
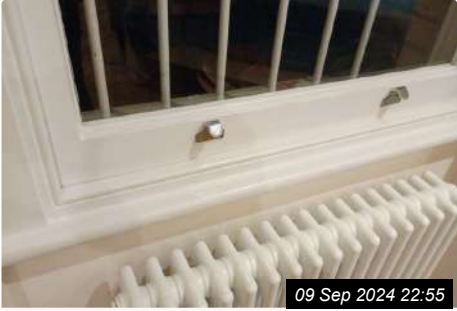
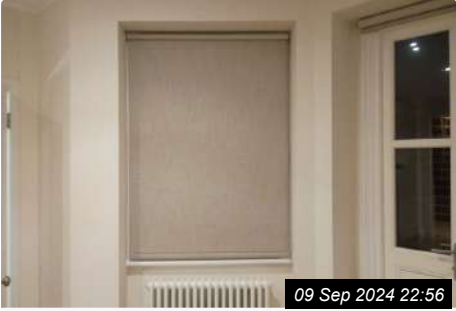
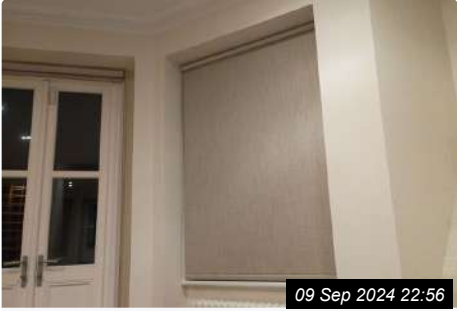
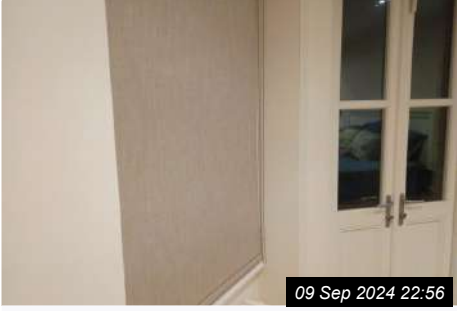
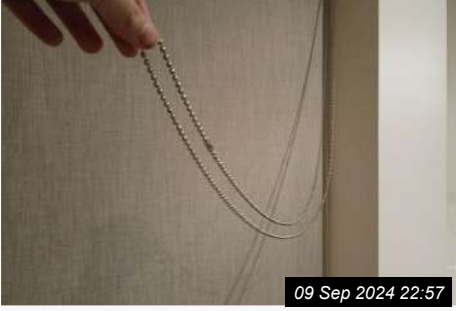
| 12. BEDROOM 1 (CONT.) | | | |
|---|---|---|---|
| 12.2 | Ref # 12.2 | | |

| 12.2 | Window(s) / Sill | X2 Two paneled window with white painted wooden frame and sill. Brushed metal locks and lifting hooks<br><br>With roll down grey fabric blind with beaded chord | In good clean condition<br><br>The beaded chord doesn't have a cleat |

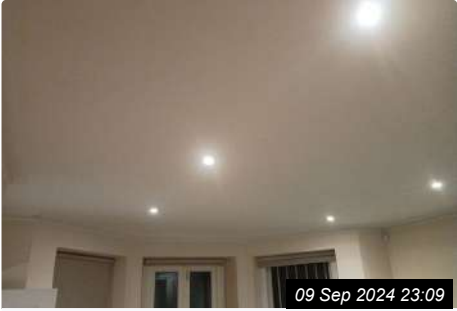
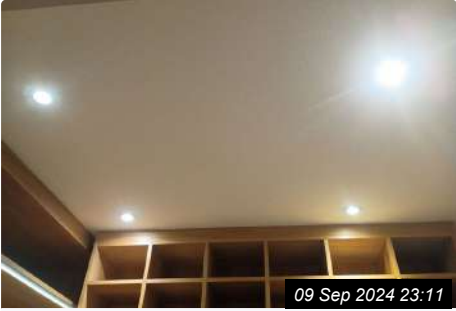
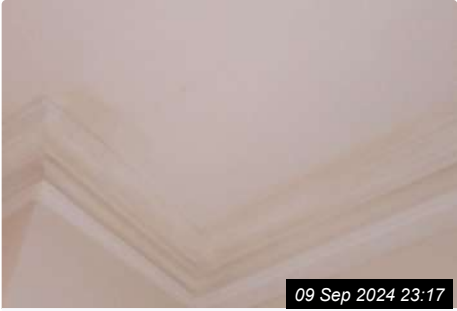
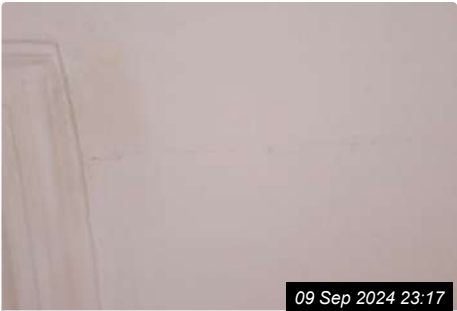
| 12. BEDROOM 1 (CONT.) | | | |
|---|---|---|---|
| 12.3 | Ref # 12.3 | | |

| 12. BEDROOM 1 (CONT.) | | | |
|---|---|---|---|
| 12.3 | Ceiling | Smooth white painted ceiling with matching moulded coving<br><br>No coving to ceiling in walk through wardrobe | Ceiling in mostly good condition with the exception of some settlement cracks above door to bathroom<br><br>Some faded paint on coving above door to bathroom |

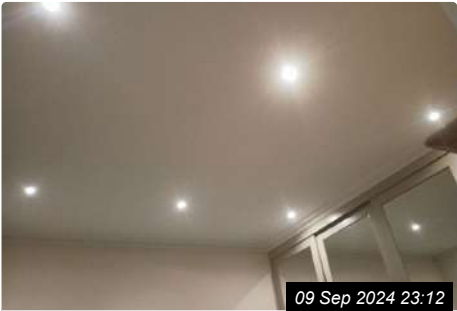
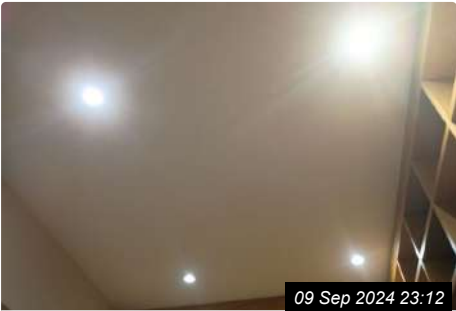
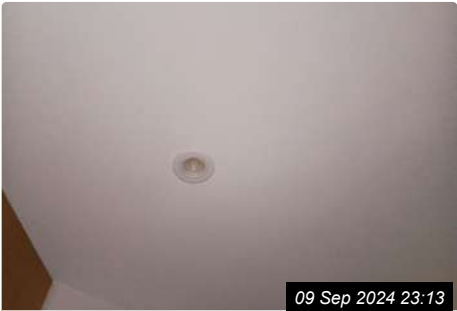
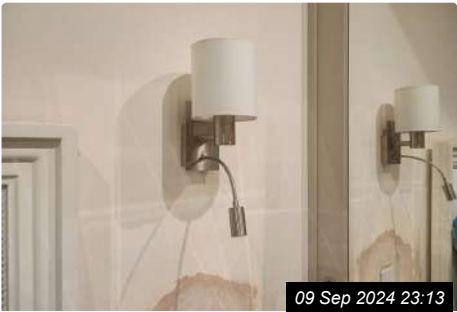
| 12. BEDROOM 1 (CONT.) | | | |
|---|---|---|---|
| 12.4 | Lighting | white surround inset spotlights x10<br><br>X2 reading lamps with torches | The spotlights are in good working order<br><br>The torches on the reading lights are working, the main lamps have not as there are no bulbs present |

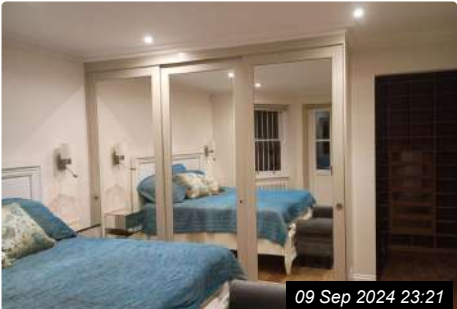
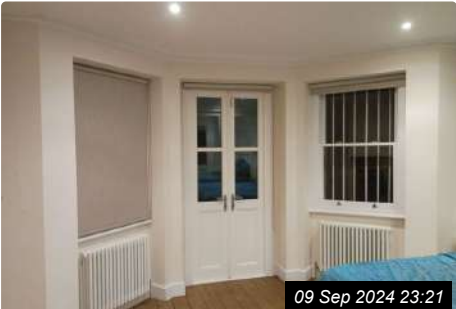
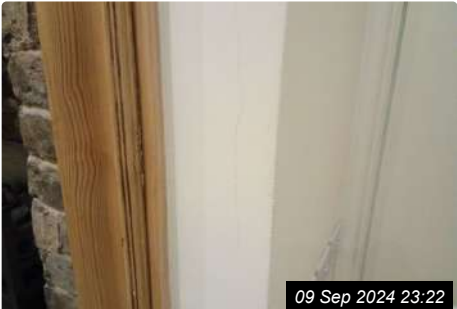
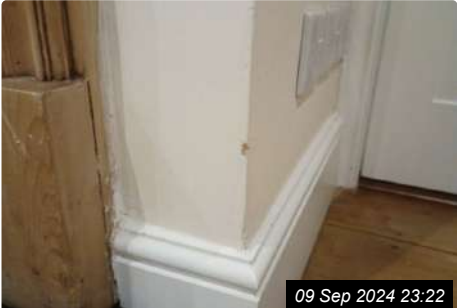
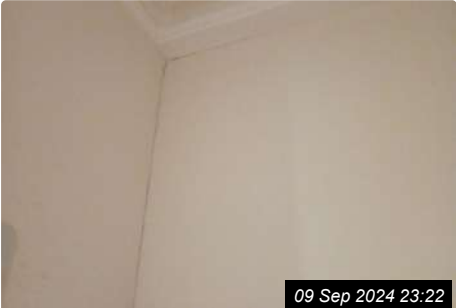
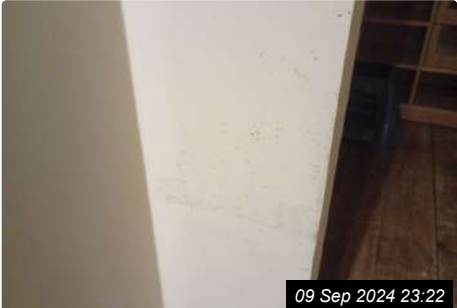
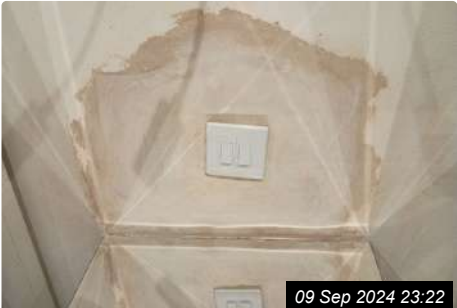
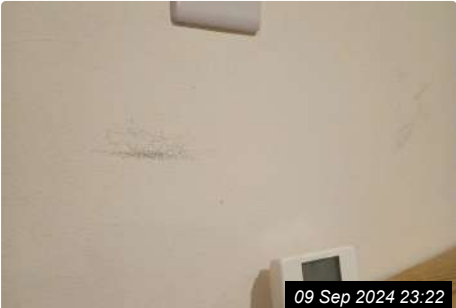
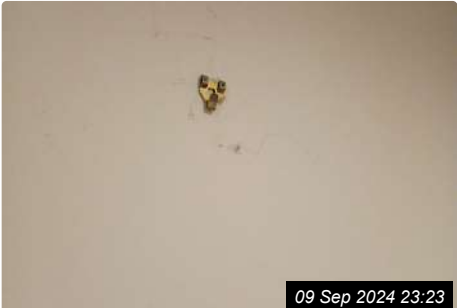
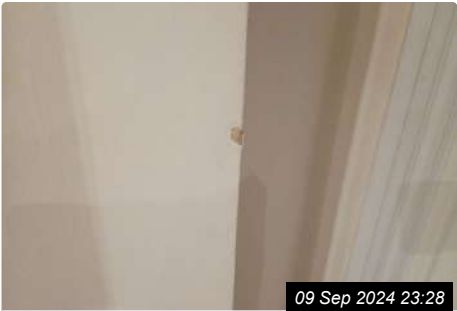
| 12. BEDROOM 1 (CONT.) | | | |
|---|---|---|---|
| 12.5<br> | Walls / Skirting | Off white smooth painted walls<br><br>Wooden white painted skirting board | Some scuffing to left and right of the archway to the walk through wardrobe.<br><br>Scuff marks above fireplace<br><br>Chip to lower edge next to bathroom door and door to garden<br><br>Large settlement cracks above door to bathroom<br><br>Scuffs next to Picture frame hook above fireplace<br><br>Skirting has some painted over defects<br><br>Plaster exposed left of bed |

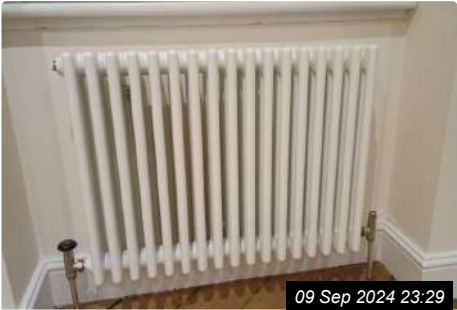
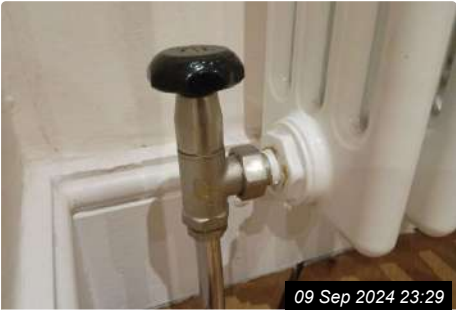
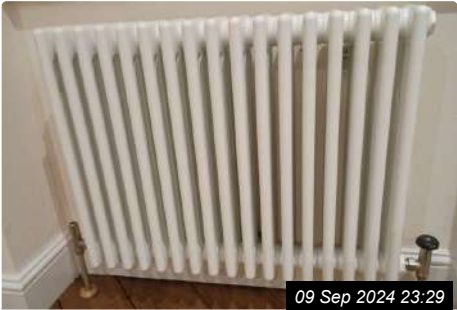
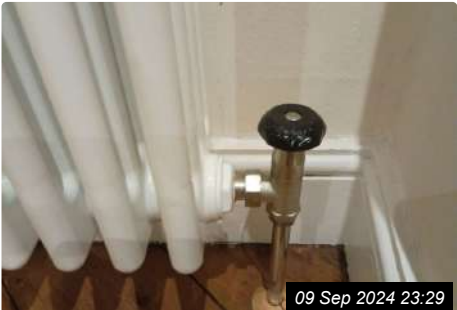
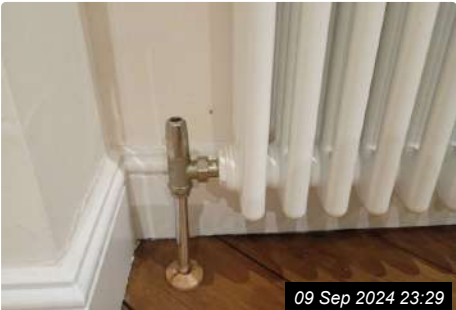
| 12. BEDROOM 1 (CONT.) | | | |
|---|---|---|---|
| 12.6 | Heating | X2 white painted metal radiators with brushed metal black valve | <div>In good clean condition</div> <div>Both radiators are missing the valve closest to the door to the garden</div> |

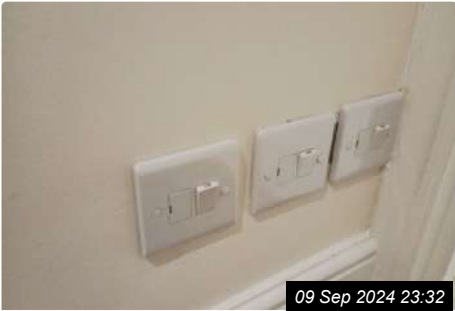
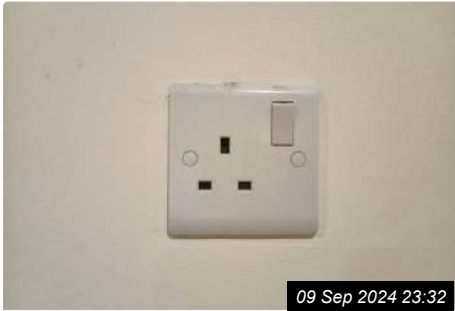
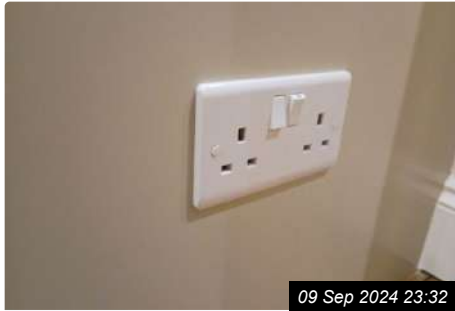
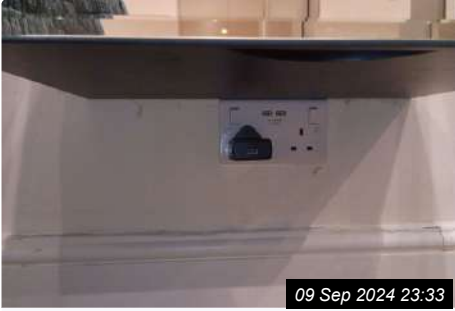
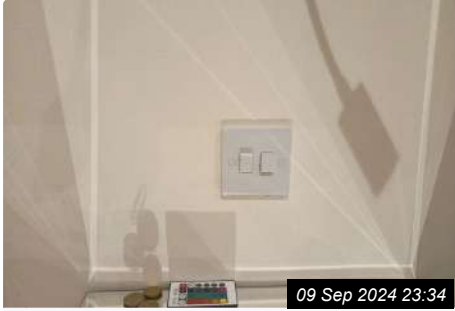
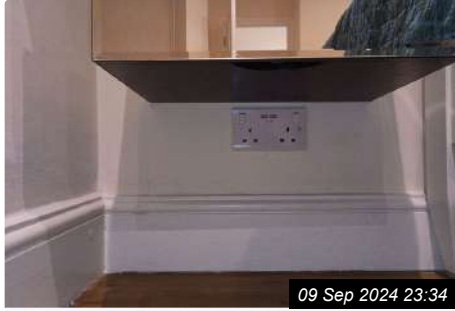
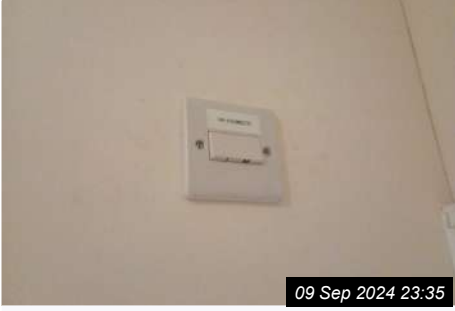
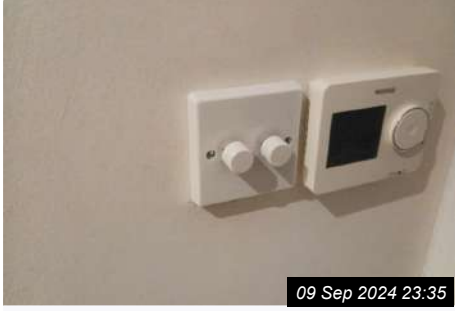
| 12. BEDROOM 1 (CONT.) | | | |
|---|---|---|---|
| 12.7 | Switches / Sockets | X3 white plastic fused single switches<br>X1 white plastic single socket switch<br>X1 white plastic double socket<br>X2 white plastic double socket with two usb ports<br>X1 white plastic double dimmer switch<br>X2 white plastic double switch<br>X1 fan switch | <div>All in good working condition</div> <div>Light on left side of bed is not level</div> |

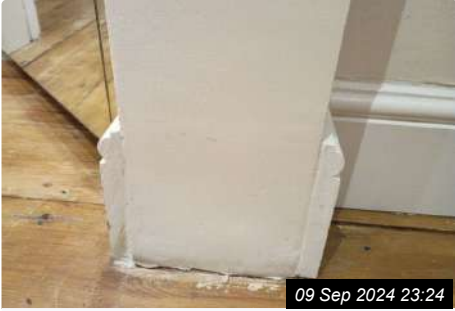
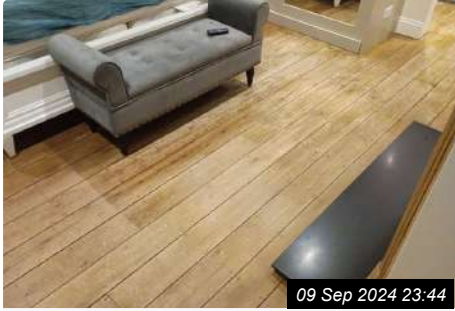
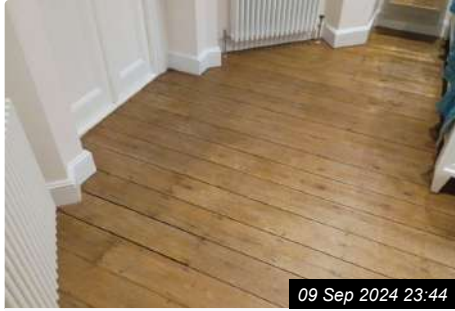
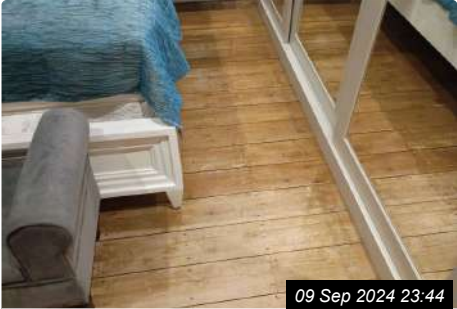
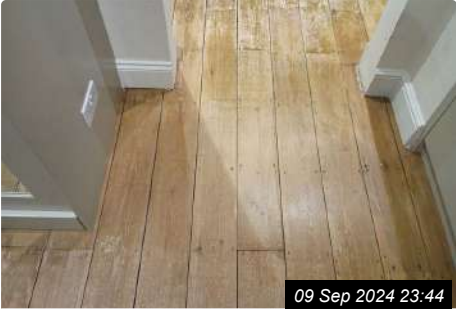
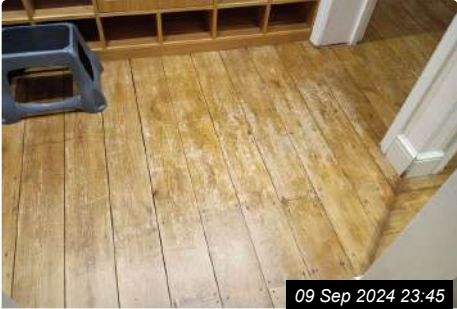
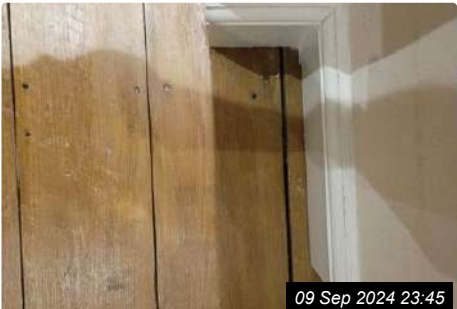
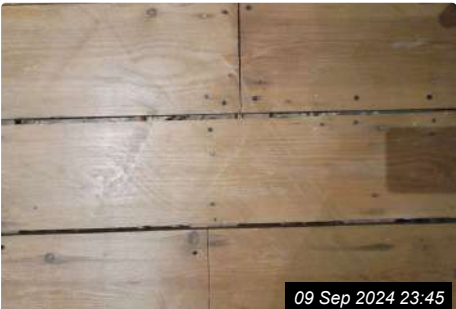
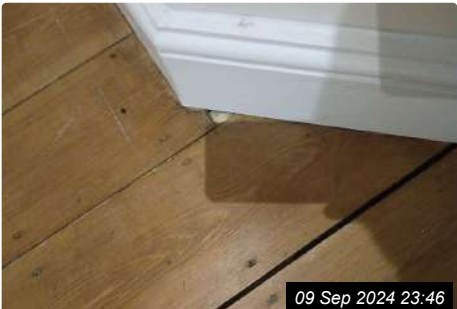
| 12. BEDROOM 1 (CONT.) | | | |
|---|---|---|---|
| 12.8<br> | Flooring | Treated Wood panel floorboards with some filled some exposed fixing screws | <p>Signs of age and wear, especially to high traffic areas</p> <p>Gaps in floorboards<br/>Small edge missing when meeting skirting board near radiator</p> |
