# Inventory & Schedule of Condition

Prepared on behalf of Example Lettings Ltd

123 Preview Street  
Sample City  
London  
AB1 2CD

**September**  
**13th 2024**

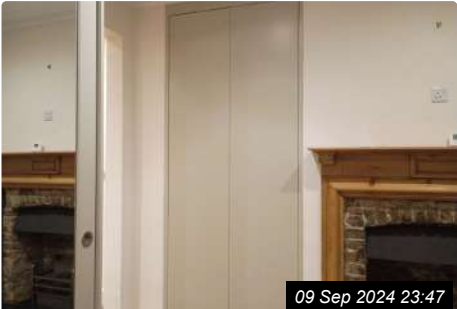
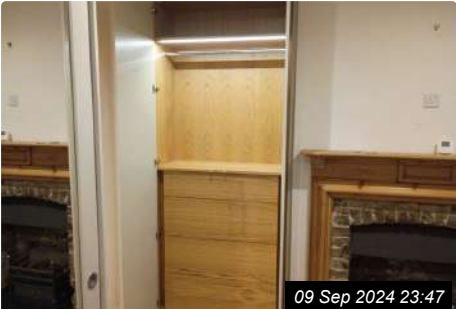
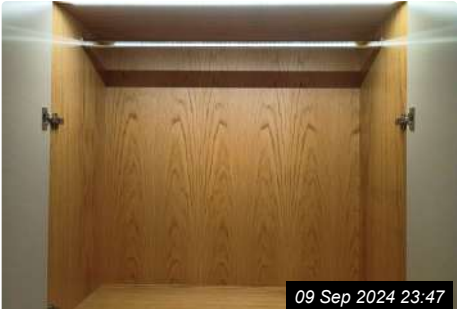
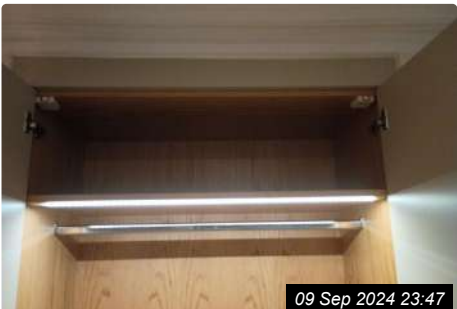
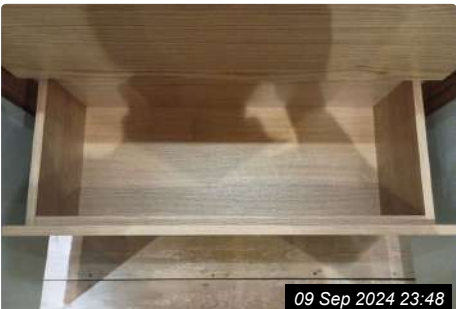
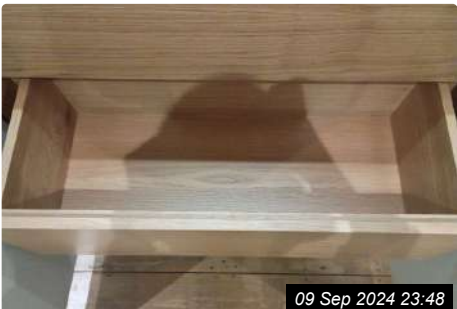
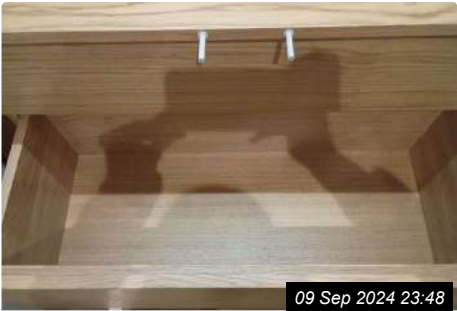
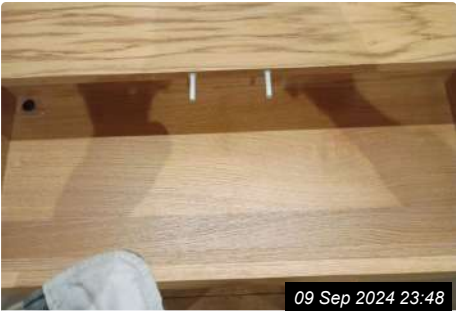
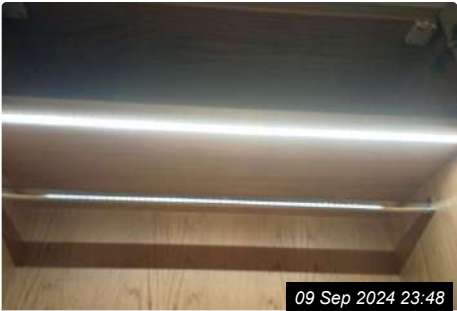
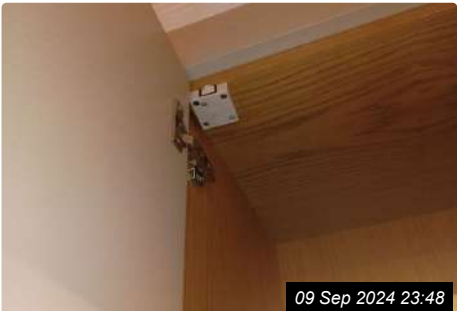
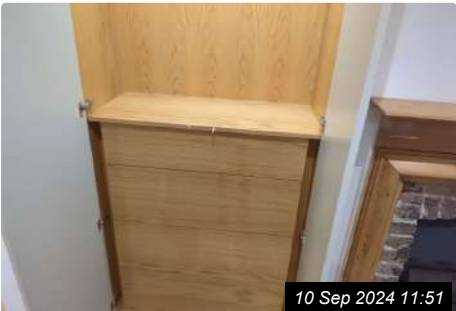
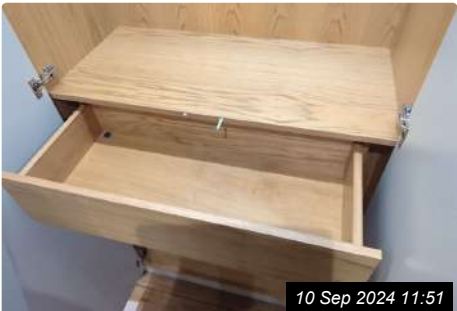
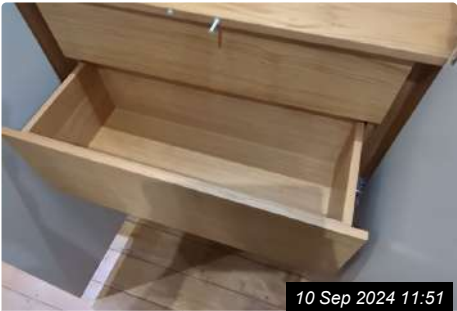
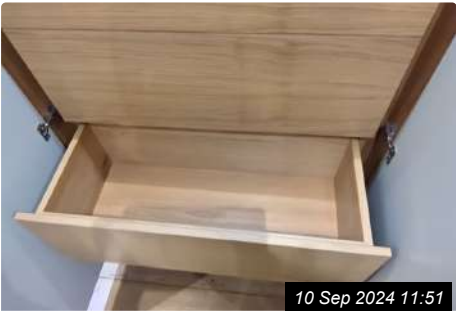
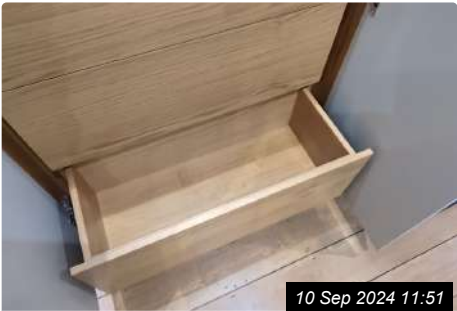
| 12. BEDROOM 1 (CONT.) | | | |
|---|---|---|---|
| 12.9<br> | Wardrobe 1 | <p>Inbuilt push to open door grey painted wooden door with frame</p> <p>Natural wood effect interior with X4 push release draws middle and top shelf</p> <p>Chrome metal hanging rail</p> | <p>On good clean condition</p> <p>All in good working order</p> |

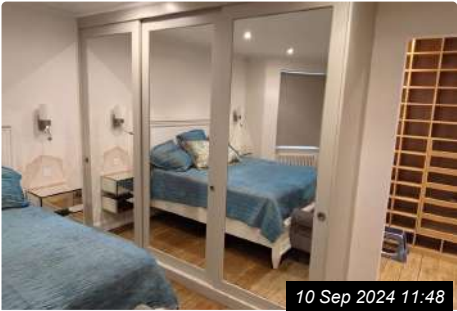
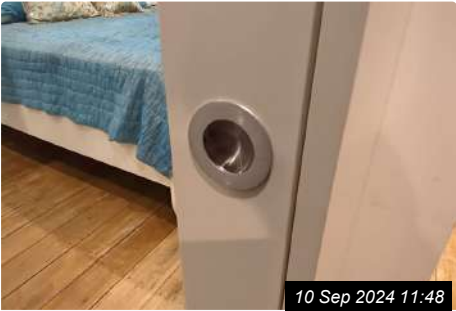
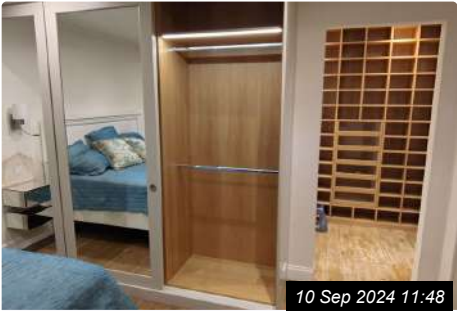
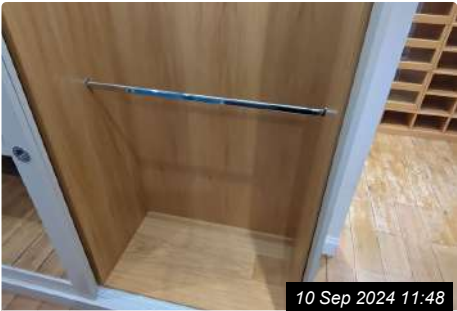
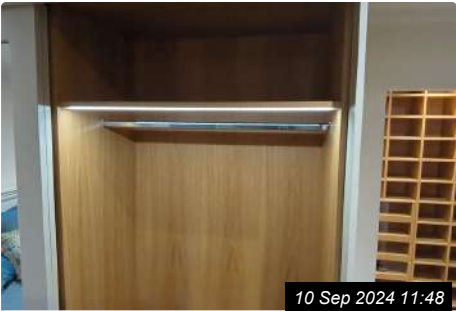
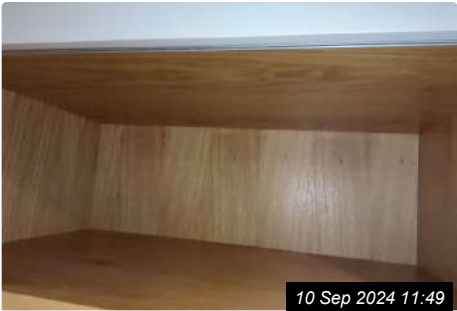
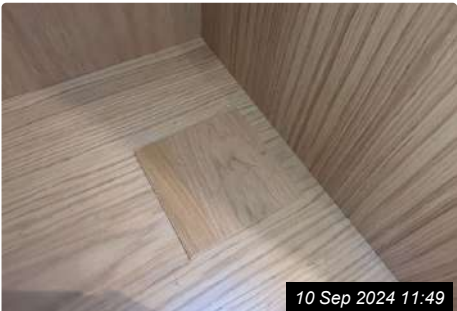
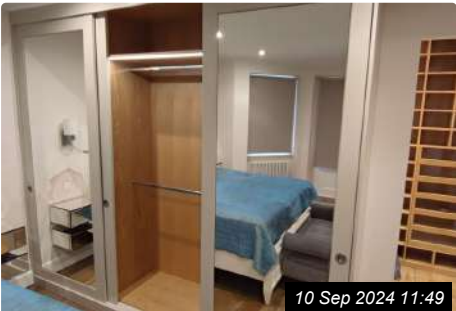
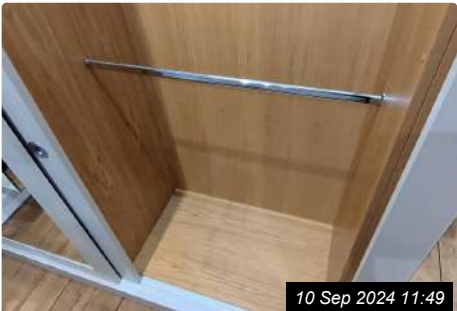
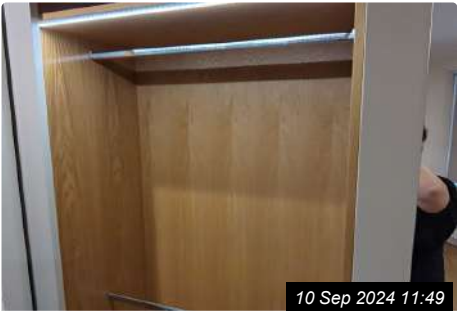
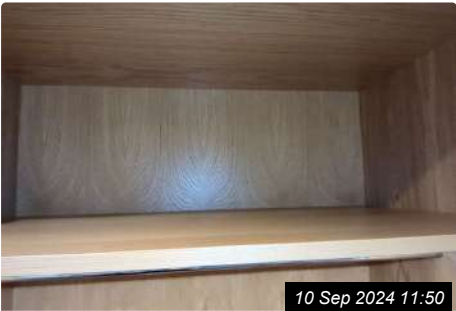
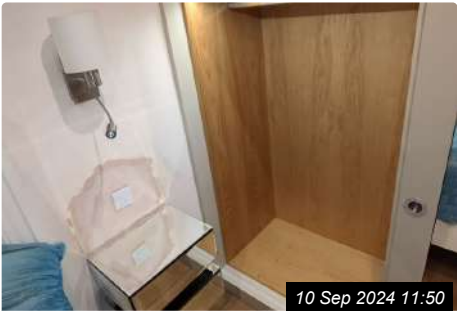
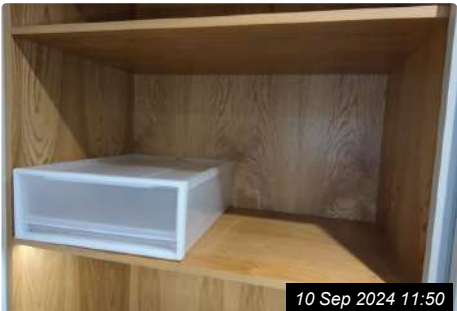
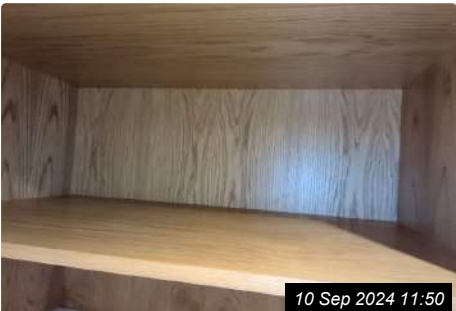
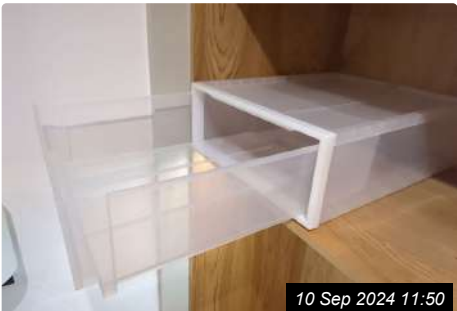
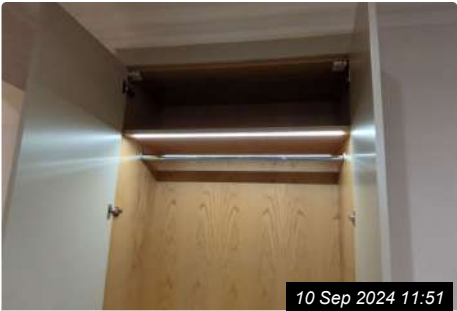
| 12. BEDROOM 1 (CONT.) | | | |
|---|---|---|---|
| 12.10<br> | Wardrobe 2 | Grey laminate sliding door inbuilt wardrobe with grey metal handles and three large glass mirror panes;<br>Interior is wood effect laminate;<br>5 Shelves;<br>White plastic box;<br>5 Grey metal curtain rails;<br>3 light bars | In good working order;<br>Minor signs of wear |

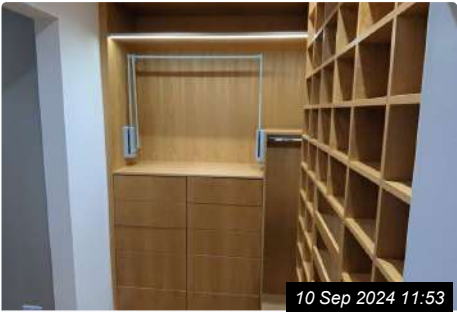
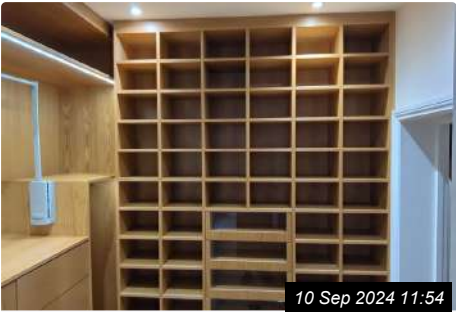
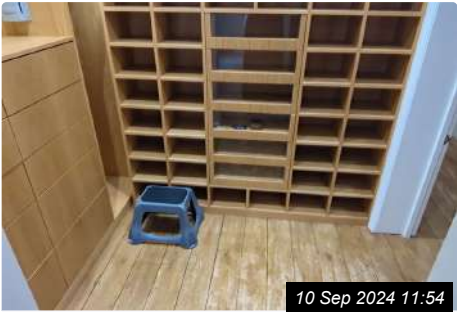
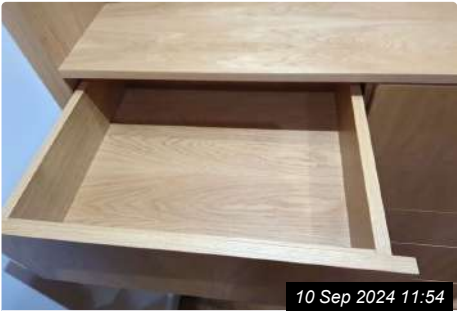
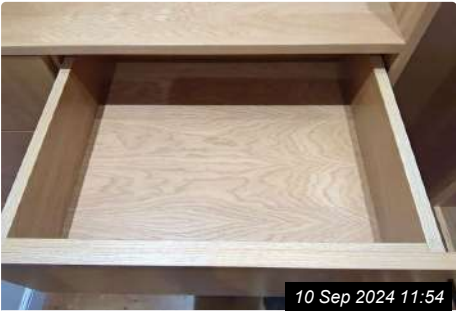
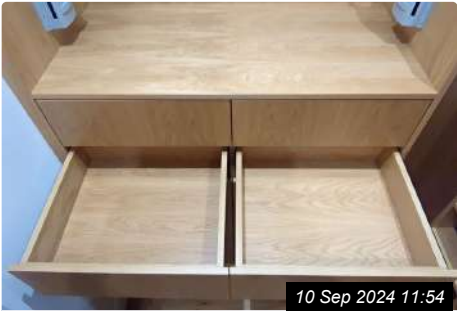
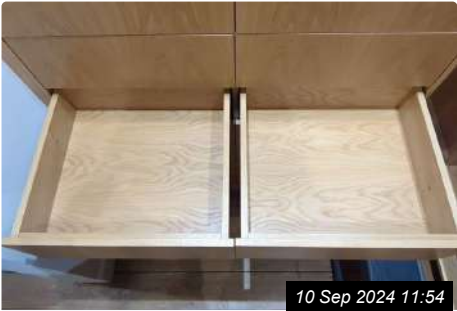
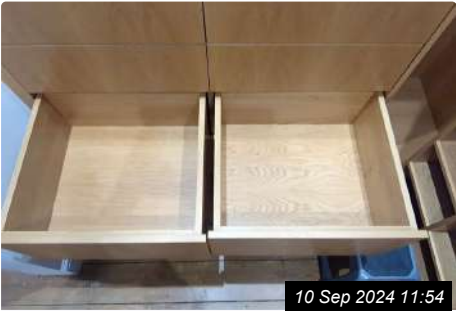
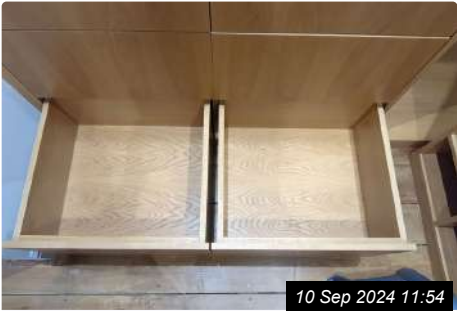
| 12. BEDROOM 1 (CONT.) | | | |
|---|---|---|---|
| 12.11 | Wardrobe 3 | Open fronted wood effect laminate;<br>66 shelves; ;<br>6 drawers with glass shelves;<br>12 drawers; ;<br>Grey metal movable fitting;<br>Grey metal hanging rail;<br>Light bar;<br>Small blue plastic stool | Good condition;<br>consistent with use |

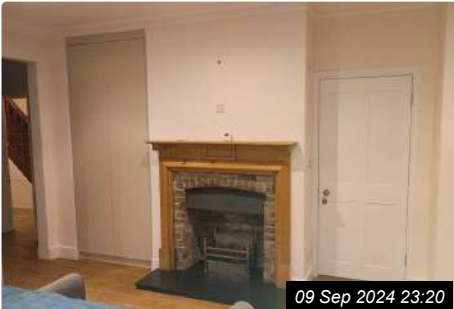
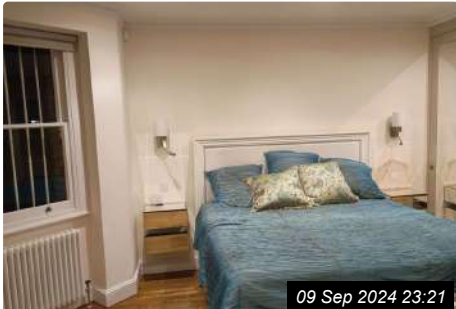
| 12. BEDROOM 1 (CONT.) | | | |
|---|---|---|---|
| 12.12<br>📷 | Furnishings | <p>Large bed with white wooden bedrame and headboard;<br/>2 offwhite mattresses;<br/>Blue bedthrow and 3 matching pillows;<br/>2 Coloured/patterned pillows;</p> <p>2 wall mounted bedside units;<br/>Glass mirror with brown wood in 2 parts;</p> <p>Fireplace: Brown wooden mantel and surround;<br/>Exposed brick inner surround and interior;<br/>Black metal flue;<br/>Grey metal fire basket;<br/>Black stone hearth;</p> <p>Grey material backless seat with brass rivets to bottom</p> | <p>Fire label present;<br/>Appears in a good condition consistent with use; ;</p> <p>Mirror fronting missing to LHS set;<br/>Signs of wear and use;</p> <p>Intact;<br/>In good condition consistent with use; ;</p> <p>Appears in a reasonable condition</p> |

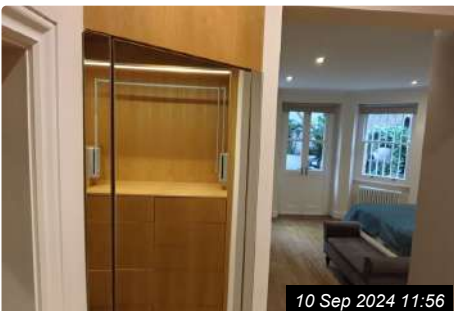
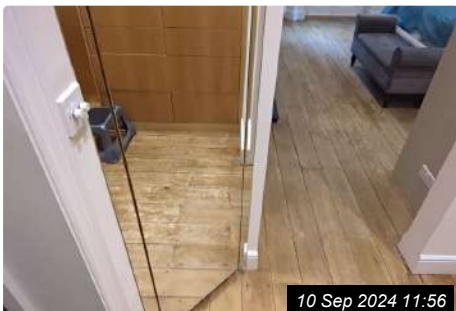
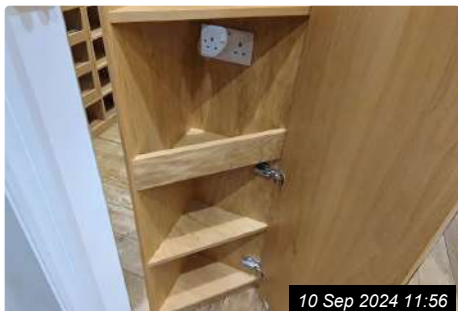
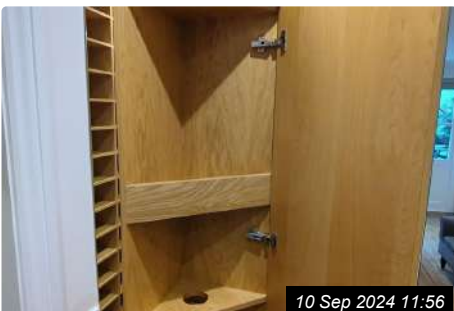
| 12. BEDROOM 1 (CONT.) | | | |
|---|---|---|---|
| 12.14 | Cupboard 1 | Glass mirror front brown wood effect laminate to interior;<br>5 shelves;<br>White plastic double socket | Good condition;<br>Intact |

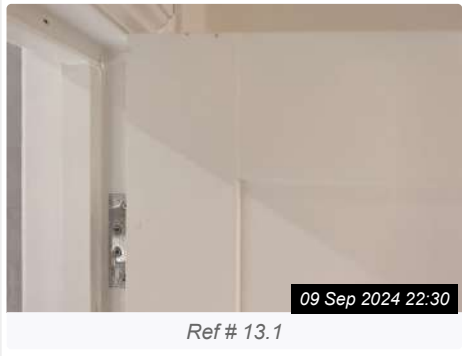
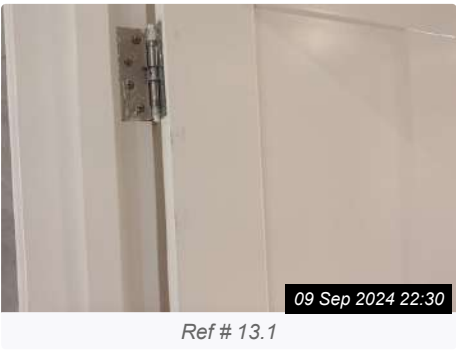
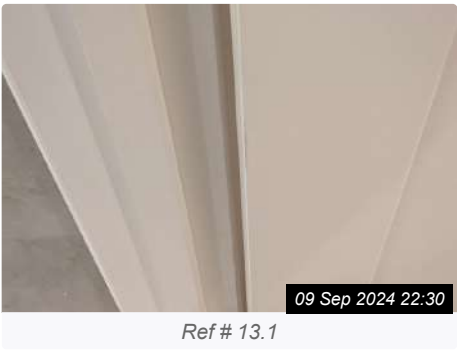
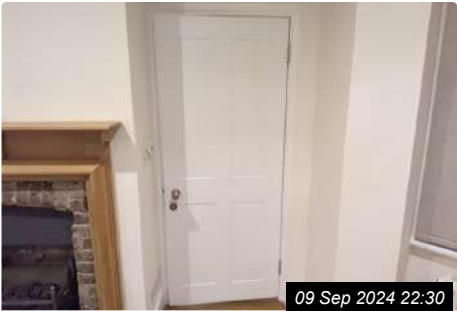
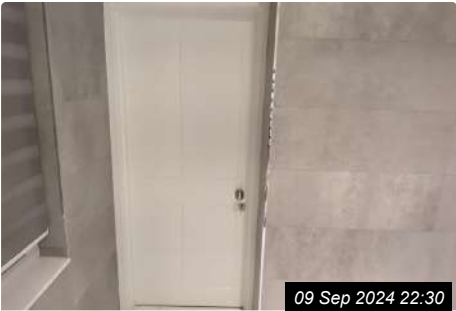
| Ref | Name | Description | Condition |
|---|---|---|---|
| 13.1<br>📷 | Door/ Frame/<br>Threshold | White painted wood panel door with chrome knobs and twist lock mechanism<br><br>White painted frame to match | Some small scuffs and marks to edges of door, left hand side, inner door. |

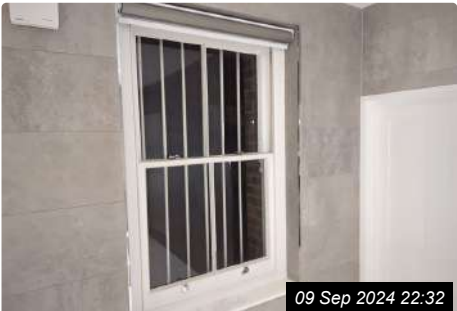
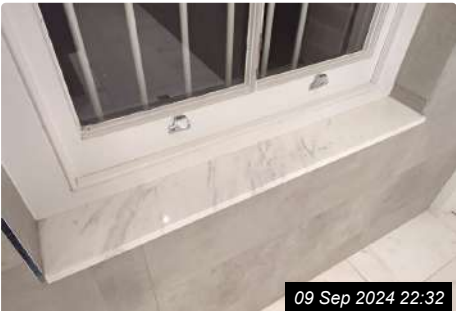
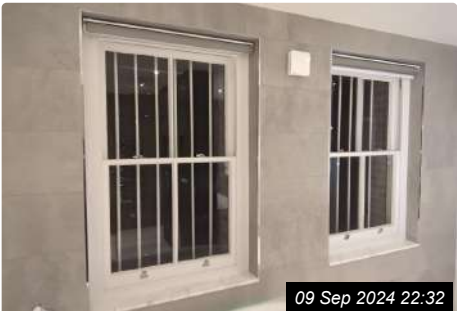
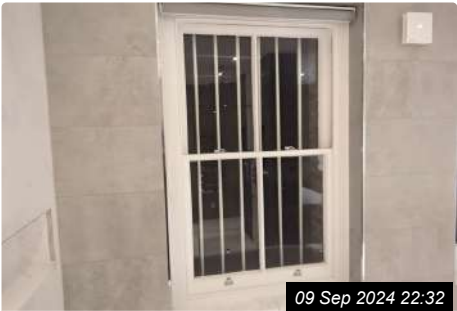
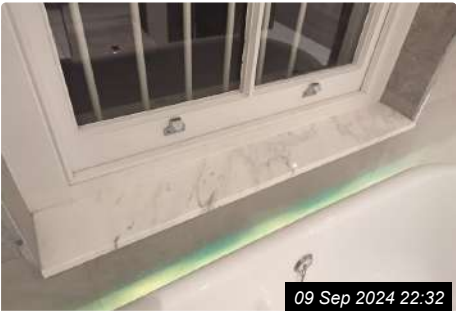
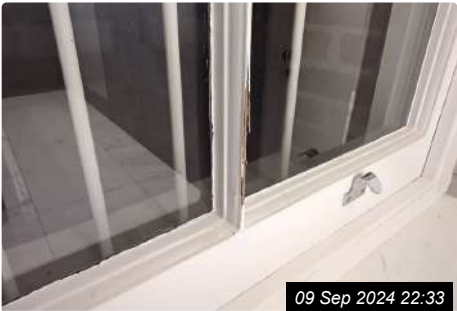
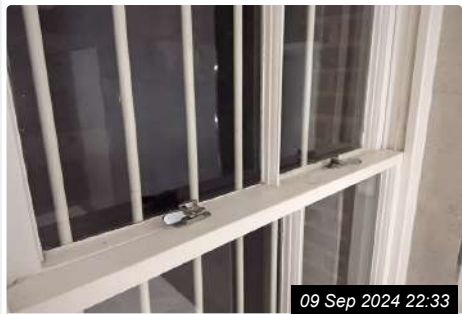
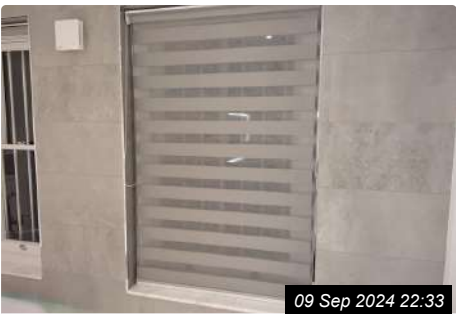
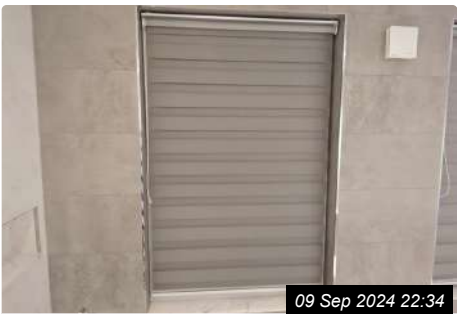
| 13. ENSUITE TO BEDROOM 1 (CONT.) | | | |
|---|---|---|---|
| 13.2 | Window(s) / Sill | <div>Pair of white painted wooden sash windows both with chrome furniture::<br/>Two hooks<br/>Two latches</div> <div>Grey fabric Double-Legged roller blinds with white plastic bead control</div> <div>Light gray marble sills</div> <div>White metal bars to exterior</div> <div>Greystone tile and chrome strip to reveals</div> | <div>Right side window has exposed wood from paint flaking to lower center</div> <div>Both have some light dust to window frames</div> <div>Both appear in otherwise good condition throughout.</div> |

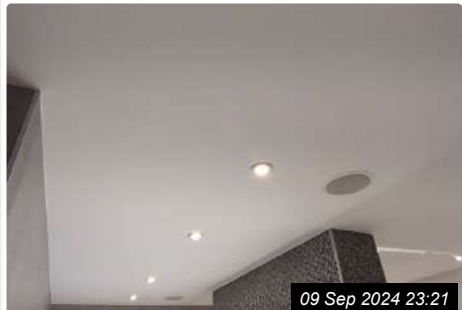
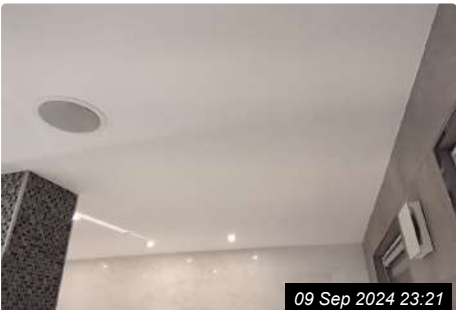
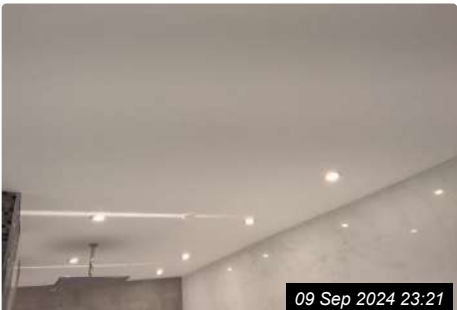
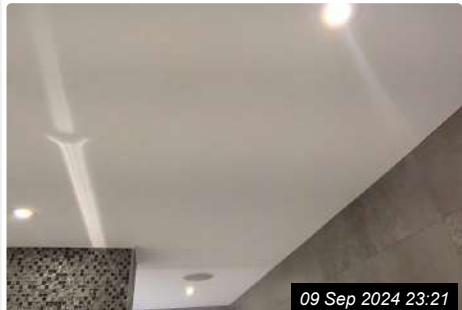
| 13. ENSUITE TO BEDROOM 1 (CONT.) | | | |
|---|---|---|---|
| 13.3 | Ceiling | Smooth white painted<br>Two white grilled inbuilt speakers | In good clean condition<br>Speakers untested. But in good clean condition. |

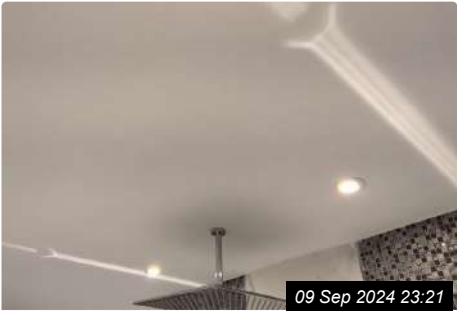
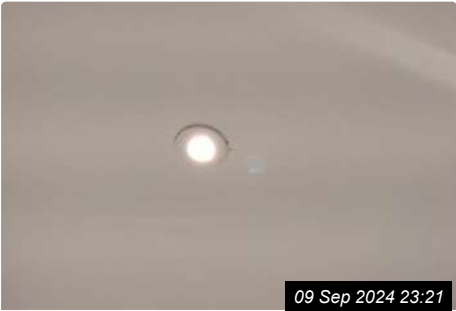
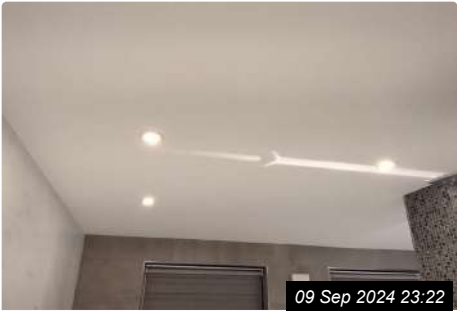
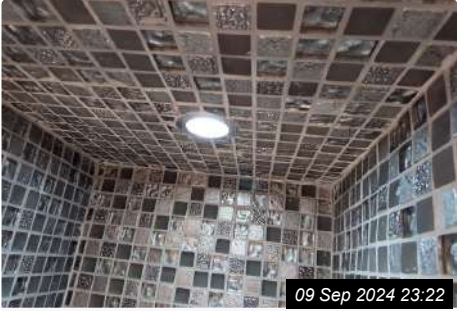
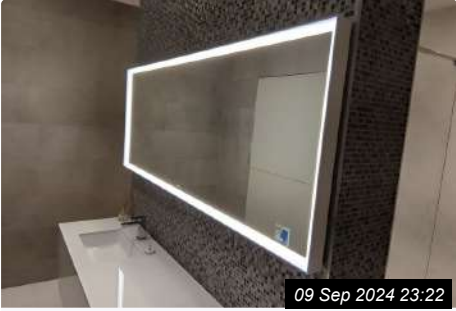
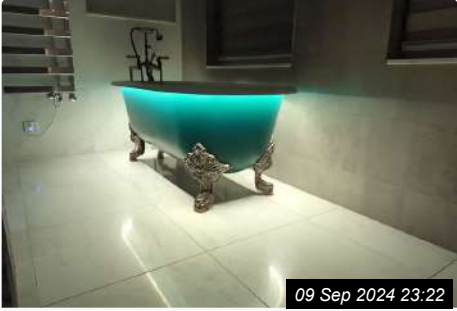
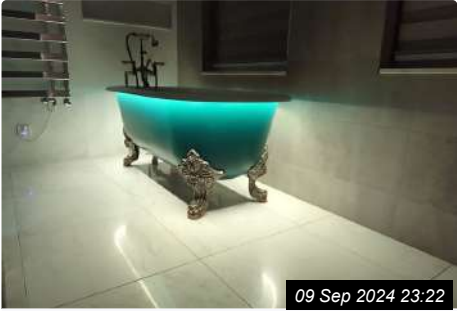
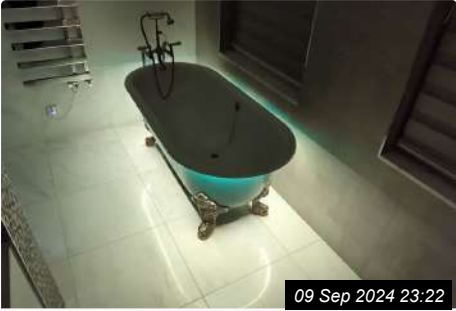
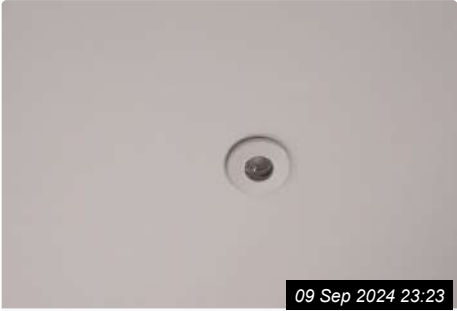
| 13. ENSUITE TO BEDROOM 1 (CONT.) | | | |
|---|---|---|---|
| 13.4 | Lighting | White surround inset spotlights<br>Led strip under bath<br>Chrome around insect shelf lighting<br>Mirror surround light<br>Automation in cabinet lighting | All in good working conditions |

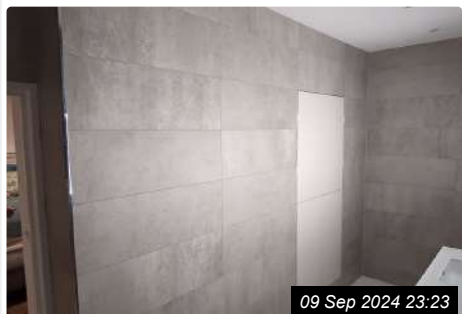
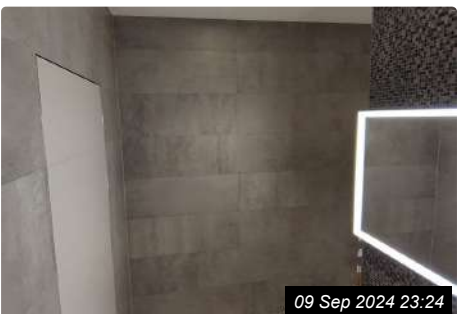
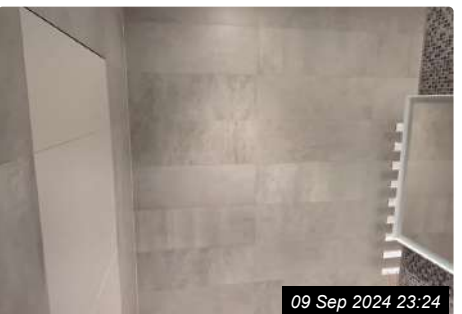
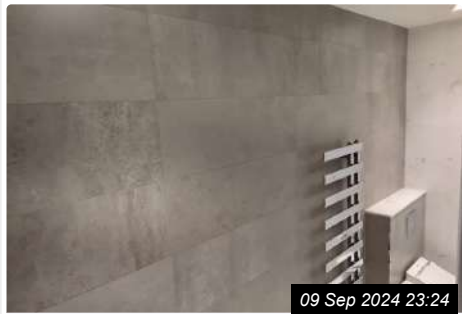
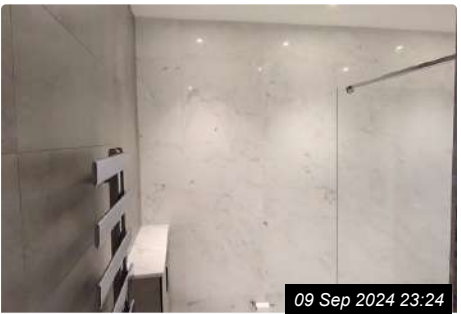
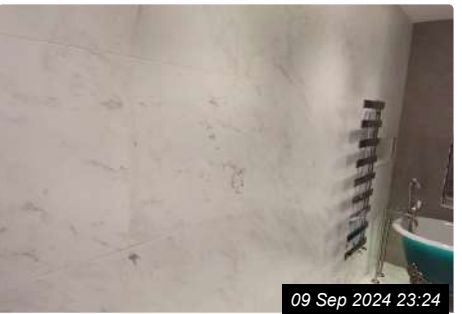
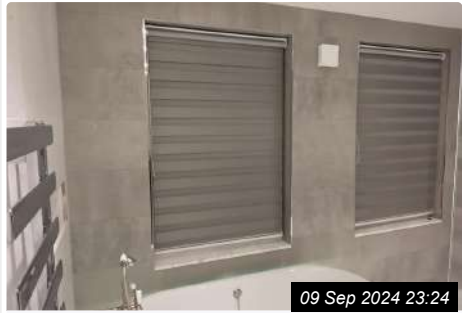
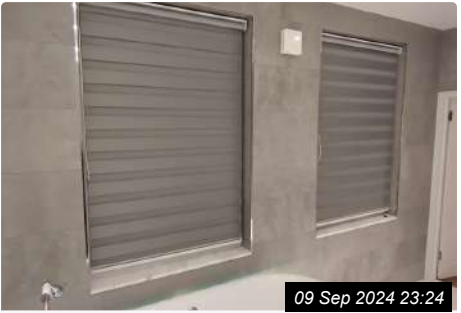
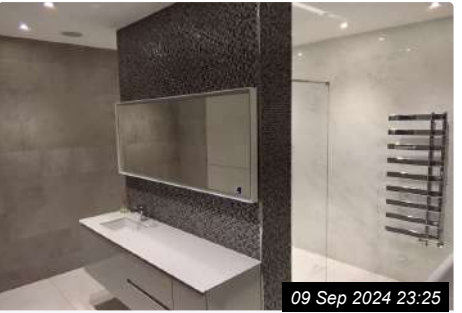
| 13. ENSUITE TO BEDROOM 1 (CONT.) | | | |
|---|---|---|---|
| 13.5<br> | Walls / Skirting | Greystone effect tiles<br>White and gray marble tiles<br>Grey/metallic mosaic tiles<br>Chrome edging strips | All in good, clean condition. |

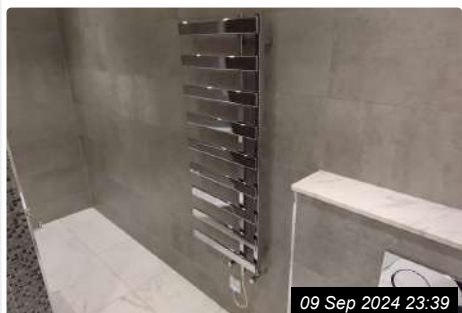
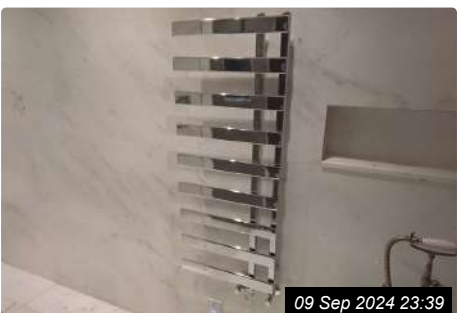
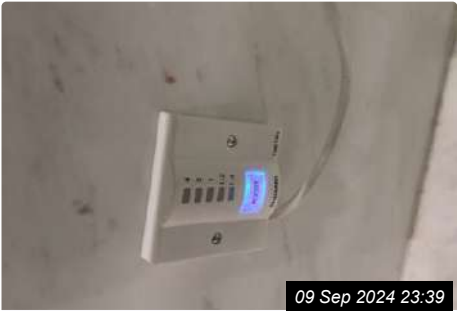
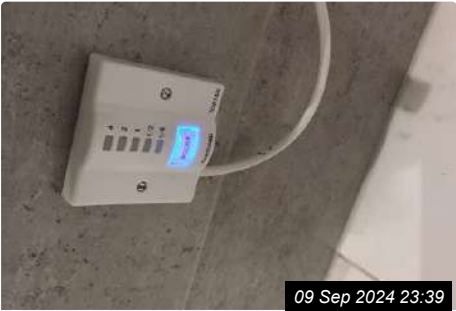
| 13. ENSUITE TO BEDROOM 1 (CONT.) | | | |
|---|---|---|---|
| 13.7 | Switches / Sockets | Two heated towel rail boost switches, White plastic with blue indicator lights. | Power to units<br><br>Not tested<br><br>Intact |

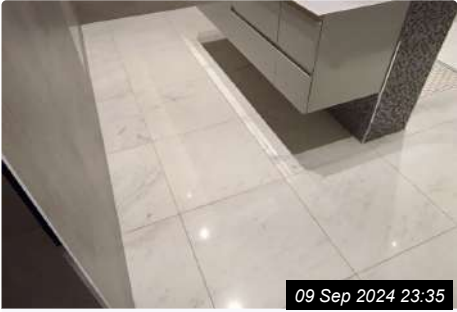
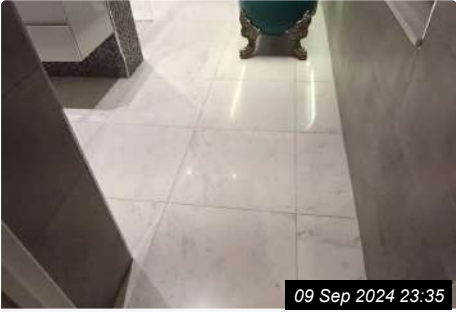
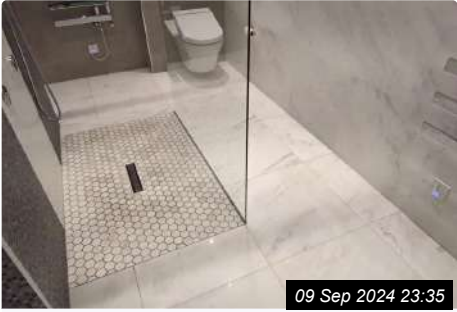
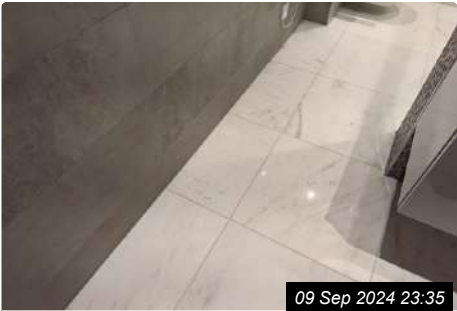
| 13. ENSUITE TO BEDROOM 1 (CONT.) | | | |
|---|---|---|---|
| 13.8 | Flooring | White and gray marble tiles | <p>Some rust markings surrounding claw feet on bath</p> <p>Some minor discoloration to grouting</p> <p>Otherwise good clean condition</p> |

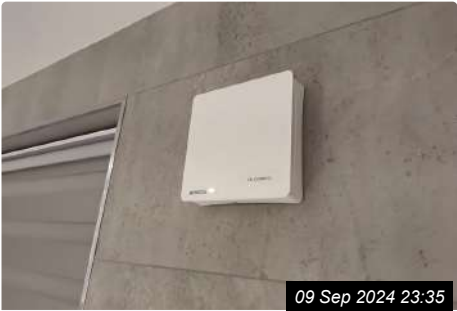
| 13. ENSUITE TO BEDROOM 1 (CONT.) | | | |
|---|---|---|---|
| 13.9 | Extractor fan | White plastic man rose silent extractor fan | <p>Switch (in Bedroom 1) and unit marked fan disconnected.</p> <p>Intact</p> |

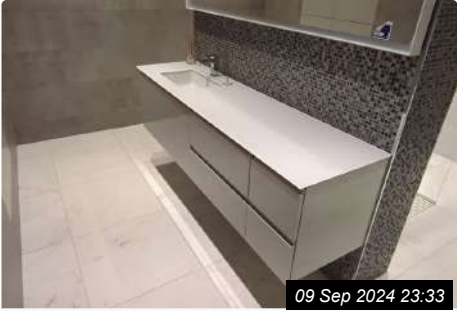
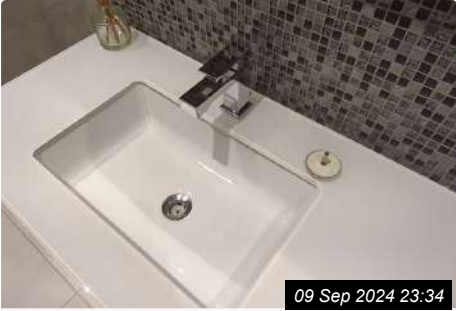
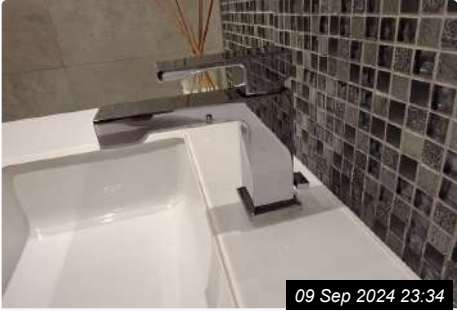
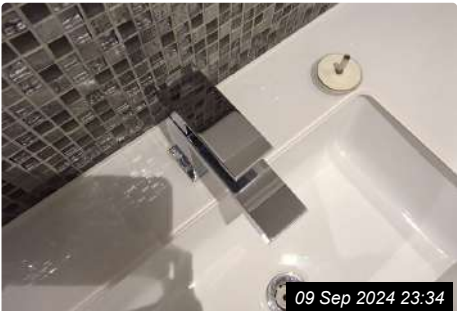
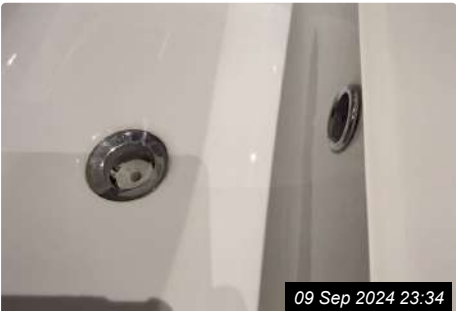
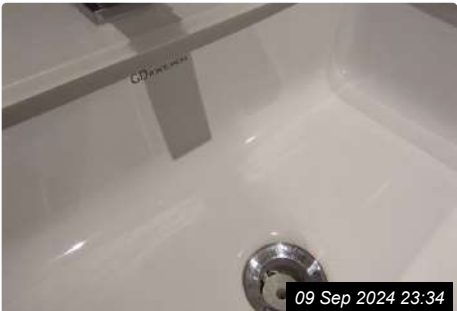
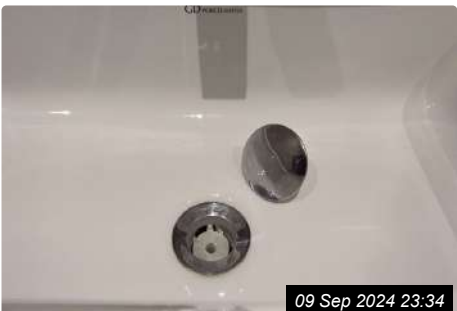
| 13. ENSUITE TO BEDROOM 1 (CONT.) | | | |
|---|---|---|---|
| 13.10<br> | Basin | <div>GD Porcelanosa.<br/>White ceramic built under sink with chrome single lever mixer tap and pop up waste.</div> <div>Set under white glass countertop</div> <div>On gloss grey floating plinth with 5 drawers</div> | All in good clean condition. |

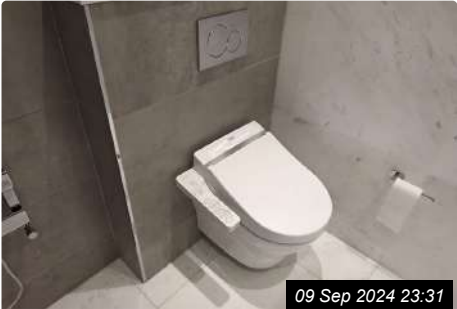
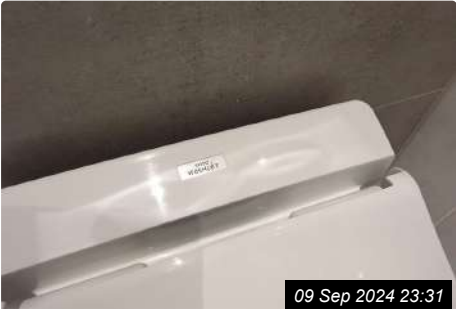
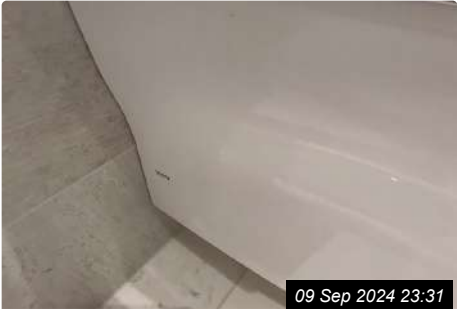
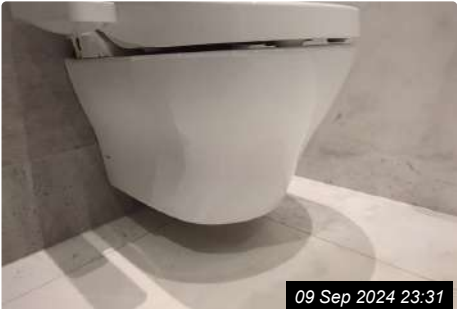
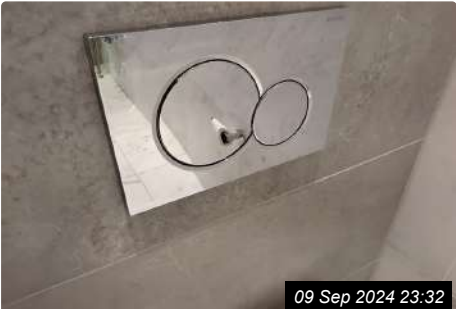
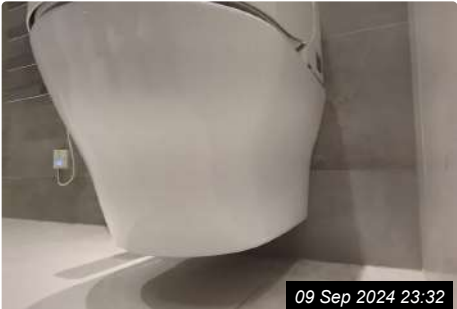
| 13. ENSUITE TO BEDROOM 1 (CONT.) | | | |
|---|---|---|---|
| 13.11<br>📷 | Toilet | Toto<br>White ceramic bowl with hidden cistern<br><br>With chrome Gerbit dual flush<br><br>Toto Washlet bidet toilet seat and lid - with wipe clean controls | Good clean condition except:<br><br>Seat is discolored.<br><br>Electronic bidet not tested - power to unit. |

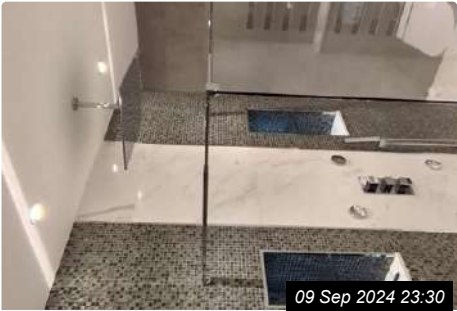
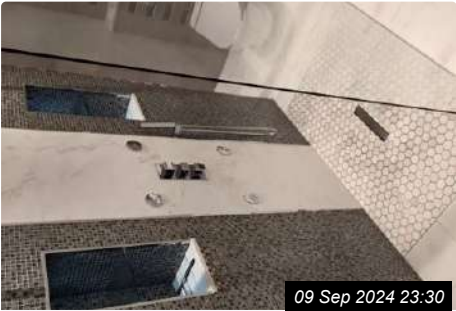
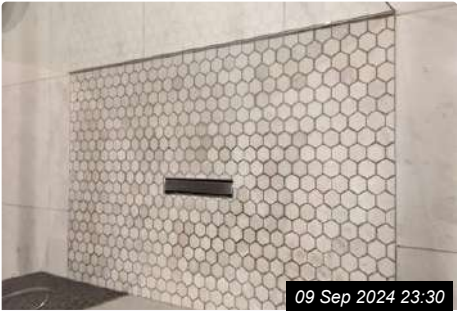
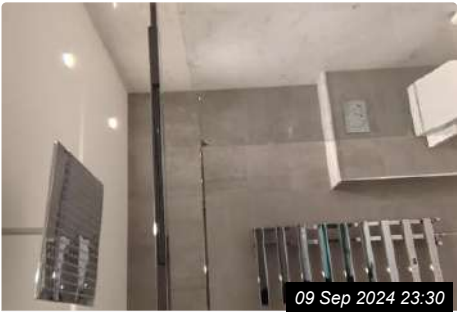
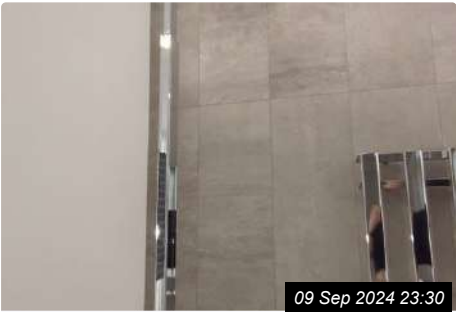
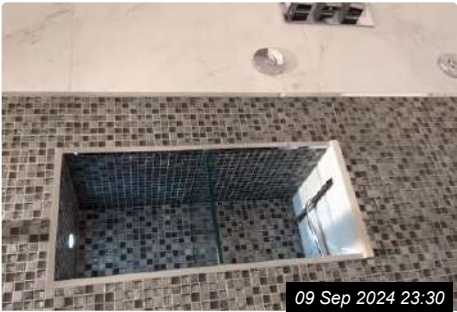
| 13. ENSUITE TO BEDROOM 1 (CONT.) | | | |
|---|---|---|---|
| 13.12<br>📷 | Shower unit/ area | Hexagonal natural stone mosaic tile with rectangular metal outlet.<br><br>Grey toned mosaic tile wall with central marble feature panel.<br><br>Glass shower screen with two chrome support bars<br><br>Two inbuilt shelves with one glass shelf and one white and gray marble sill. Each with one Chrome surround spotlight.<br><br>Large overhead Chrome rainfall shower head - ceiling fed<br><br>4 chrome wall jets<br><br>Chrome 3 lever control panel<br><br>Chrome rinsing shower, hose and hook. | In overall good clean condition<br><br>Some very light limescale remains to overhead shower head, rinsing shower head and hook, jet outlets and controls. |

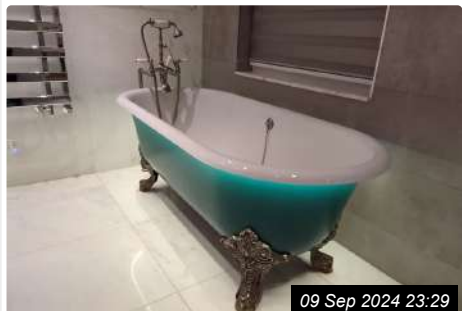
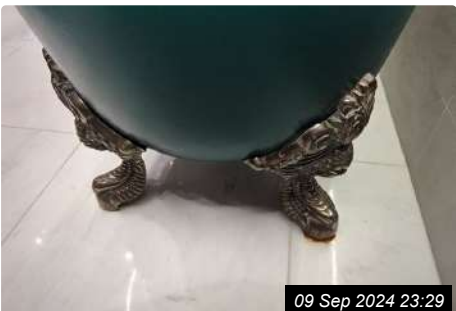
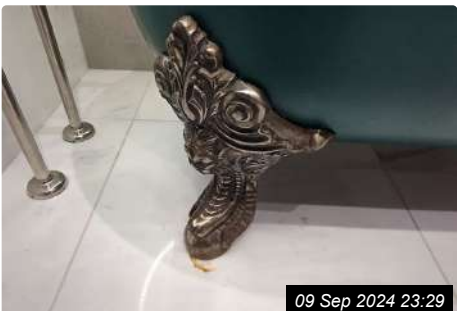
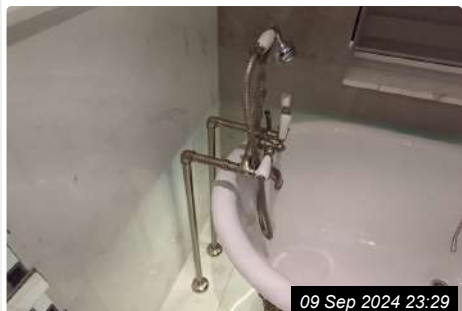
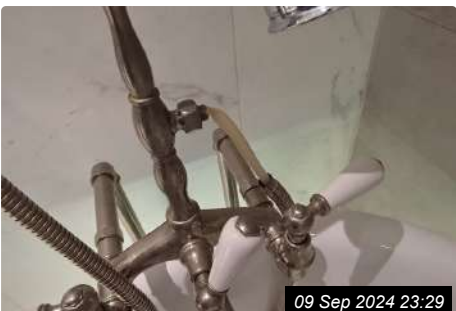
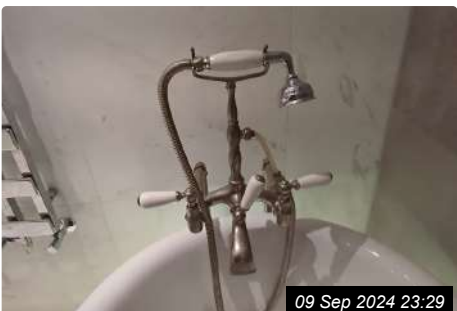
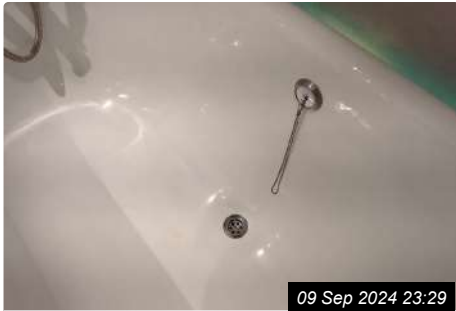
| 13. ENSUITE TO BEDROOM 1 (CONT.) | | | |
|---|---|---|---|
| 13.13 | Bath/ Bath panel | <p>White enameled metal tub with green enamel to exterior with:</p> <p>Four silver toned claw feet.</p> <p>Chrome waste outlet and overflow with plug on beaded chain</p> <p>Floor standing telephone style three lever mixer tap in metal and white ceramic with matching shower head and hose.</p> | <p>Some rust/tarnishing to feet and overflow surround.</p> <p>Some tarnishing to tap, tap and shower.</p> <p>Shower hose is damaged with inner hose exposed.</p> |

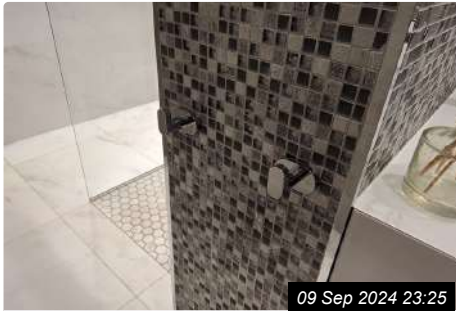
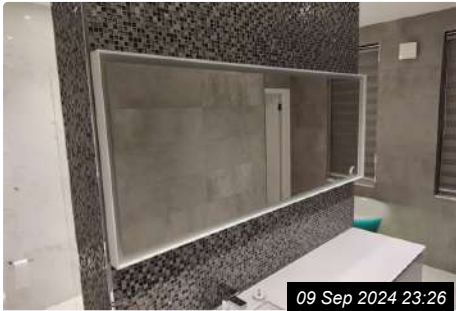
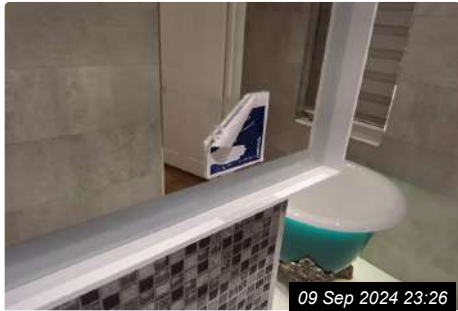
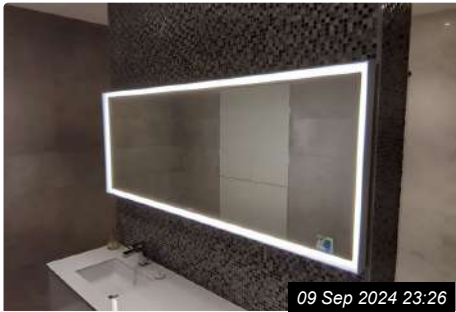
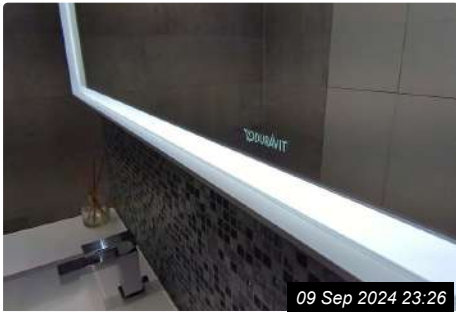
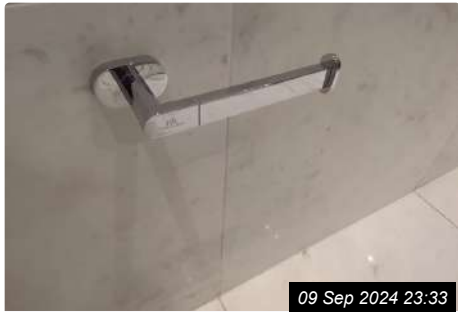
| 13. ENSUITE TO BEDROOM 1 (CONT.) | | | |
|---|---|---|---|
| 13.14<br> | Accessories | <div>Large white metal framed mirror with built in light.</div> <div>Two chrome hooks to wall to right of shower area</div> <div>Chrome toilet roll holder - NK porcelanosa</div> | <div>Sticker to pane for wave control location falling off and leaving residue behind</div> <div>Otherwise good clean working order</div> |

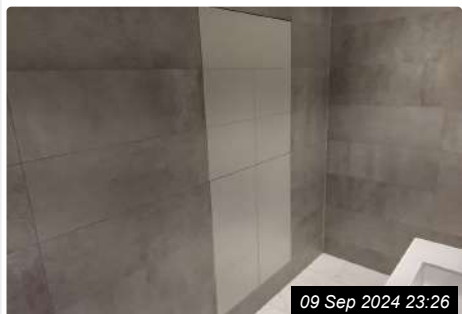
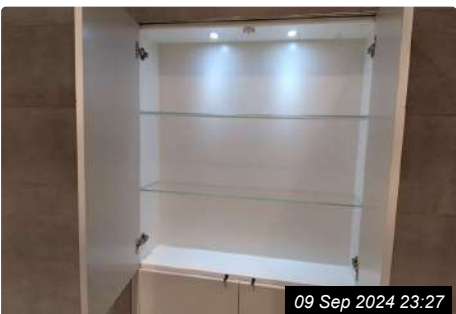
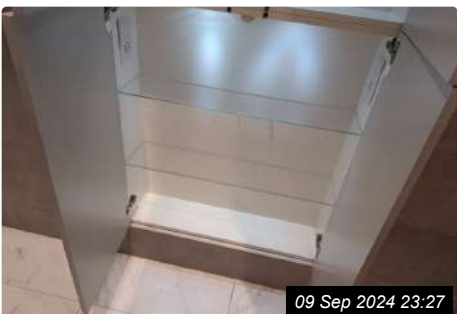
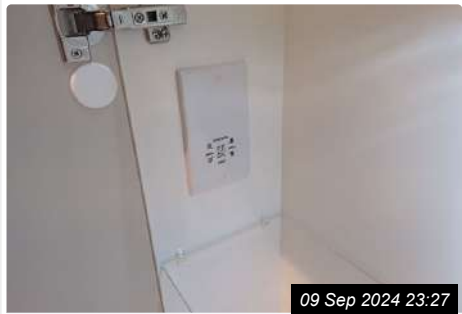
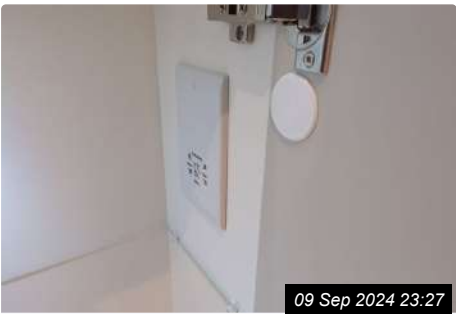
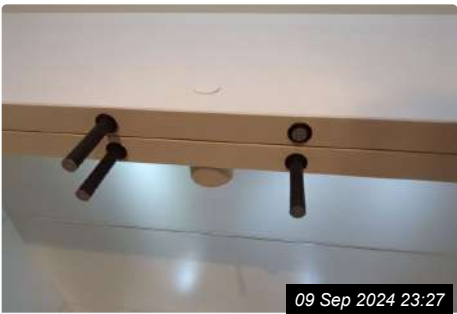
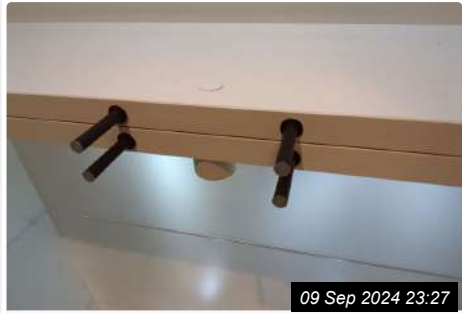
| 13. ENSUITE TO BEDROOM 1 (CONT.) | | | |
|---|---|---|---|
| 13.15<br> | Cupboard 1 | <div>Four Matte grey laminate tile effect doors with push open mechanisms with:</div> <div>White interiors and four glass shelves.</div> <div>Internally there is two white plastic shaver sockets</div> | <div>Good clean working order except upper right side cupboard push control is temperamental</div> |

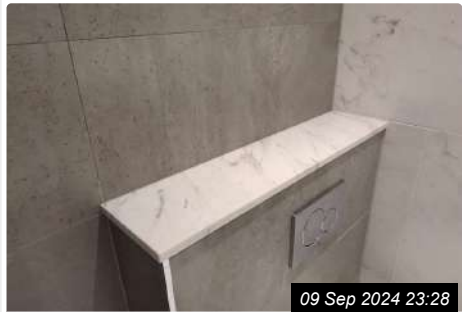
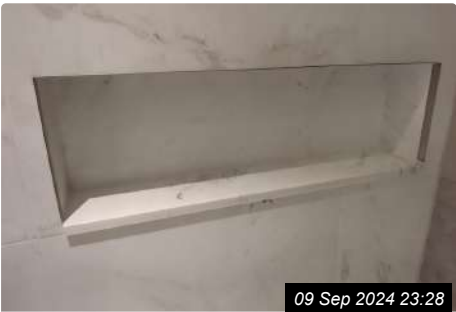
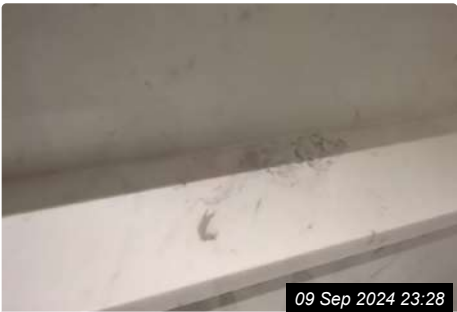
| 13. ENSUITE TO BEDROOM 1 (CONT.) | | | |
|---|---|---|---|
| 13.16<br> | Furnishings | Two built in or recessed white and grey marble shelves:<br>One above toilet<br>One above bath taps | Good clean condition<br><br>Slight pink staining to shelf above bath taps |

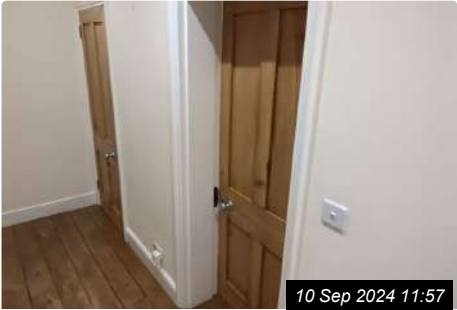
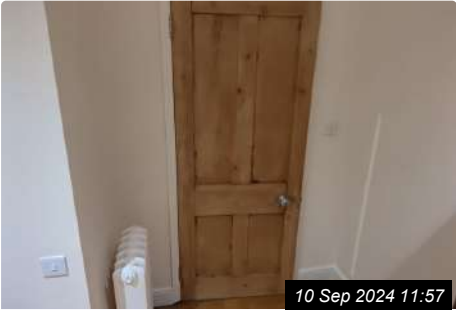
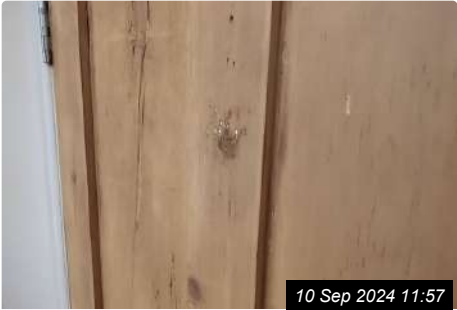
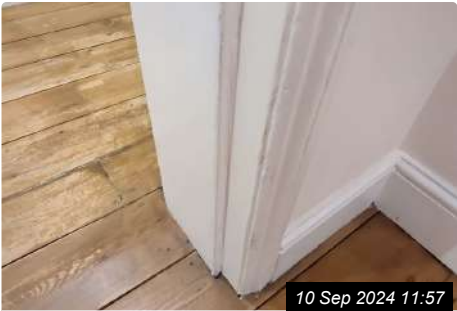
| Ref | Name | Description | Condition |
|---|---|---|---|
| 14.1<br> | Door/ Frame/ Threshold | Wooden panel door with brushed metal furnishings.<br>X2 chrome hinges<br><br>White painted wooden frame<br><br>Wooden floor board threshold | Some cracks in the woodwork<br><br>Frame in good condition;<br><br>Overpainted |

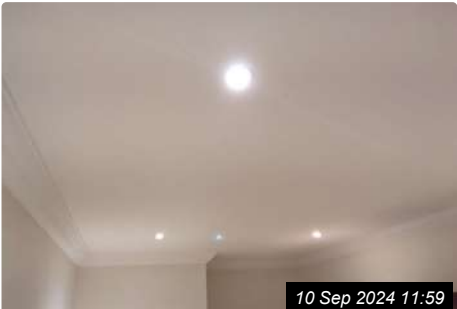
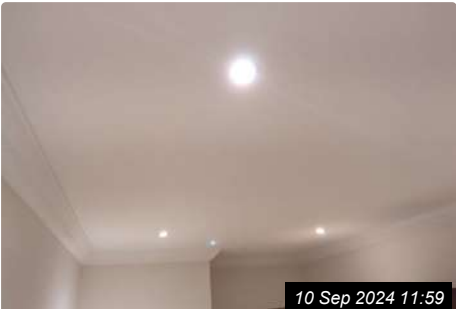
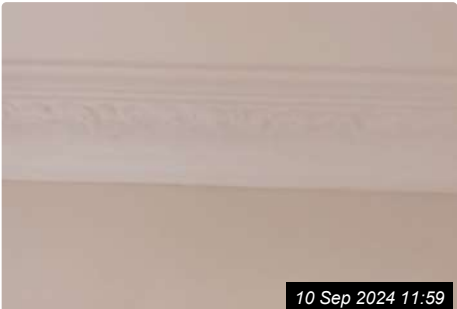
| 14. BEDROOM 2 (CONT.) | | | |
|---|---|---|---|
| 14.3 | Ceiling | Smooth white painted with moulded coving to match | 2 medium sized darkened patches to RHS corner from entry |
