# Inventory & Schedule of Condition

Prepared on behalf of Example Lettings Ltd

123 Preview Street  
Sample City  
London  
AB1 2CD

**September**  
**13th 2024**

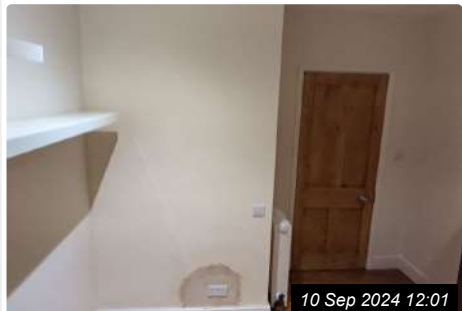
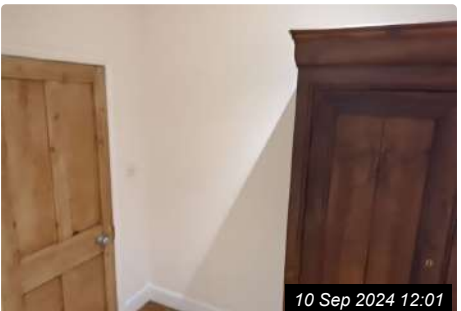
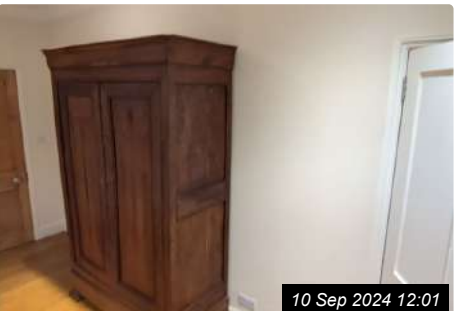
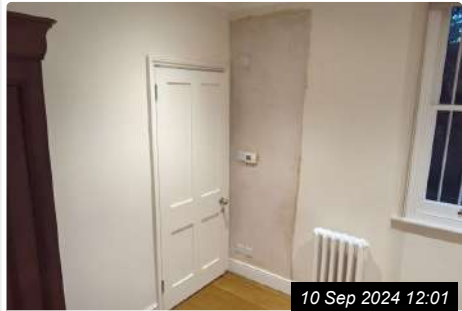
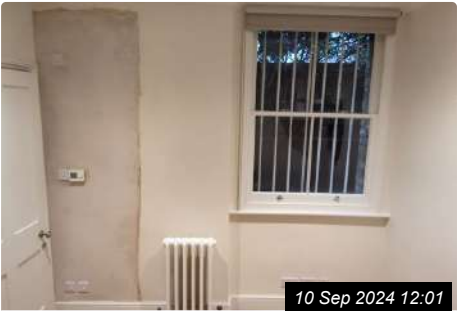
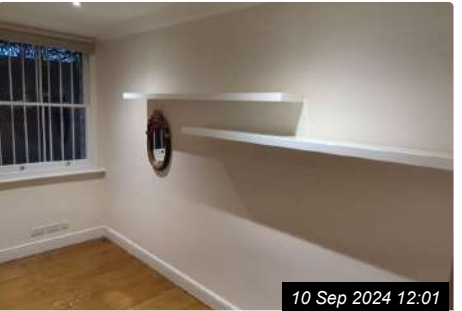
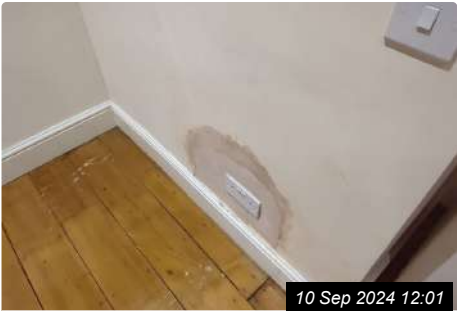
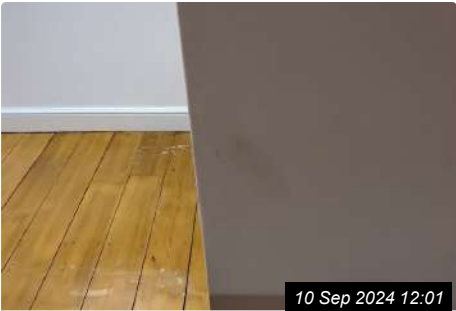
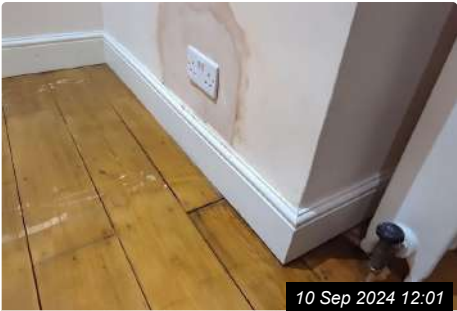
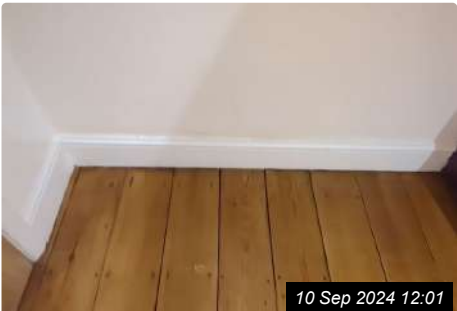
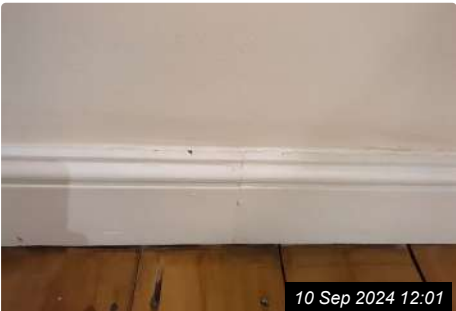
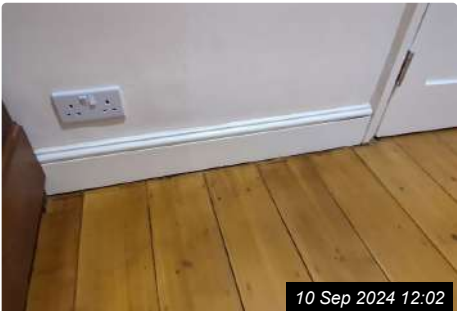
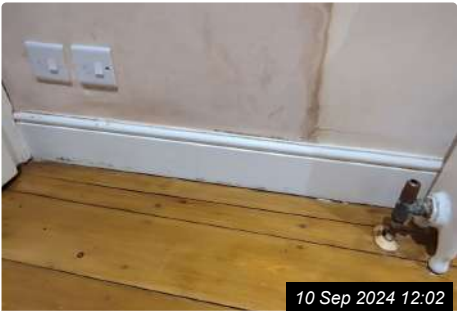
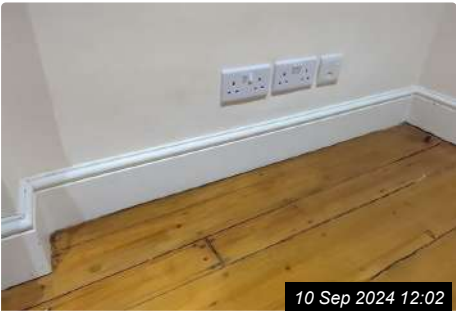
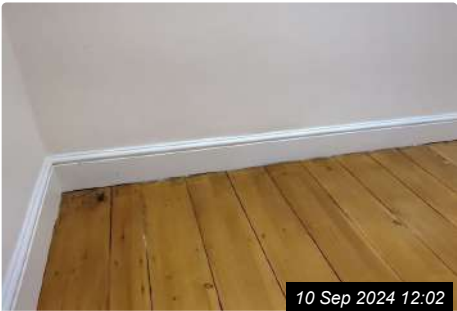
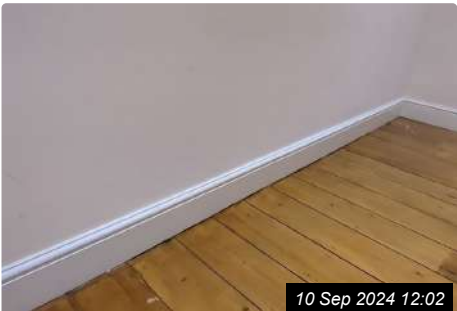
| 14. BEDROOM 2 (CONT.) | | | |
|---|---|---|---|
| 14.5 | Walls / Skirting | Smooth white painted walls;<br><br>White painted wooden skirting | Small marks and scuffs to entrance especially to entranceway at low level; ;<br><br>Unpainted plaster;<br><br>Settlement cracks;<br><br>Some discolouration;<br><br>Some scuffs to skirting |

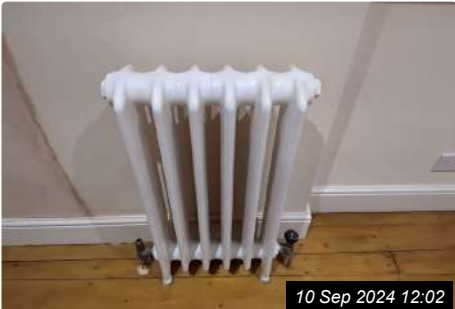
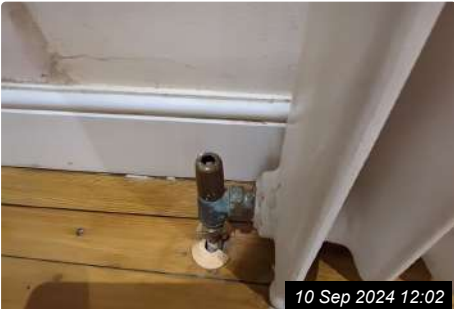
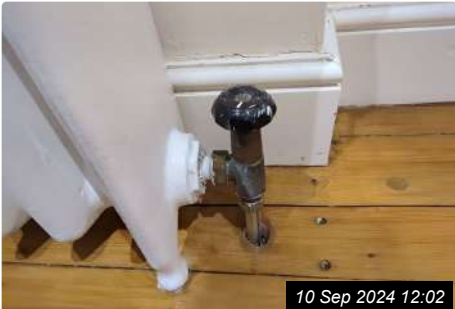
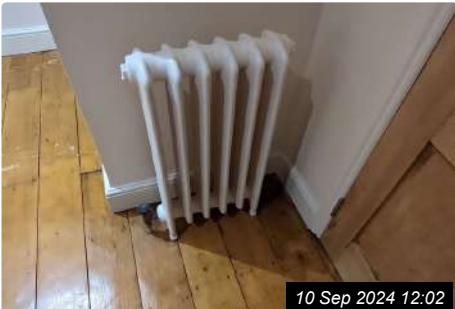
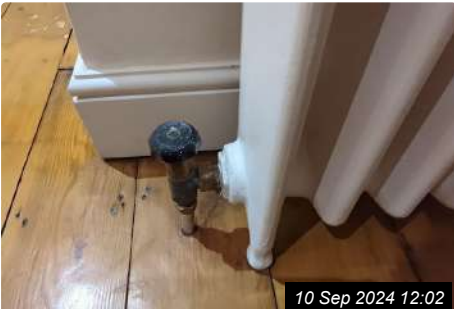
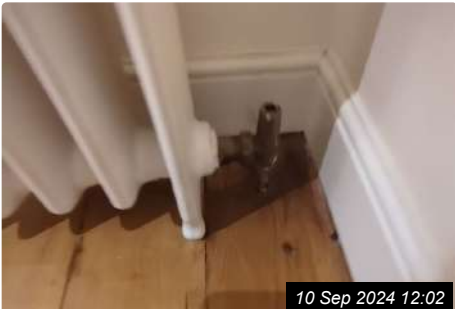
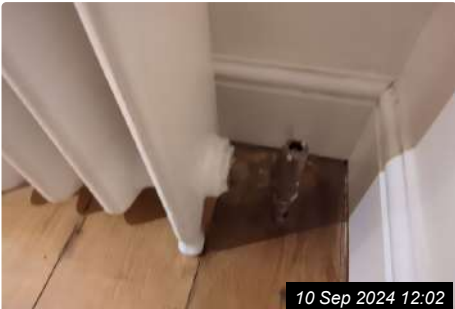
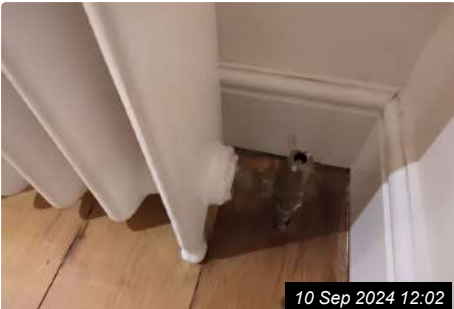
| 14. BEDROOM 2 (CONT.) | | | |
|---|---|---|---|
| 14.6<br> | Heating | 2x White metal column radiator | Clean and consistent with age/use |

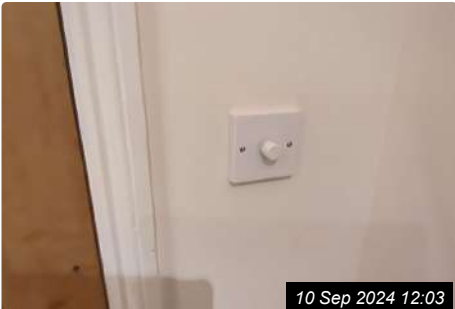
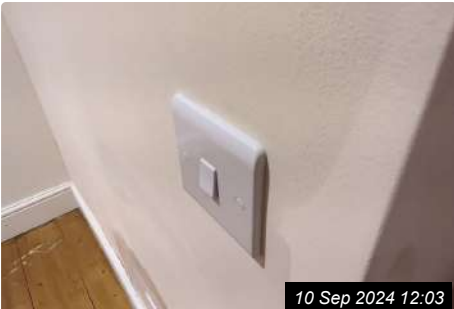
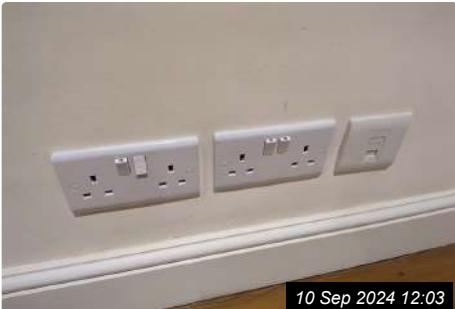
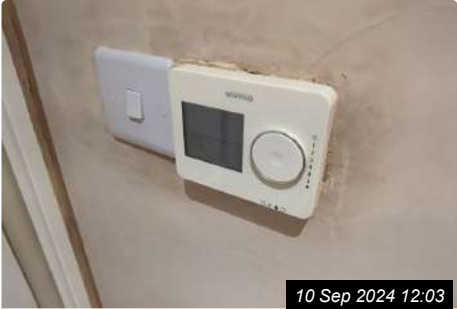
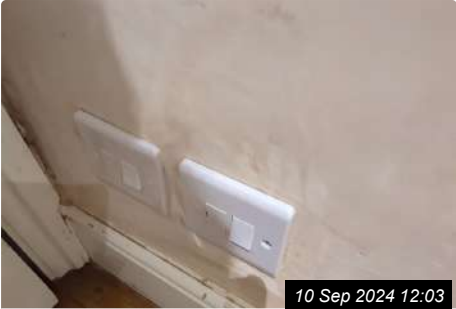
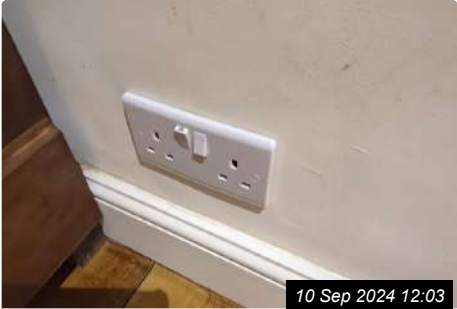
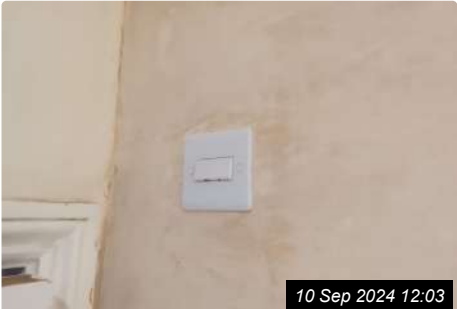
| 14. BEDROOM 2 (CONT.) | | | |
|---|---|---|---|
| 14.7 | Switches / Sockets | 2 White plastic lightswitch;<br>White plastic dimmerswitch;<br>White plastic isolator switch<br><br>4 White plastic double socket | Switches in good working order;<br><br>Sockets untested |

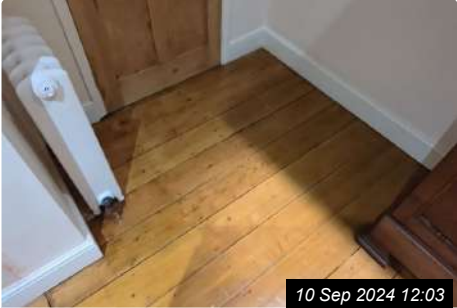
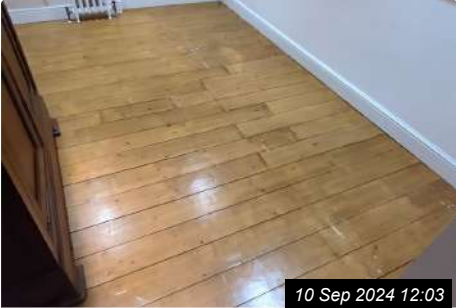
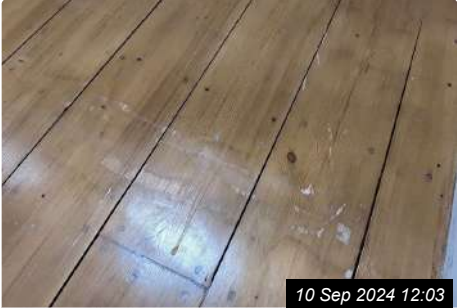
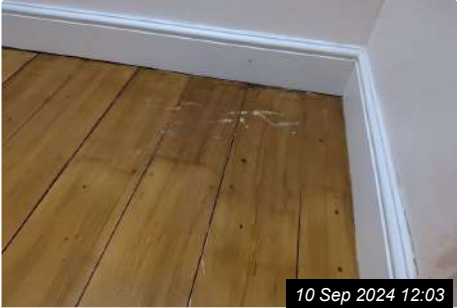
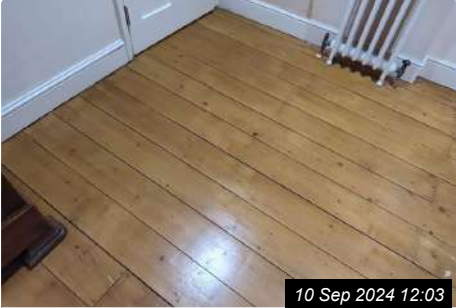
| 14. BEDROOM 2 (CONT.) | | | |
|---|---|---|---|
| 14.8 | Flooring | Treated Wood panel floorboards with some filled some exposed fixing screws | Signs of use and age<br><br>Some gaps in between floorboards |

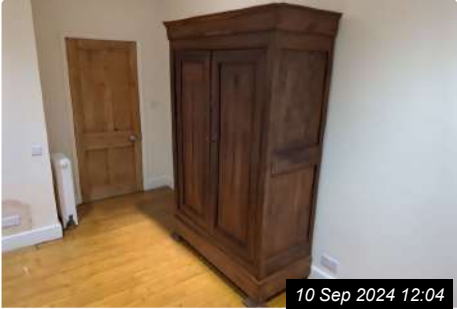
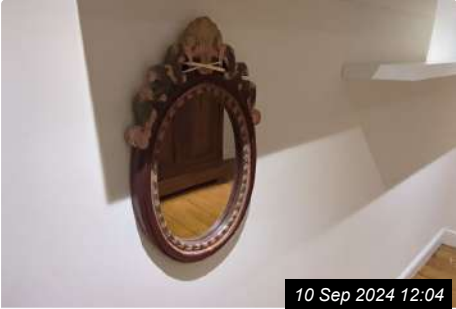
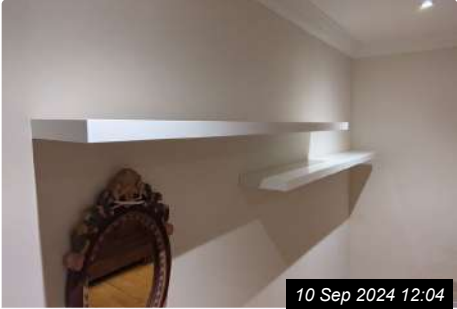
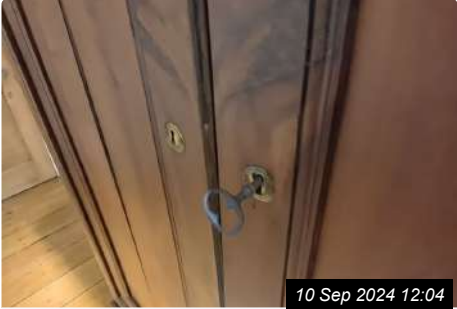
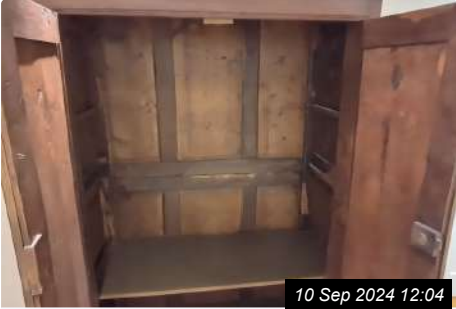
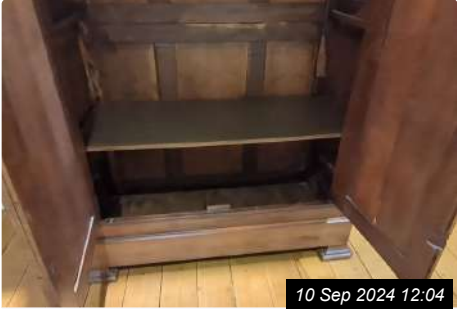
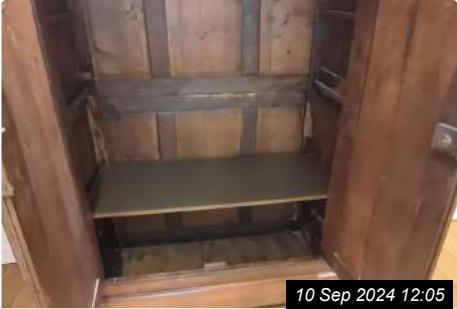
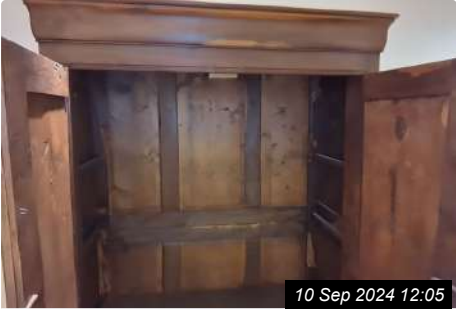
| 14. BEDROOM 2 (CONT.) | | | |
|---|---|---|---|
| 14.9<br> | Furnishings | <p>Brown wooden wardrobe with matching interior;<br/>1 shelf; ;<br/>1 dark metal key;</p> <p>Brown wooden oval ornate frame with glass mirror to interior;</p> <p>2 white laminate shelves</p> | Furnishings clean and consistent with age |

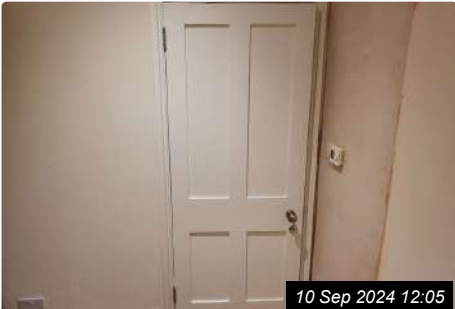
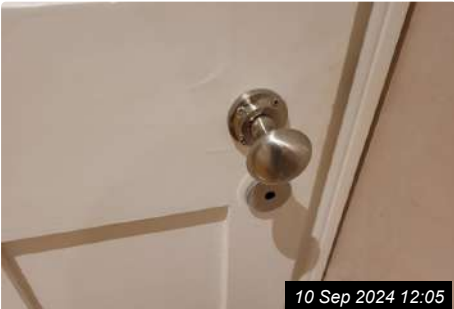
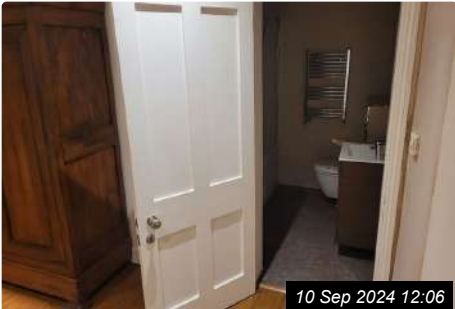
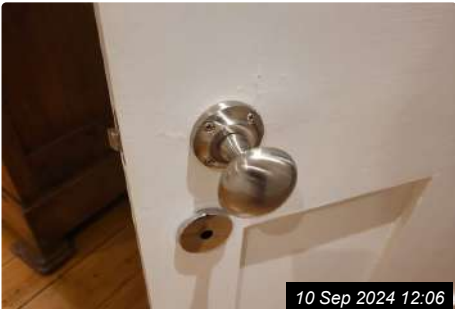
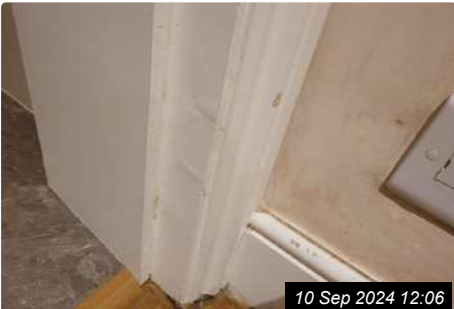
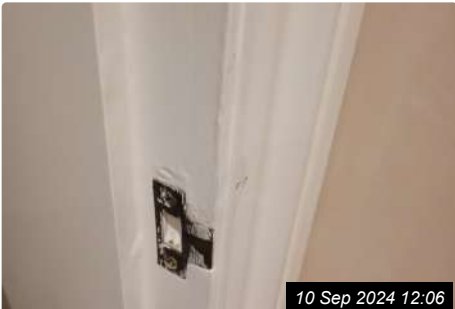
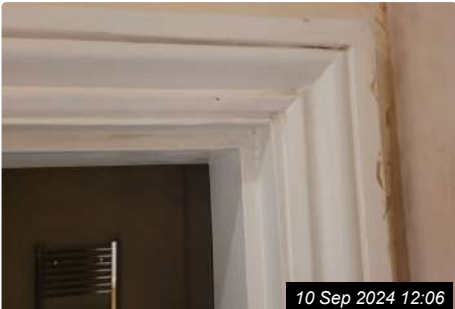
| Ref | Name | Description | Condition |
|---|---|---|---|
| 15.1<br>📷 | Door/ Frame/ Threshold | White painted wooden panel door with grey metal knobs | Plaster marks to lower and upper frame RHS;<br>Light scuffing;<br>Condition consistent with age and use |

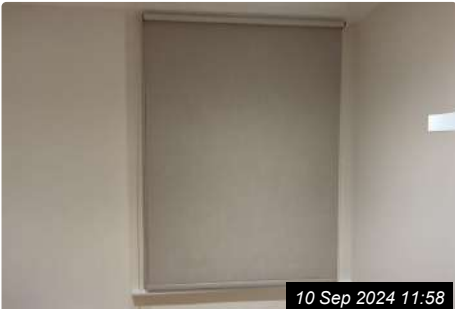
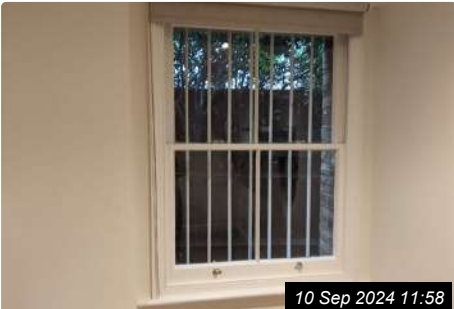
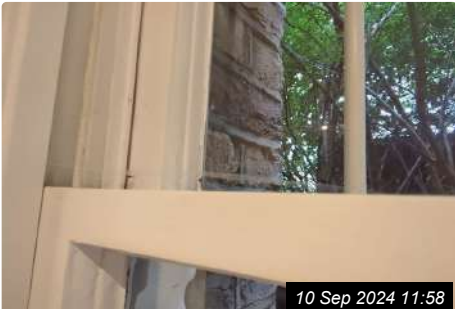
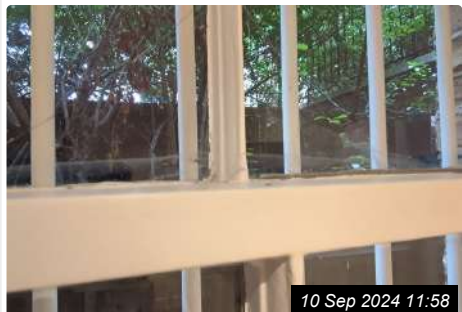
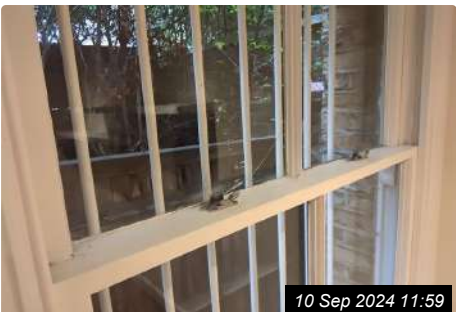
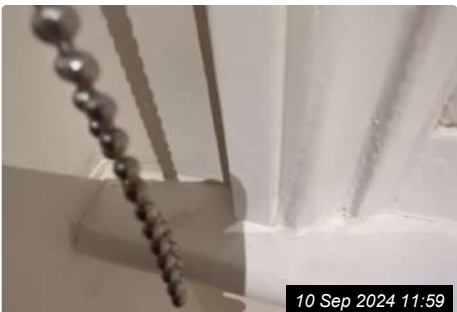
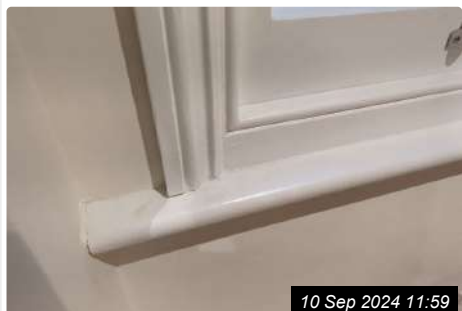
| 15. ENSUITE TO BEDROOM 2 (CONT.) | | | |
|---|---|---|---|
| 15.2<br>📷 | Window(s) / Sill | <p>White wooden sash window and frame with 4 clear glass panes and 2 grey metal locks and handles;</p> <p>White metal bars to exterior;</p> <p>White painted wooden sill;</p> <p>Grey material roller blind with grey metal beaded cord</p> | <p>Some signs of age;<br/>Dust to surfaces;</p> <p>Mark to LHS;</p> <p>No cord cleat present;<br/>In working order</p> |

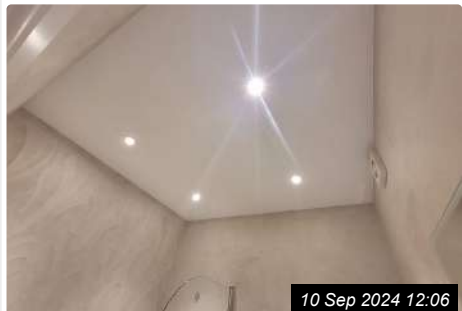
| 15. ENSUITE TO BEDROOM 2 (CONT.) | | | |
|---|---|---|---|
| 15.3 | Ceiling | Smooth white painted with ornate moulded coving to match | Good condition |

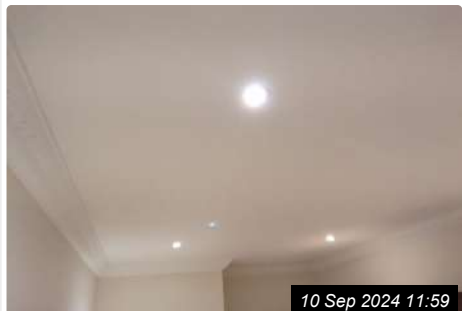
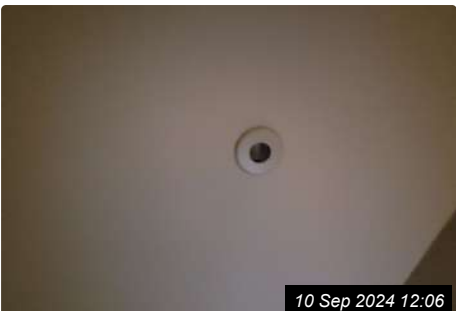
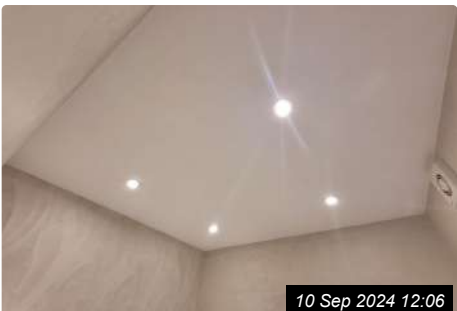
| 15. ENSUITE TO BEDROOM 2 (CONT.) | | | |
|---|---|---|---|
| 15.4 | Lighting | 5 inset spotlights with white plastic surrounds | 1 spotlight is not working |

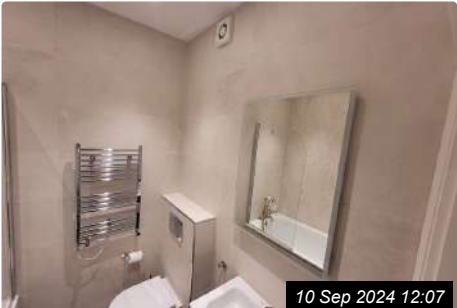
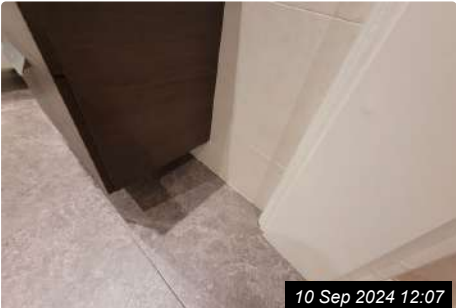
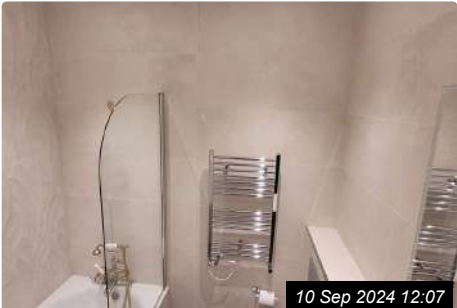
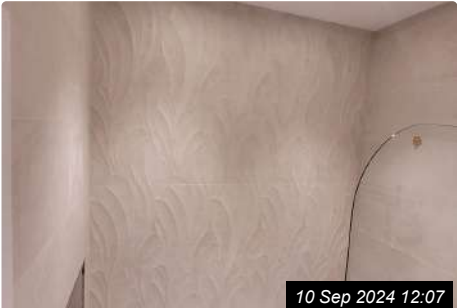
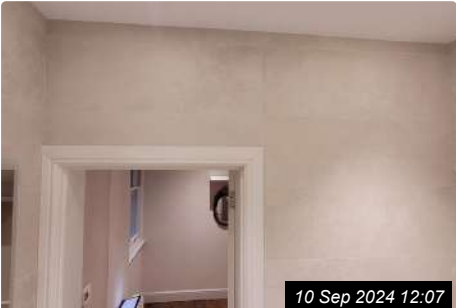
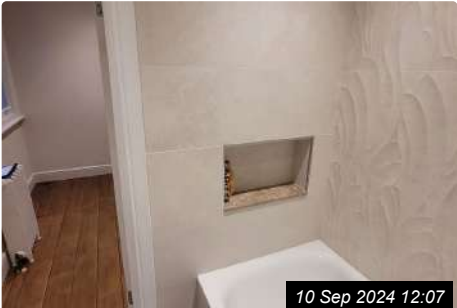
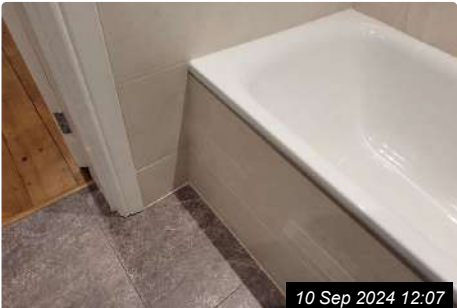
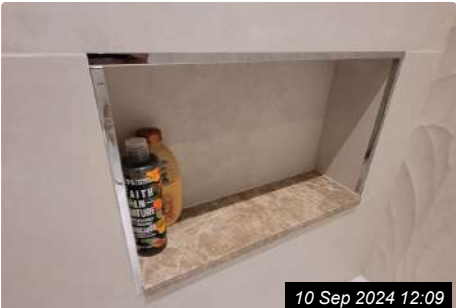
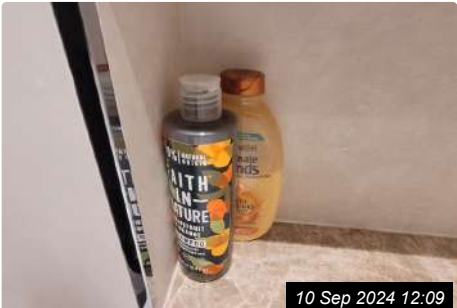
| 15. ENSUITE TO BEDROOM 2 (CONT.) | | | |
|---|---|---|---|
| 15.5<br>📷 | Walls / Skirting | Light brown stone effect tiling;<br><br>Window recess with brown stone shelf and chrome effect metal trim | Very good condition;<br><br>2 personal hygiene products left in recess |

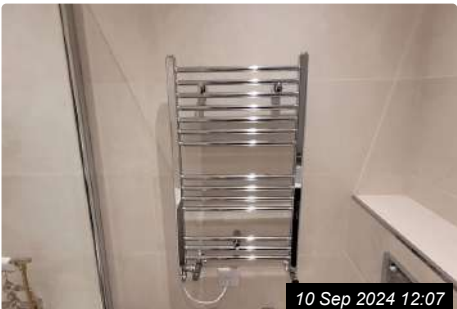
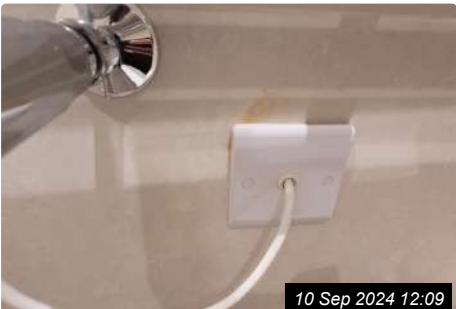
| 15. ENSUITE TO BEDROOM 2 (CONT.) | | | |
|---|---|---|---|
| 15.6<br>📷 | Heating | Chrome effect metal towel radiator | Appears in a good conditon;<br>Untested |

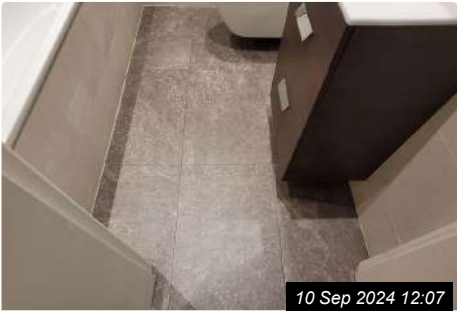
| 15. ENSUITE TO BEDROOM 2 (CONT.) | | | |
|---|---|---|---|
| 15.7<br> | Flooring | Grey stone effect flooring | Good condition;<br>Intact |

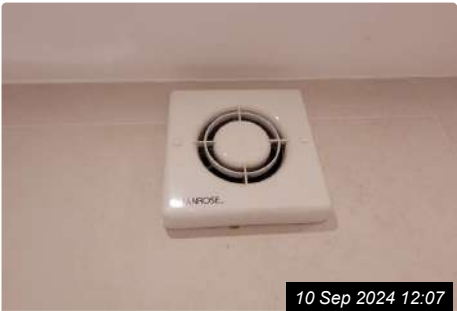
| 15. ENSUITE TO BEDROOM 2 (CONT.) | | | |
|---|---|---|---|
| 15.8<br> | Extractor fan | White plastic | Slightly dusty to vent |

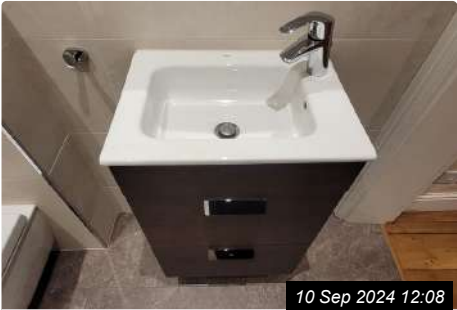
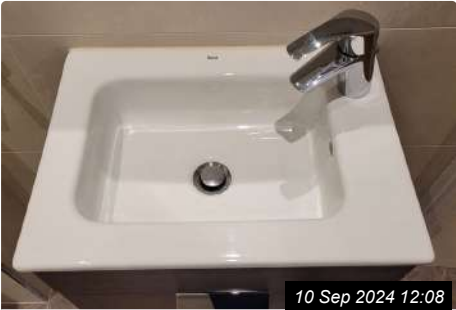
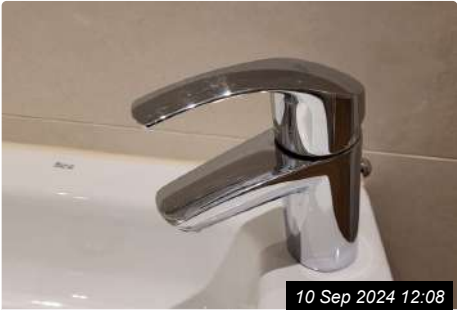
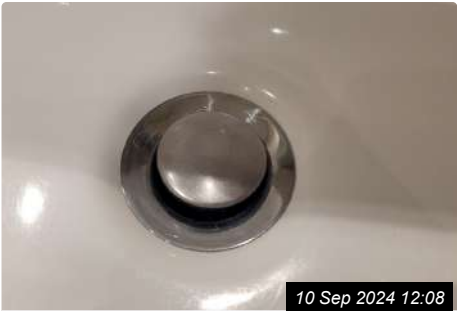
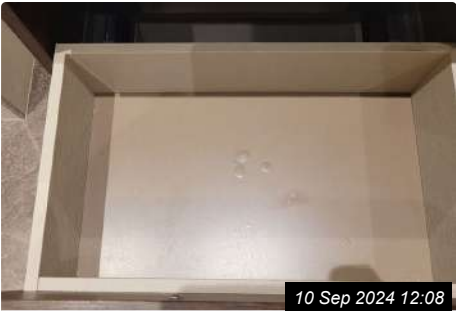
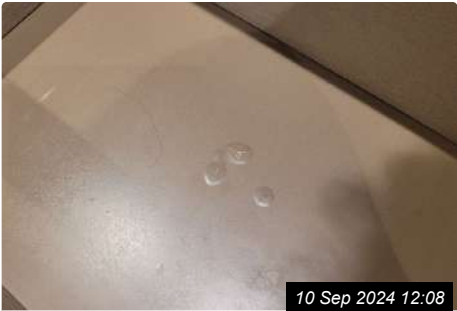
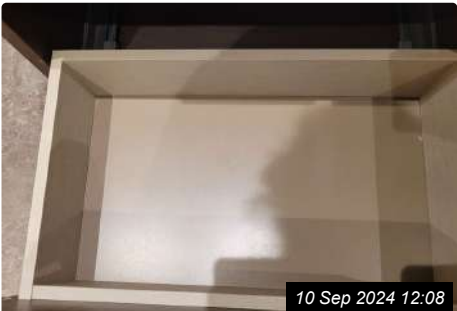
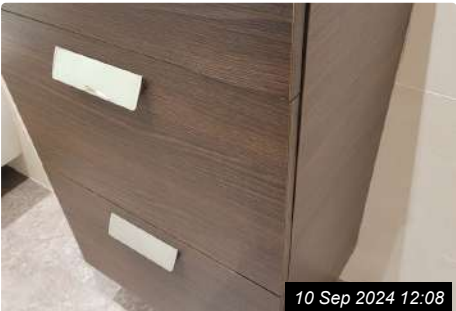
| 15. ENSUITE TO BEDROOM 2 (CONT.) | | | |
|---|---|---|---|
| 15.9<br> | Basin | <div>Rectangular white ceramic basin with chrome effect mixer tap, and push plug; ;</div> <div>Brown wood effect laminate underbase unit with grey metal handles;<br/>Interior light brown material effect laminate<br/>2 drawers</div> | <div>Discolouring around drain;<br/>Limescale and tarnishing to tap;</div> <div>Laminate bubbling</div> |

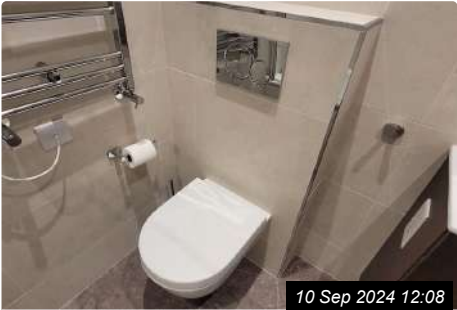
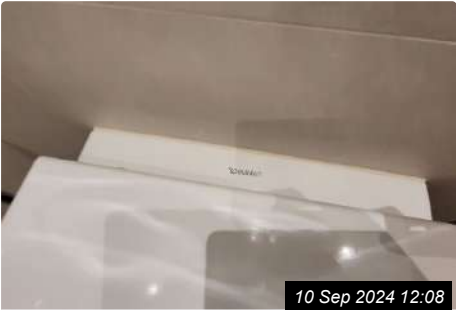
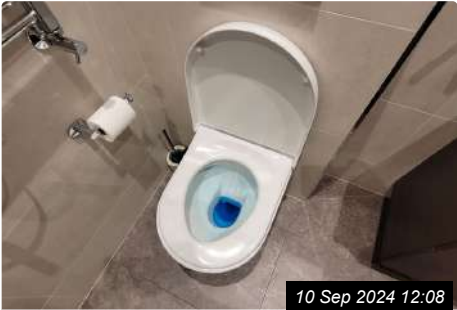
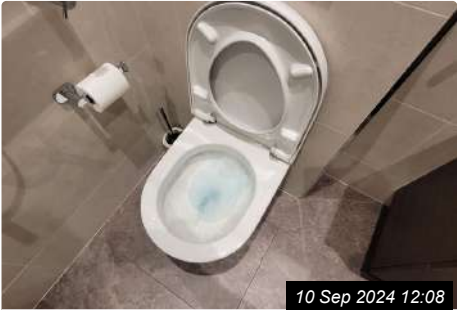
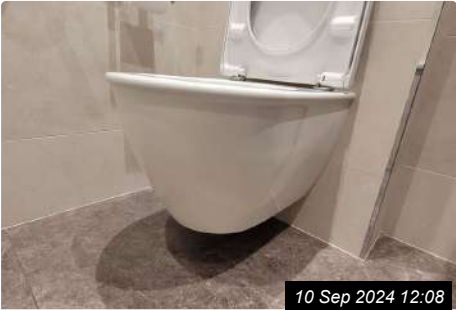
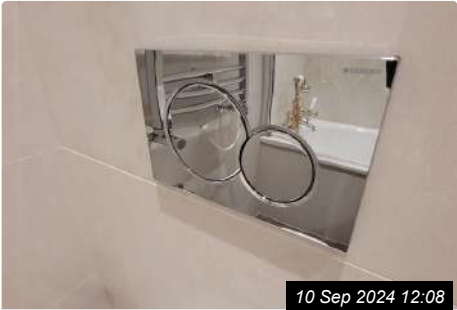
| 15. ENSUITE TO BEDROOM 2 (CONT.) | | | |
|---|---|---|---|
| 15.10 | Toilet | White ceramic toilet with hidden cistern with white plastic toilet seat and lid;<br>Chrome effect 2 button flush | Good clean condition;<br>In working order |

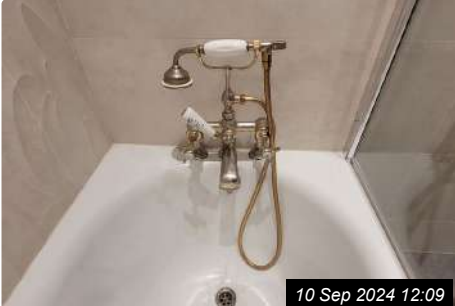
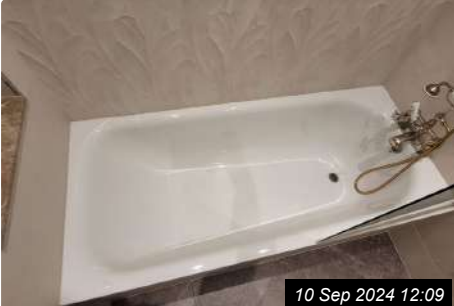
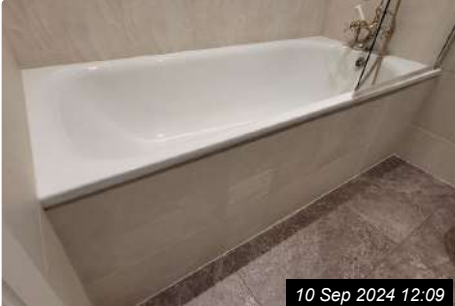
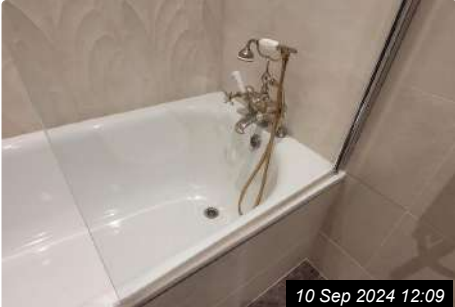
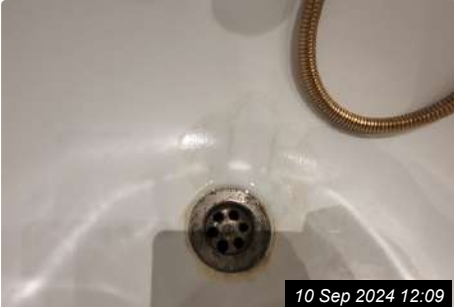
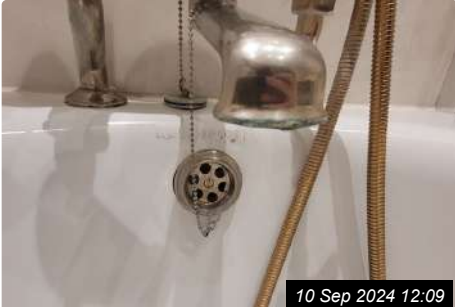
| 15. ENSUITE TO BEDROOM 2 (CONT.) | | | |
|---|---|---|---|
| 15.12<br> | Bath/ Bath panel | White composite bath with gold effect/ grey metal and ceramic mixer tap, showerhead and hose, over flow, plug and chain/ drain;<br><br>Bath panel to match walls | Tarnishing to metal;<br>Untested;<br>Limescale to showerhead |

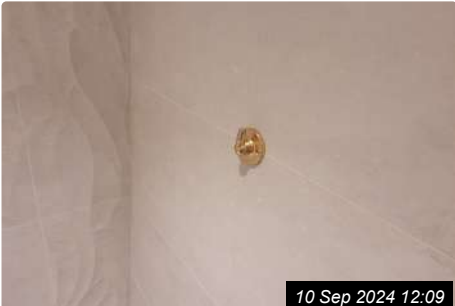
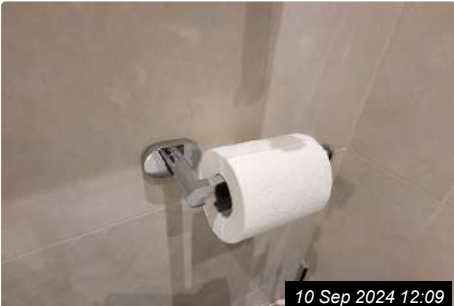
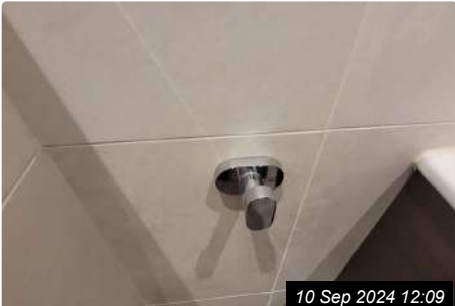
| 15. ENSUITE TO BEDROOM 2 (CONT.) | | | |
|---|---|---|---|
| 15.13<br> | Accessories | 1 gold effect metal and 1 grey metal towel hook;<br><br>Grey metal toilet roll holder | All in good working order |

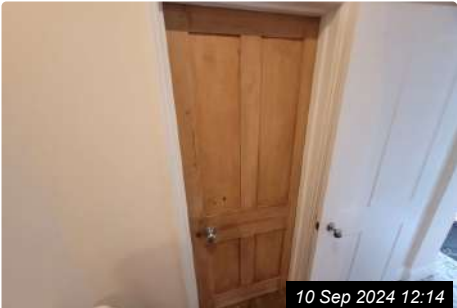
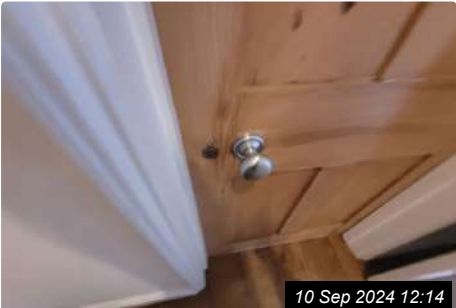
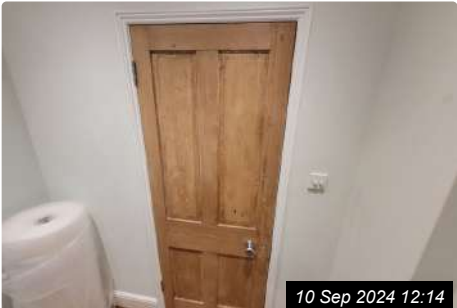
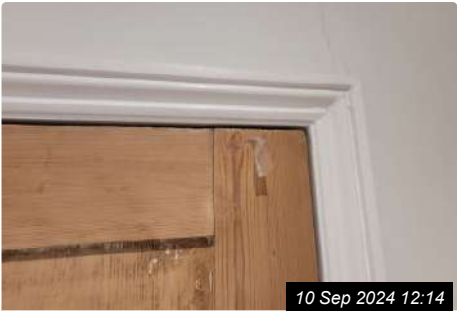
| 16. BEDROOM 3 (CONT.) | | | |
|---|---|---|---|
| 16.1<br> | Door/ Frame/ Threshold | Wooden panel door with brushed metal furnishings.<br>X2 chrome hinges<br><br>White painted wooden frame<br><br>Wooden floor board threshold | Some cracks in the woodwork;<br>Good condition consistent with age and use; ;<br>tapemark to interior top;<br><br>Frame in good condition;<br>Painted over defects |

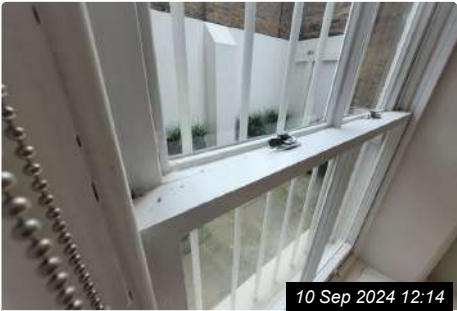
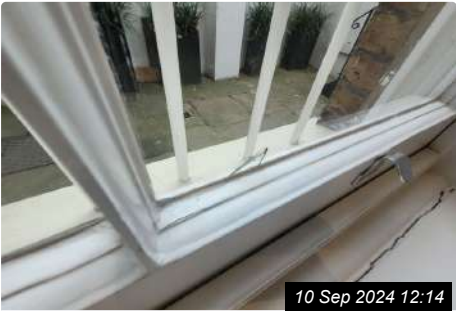
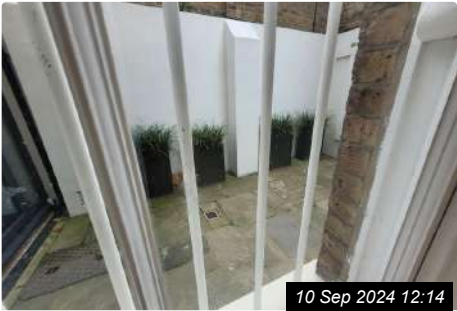
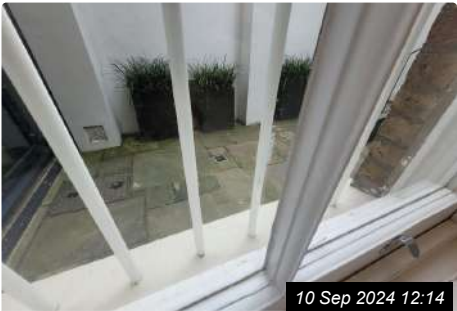
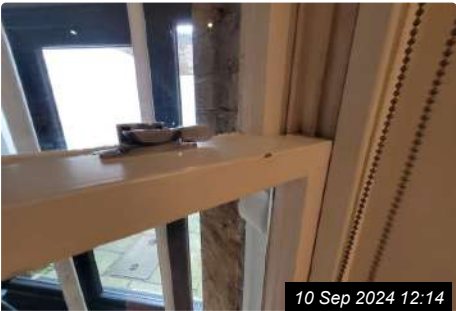
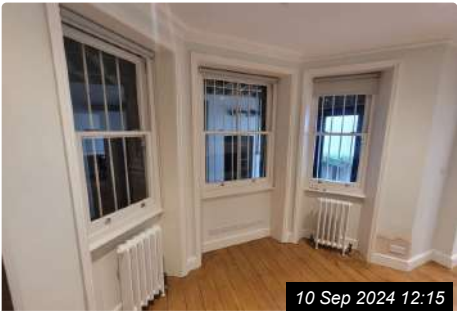
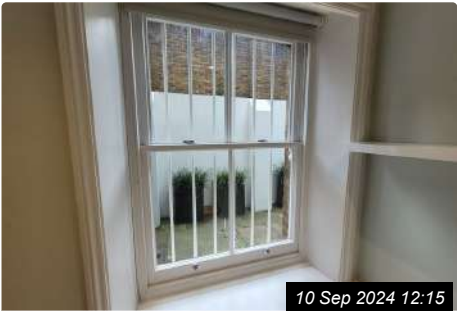
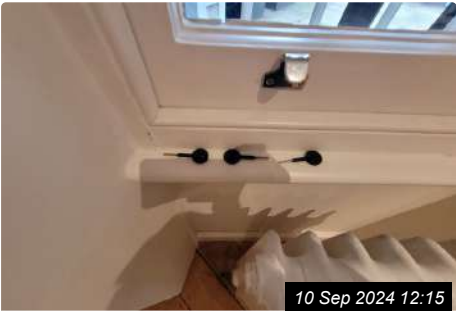
| 16. BEDROOM 3 (CONT.) | | | |
|---|---|---|---|
| 16.2 | Window(s) / Sill | <div>4 White painted wooden sash windows with 4 clear glass panes, 2 grey metal lock mechanisms and handles;<br/>White painted metal bards to exterior</div> <div>White painted wooden sill;</div> <div>Green material roller blinds with grey metal beaded cords</div> | <div>Dust and cobwebs;<br/>RHS window has a crack between sill and frame;<br/>Overpainting to pane;<br/>Second from right has chip to mid rhs<br/>Otherwise in good condition;<br/>4 Black plastic and metal window keys</div> |

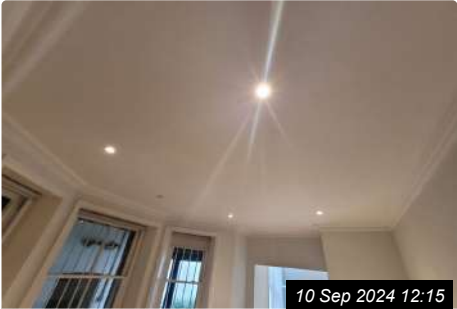
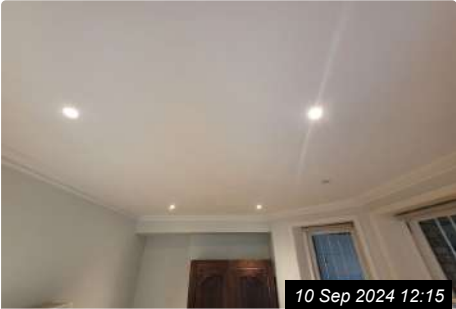
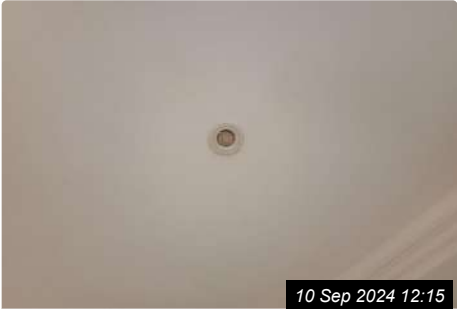
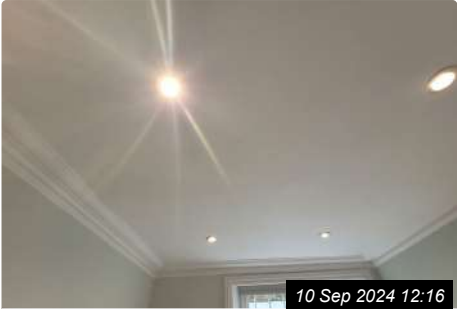
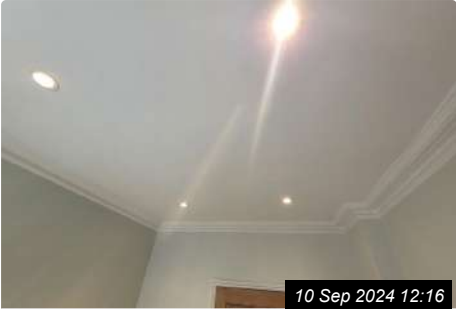
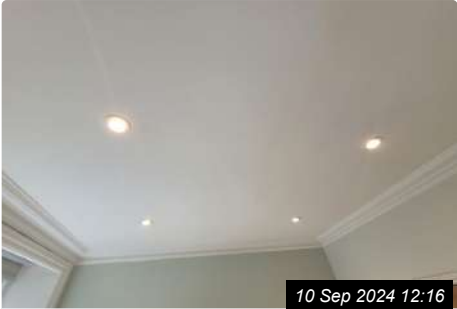
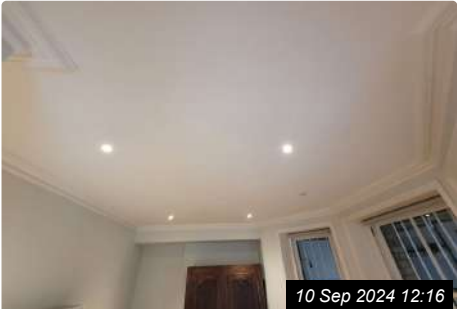
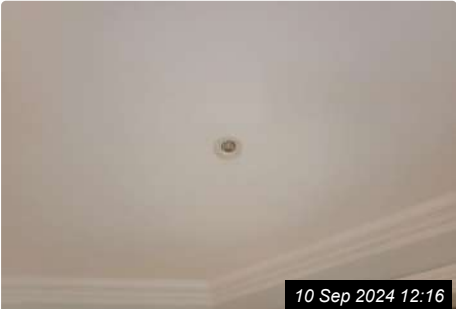
| 16. BEDROOM 3 (CONT.) | | | |
|---|---|---|---|
| 16.4 | Lighting | white surround inset spotlights | 1 not working in window area |

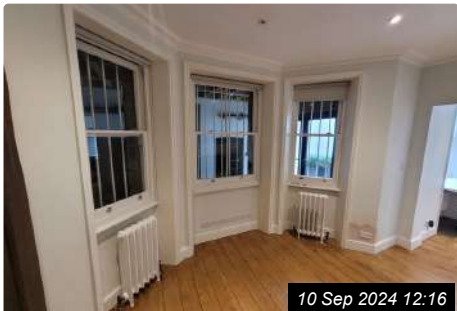
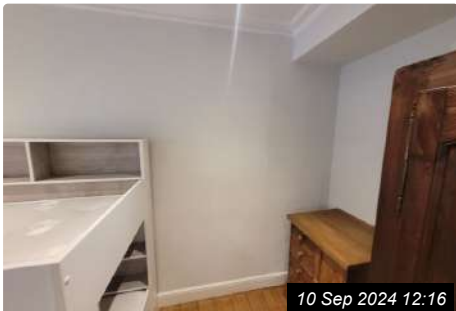
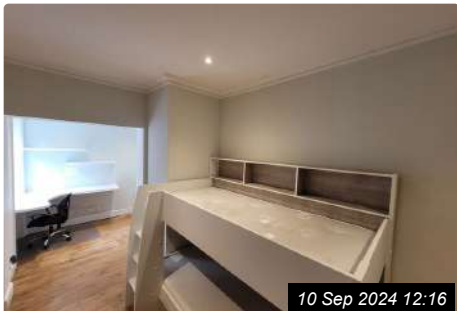
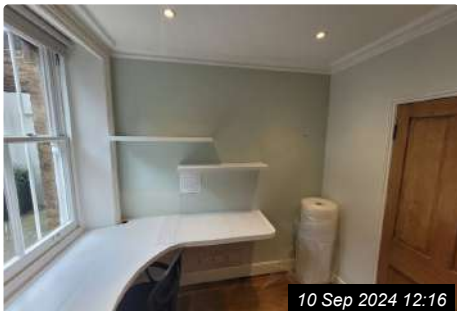
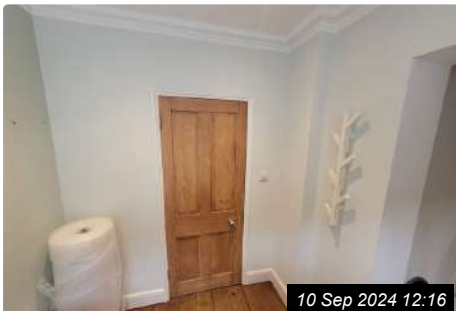
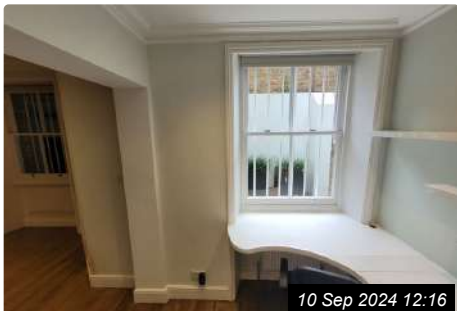
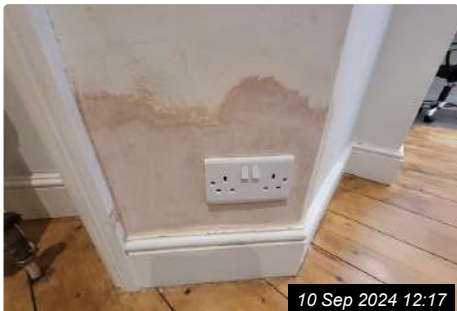
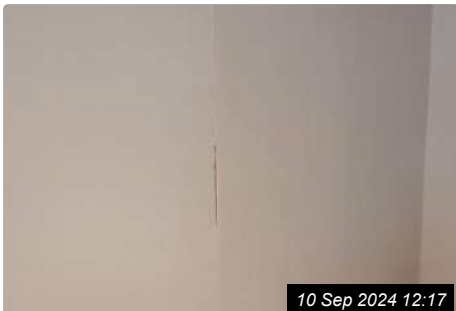
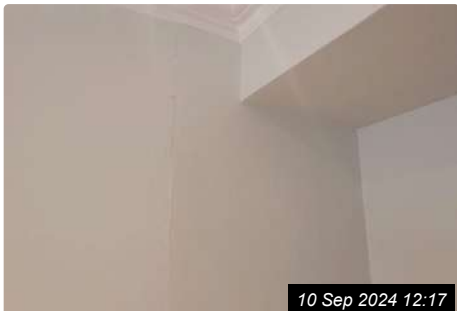
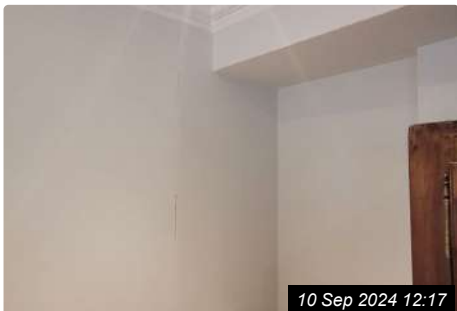
| 16. BEDROOM 3 (CONT.) | | | |
|---|---|---|---|
| 16.5 | Walls / Skirting | Smooth white painted walls;<br><br>White painted wooden skirting | patches of exposed plaster to RHS and Far walls;<br>marks and scuffs throughout;<br>Settlement cracks in places;<br>Scattered chips on wall opposite door;<br>some tape marks;<br>2 screws mid to upper level rear wall;<br><br>Skirting in reasonable condition;<br>some plaster overlap |

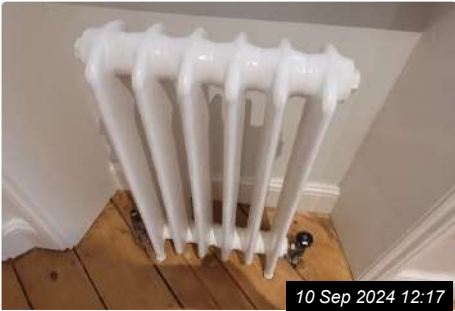
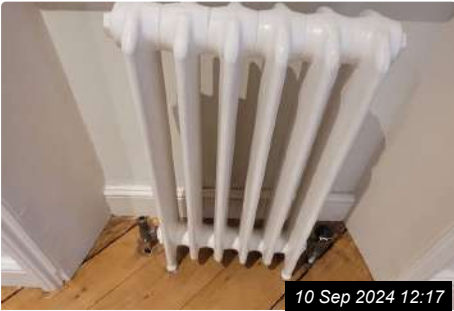
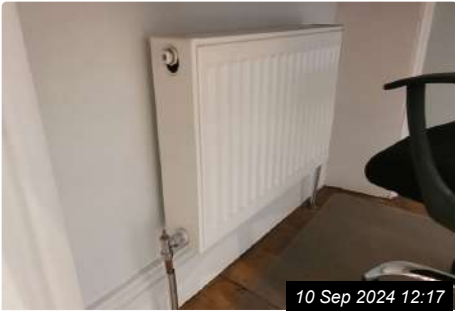
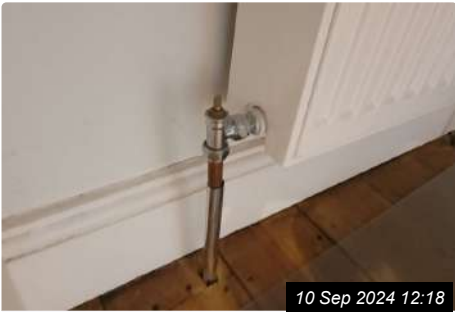
| 16. BEDROOM 3 (CONT.) | | | |
|---|---|---|---|
| 16.6<br> | Heating | 2 White painted metal column radiators;<br><br>1 white metal panel radiator | <div><p>10 Sep 2024 12:16</p><p>Ref # 16.5</p></div> |
| untested;<br>Appear in good condition;<br>Missing valve cap to panel radiator | | | |

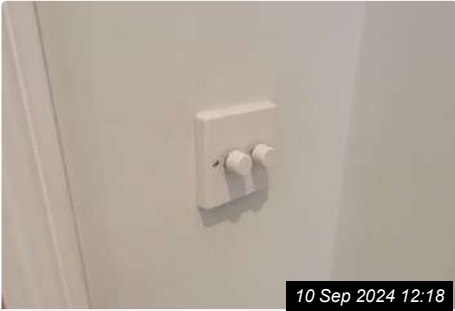
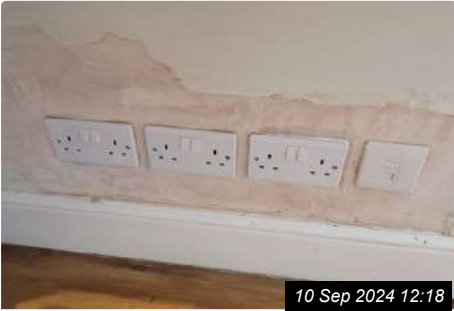
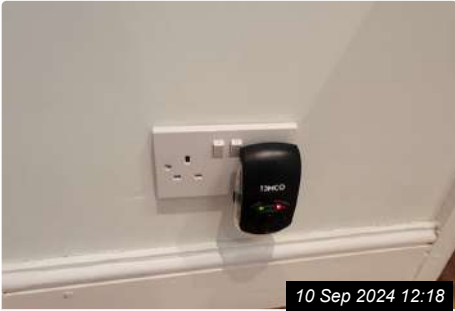
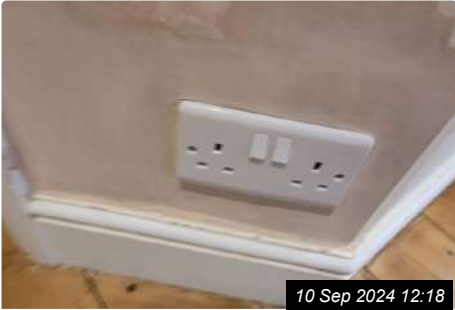
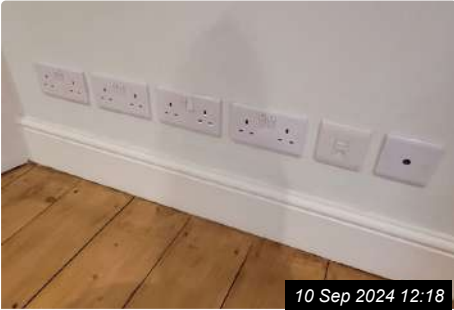
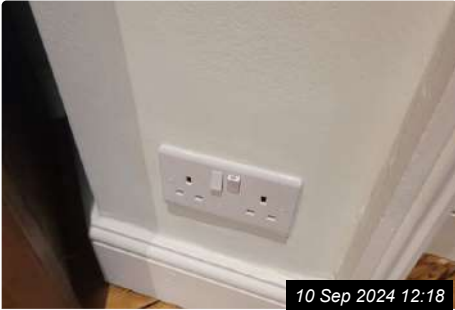
| 16. BEDROOM 3 (CONT.) | | | |
|---|---|---|---|
| 16.7 | Switches / Sockets | White plastic dimmer switch<br><br>10 White plastic double socket | Dimmer switch in good working order;<br><br>Sockets untested but appear in good condition |

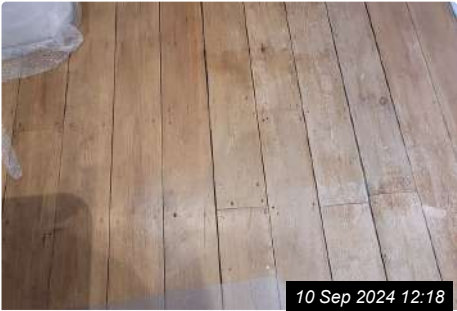
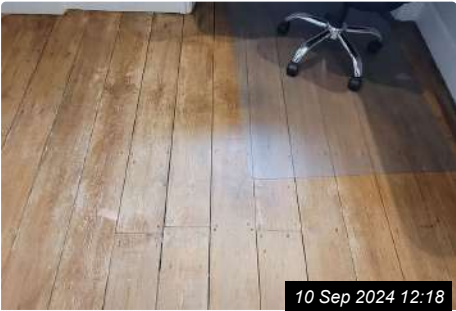
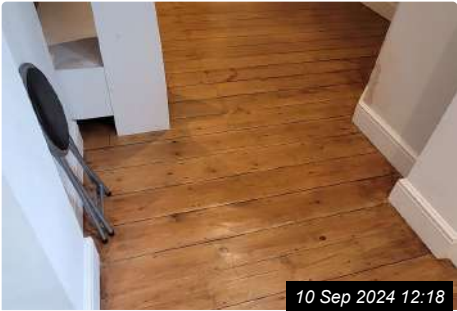
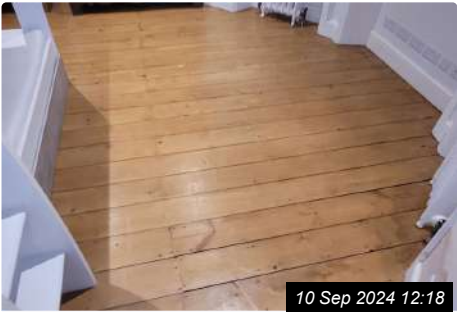
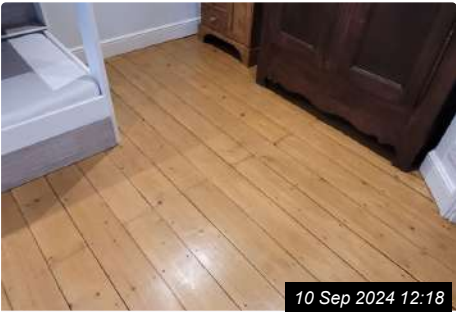
| 16. BEDROOM 3 (CONT.) | | | |
|---|---|---|---|
| 16.8 | Flooring | Treated Wood panel floorboards with some filled<br>some exposed fixing screws | Signs of use and age<br><br>Some gaps in between floorboards |
