# Inventory & Schedule of Condition

Prepared on behalf of Example Lettings Ltd

123 Preview Street  
Sample City  
London  
AB1 2CD

**September**  
**13th 2024**

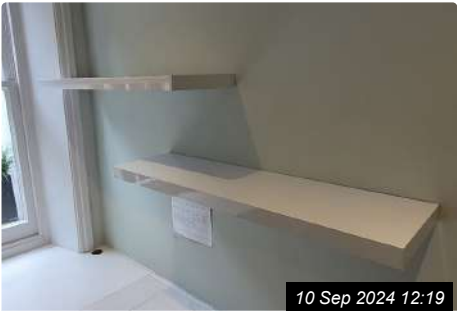
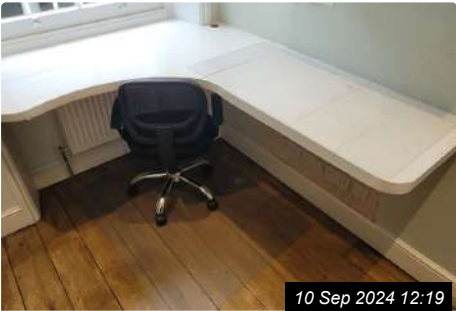
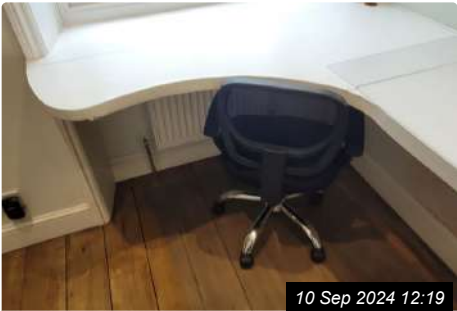
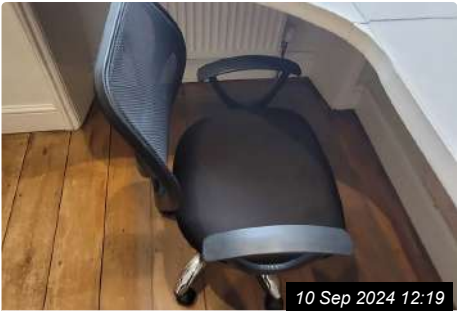
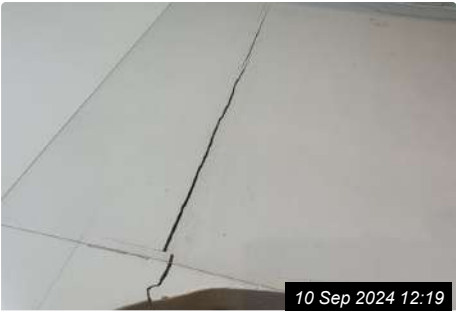
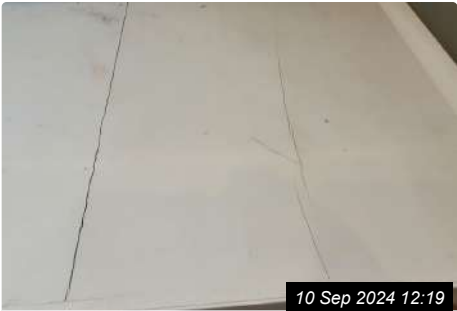
| 16. BEDROOM 3 (CONT.) | | | |
|---|---|---|---|
| 16.9 | Furnishings | <div>2 white laminate shelves;</div> <div>White laminate corner desk;</div> <div>Black fabric office style chair with chrome base and black plastic castors; ;</div> <div>White laminate wall mounted coat rack;</div> <div>White and brown wood effect bunk beds with 3 open front storage sections to each bed;</div> <div>2 white mattresses;</div> <div>Black material and grey metal folding stool;</div> <div>Brown wooden unit with knobs to match;</div> <div>4 drawers;</div> <div>1 cupboard door with 1 shelf to interior;</div> <div>Brown wooden wardrobe with ornate brass lock covers and interior to match;</div> <div>4 wood effect laminate shelves;</div> <div>Grey metal hanging rail</div> | <div>Appear in good condition;</div> <div>Heavy cracking to surface; ;</div> <div>Dust, some signs of use;</div> <div>Good condition;</div> <div>Good condition;</div> <div>some signs of use;</div> <div>Fire labels present on mattresses</div> <div>Good condition consistent with use;</div> <div>Signs of age and use;</div> <div>Condition consistent with age and use</div> |

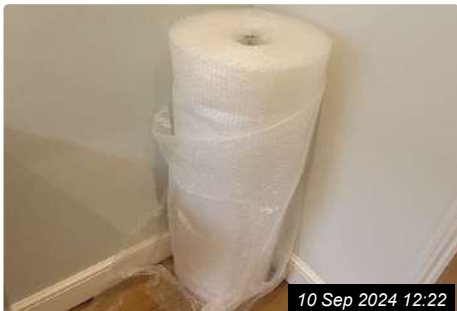
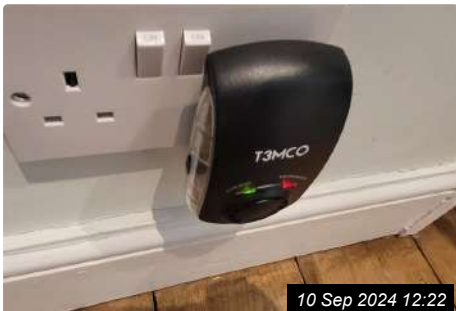
| 16. BEDROOM 3 (CONT.) | | | |
|---|---|---|---|
| 16.10<br> | Additional items | Roll of clear plastic bubble wrap;<br><br>Black plastic T3mco plug in | Assumed discarded;<br><br>Unknown function;<br>Appears in reasonable condition |

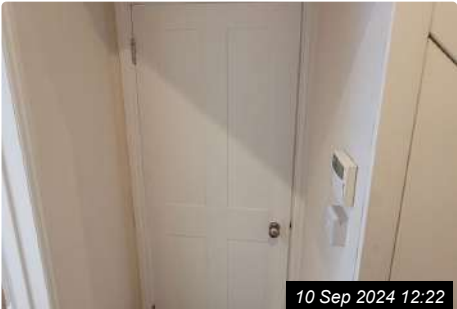
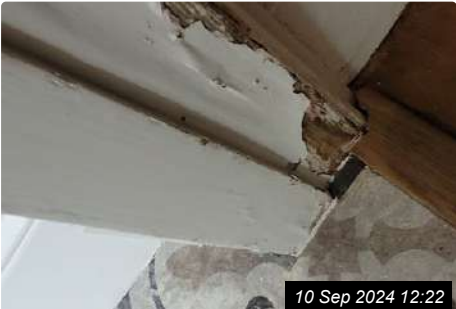
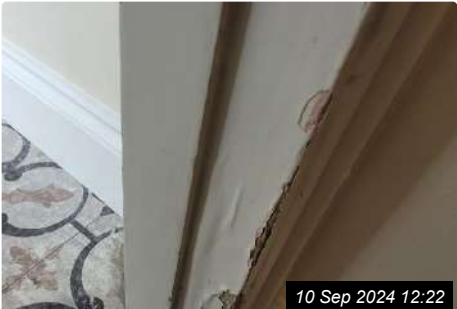
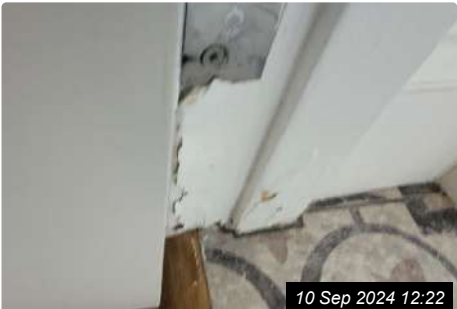
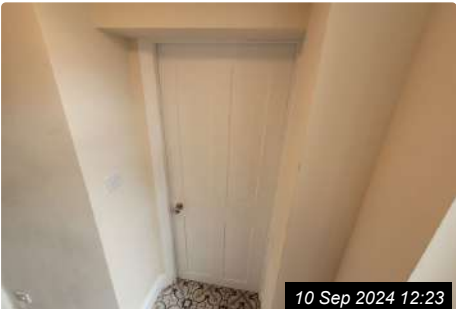
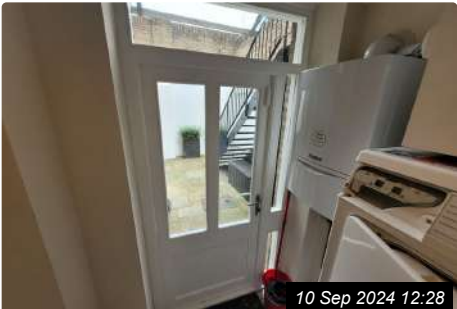
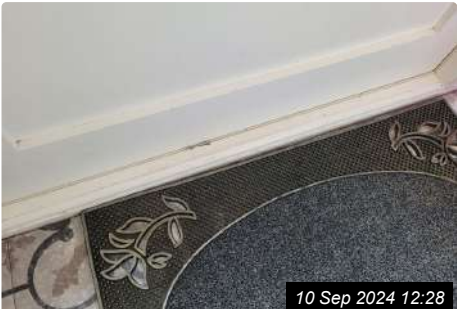
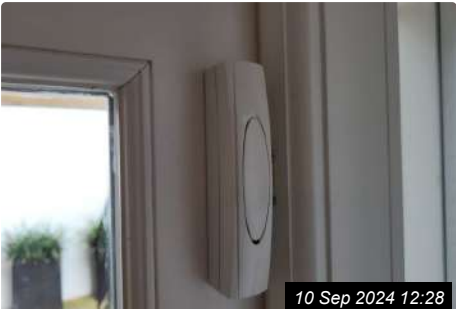
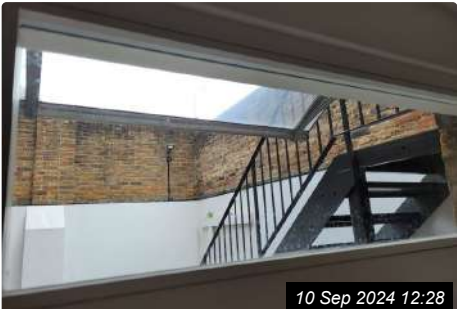
| 17. UTILITY (CONT.) | | | |
|---|---|---|---|
| 17.1 | Ref # 17.1 | | |

| 17. UTILITY (CONT.) | | | |
|---|---|---|---|
| 17.1<br> | Door/ Frame/ Threshold | <p>1- White painted four panel door with brass knob and reverse to match;</p> <p>White painted wooden frame;</p> <p>Brown wooden transverse strip</p> <p>2- White painted wooden door with 2 clear glass panes and grey metal thumb twist lock/ handles; White plastic security fitting to top</p> <p>Frame is white painted wooden with clear glass transom pane to top and two further clear glass panes to RHS</p> <p>White painted wooden threshold</p> | <p>Both in good condition, consistent with age and use;</p> <p>1- Damage to door frame exterior lower RHS and surface damage to mid level;</p> <p>Damage around lower hinge attachment to frame;</p> <p>;</p> <p>2- Dust/ dirt to lower levels</p> |

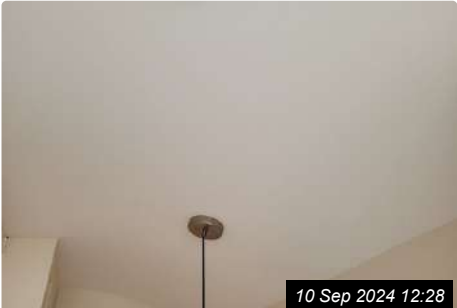
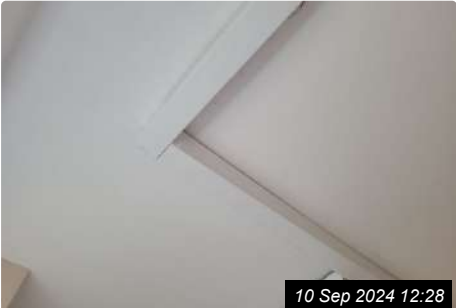
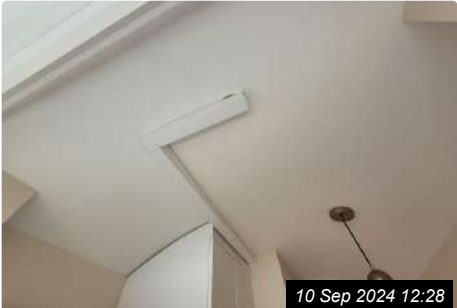
| 17. UTILITY (CONT.) | | | |
|---|---|---|---|
| 17.2 | Ref # 17.2 | | |

| 17. UTILITY (CONT.) | | | |
|---|---|---|---|
| 17.2 | Ceiling | Smooth white painted | Good condition |

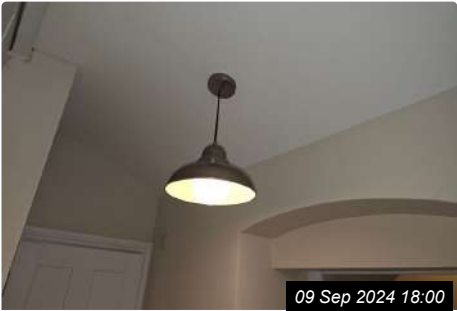
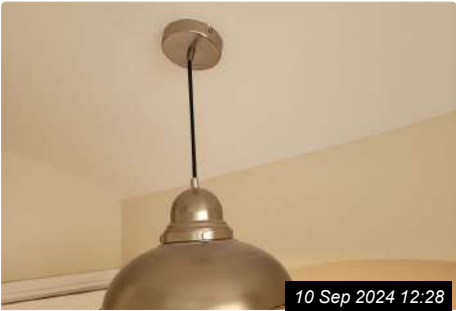
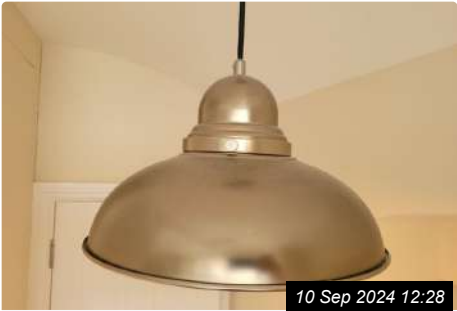
| 17. UTILITY (CONT.) | | | |
|---|---|---|---|
| 17.3 | Lighting | Grey metal pendant light with matching ceiling rose and black wire | Dust to top;<br>In working order |

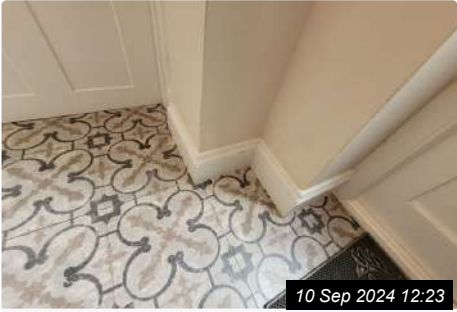
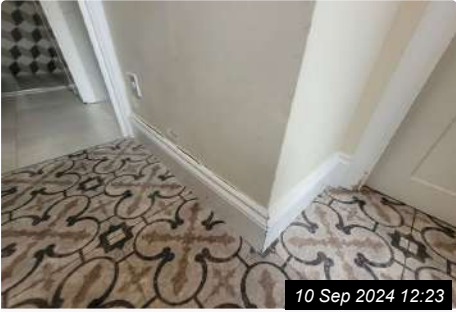
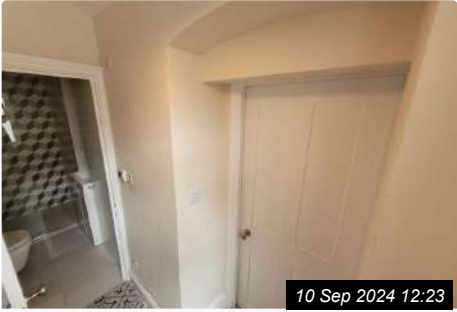
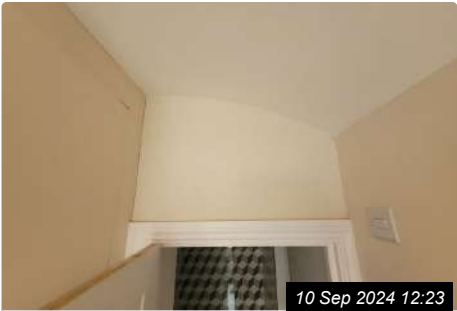
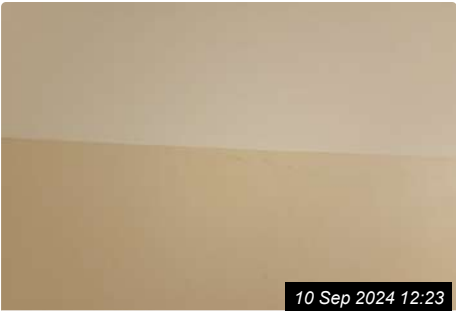
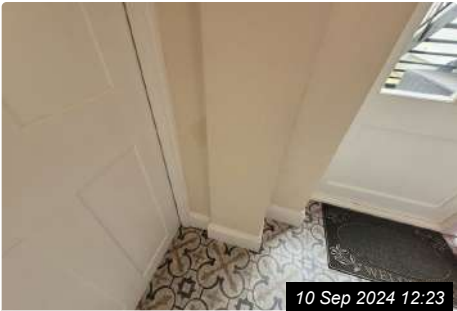
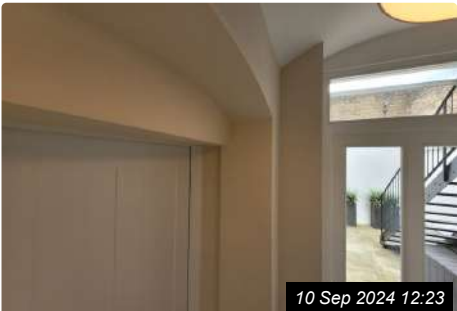
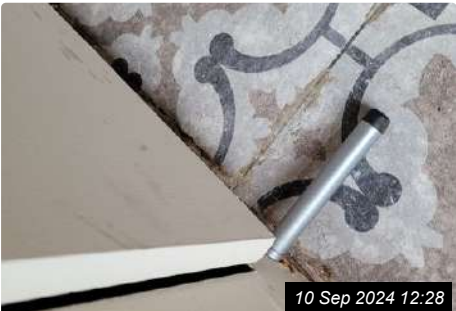
| 17. UTILITY (CONT.) | | | |
|---|---|---|---|
| 17.4 | Walls / Skirting | Smooth cream painted walls;<br><br>White painted wooden skirting;<br>Grey metal and black plastic doorstep | Generally in good condition;<br>Patch of discolouration mid level LHS up entry;<br>Chipping to corners;<br><br>Chipping to skirting;<br>worn |

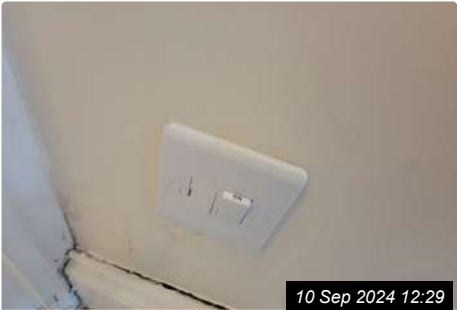
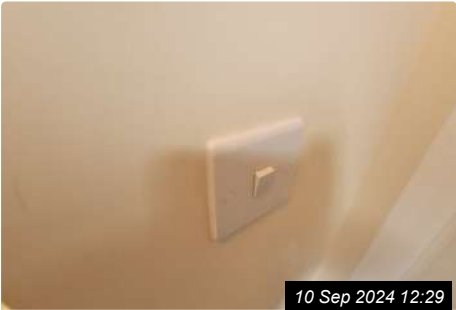
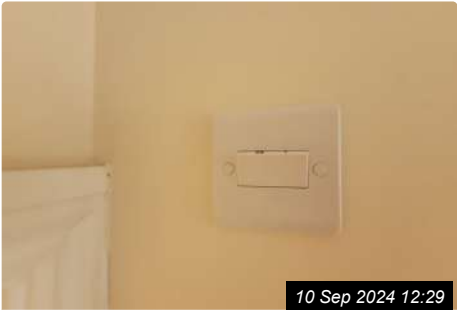
| 17. UTILITY (CONT.) | | | |
|---|---|---|---|
| <div> </div> <div> <i>Ref # 17.5</i> <i>Ref # 17.5</i> <i>Ref # 17.5</i> </div> | | | |

| 17. UTILITY (CONT.) | | | |
|---|---|---|---|
| 17.5<br> | Switches / Sockets | White plastic;;<br>Fuse switch;<br>Isolator switch;<br>Two single lightswitches | In working order |

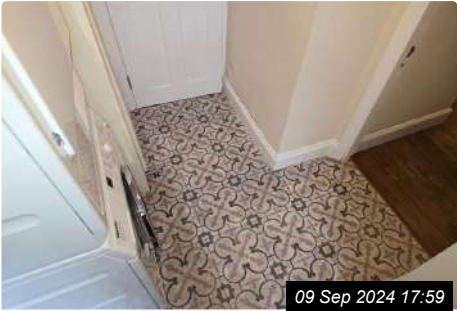
| 17. UTILITY (CONT.) | | | |
|---|---|---|---|
| 17.6<br> | Flooring | Light brown / Grey and offwhite patterned square tiles | Intact;<br>Light dirt and debris |

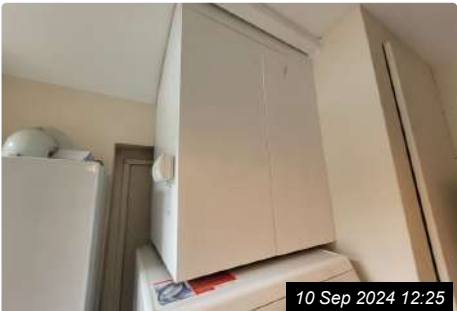
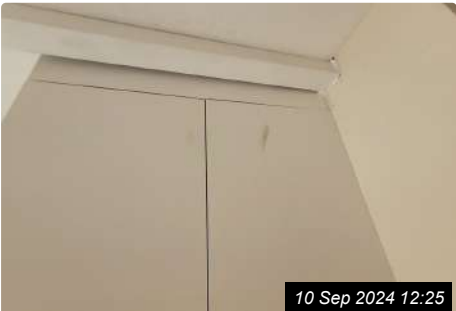
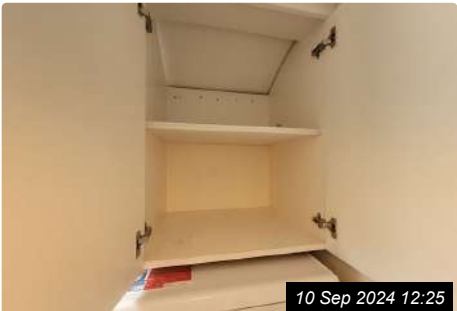
| 17. UTILITY (CONT.) | | | |
|---|---|---|---|
| <div> </div> <div> <i>Ref # 17.7</i> <i>Ref # 17.7</i> <i>Ref # 17.7</i> </div> | | | |

| 17. UTILITY (CONT.) | | | |
|---|---|---|---|
| 17.7<br> | Units | White laminate unit with 2 doors;<br>Interior to match with 1 shelf | Light marking throughout interior and exterior;<br>Otherwise intact and in working order |

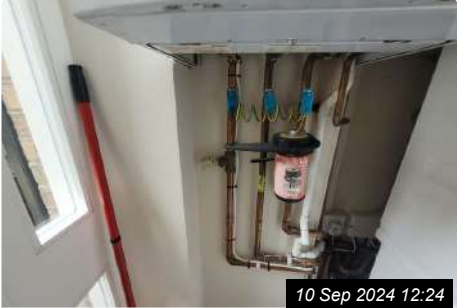
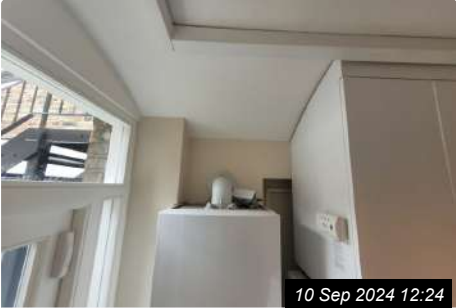
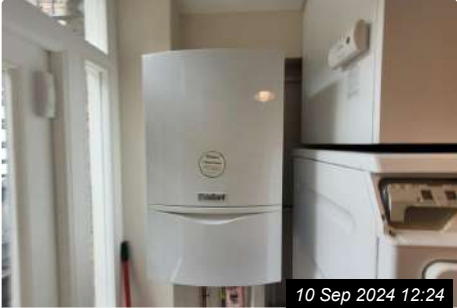
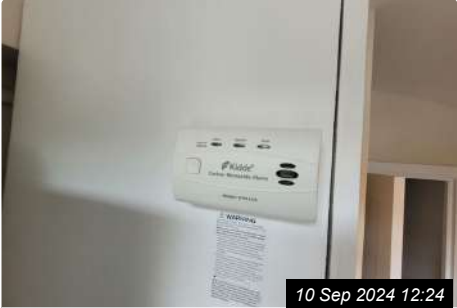
| 17. UTILITY (CONT.) | | | |
|---|---|---|---|
| 17.11 | Boiler | White Vaillant boiler and associated pipework | Carboard box to top; ;<br>Tested for power;<br>Appears in good condition |

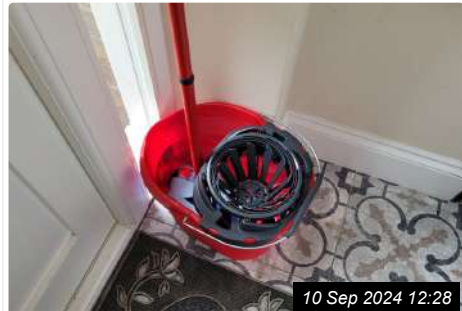
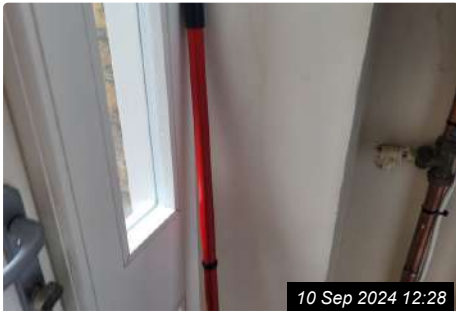
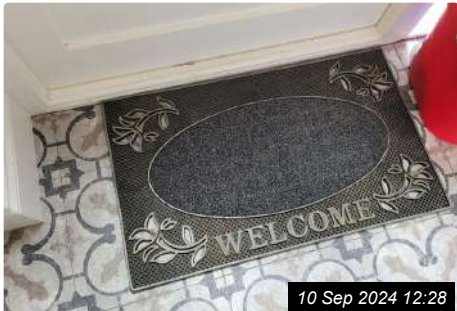
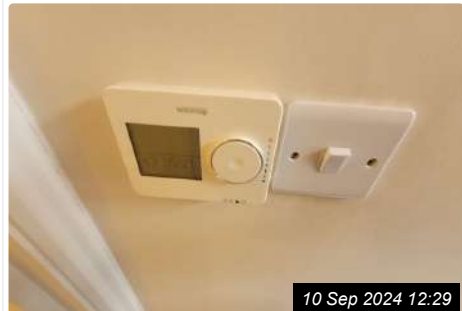
| 17. UTILITY (CONT.) | | | |
|---|---|---|---|
| 17.12<br>📷 | Additional items | Red and grey plastic mop and bucket;<br><br>Black rubber and grey material patterned "welcome" mat;<br><br>White plastic "warmup" heating control | Used condition;<br><br>Intact;<br>Signs of wear and dirt;<br><br>Tested for power;<br>In reasonable condition |

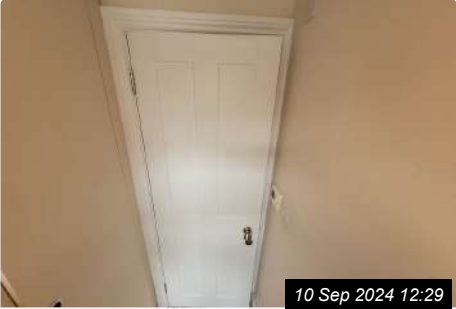
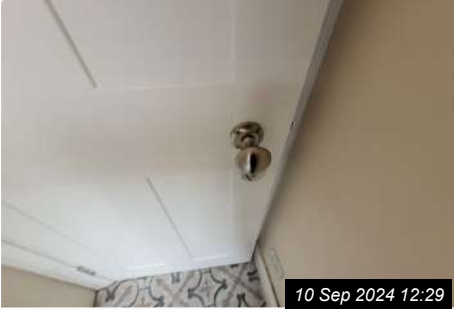
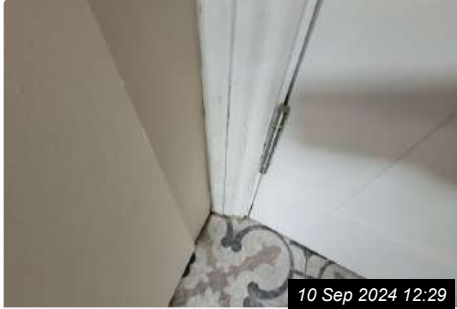
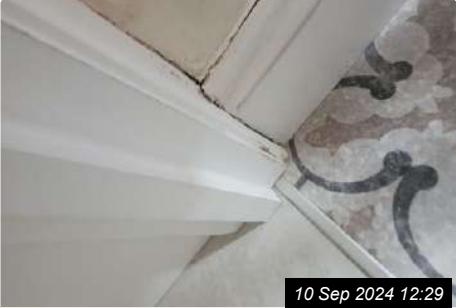
| 18. SHOWER ROOM (CONT.) | | | |
|---|---|---|---|
| 18.1<br> | Door/ Frame/<br>Threshold | White painted wooden four panel door with grey metal knobs;<br><br>White painted wooden frame;<br><br>Grey metal transverse strip | Good condition, consistent with age and use;<br><br>Light damage/ marking to low level frame exterior |

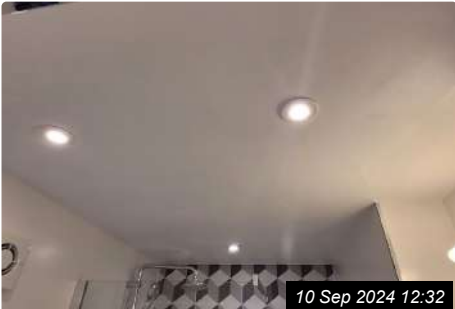
| 18. SHOWER ROOM (CONT.) | | | |
|---|---|---|---|
| 18.2<br> | Ceiling | Smooth white painted | Good condition |

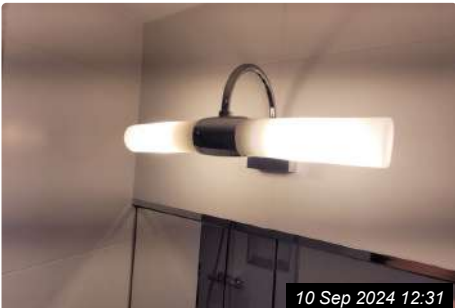
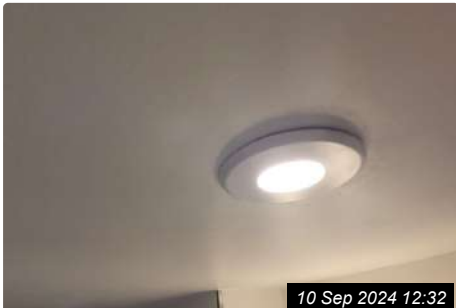
| 18. SHOWER ROOM (CONT.) | | | |
|---|---|---|---|
| 18.3<br> | Lighting | Three inset spotlights with white plastic surrounds;<br><br>grey metal fitting with two translucent shades | Good working order |

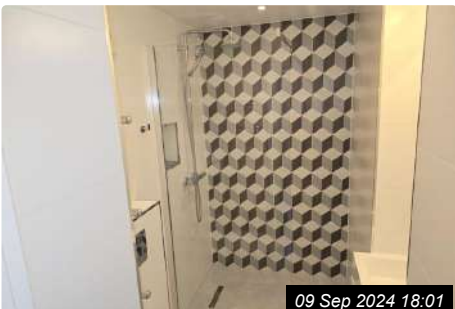
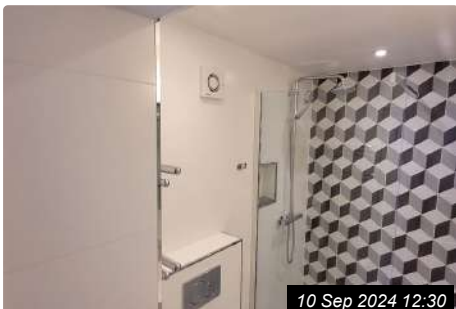
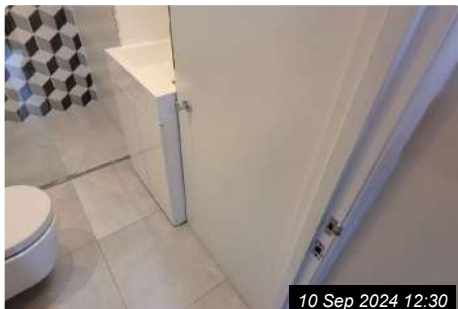
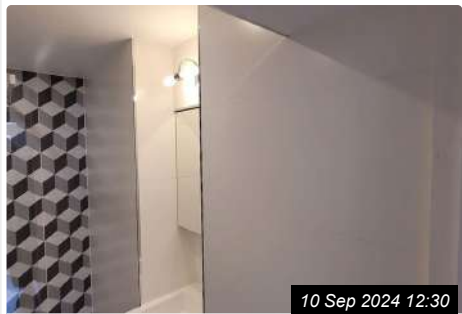
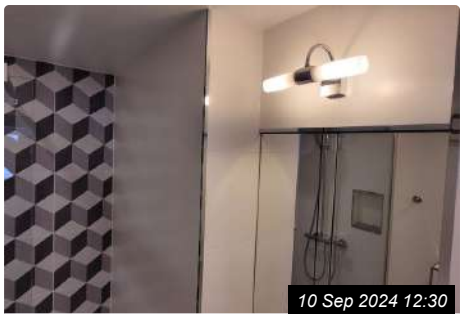
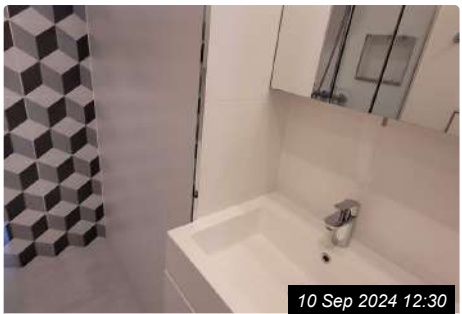
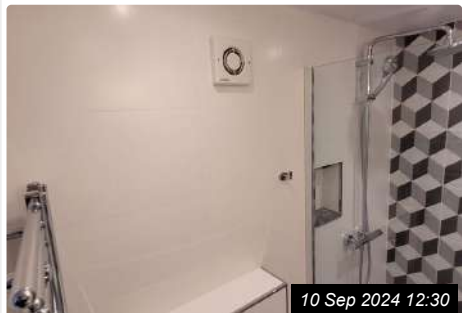
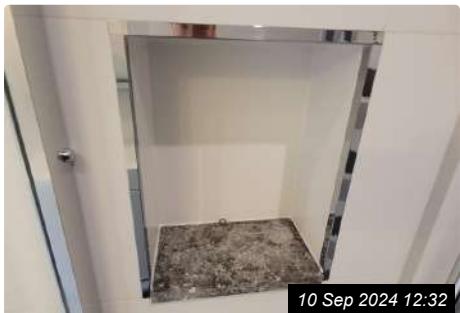
| 18. SHOWER ROOM (CONT.) | | | |
|---|---|---|---|
| 18.4<br> | Walls / Skirting | Large white ceramic tiles with white grouting;<br><br>Rectangular black/ grey/ white cuboid patterned tiling with white grouting to far wall;<br><br>Inset grey stone shelf to shower area with reveal to match walls and chrome effect metal trim | Good clean condition;<br>Intact |

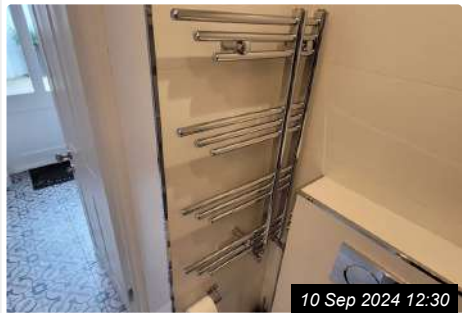
| 18. SHOWER ROOM (CONT.) | | | |
|---|---|---|---|
| 18.5<br> | Heating | Grey metal heated towel radiator | Good clean condition;<br>Untested |

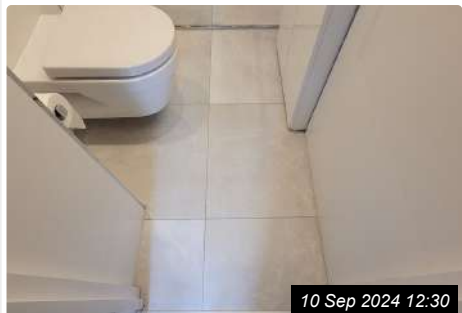
| 18. SHOWER ROOM (CONT.) | | | |
|---|---|---|---|
| 18.6<br> | Flooring | Off white stone effect square tiling | Good condition |

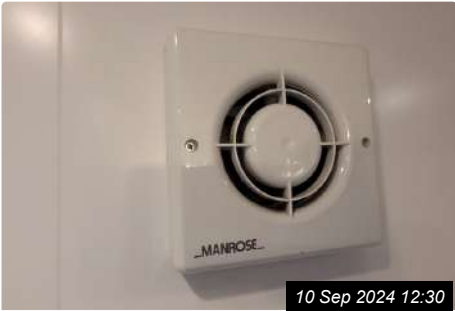
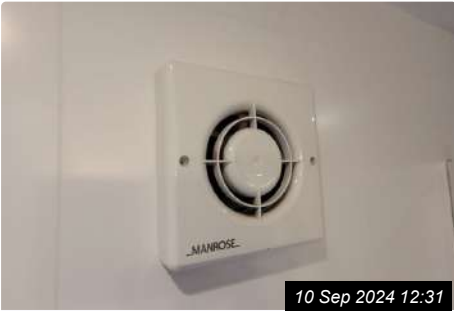
| 18. SHOWER ROOM (CONT.) | | | |
|---|---|---|---|
| 18.7<br> | Extractor fan | White plastic | Good working order |

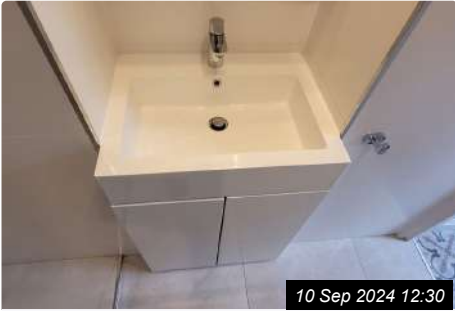
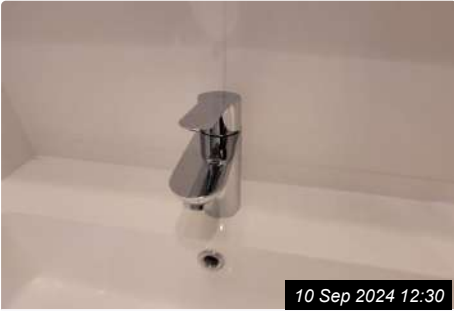
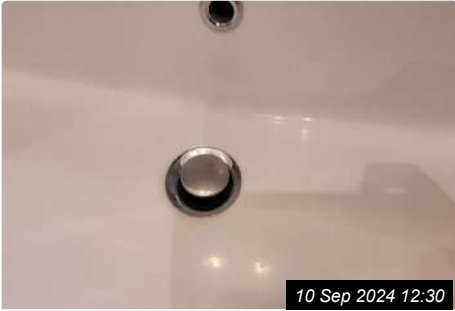
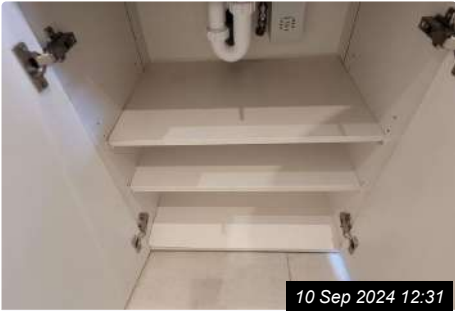
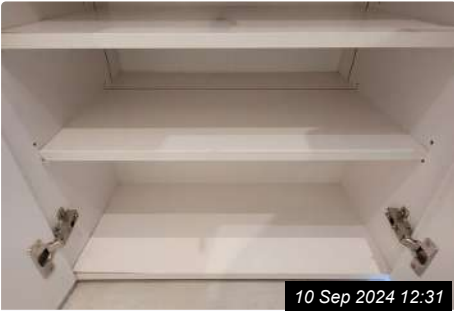
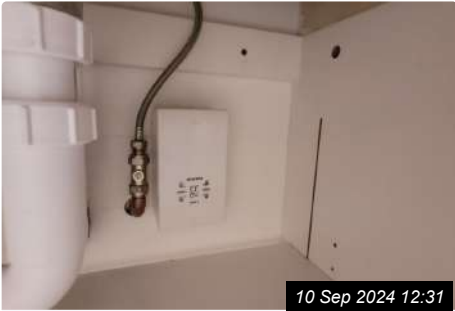
| 18. SHOWER ROOM (CONT.) | | | |
|---|---|---|---|
| <div>18.8</div> <div>📷</div> | Basin | <div>Rectangular white ceramic sink with Chrome effect metal mixer tap, push plug and overflow cover;</div> <div>White laminate underbase cupboard with 2 doors; Interior to match with 3 shelves;</div> <div>White plastic shaving socket to upper RHS interior</div> | <div>In good clean working order</div> <div>Light laminate peel to interior shelf edges</div> |

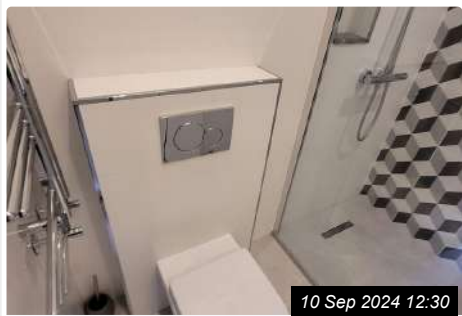
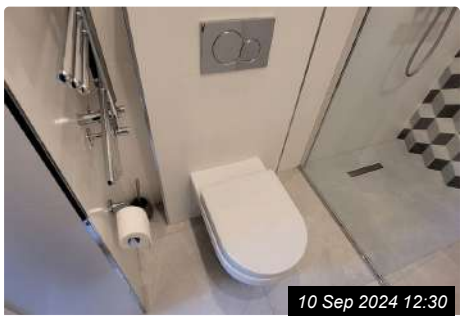
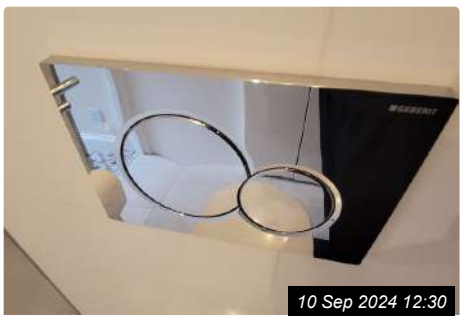
| 18. SHOWER ROOM (CONT.) | | | |
|---|---|---|---|
| <div>18.9</div> <div>📷</div> | Toilet | <div>White ceramic toilet with hidden cistern;</div> <div>White plastic toilet seat and lid;</div> <div>Chrome effect two button flush</div> | <div>Good clean working order</div> |

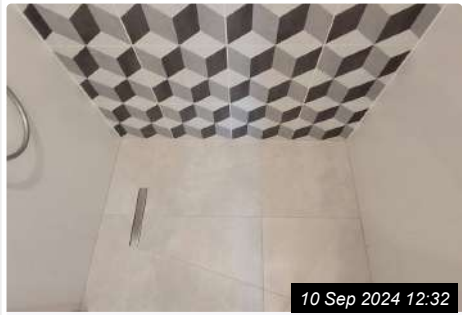
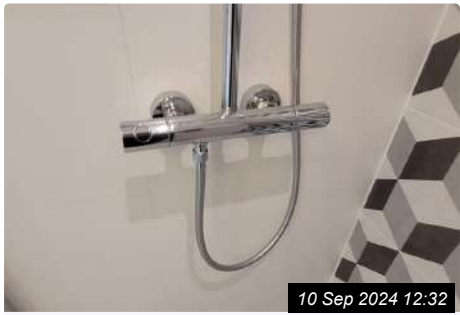
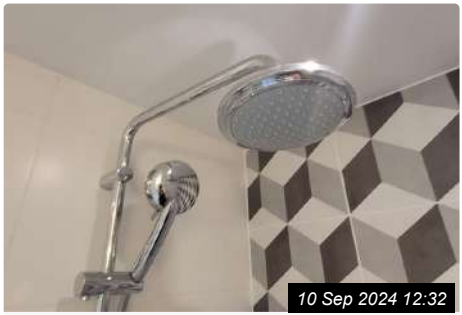
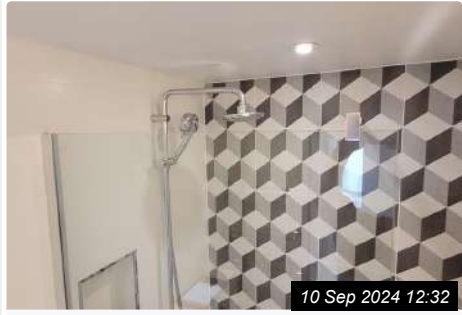
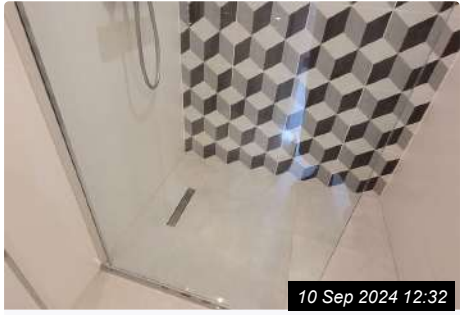
| 18. SHOWER ROOM (CONT.) | | | |
|---|---|---|---|
| 18.10<br> | Shower unit/ area | Chrome effect metal frame;<br>Clear glass pane;<br>Grey metal fitted and standard shower head with wall mounted controls;<br>Base to match flooring with Linear drain | Dust to top of fixed shower head;<br>Otherwise in good clean condition |

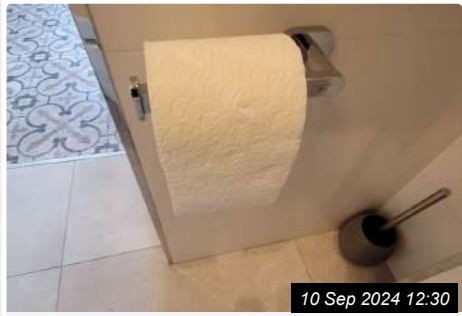
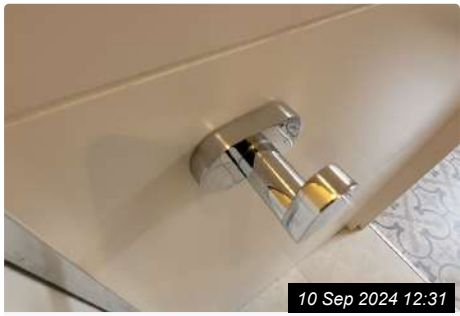
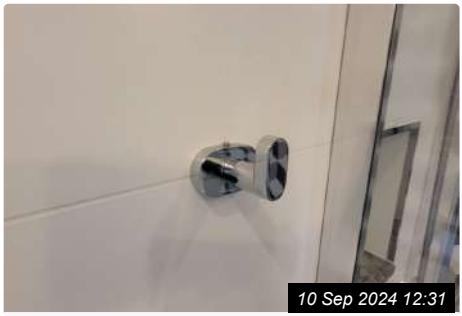
| 18. SHOWER ROOM (CONT.) | | | |
|---|---|---|---|
| 18.11<br> | Accessories | Two chrome effect metal towel hooks;<br><br>Chrome effect metal toilet roll holder | all In good clean condition/ working order |

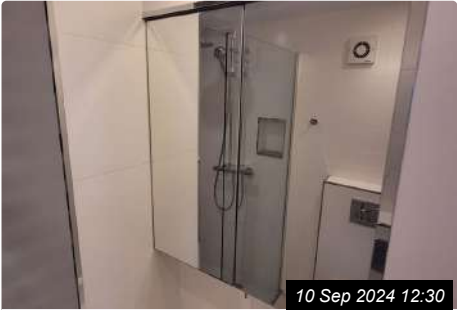
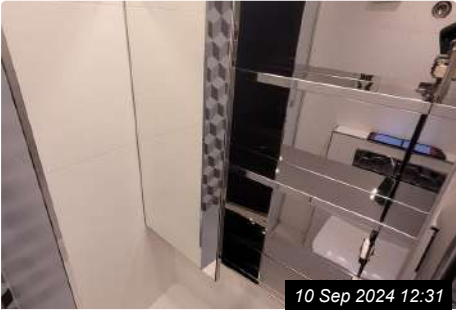
| 18. SHOWER ROOM (CONT.) | | | |
|---|---|---|---|
| 18.12<br> | Furnishings | Wall mounted vanity unit with glass mirror fronted doors;<br>Grey metal interior with 2 shelves | Appears in a good clean condiiton;<br>intact;<br>Light marking/scratching to interior |

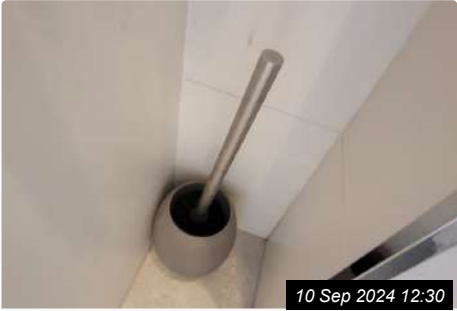
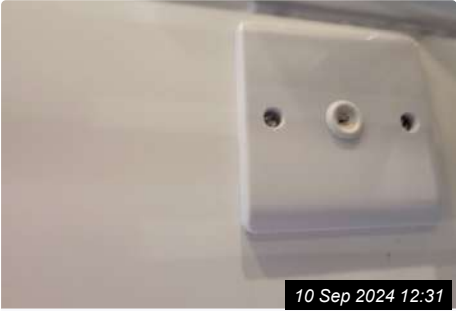
| 18. SHOWER ROOM (CONT.) | | | |
|---|---|---|---|
| 18.13<br> | Additional items | White plastic electrical cover;<br><br>Grey metal and black plastic toilet brush | Missing wire;<br><br>Unchecked |

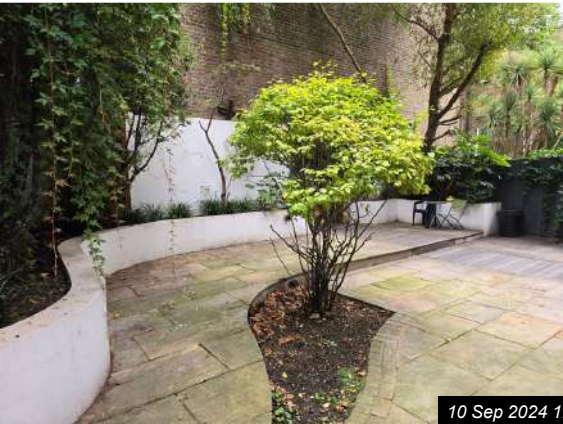
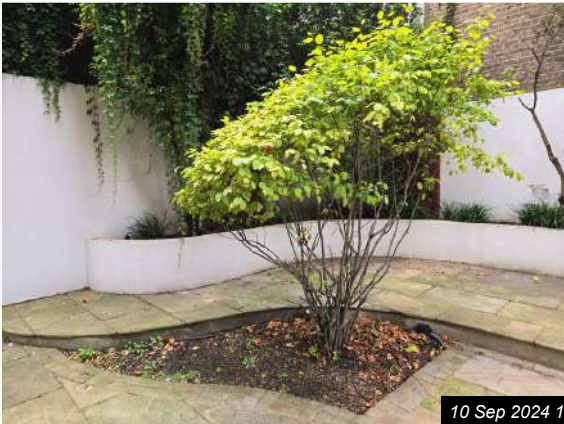
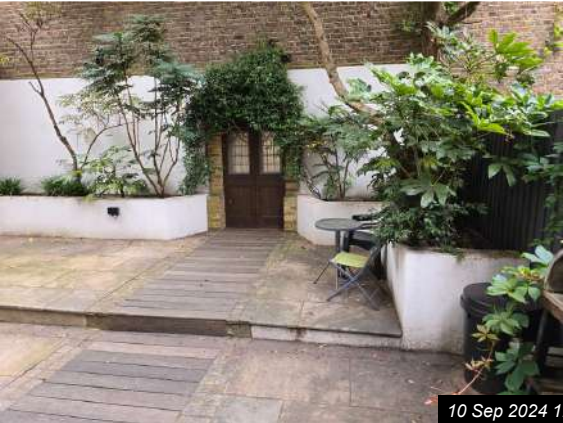
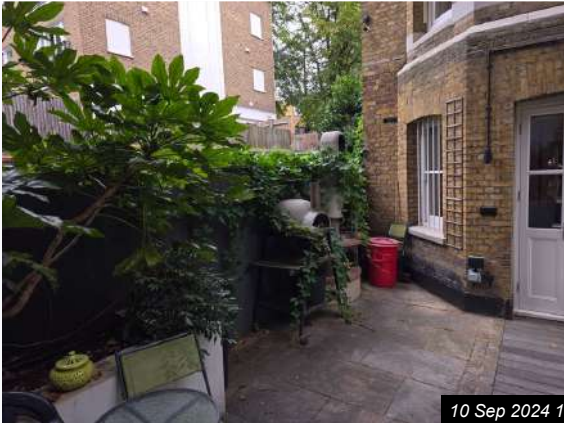
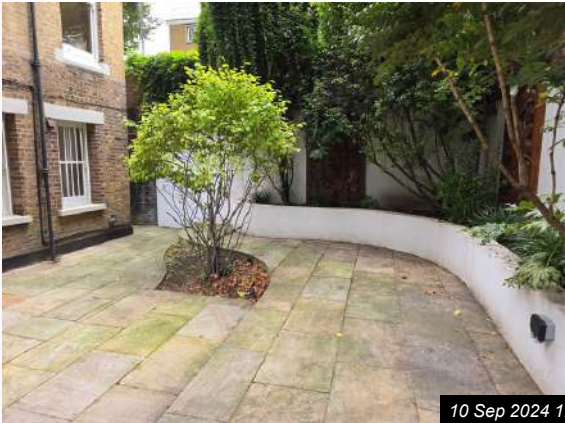
| 19. EXTERIOR REAR (CONT.) | | | |
|---|---|---|---|
| <div>19.1</div> <div>📷</div> | Rear garden | <p>1- Light brown paved garden area with wooden decking leading out from bedroom 1; White painted render to raised beds at edges containing various trees and shrubs; Bed to centre containing shrub; Brown wooden double doors to neighbouring property at far side;</p> <p>2- Passageway leading between two garden sections is exposed brickwork, white painted to top with paving to match</p> <p>3- Courtyard style garden when exiting from utility room with Light brown paving; Access to gym room; Black metal stairs leading to street level with matching gate at the top</p> | <p>Good seasonal order;<br/>Discolouration to paving;<br/>Trees and shrubs well tended;<br/>Stairs in good condition</p> |

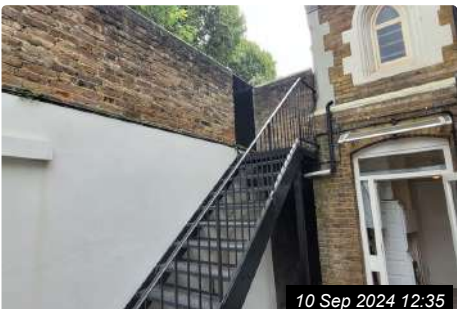
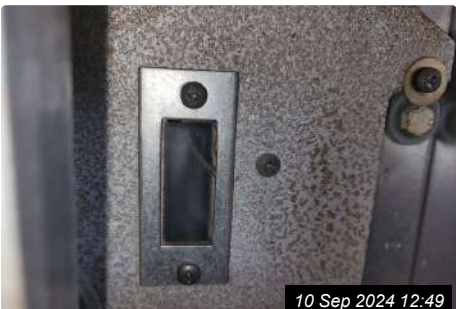
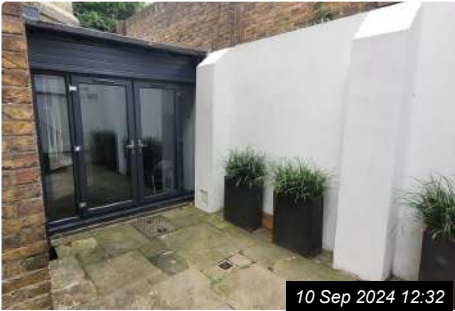
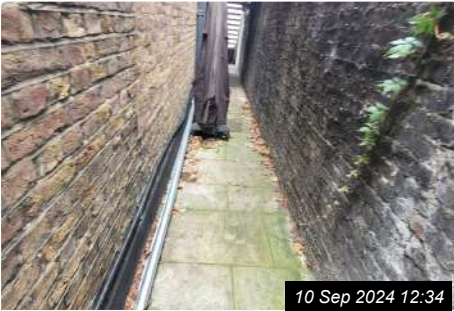
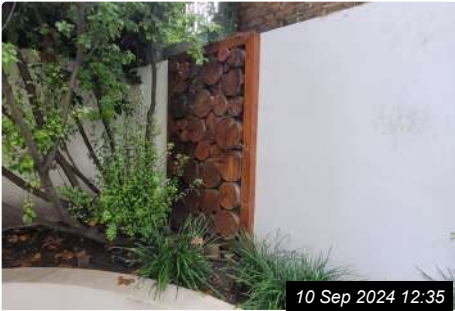
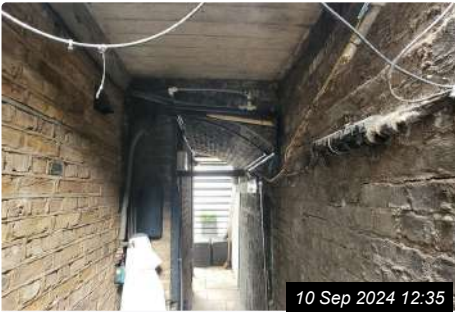
| 19. EXTERIOR REAR (CONT.) | | | |
|---|---|---|---|
| 19.2 | Boundaries | A mixture of white painted render and exposed brickwork;<br>Brown wooden log style feature to LHS of far wall when exiting bedroom 1 | Good condition;<br>Some wear and discolouration to exposed brick parts |

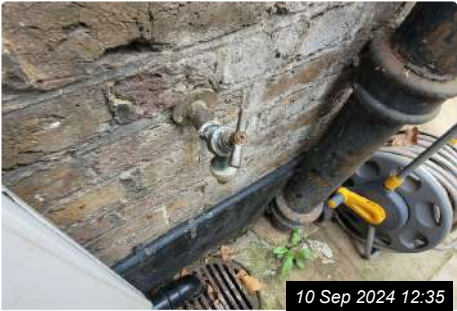
| 19. EXTERIOR REAR (CONT.) | | | |
|---|---|---|---|
| 19.5 | Additional items/<br>Information | Brass outdoor tap;<br><br>2 grey and black plastic double sockets/ covers;<br><br>White plastic security camera;<br><br>2 Black sensor lights;<br><br>2 ceramic wall plaques with elephants on | Items untested ;<br>Appear in reasonable condition for use |

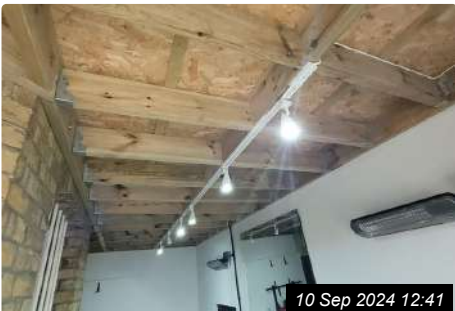
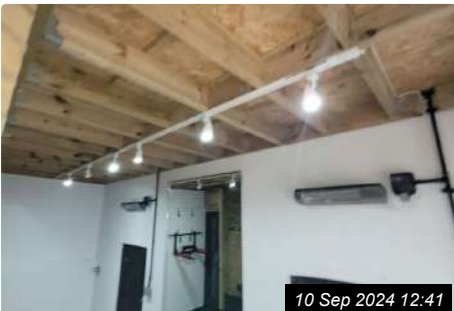
| 20. GYM OUTBUILDING (CONT.) | | | |
|---|---|---|---|
| 20.3 | Ceiling | Exposed timber roofing. | In good clean condition |

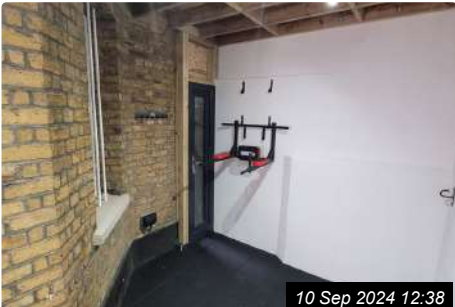
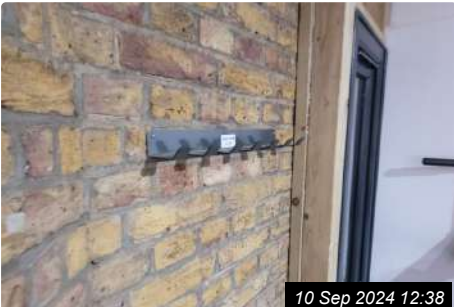
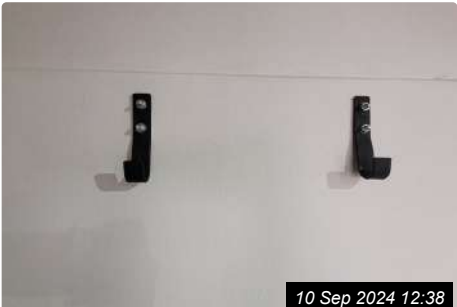
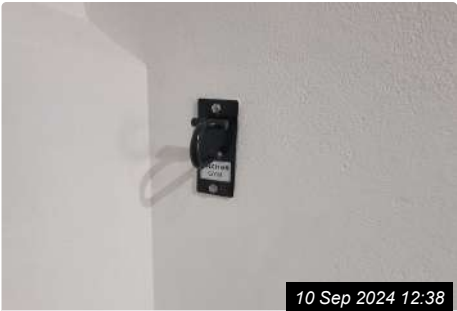
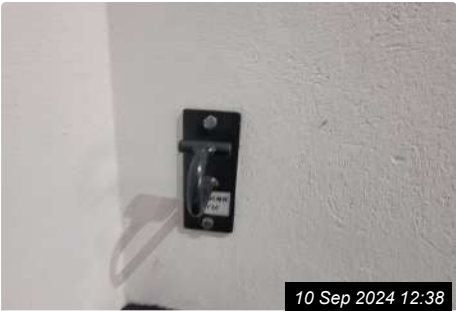
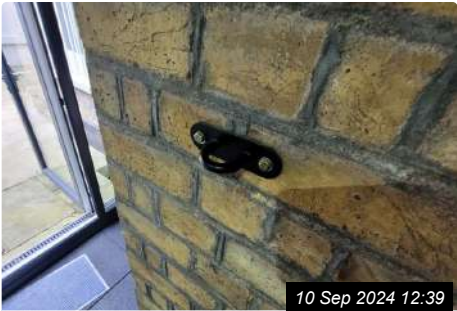
| 20. GYM OUTBUILDING (CONT.) | | | |
|---|---|---|---|
| 20.5 | Walls / Skirting | Part exposed brick<br>Part textured white plaster<br>Part wooden stud walling | All intact and in good condition. |

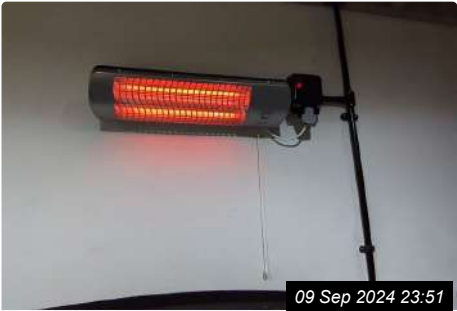
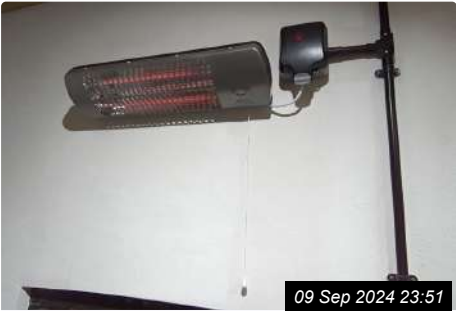
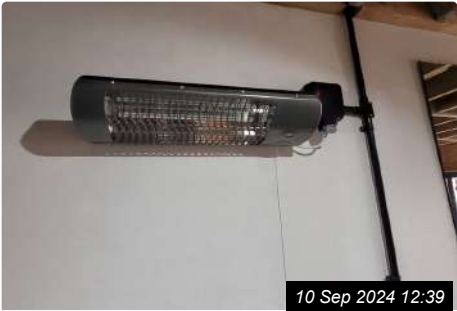
| 20. GYM OUTBUILDING (CONT.) | | | |
|---|---|---|---|
| 20.6 | Heating | Two wall mounted infrared heaters, brushed metal effect. | Tested working |

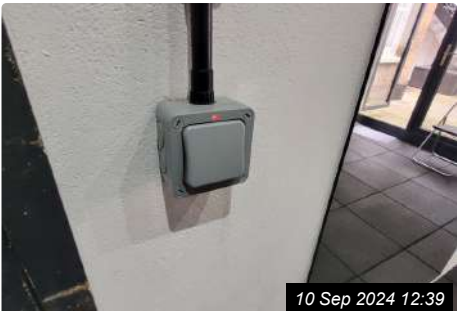
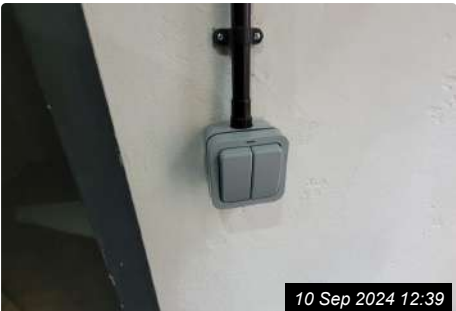
| 20. GYM OUTBUILDING (CONT.) | | | |
|---|---|---|---|
| 20.7 | Switches / Sockets | Gray plastic :<br><br>One single switch<br>One double switch<br><br>Five double sockets with black plastic cover.<br>Two single sockets with black plastic cover | Double grey plastic switch not working to one side;<br><br>Sockets untest but appear in good condition |

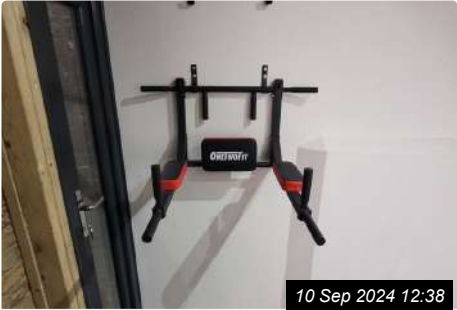
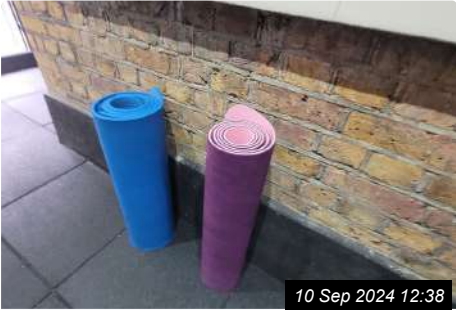
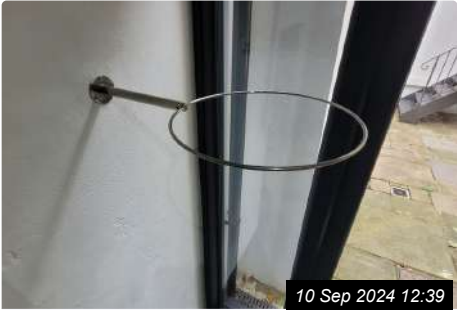
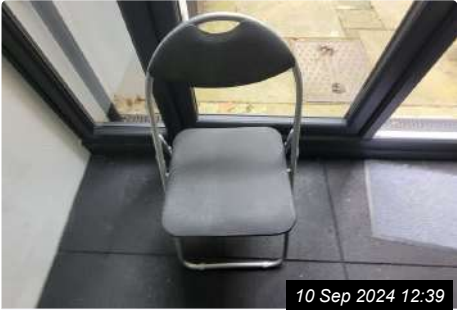
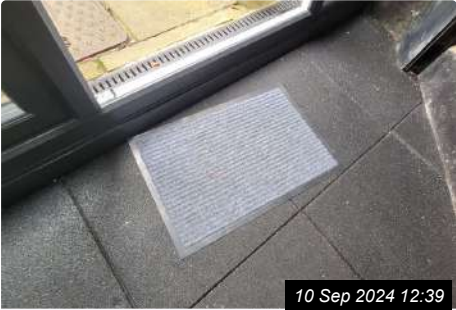
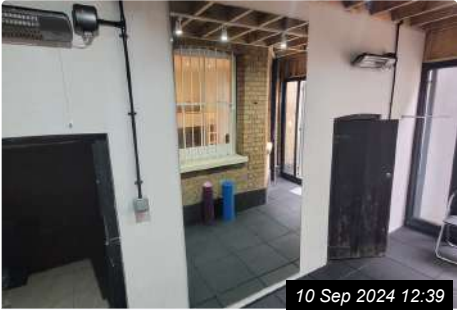
| 20. GYM OUTBUILDING (CONT.) | | | |
|---|---|---|---|
| 20.9 | Additional items | <div>An assortment of household spares</div> <div>One gray fabric and rubber edged doormat</div> <div>Two yoga mats, one blue, one pink and purple</div> <div>One large black metal bar with mounting points</div> <div>A small selection of unassembled boxes</div> <div>Large wall mounted unframed mirror</div> <div>Chrome wall mounted loop on post</div> <div>An assortment of hooks and loops for gym equipment</div> | <div>Door mat in good condition;</div> <div>Yogo mats in good used condition;</div> <div>Mirror is in good clean condition;</div> <div>metal loop is in reasonable condition</div> |

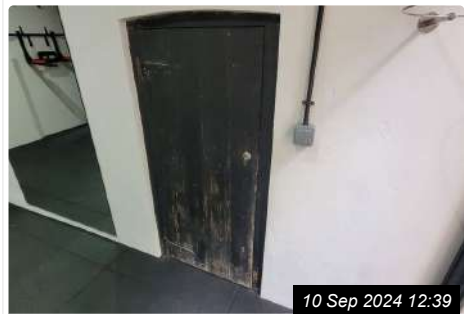
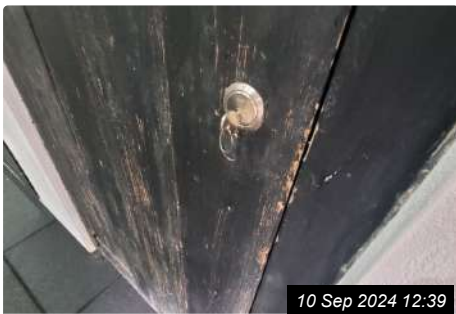
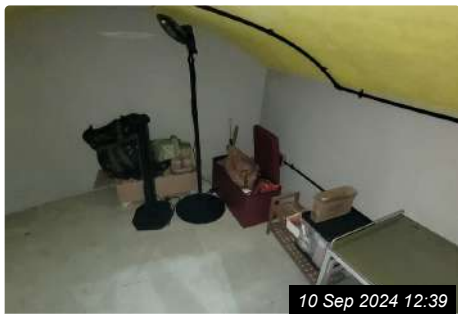
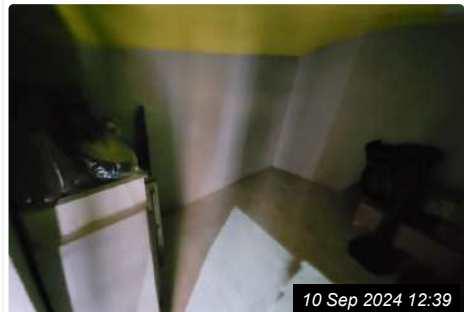
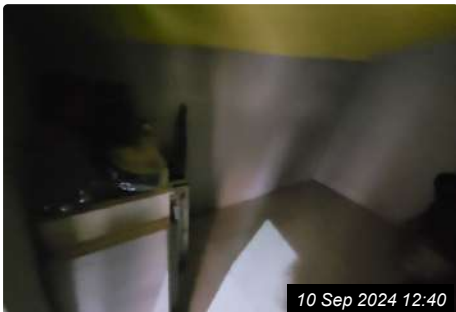
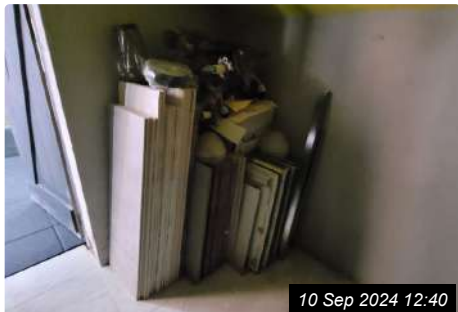
Ref # 20.11

| 20. GYM OUTBUILDING (CONT.) | | | |
|---|---|---|---|
| 20.11 | Built-In cupboards | To built-in cupboards with black wooden doors, both with Yale style locks<br>Internally flooring is stone tile<br>Gray plastered walls<br>Orange painted plastered ceiling to left<br>Yellow painted plastered ceiling to right | There appears to be damp within both cupboards. Plaster has visible water markings and there is a damp smell within<br><br>Otherwise in good use, order and doors are in good condition with locks working keys in locks; ;<br><br>No light to storage cupboard with orange ceiling |
