OnPoint Property Inspections, LLC

Home Inspection Report

117 Callee Dr

Inspected on Wed, Jun 2 2021 at 9:49 PM

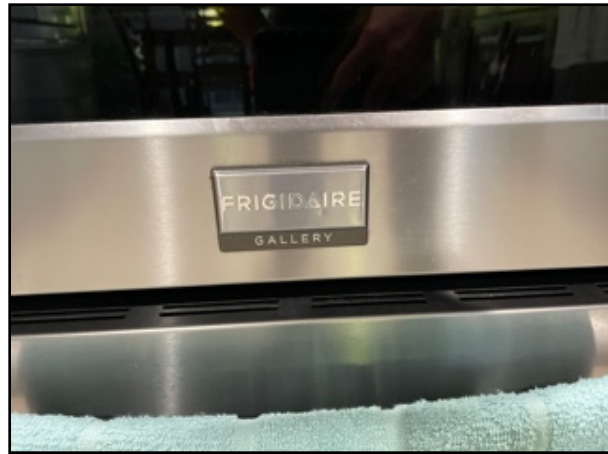
Comment 6:

Anti-tip was not installed. Recommend having the anti-tip device installed for child safety.

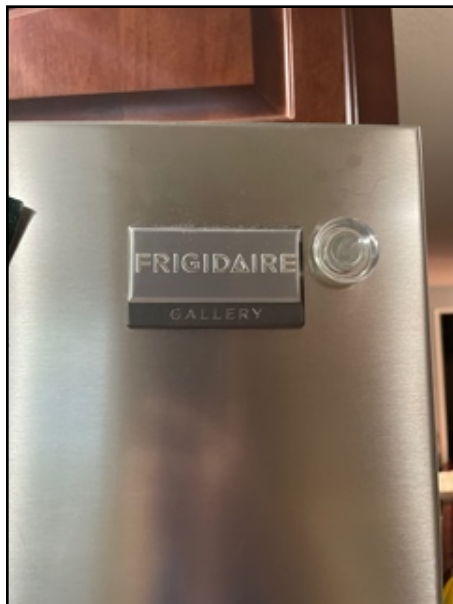
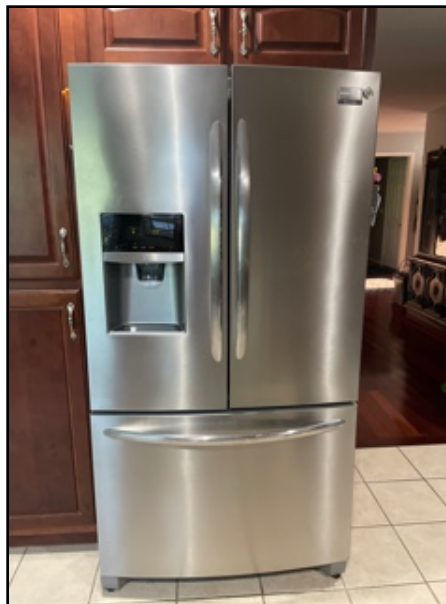
Comment 7:

Please note, as it states in our agreement, we do not fully evaluate Refrigerators. Upon the visual only inspection it appeared to be in Satisfactory condition at the time of Inspection.

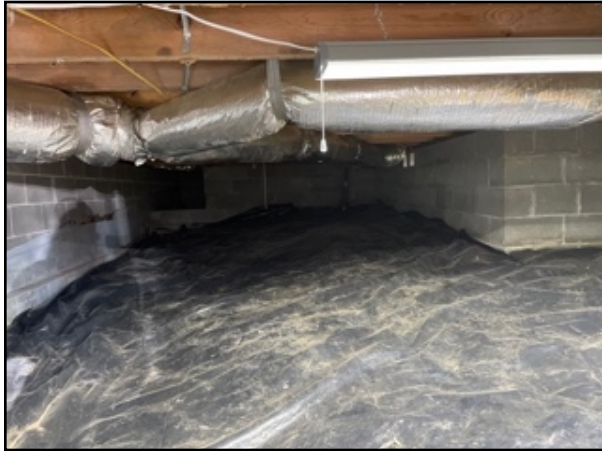
Figure 25-1

Crawl Space was properly vented. Vapor barrier was Satisfactory. Observed a sump pump perimeter drain system. Sump pump functioned properly when tested.
