**Property Inspection Report**

**10 Estrada St.  
Sunnyvale, CA 94087**

**May 30, 2025**

**Prepared for: Happy Homeowner**

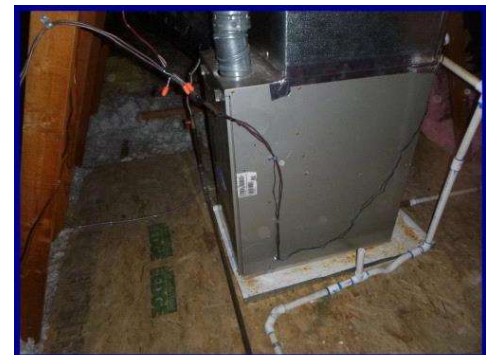
**HVAC view**

This appliance is located in the attic, controlled by a wall thermostat.

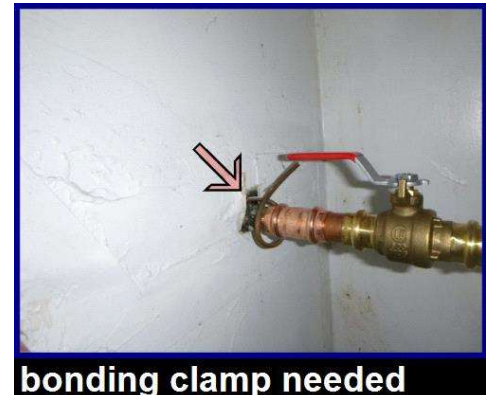
This appliance is located in the garage. The first 5 feet of (both cold and hot) piping at any water heater in an unheated area should be fully insulated for energy efficiency, in accordance with current California Energy Standards. **Pipe insulation improvement is suggested here.** (This pipe insulation must have mitered elbows, notched tees and sealed seams.)

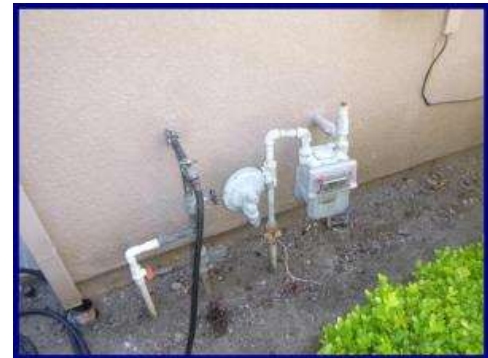
**Rust is noted at the gas piping connections at the rear exterior - see photo.** No gas smell was detected, but we did not test with any specialized equipment. For enhanced safety / peace of mind we suggest review of this gas pipe section by a gas company representative.

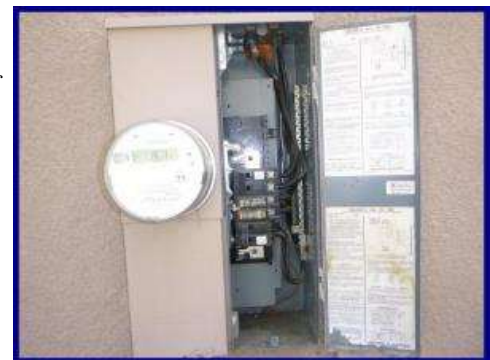
The electrical service panel / meter is located at the exterior of the dwelling. The electrical service panel / meter is located at the exterior of the garage. *Power company anti-tamper seal is needed at the utility side of the meter.* We suggest notifying the power company so they can install a new seal.

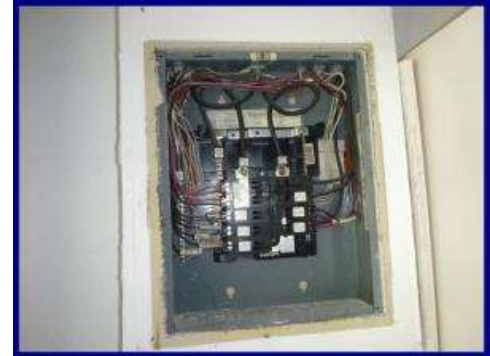
This electrical equipment panel is located in the garage. Circuits are completely and clearly labeled. Our inspection does not verify the accuracy of this legend.

Circuit and wire sizing correct so far as visible. We believe that the panel enclosure components are correctly bonded.
