**Commercial & Residential Inspections**

**Property Inspection Report**

**268 Country Road  
Calabasas, CA 91302**

**September 29, 2024**

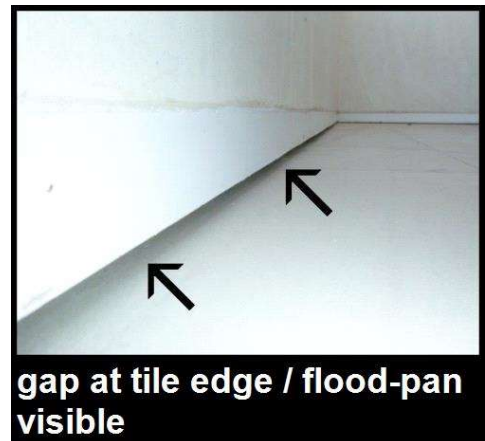
**Several of the balconies are not sealed at the (outer) railing edge. There is a visible gap at the edge of the tile - see photo.** We advise review and correction in accordance with current building standards by a qualified tradesperson / balcony-deck specialist. We imagine that this would be sealing with an exterior-grade caulking or, ideally, a tile mortar mix.

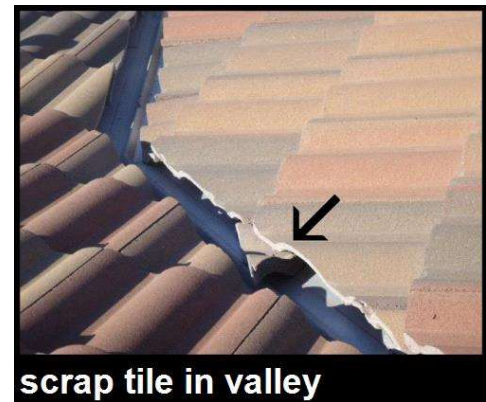
The field of the sloped roof covering appears to be in good condition / well within the expected useful service life. **Note:** Roof pitch of 2:12 or less (which is present at three or more areas of this roof) is not usually associated with a tile installation unless a rubber or double underlayment is used, which did not determine. Inquiry with the builder or as approved plans may be informative.

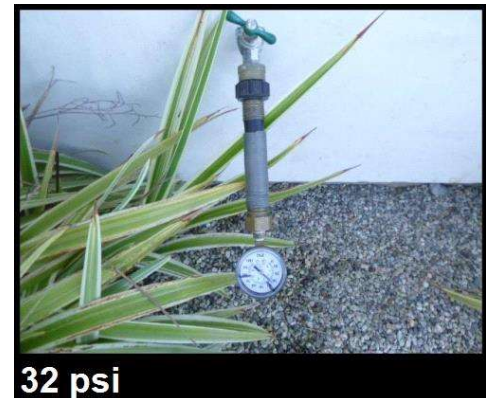
The potable water supply pressure was tested by us at exterior faucet. **The potable supply water pressure was rather low (approx. 32 psi).** The generally accepted range for residential water pressure is 40-75 psi. This can usually be easily adjusted at the water pressure regulator, which is present at this home.

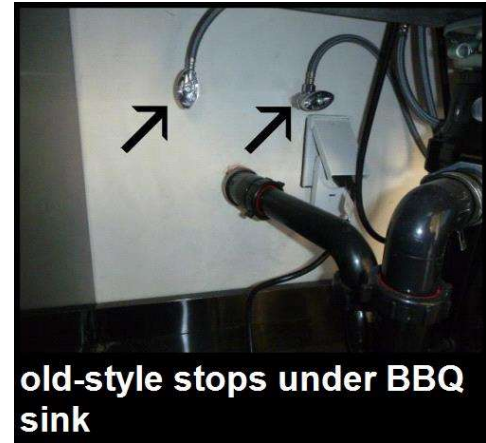
Copper make ups the majority of the supply plumbing. PEX (cross-linked polyethylene) lines were seen in one undersink location. **Older-style water shutoff valves noted at the BBQ sink.** Consider proactive replacement with modern-style 1/4-turn shutoff valves as they are more reliable.

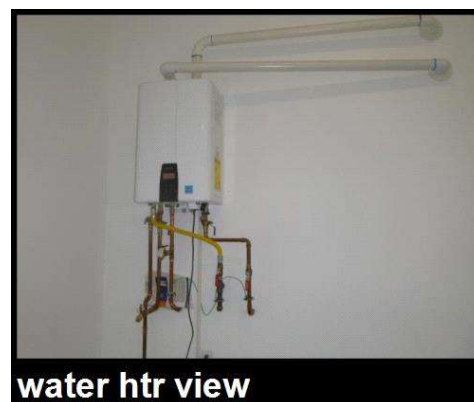
The first 5 feet of (both cold and hot) piping at any water heater in an unheated area should be fully insulated for energy efficiency, in accordance with current California Energy Standards. **Pipe insulation is suggested.** (This pipe insulation must have mitered elbows, notched tees and sealed seams.)

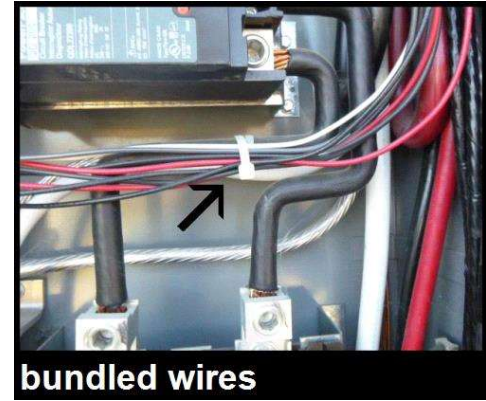
Grounding system is present. Circuit and wire sizing correct so far as visible. The important panel bonding connection is present. **Excess paper (insulative wire wrapping) is present inside this panel** - which should be safely trimmed / removed to reduce hazard from any wire sparking.

**Some wires are arranged in a bundle inside this panel.** This can cause heat to build up in the wiring and the ampere rating of the wires is reduced. We suggest simple un-bundling of these wires for in accordance with intended design and standard building practice.

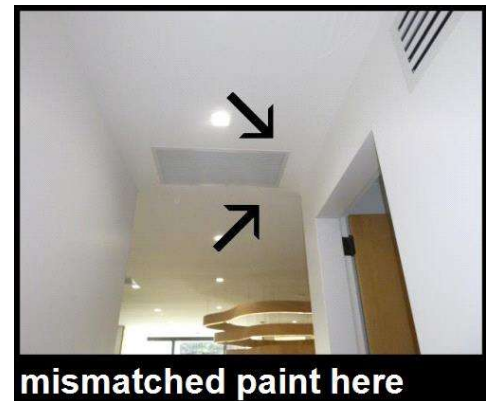
The visible portions of the walls and ceilings are in generally very good condition. There was a poorly finished wall repair at the upstairs (rear hall) HVAC thermostat. **An area of mismatched paint is noted at the upstairs rear hallway ceiling (near a air filter opening) and there are several areas of mismatched paint is noted at the exterior patio ceiling.** Inquiry with the seller may be informative. Stored items or furnishings prevented full inspection. We suggest a careful examination by interested parties once full viewing is possible.

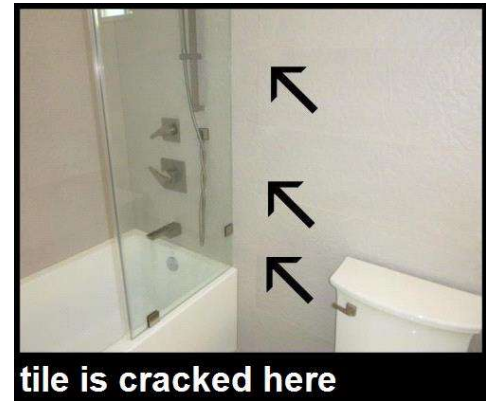
**There is a long vertical crack at the wall tile (just outside the shower enclosure).** We suggest review and repair by a qualified tradesperson and then monitoring this area over time. Inquiry with the builder may be informative.

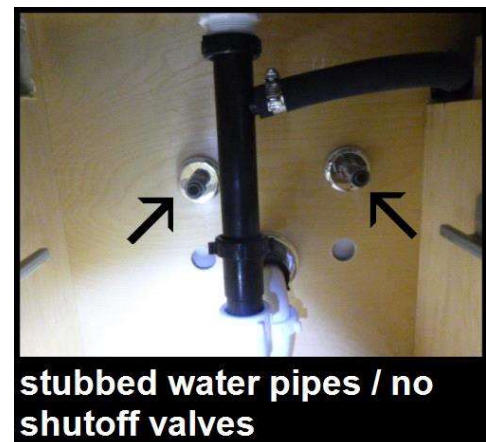
We inspected the sink including the drain trap and fixtures. **The faucet (cold water control) is loosely mounted. Valve stops are not present at this sink as we usually expect to see.** A qualified plumber should make correction in conformance with current standards.

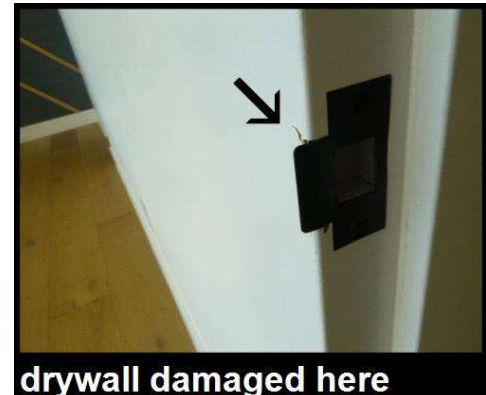
**This bathroom entry door does not latch properly (and the drywall is a bit damaged here).** Simple adjustment to the striker plate is needed.

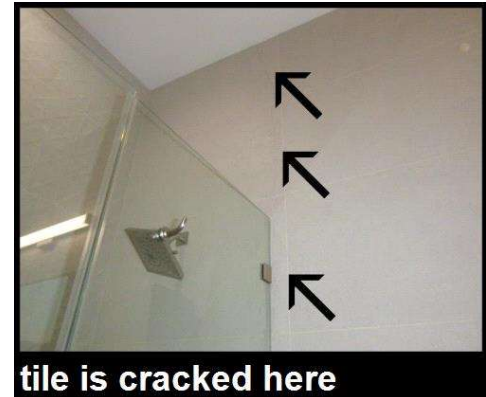
**There is a long vertical crack at the wall tile (just outside the shower enclosure).** We suggest review and repair by a qualified tradesperson and then monitoring this area over time. Inquiry with the builder may be informative.

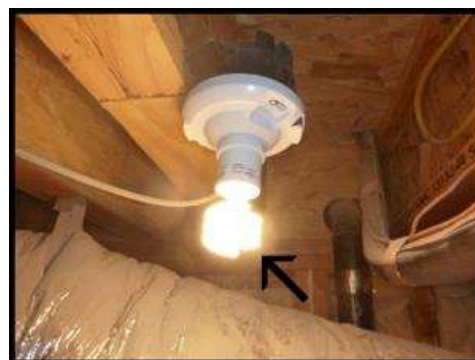
#### Photo #4

CFL light bulb in pantry attic = replace it with an LED bulb and a protective cage
