192 S Foster Street
Dothan, AL 36301
334-447-9405
Inspector: Buck Meyers

Table of Contents

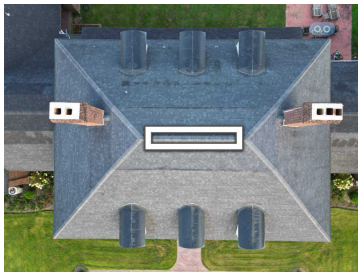
Satisfactory, Marginal Ventilation: Soffit vents, Ridge vents - No ridge vents installed at mansford roof above third floor. Recommend a licensed roofer install for proper ventilation.

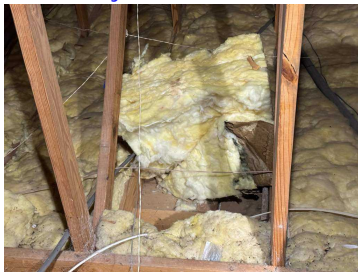
Satisfactory, Marginal Insulation: Batts - Some batts have been displaced. Recommend reinstalling for greater energy efficiency.

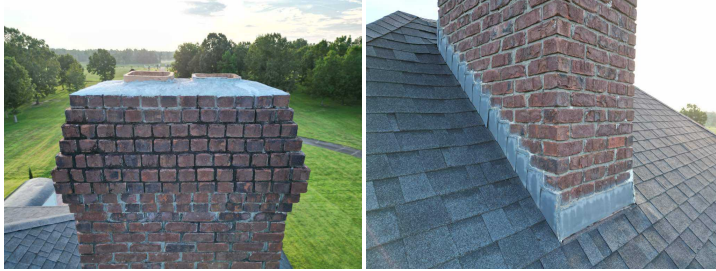
Satisfactory, Marginal Chimney: Brick - [Evidence of past tuck point repairs noted.](#)

[Recommend installing a screen/rain cap to prevent small animal/rain access to chimney flue](#)

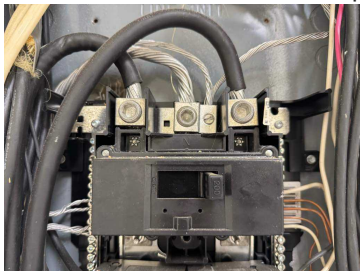
Satisfactory, Safety Hazard Manufacturer: Square D - **Partially labeled panel, recommend completely labeling in case of emergency.**

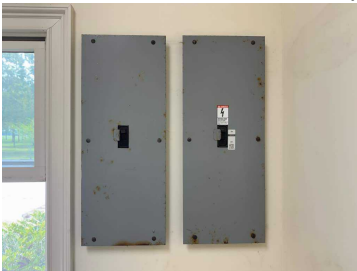
Safety Hazard Breakers: Copper and Aluminum - Double taps are present at breakers. These circuits need to be moved to their own circuit breaker and cannot share a breaker. It is recommended that a qualified electrical contractor evaluate the electrical, the new circuits and properly connect the new circuits to an individual breaker for each circuit.

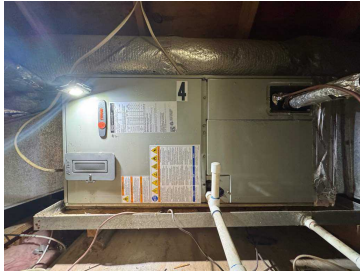
Satisfactory, Marginal Condensate Removal: PVC - No drain pan installed. Recommend installing.

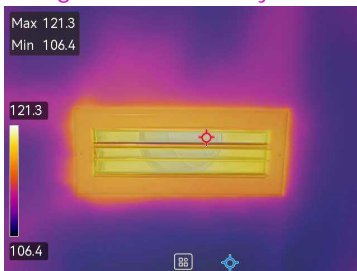
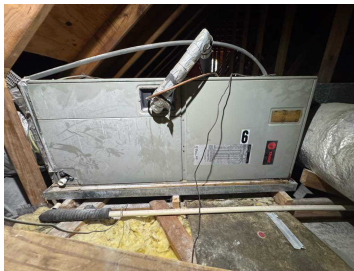
Poor HVAC System Operation: Recommend Service - **The unit is currently in service beyond the typical design life of 15-20 years. Recommend the unit be evaluated by a licensed HVAC company.**

Unit has reached or exceeded it's normal life cycle and may require replacement soon: Yes Unit is very old and should be evaluated by a licensed HVAC technician before closing so you have a good understanding of its condition.

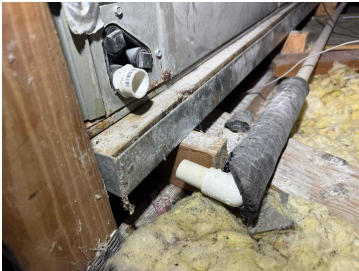
Condensate Removal: PVC - **Disconnected. Recommend repair by a licensed HVAC technician.**

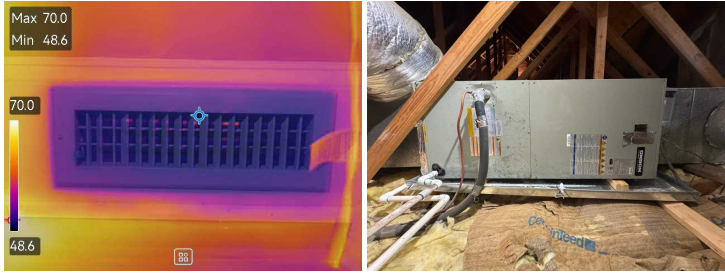
Satisfactory, Marginal Condensate Removal: PVC - Although not required, we recommend installing an overflow prevention switch in the condensation line to prevent future damage in the event of a clogged drain line.

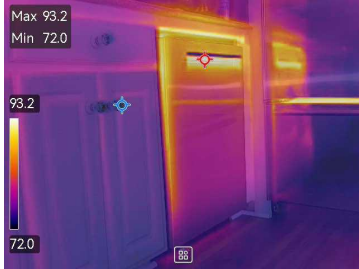
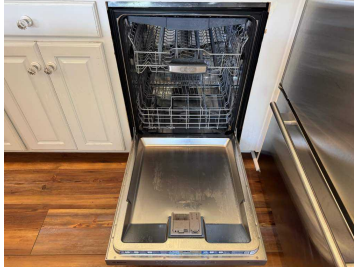
Satisfactory Dishwasher: Bosch

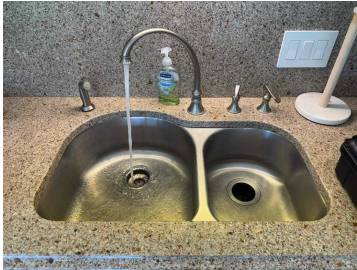
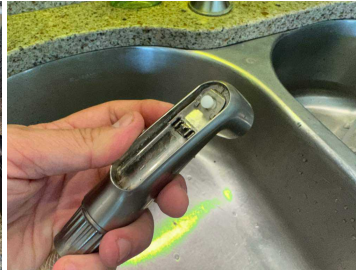
Satisfactory, Poor Sink & Fixtures: Stainless Steel - Sprayer handle is broken. Recommend repair.

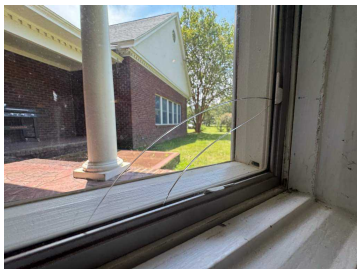
Satisfactory, Marginal Windows: Wood Casement - Broken glass noted. Recommend repair.

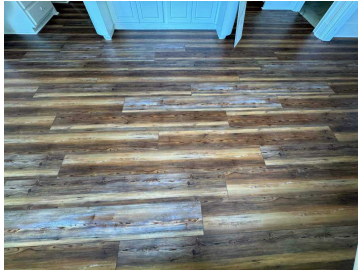
Satisfactory, Marginal Floor: Laminate / Vinyl floor covering. [Recommend installing threshold at pantry.](#)

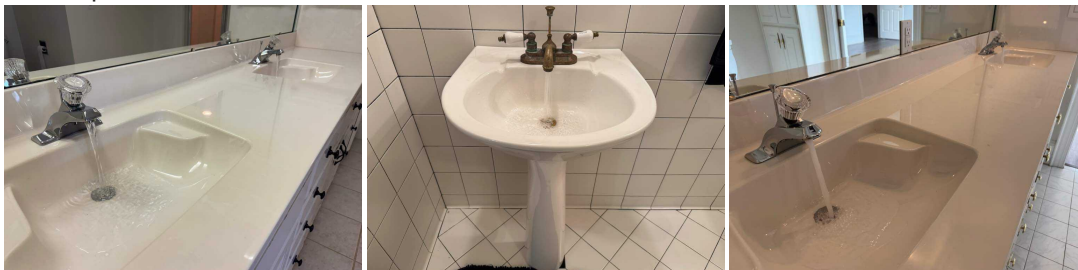
Sink / Basin His and Hers, Molded single bowl - Plumbing at right sink in south east bathroom was not inspected.

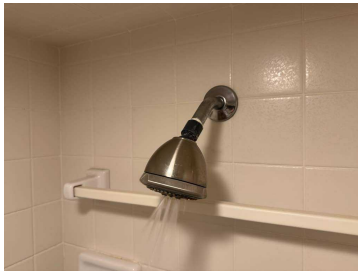
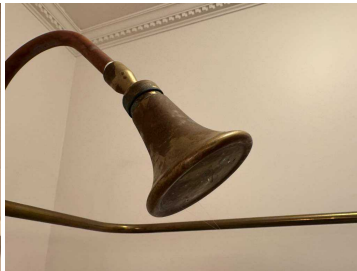
Satisfactory, Marginal Shower Plumbing Single handled faucet - [Recommend cleaning mineral deposits from showerhead in southeast bathroom and retesting.](#)

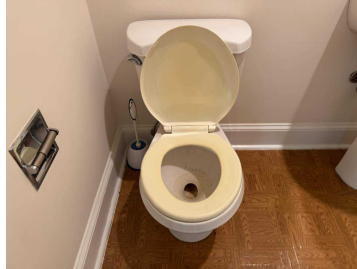
Toilets: (continued)

Satisfactory, Not Inspected, Marginal, Poor Toilets: Floor Mount - Toilets in Southwest in northeast bathroom did not function as designed. Recommend repair.

All toilets are loose in the flanges. Recommend securing to prevent potential damage to wax seal.

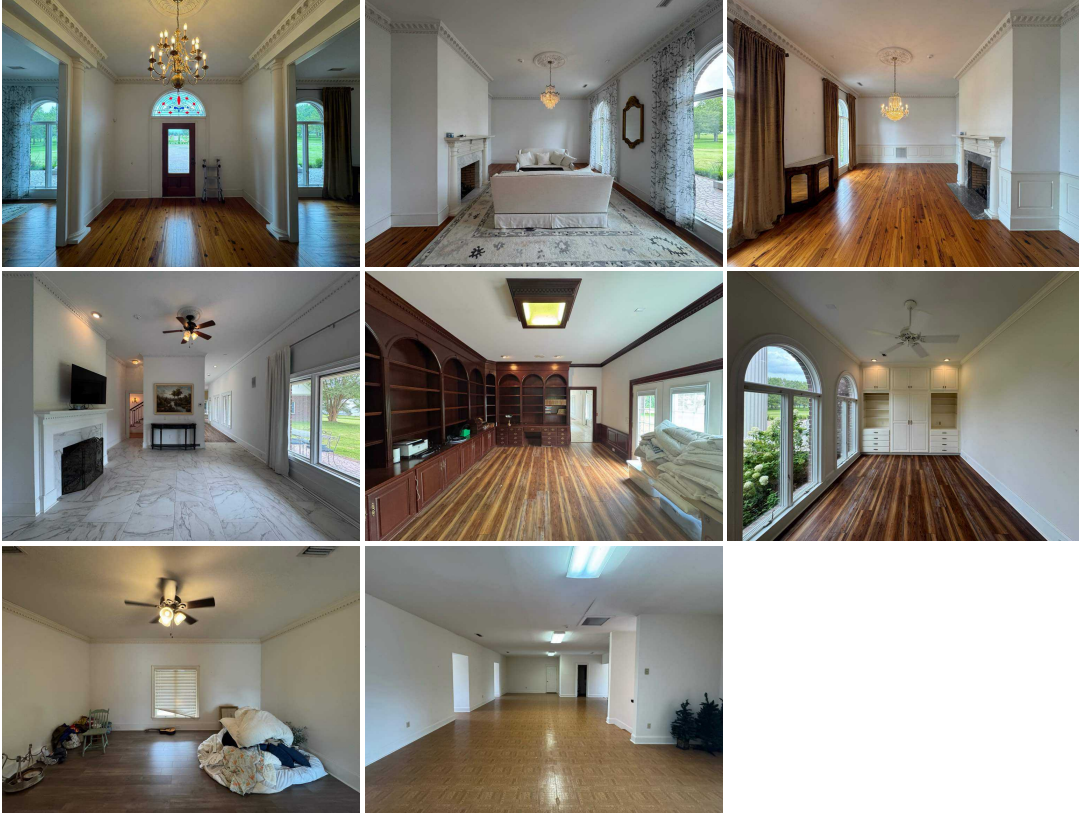
Satisfactory, Marginal Ceiling: Drywall - [Loose/failing drywall noted at third floor. Recommend repair.](#)

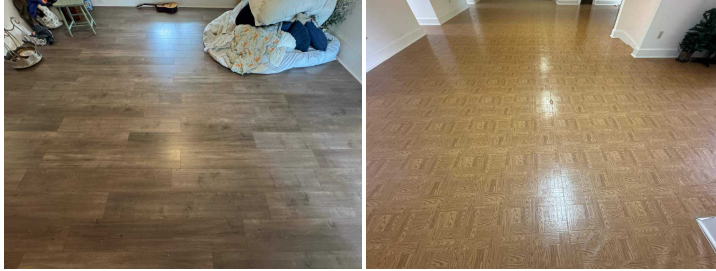
Floor: (continued)

Satisfactory, Marginal Floor: Wood, Tile, Laminate / Vinyl floor covering. [Recommend installing missing thresholds.](#)

[Large tears in linoleum flooring noted at third floor.](#)

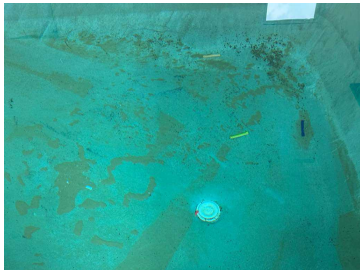
Cleanliness: (continued)

Satisfactory, Marginal Cleanliness: Needs to be cleaned - Sand present

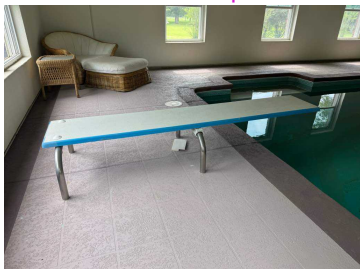
Not Inspected Diving Board: Fiberglass - Diving board is not within the scope of this inspection and is therefore not included in this report
