# Stone Creek Canyon HOA

## Level 1 Reserve Study

**Report Period – 01/01/2022 – 12/31/2022**

**Report prepared on – Tuesday, February 15, 2022**

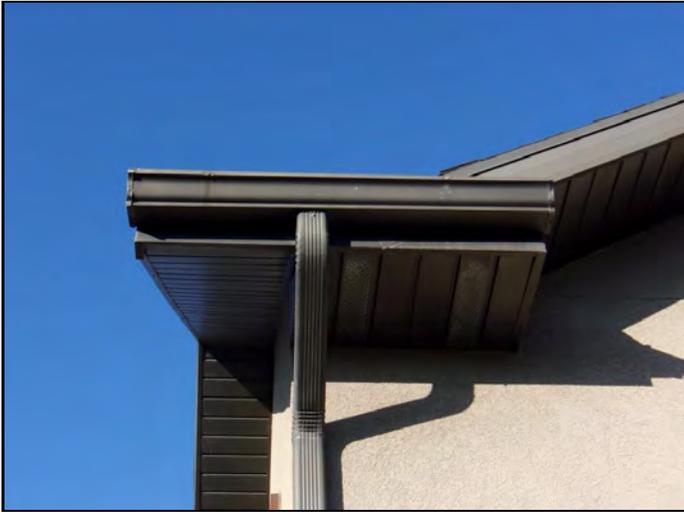
Comp #: 120 Rain Gutters/Downspouts - 2016-2019 - Replace

*Location:* **Building Exteriors**

*Quantity:* **Approx 6,225 Linear ft.**

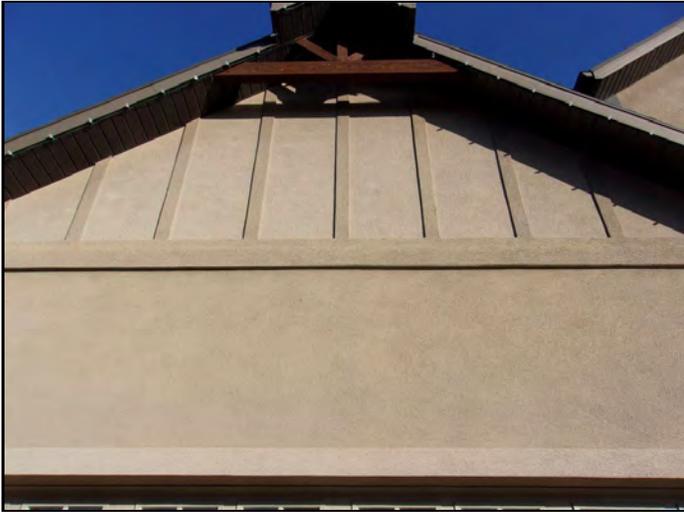
Comp #: 201 Stucco Surfaces - 2016-2019 - Repair/Repaint

*Location:* **Building Exteriors**

*Quantity:* **Approx 99,375 Sq.ft.**

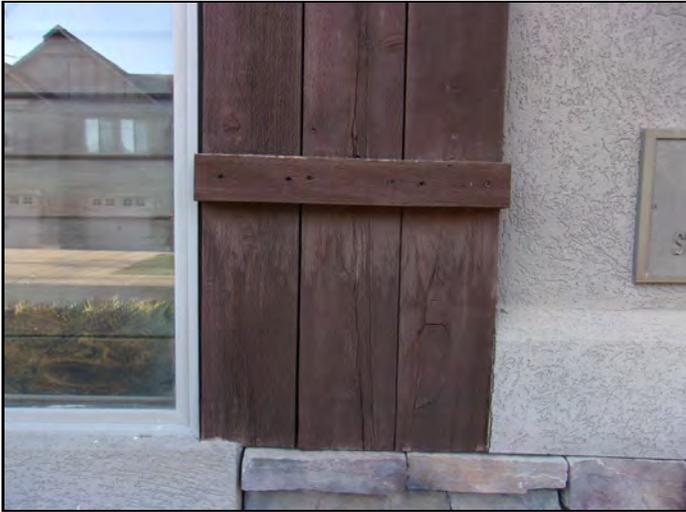
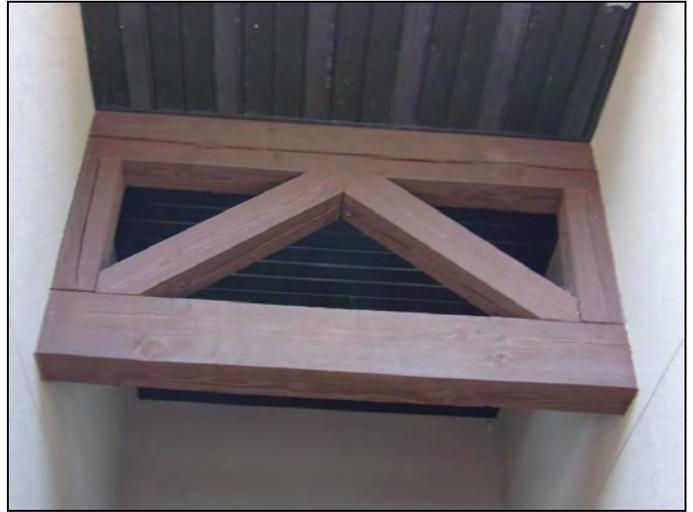
Comp #: 202 Wood Trim - Repaint

*Location:* **Building Exteriors**

*Quantity:* **(30) Buildings**

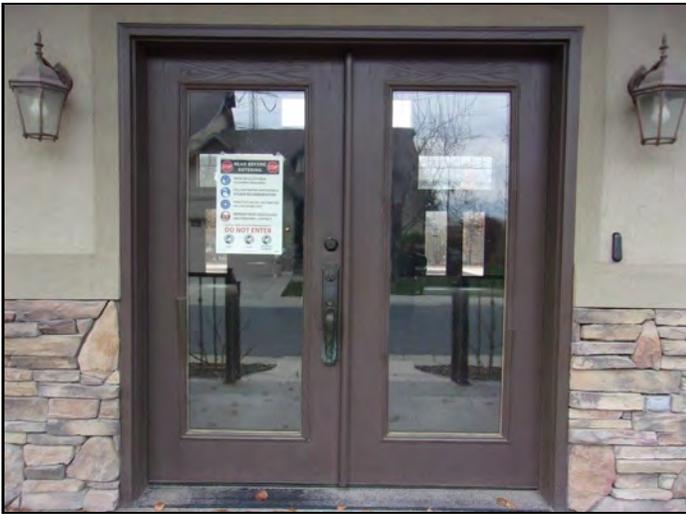
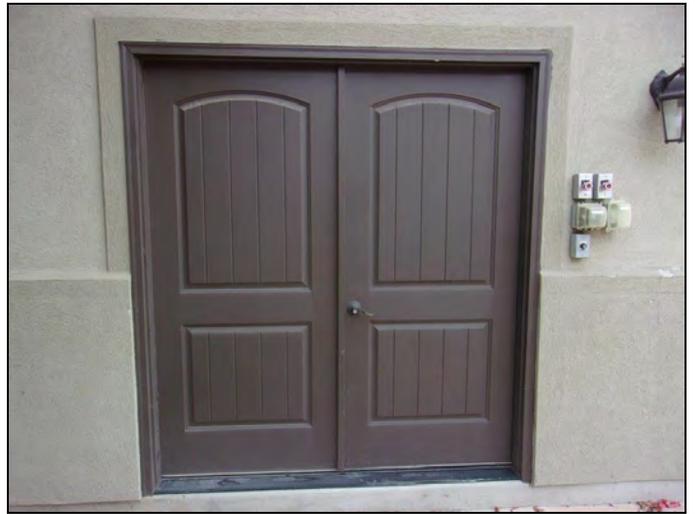
Comp #: 204 Doors - Clubhouse & Mail - Repaint

*Location:* **Clubhouse & Mail Building**

*Quantity:* **(11) Doors**

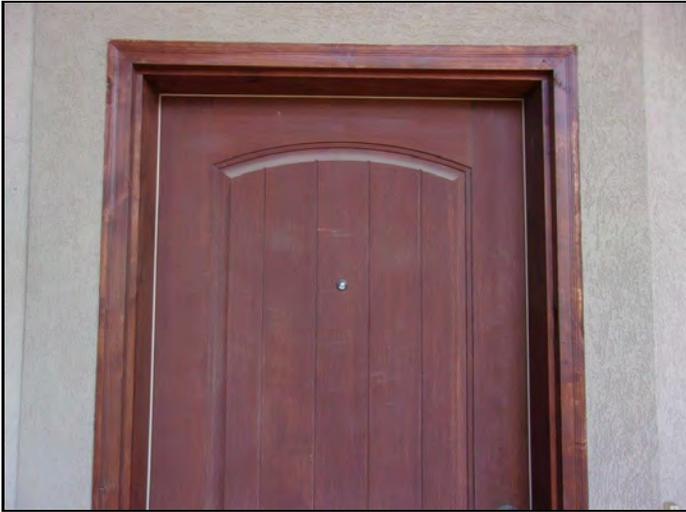
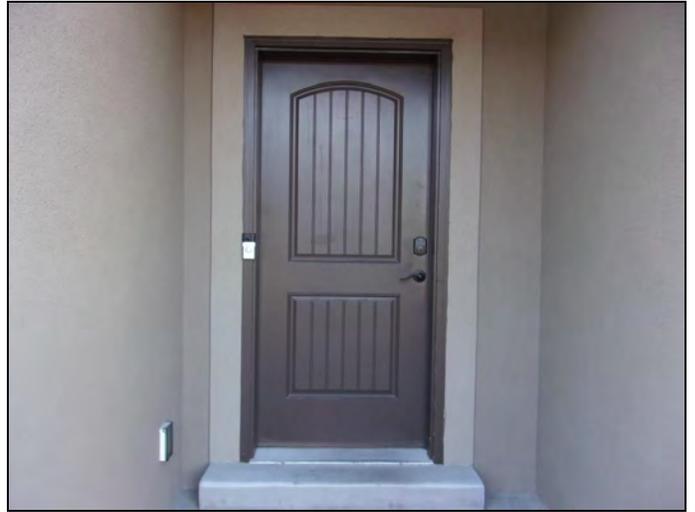
Comp #: 205 Front Doors - Residential - Repaint

*Location:* **Unit Entrances**

*Quantity:* **(131) Doors**

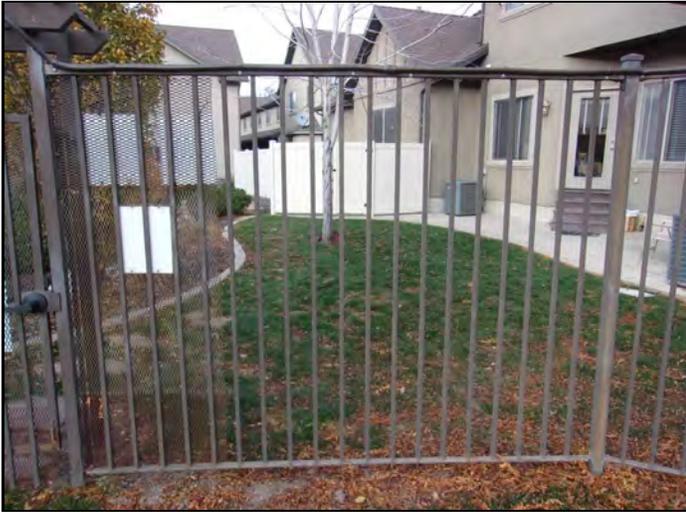
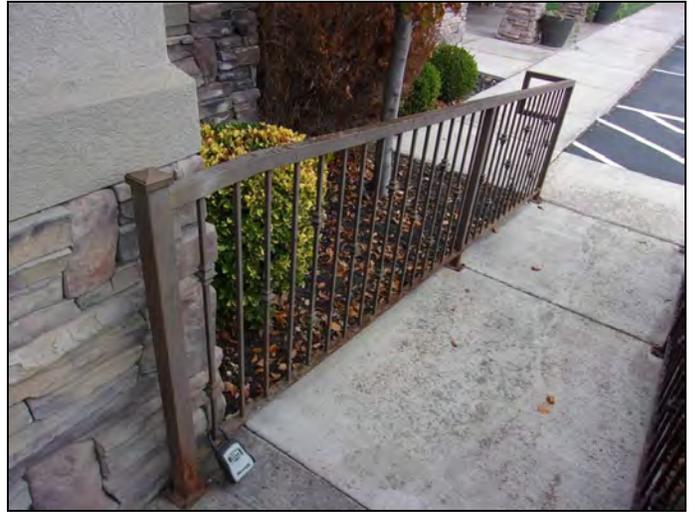
Comp #: 212 Metal Fencing & Railing - Repaint

*Location:* **Common Area, & Pool Area**

*Quantity:* **Approx 280 Linear ft.**

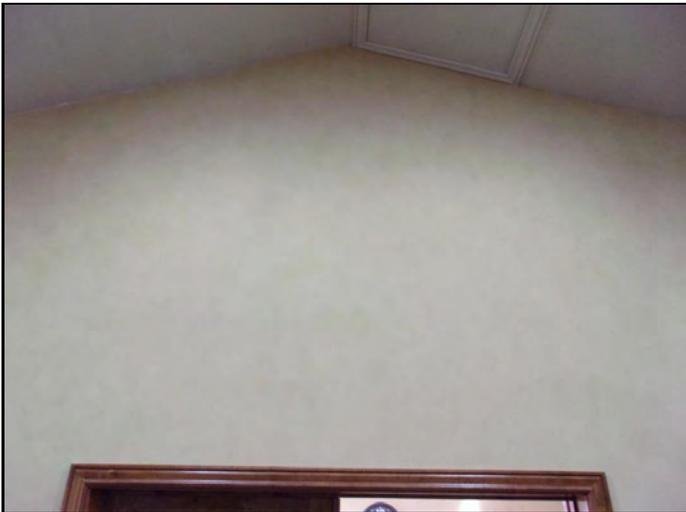
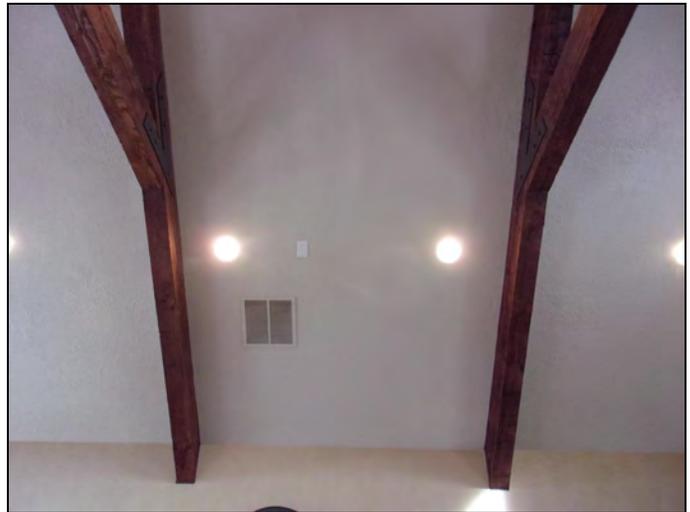
Comp #: 216 Interior Surfaces - Repaint

*Location:* **Clubhouse Interior**

*Quantity:* **Approx 4,475 Sq.ft.**

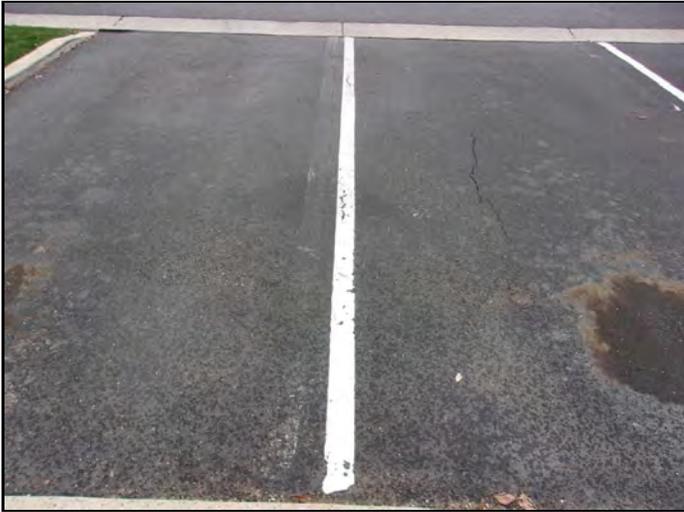
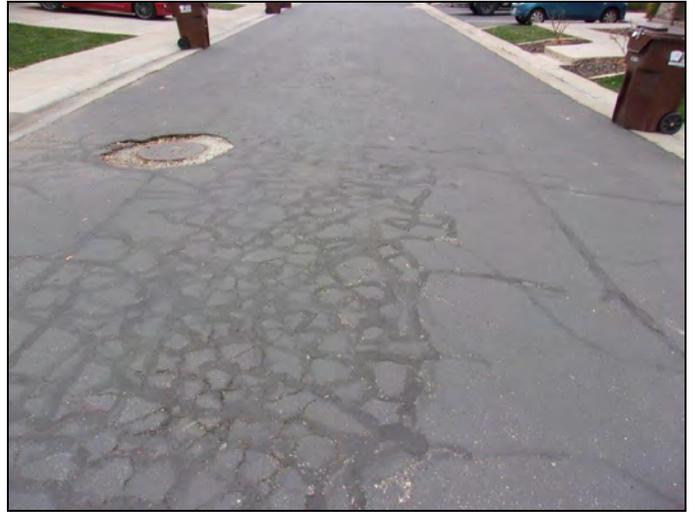
Comp #: 401 Asphalt - Major Rehab

*Location:* **Community Streets**

*Quantity:* **Approx 75,450 Sq.ft.**

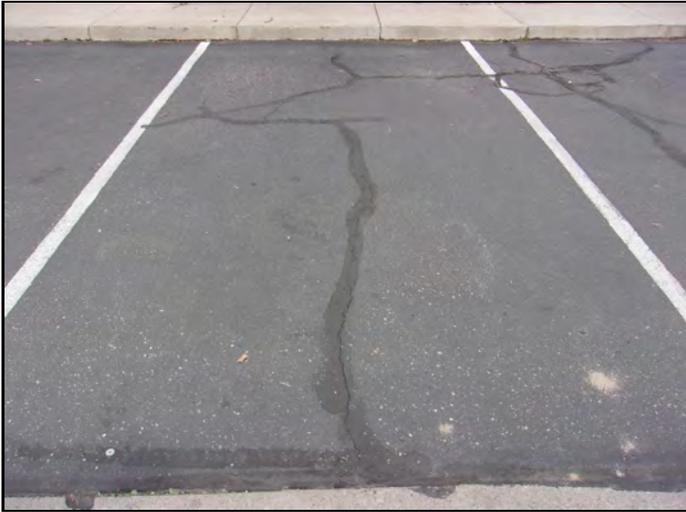
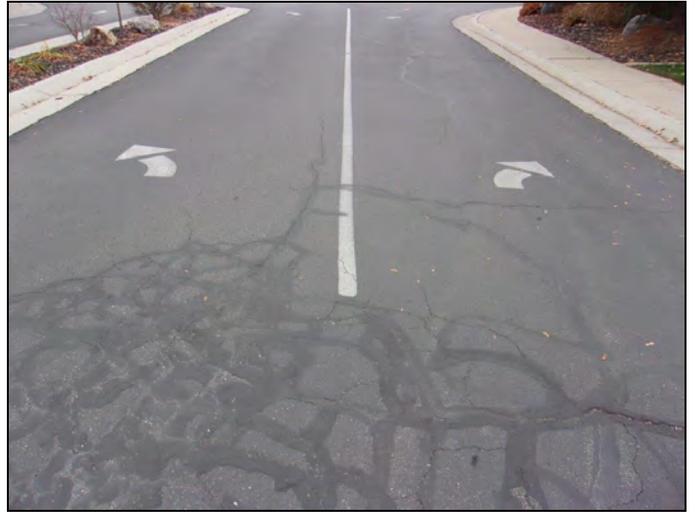
Comp #: 402 Asphalt - Seal Coat

*Location:* **Community Streets**

*Quantity:* **Approx 75,450 Sq.ft.**

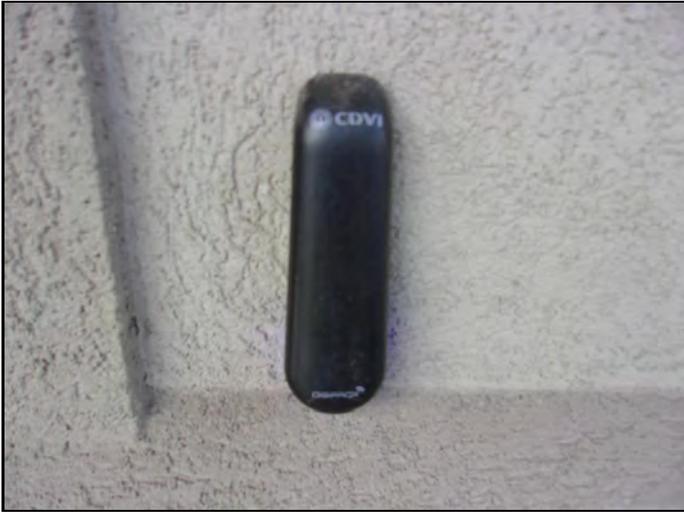
Comp #: 508 Access Control System - Replace

*Location:* **Clubhouse/Pool Area**

*Quantity:* **(1) System**

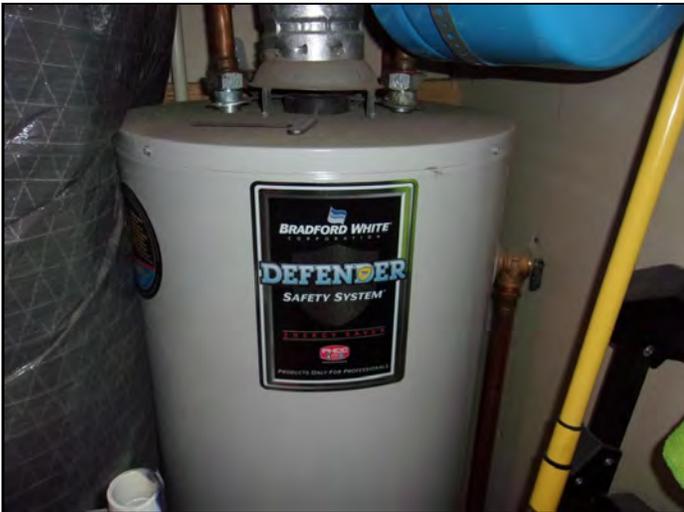
Comp #: 703 Water Heater - Replace

*Location:* Clubhouse

*Quantity:* (1) Heater

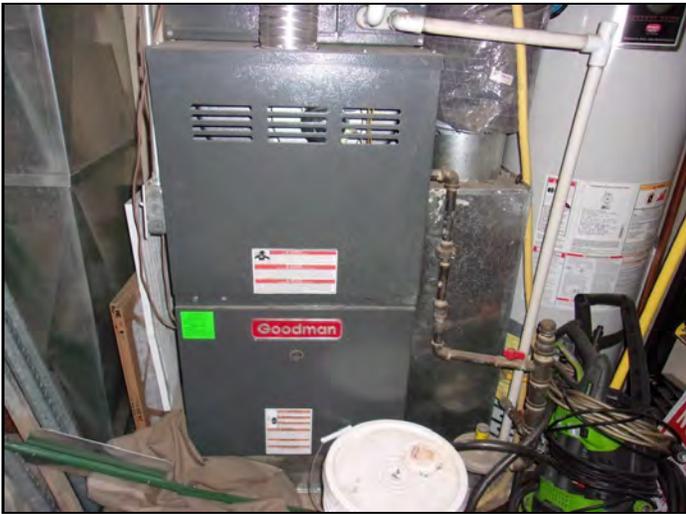
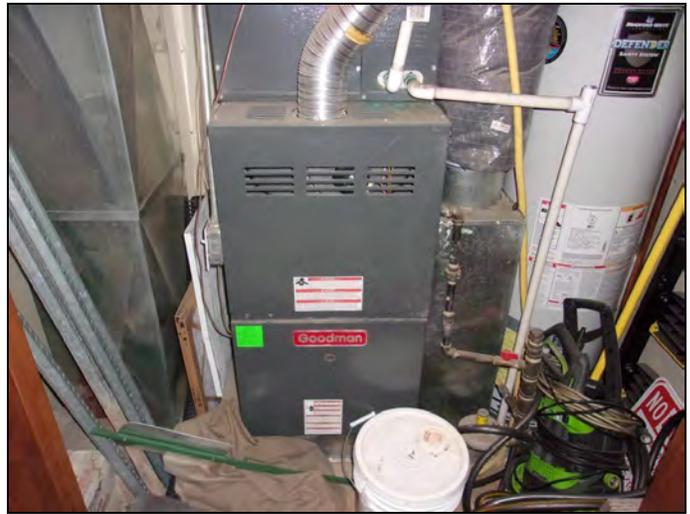
Comp #: 706 HVAC Furnace - Replace

*Location:* **Clubhouse**

*Quantity:* **(1) Furnace**

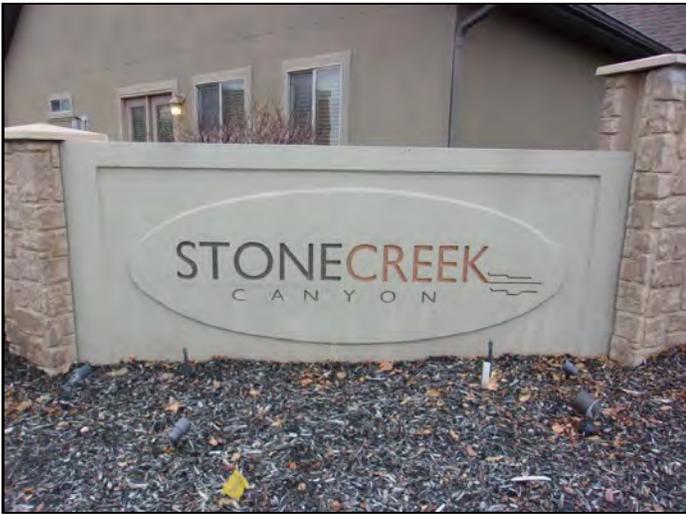
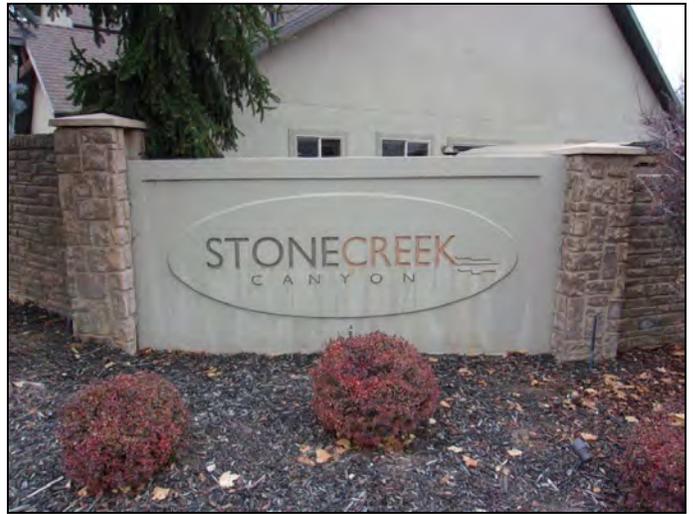
Comp #: 801 Monument Signs - Replace

*Location:* **Community Entrance**

*Quantity:* **(4) Signs**

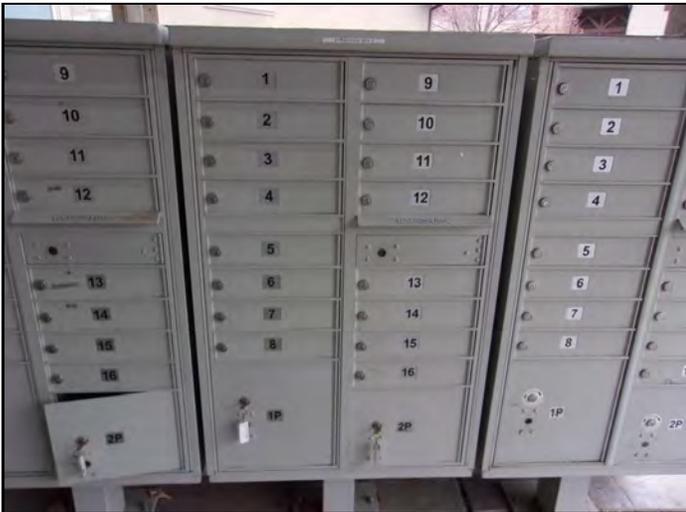
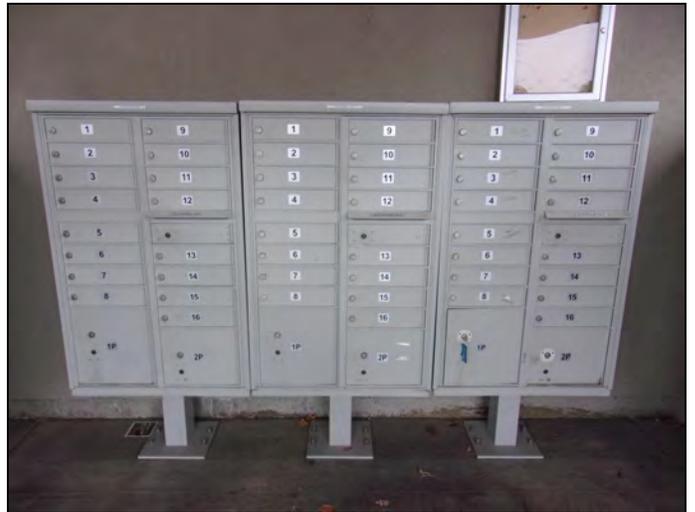
Comp #: 803 Mailboxes - Replace

*Location:* **Common Area**

*Quantity:* **(9) Clusters**

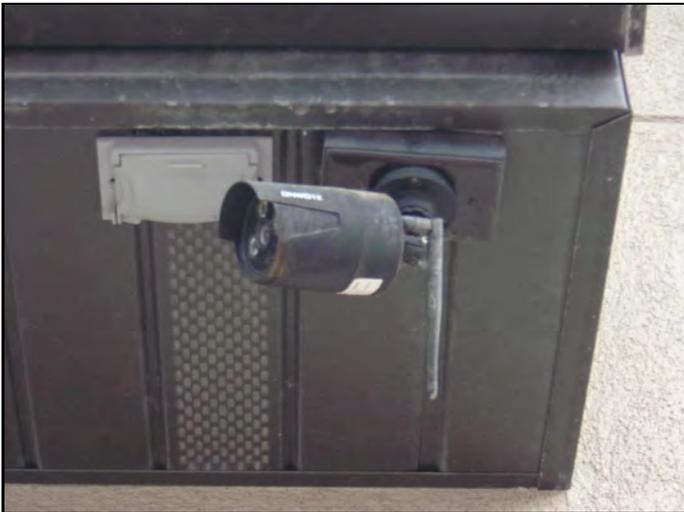
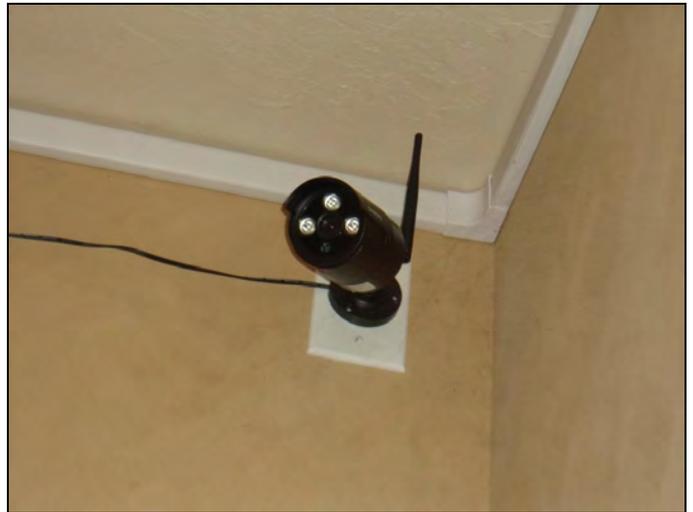
Comp #: 903 Security Camera System - Replace

*Location:* **Clubhouse & Pool Area**

*Quantity:* **(1) System**

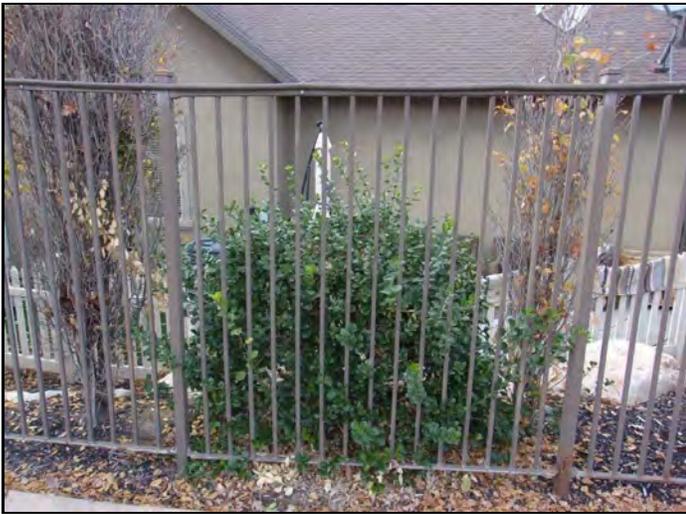
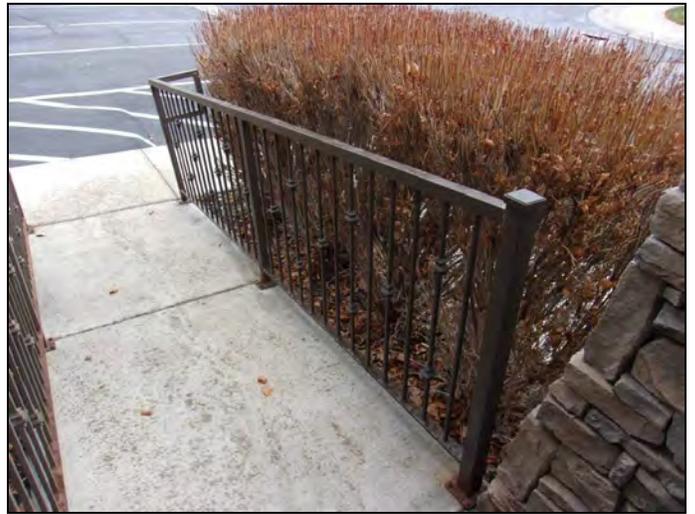
Comp #: 1002 Metal Fencing & Railing - Replace

*Location:* **Common Area, & Pool Area**

*Quantity:* **Approx 250 Linear ft.**

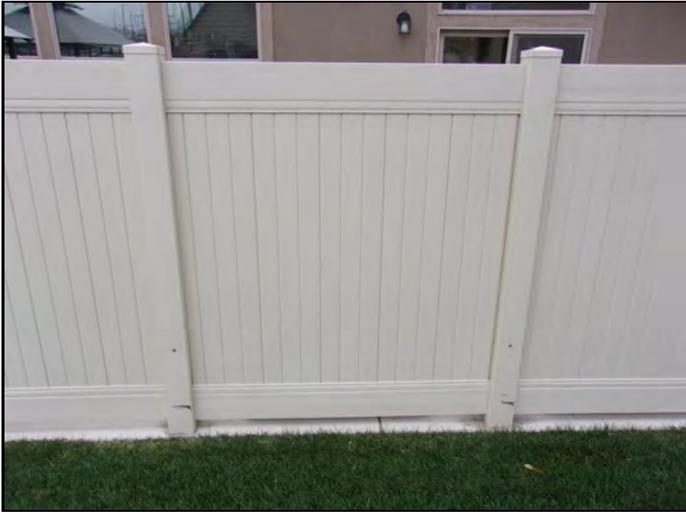
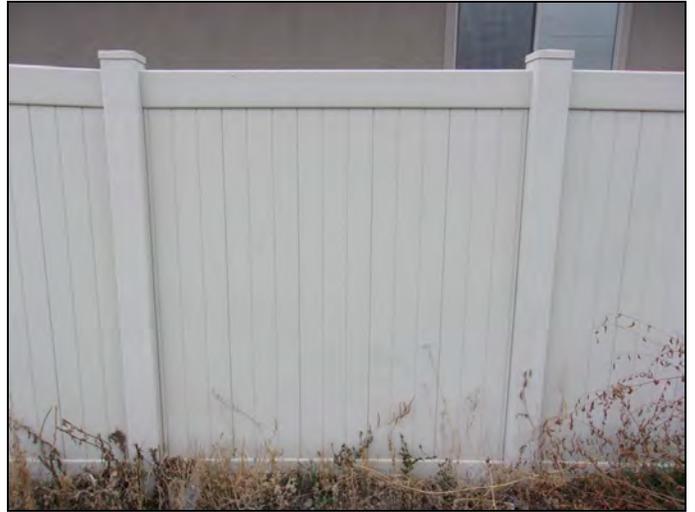
Comp #: 1008 Vinyl Fencing - Backyards - Replace

*Location:* **Backyards**

*Quantity:* **Approx 1,475 Linear ft.**

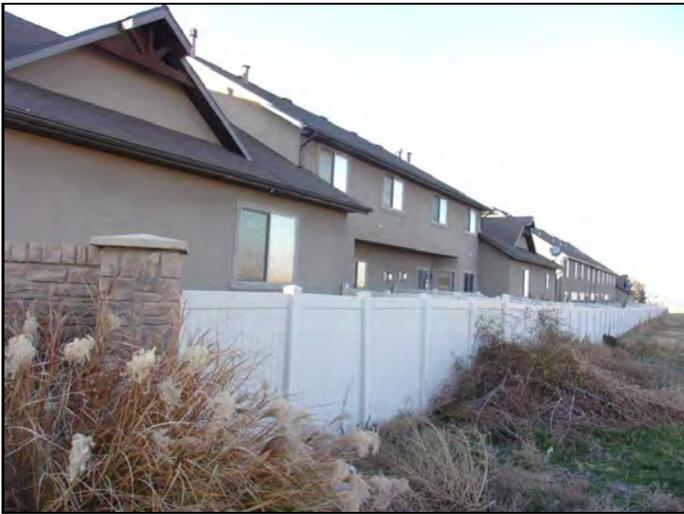
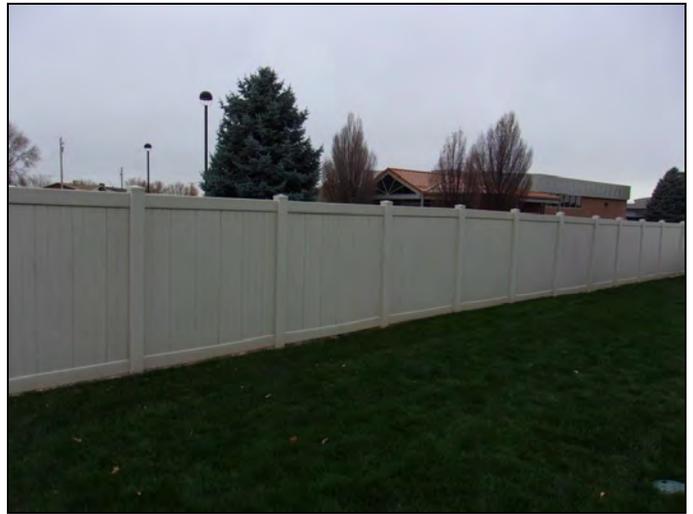
Comp #: 1008 Vinyl Fencing - Perimeter - Replace

*Location:* **East, North, & South Perimeter**

*Quantity:* **Approx 1,330 Linear ft.**

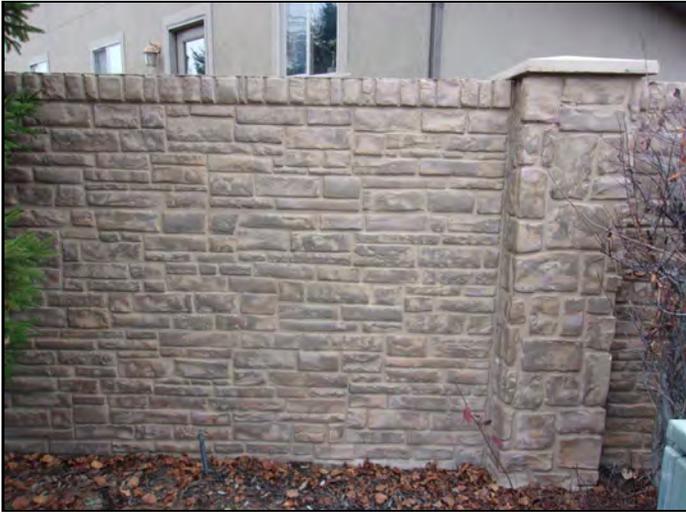
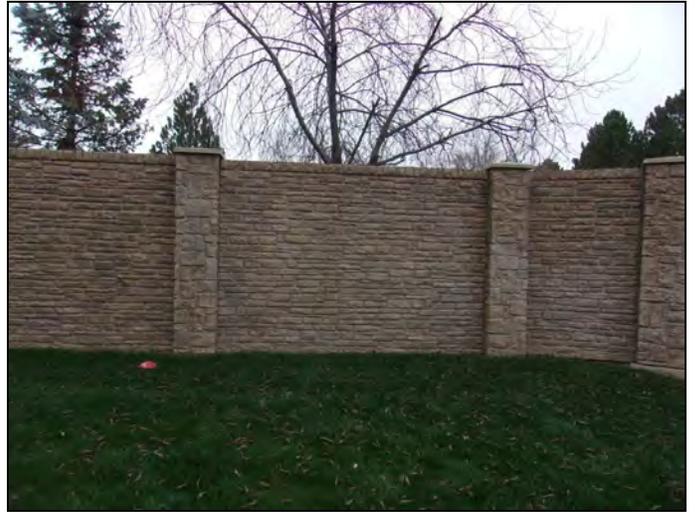
Comp #: 1012 Prefab Concrete Fence - Replace

*Location:* **East Perimeter**

*Quantity:* **Approx 685 Linear ft.**

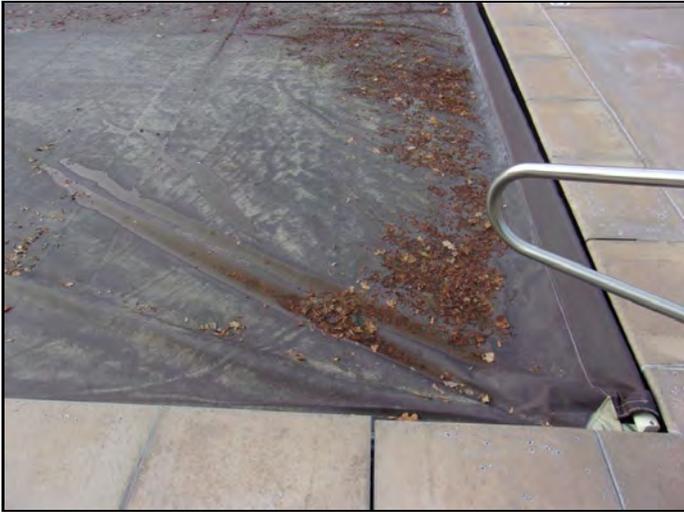
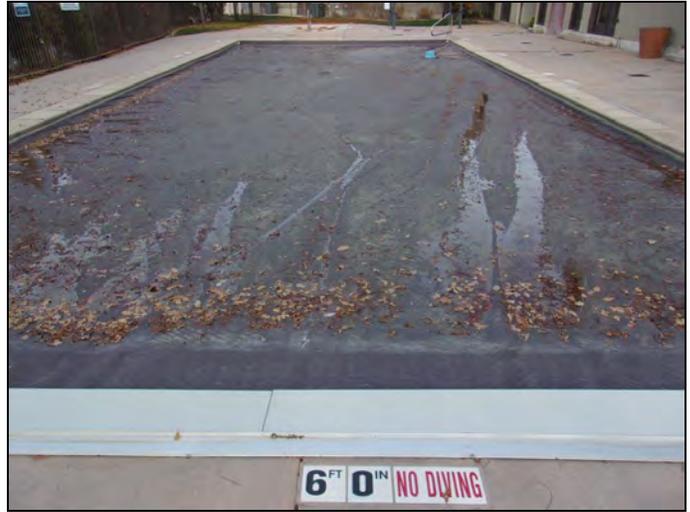
Comp #: 1101 Pool - Resurface

Unable to inspect this component at the time of the site visit. We recommend funding to resurface this component every 10 - 12 years. Remaining life based on current age.

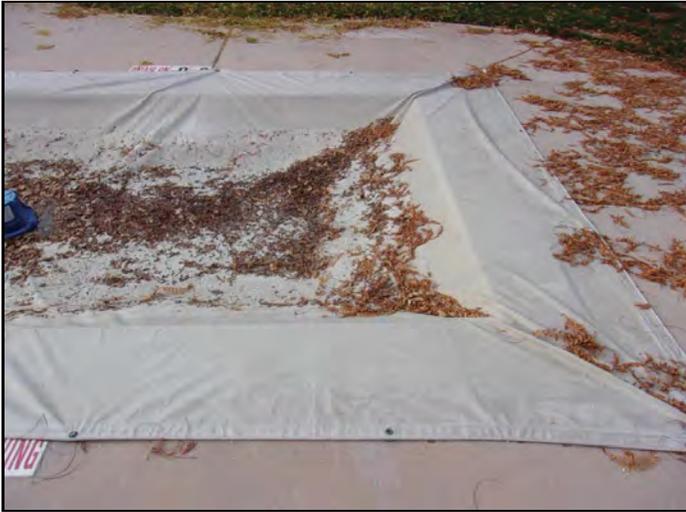
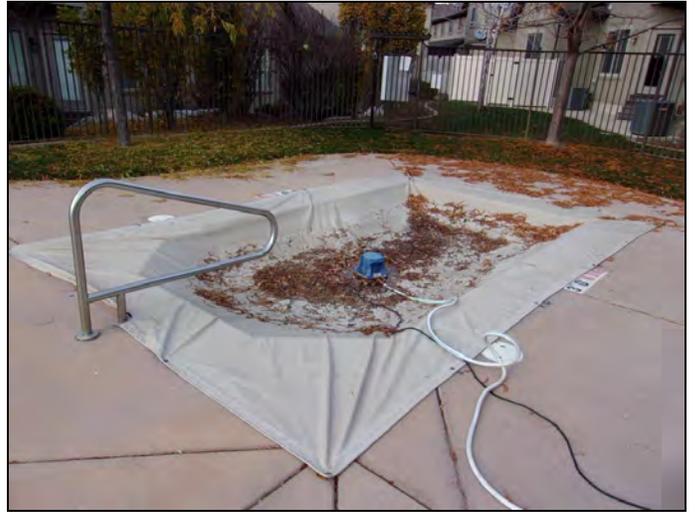
Comp #: 1102 Spa - Resurface

Unable to inspect this component at the time of the site visit. We recommend funding to resurface this component every 10 - 12 years. Remaining life based on current age.

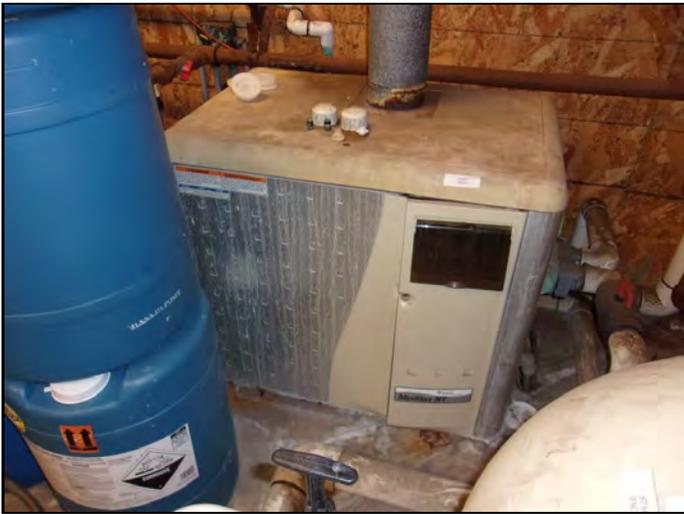
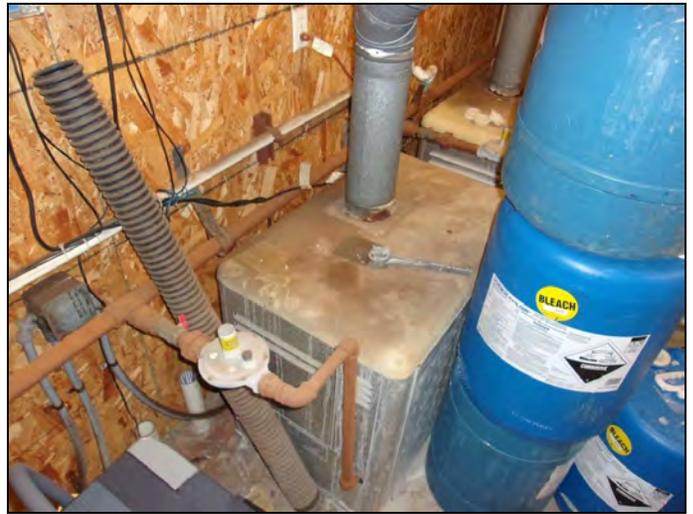
Comp #: 1104 Pool Heaters - Replace

The pool heater is in working condition. We recommend funding to replace this component approximately every 12 years. Remaining life based on current age and condition.

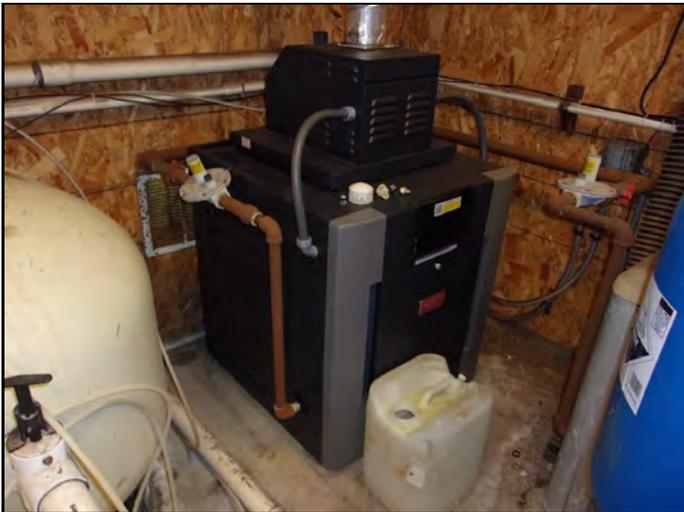
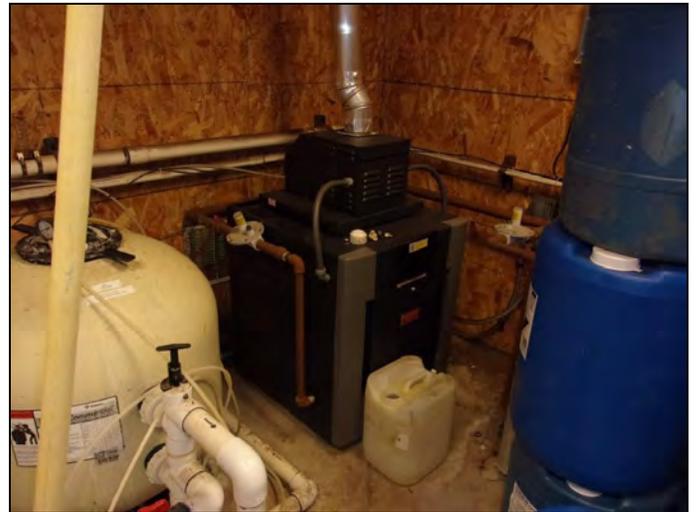
Comp #: 1105 Spa Heater - Replace

The spa heater is in working condition. We recommend funding to replace this component approximately every 12 years. Remaining life is based on current age and condition.

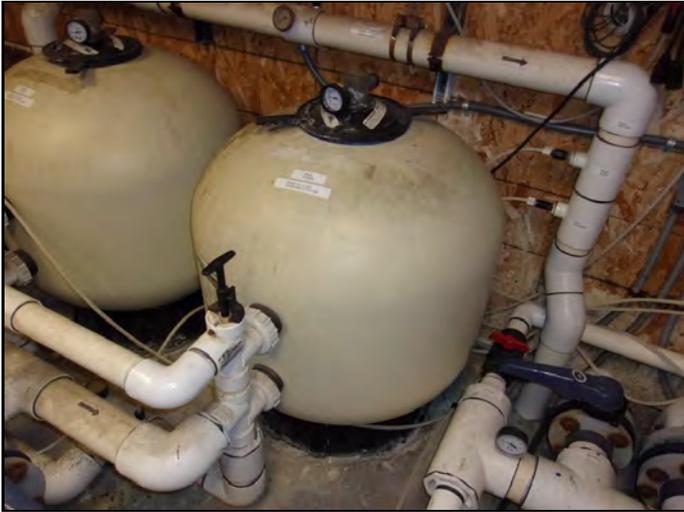
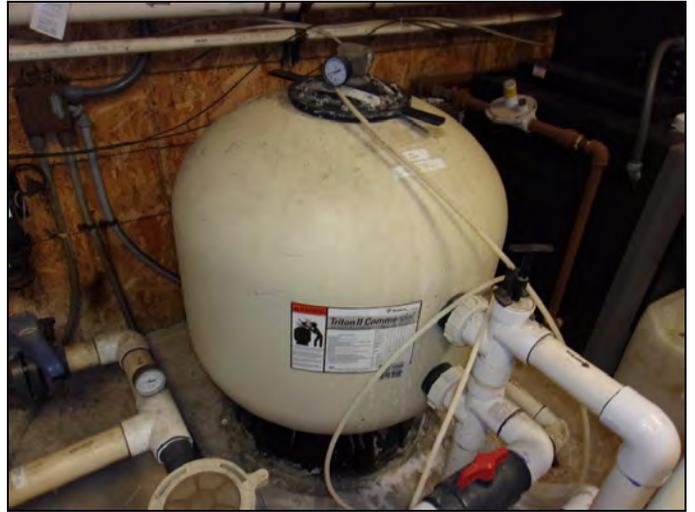
Comp #: 1107 Pool & Spa Filters - Replace

The pool and spa filters are in working condition. We recommend funding to replace this component approximately every 12 - 15 years. Remaining life based on current age.

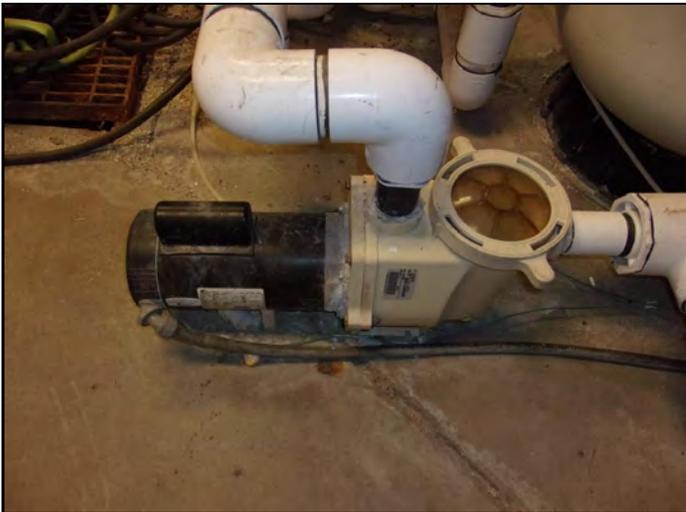
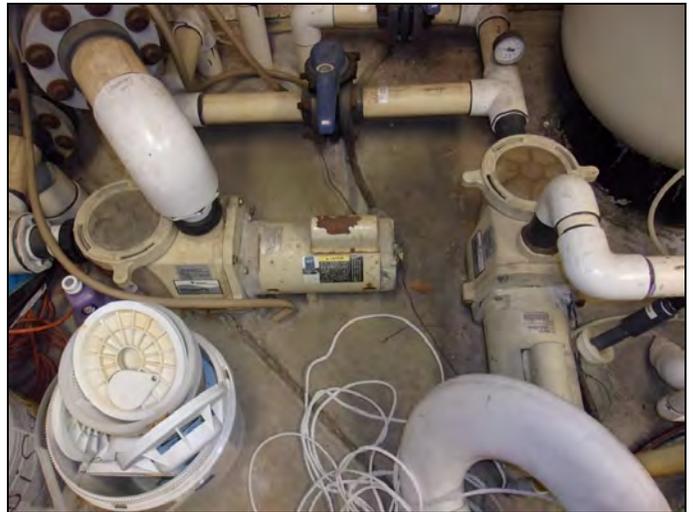
Comp #: 1110 Pool & Spa Pumps - Replace

The pool and spa pumps are in working condition. We recommend funding to replace this component approximately every 8 - 10 years. Remaining life based on current age and condition.

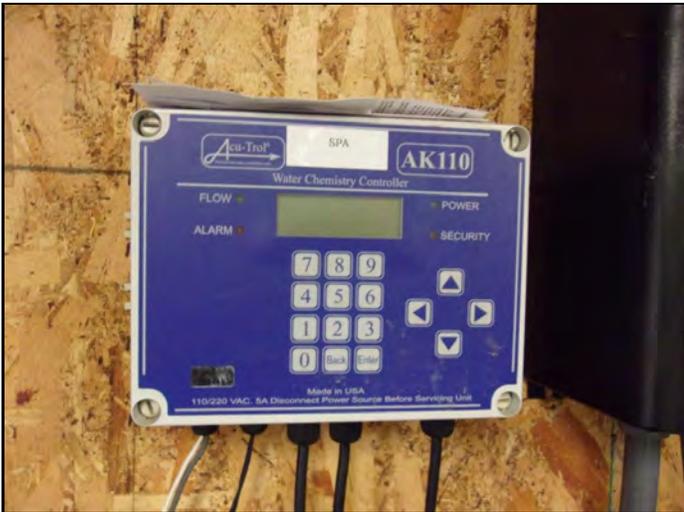
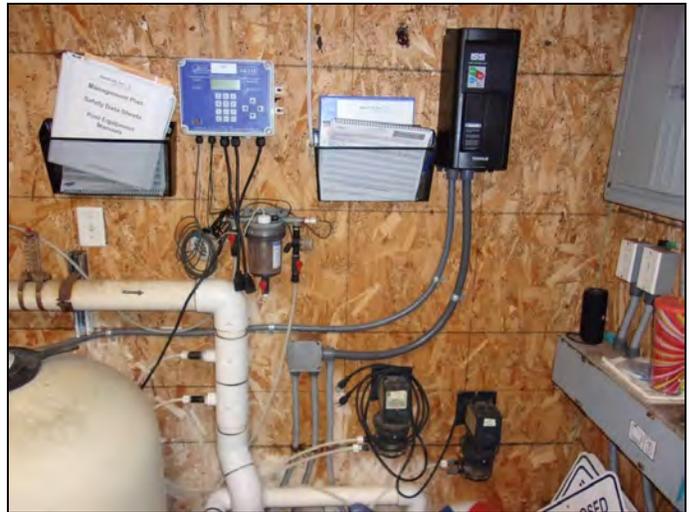
Comp #: 1111 Chemical Controller Systems - Replace

The chemical controller systems are in working condition. We recommend funding to replace this component approximately every 10 - 12 years. Remaining life based on current age and condition.

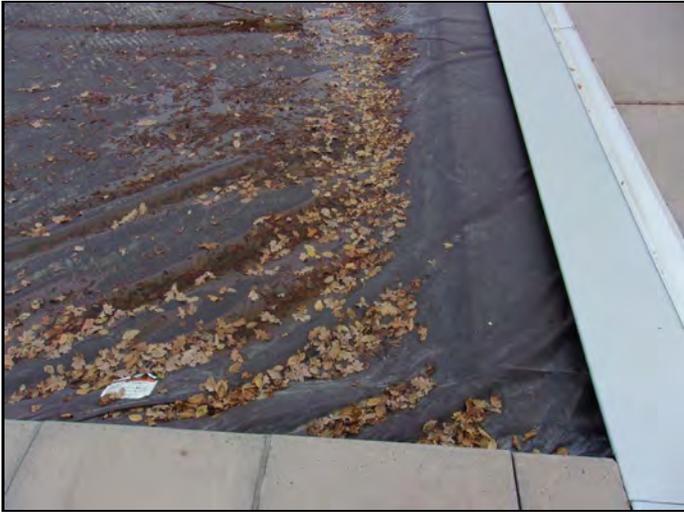
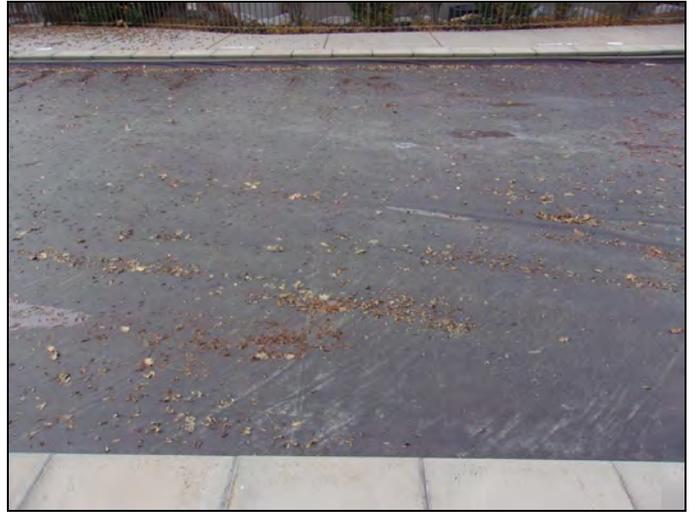
Comp #: 1112 Pool Cover - Replace

The pool cover appears to be in good condition. We recommend funding to replace this component approximately every 10 years. Remaining life based on current age.

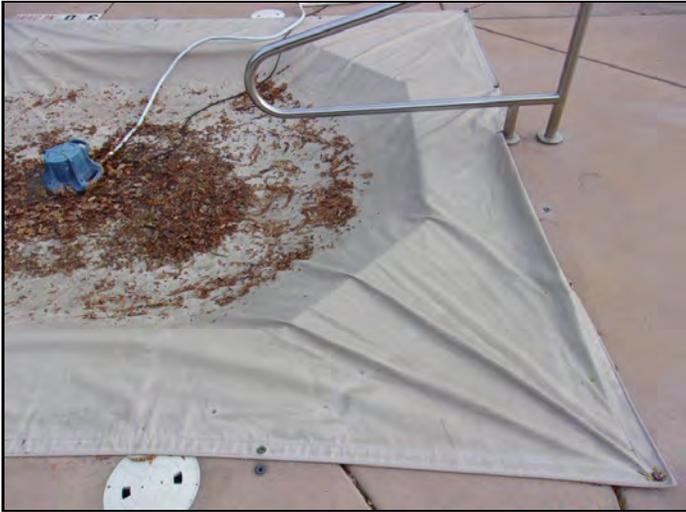
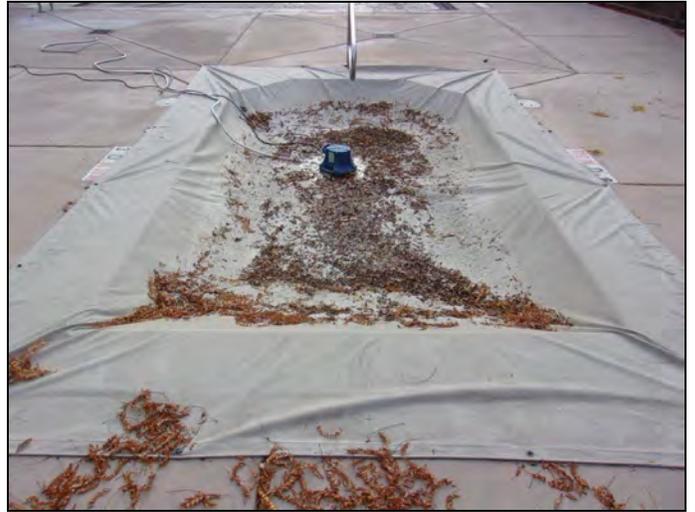
Comp #: 1113 Spa Cover - Replace

Due to the minimal cost of replacing this component, reserve funding is not appropriate. Replace as necessary as an operating expense.

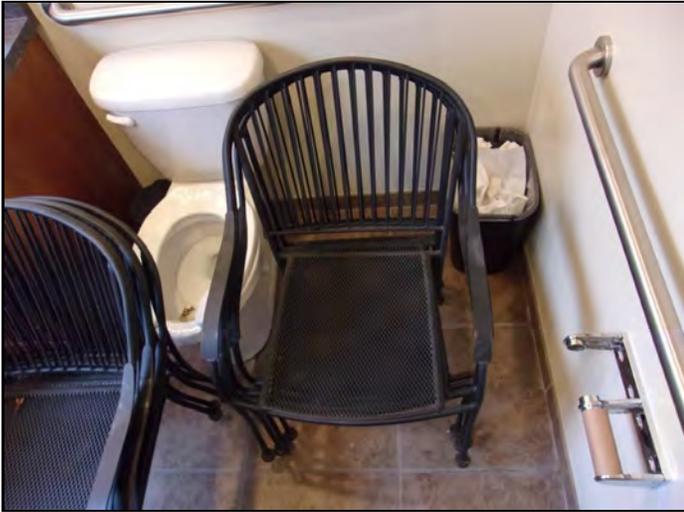
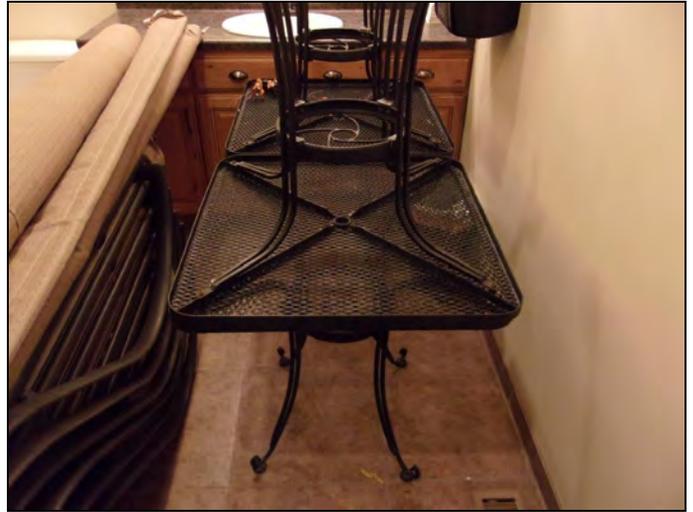
Comp #: 1121 Pool Furniture - Replace

The pool furniture is in fair condition. We recommend funding an allowance to make replacements to this component approximately every 6 years. Remaining life based on current age and condition.

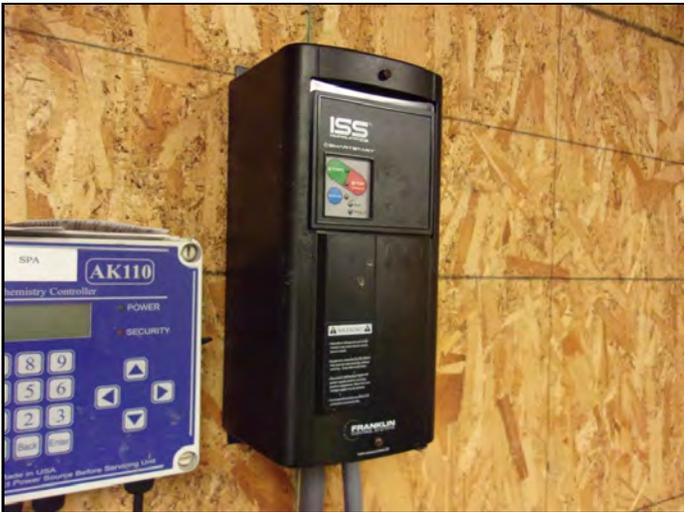
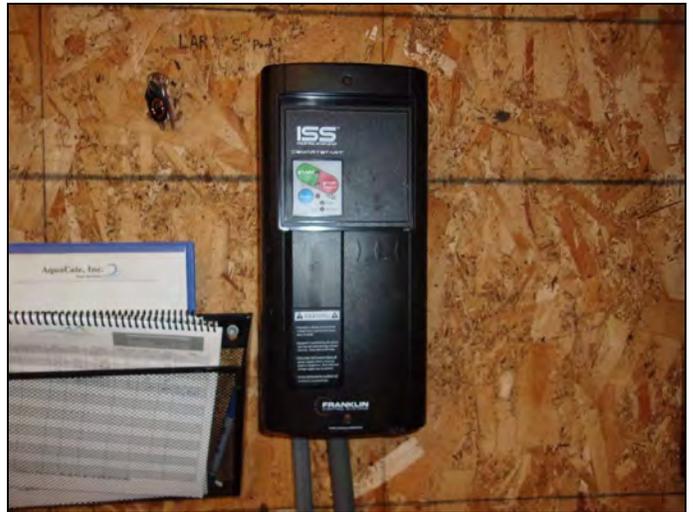
Comp #: 1190 Pump Controllers - Replace

The controllers are in working condition. NWe recommend funding to replace this system approximately every 10 - 15 years. Remaining life based on current age.

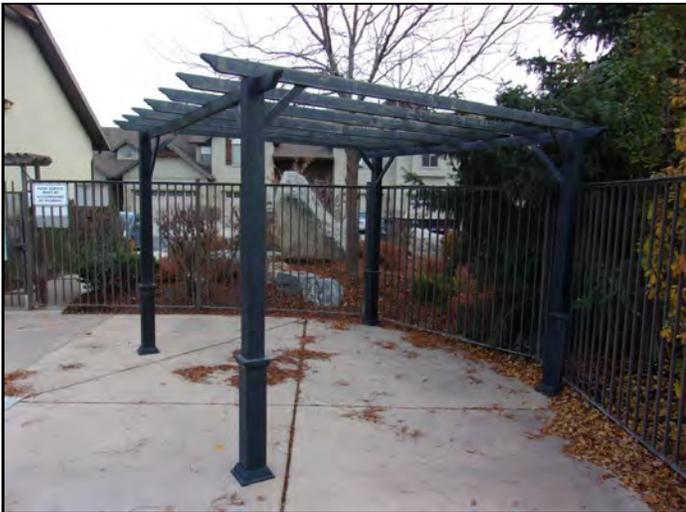
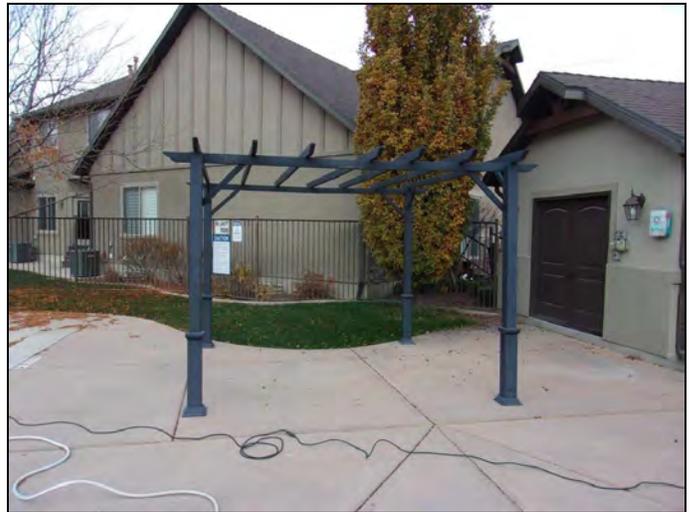
Comp #: 1309 Metal Pergola - Replace

The pergolas are in good to fair condition. We recommend funding to replace this component approximately every 30 - 40 years. Remaining life based on current age.

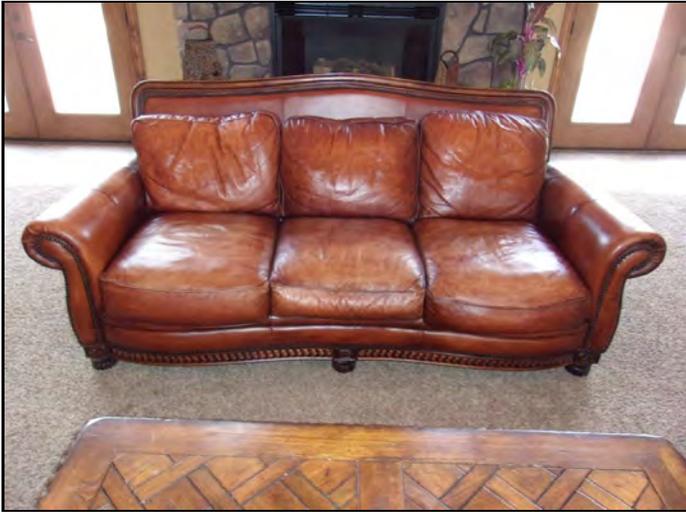
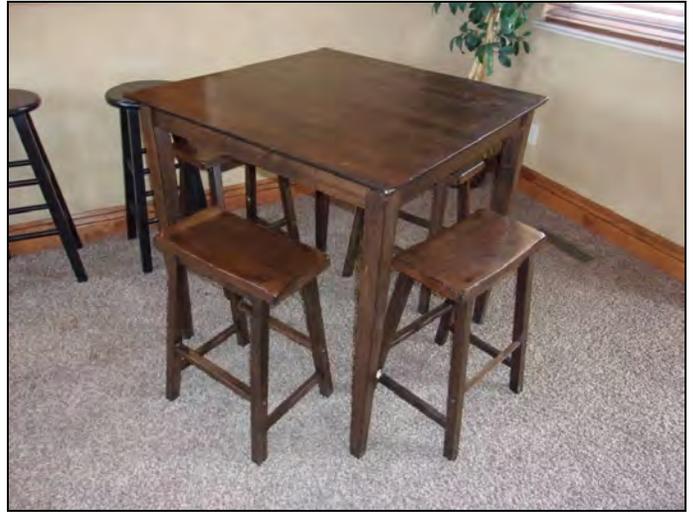
Comp #: 1405 Furniture - Replace

The furniture is in fair condition. We recommend funding an allowance to make replacements approximately every 10 years. Remaining life based on current age.
