# Stone Creek Canyon HOA

## Level 1 Reserve Study

**Report Period – 01/01/2022 – 12/31/2022**

**Report prepared on – Tuesday, February 15, 2022**

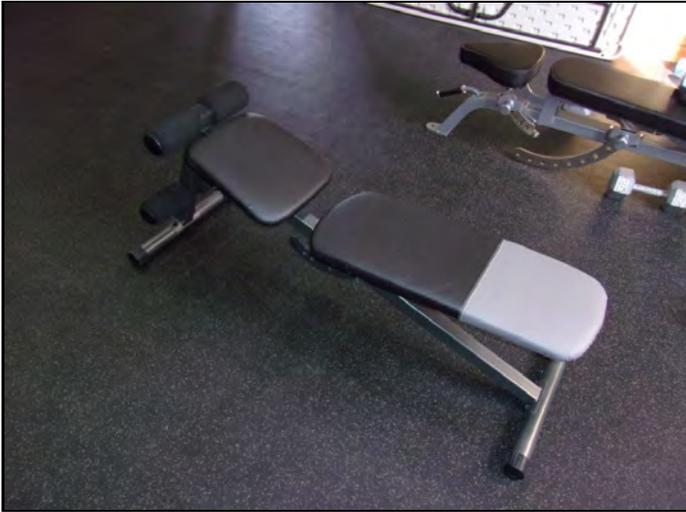
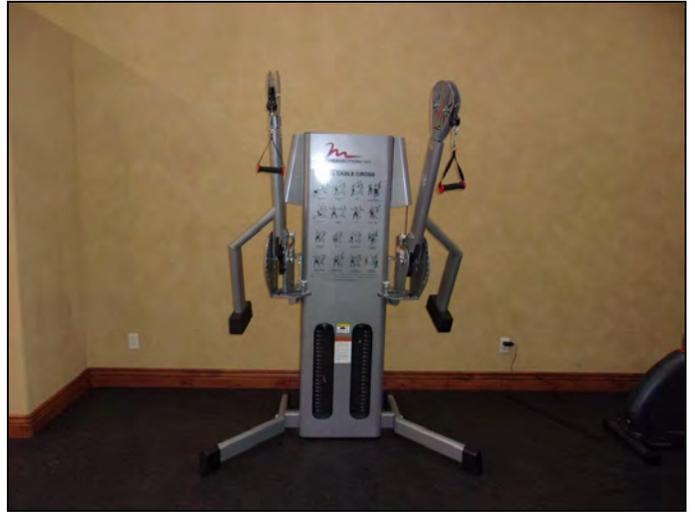
Comp #: 1406 Fitness Equipment - Replace

The fitness equipment is in working condition. We recommend funding to replace this component approximately every 15 years. Remaining life based on current age.

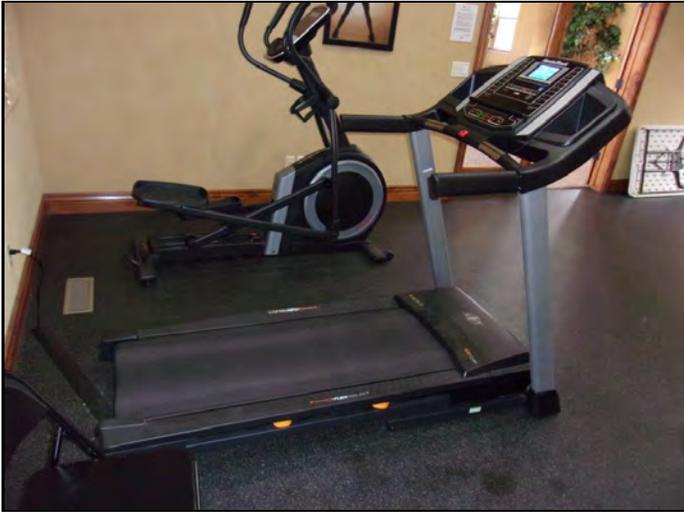
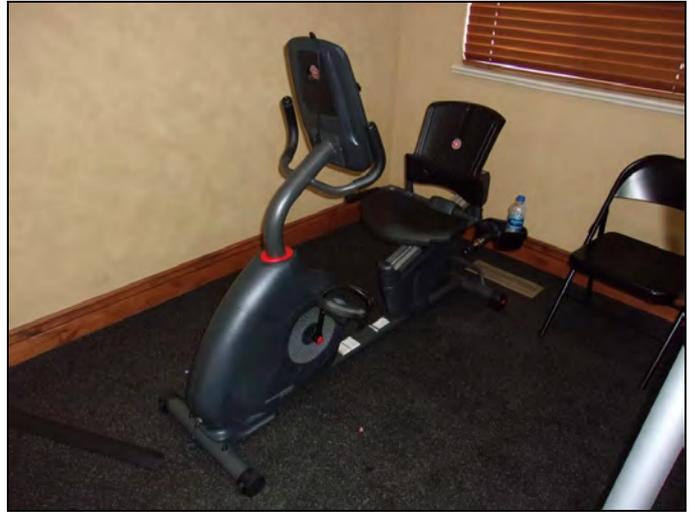
Comp #: 1407 Cardio Equipment - Replace

The cardio fitness equipment is in working condition. We recommend funding to replace this component approximately every 8 - 10 years. Remaining life based on current age and condition.

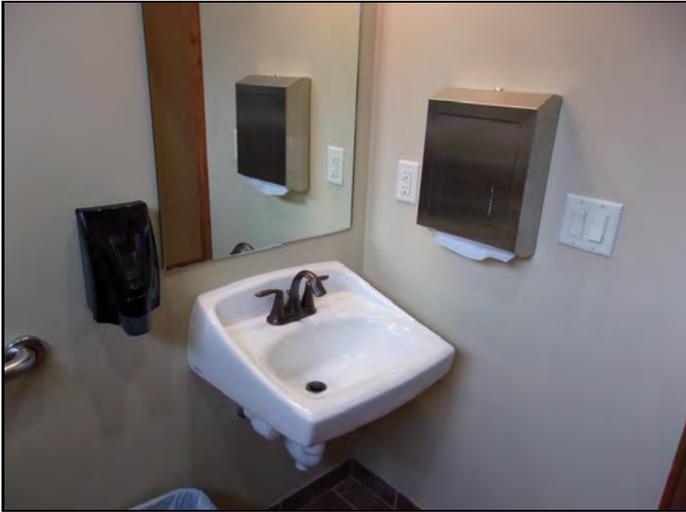
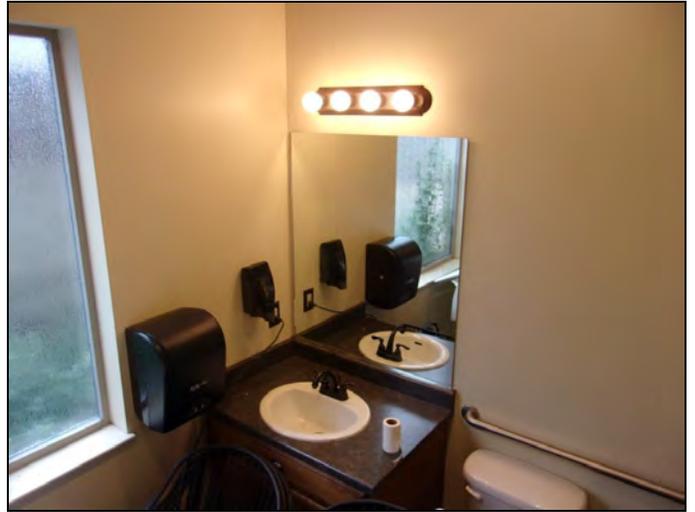
Comp #: 1413 Restrooms & Shower - Remodel

The restrooms and shower appear to be in good condition. We recommend funding to remodel this component approximately every 20 years. Remaining life based on current age.

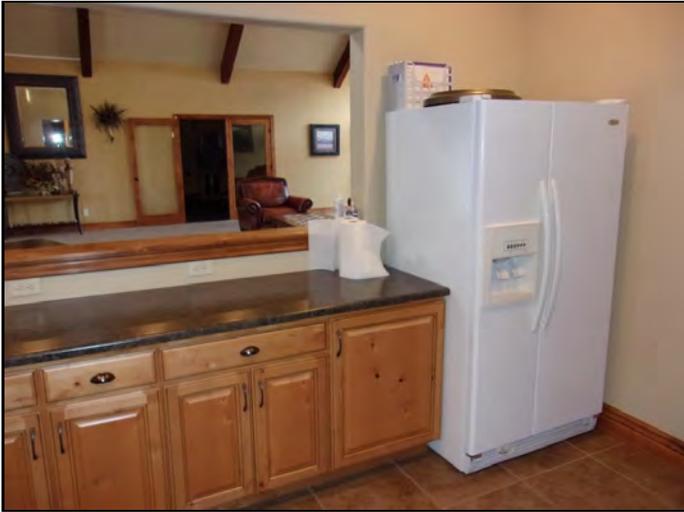
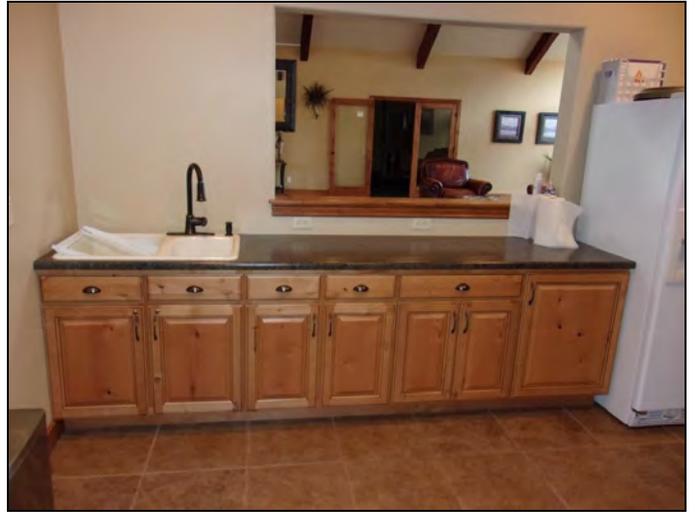
Comp #: 1417 Kitchen - Remodel

The kitchen is in good condition. We recommend funding to remodel this component approximately every 20 years. Remaining life based on current age.

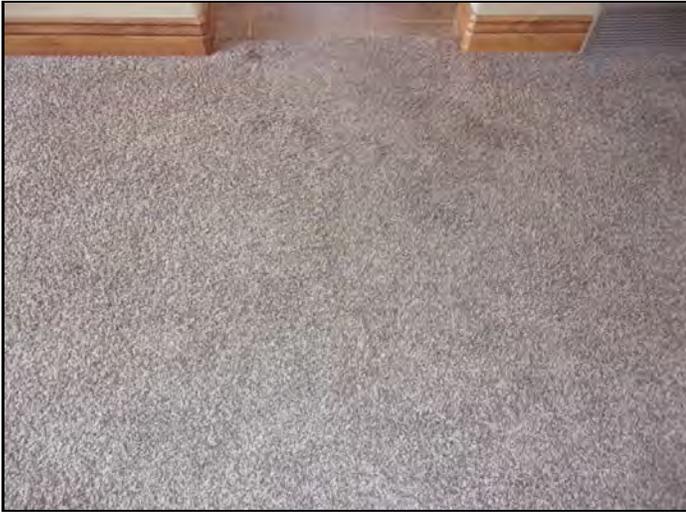
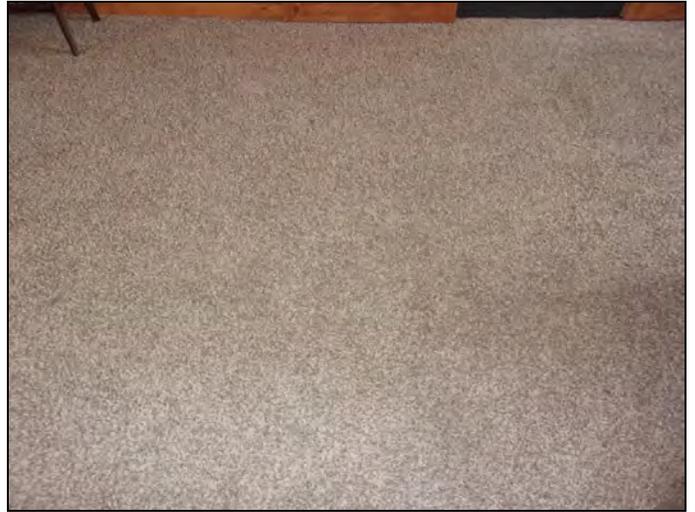
Comp #: 1501 Carpeting - Replace

The carpeting is in fair condition. We recommend funding to replace this component approximately every 8 - 10 years. Remaining life based on current age and condition.

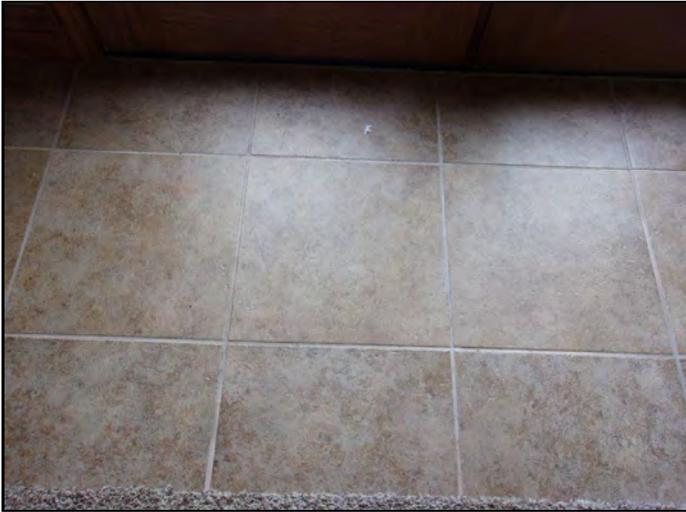
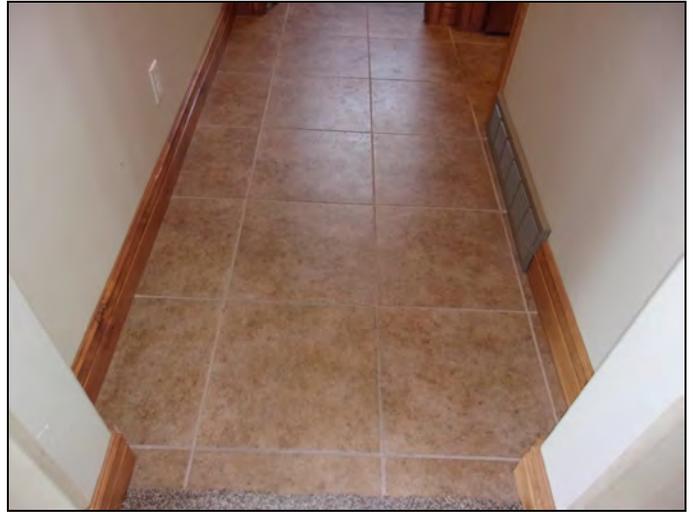
Comp #: 1503 Tile Flooring - Replace

The tile flooring is in good condition. We recommend funding to replace this component approximately every 30 years. Remaining life based on current age.

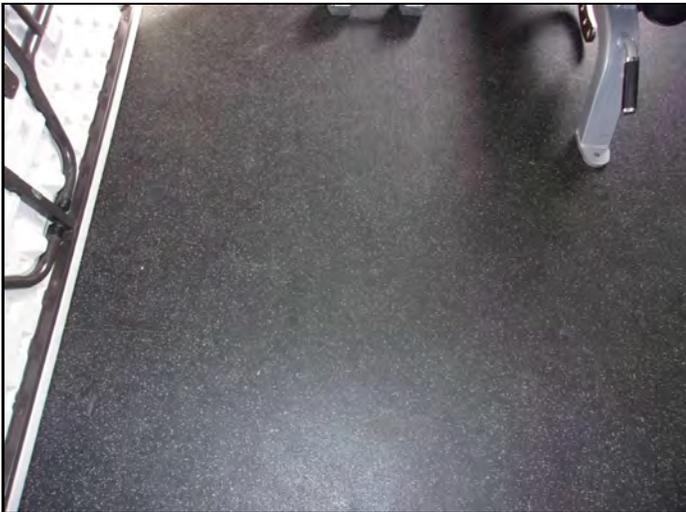
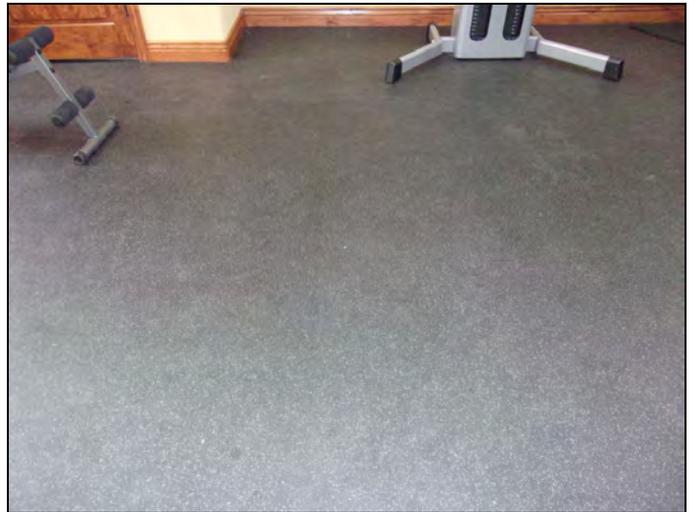
Comp #: 1590 Rubber Flooring - Replace

The rubber safety flooring is in good condition. We recommend funding to replace this component approximately every 10 - 12 years. Remaining life based on current age and condition.

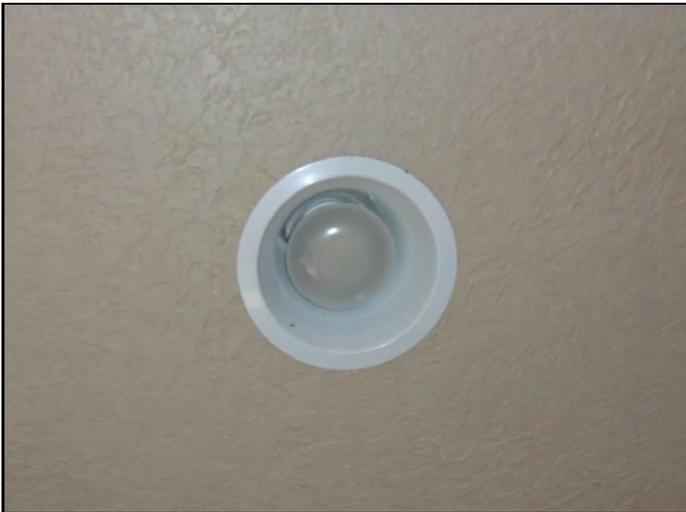
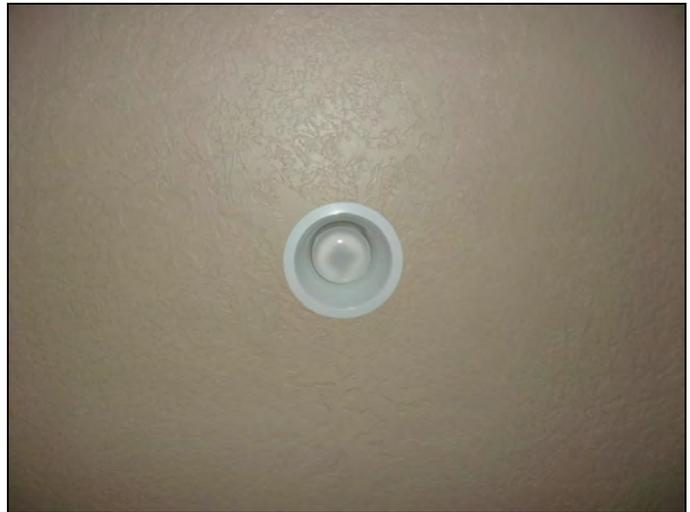
Comp #: 1601 Interior Light Fixtures - Replace

The interior light fixtures are in good condition. We recommend funding to replace this component approximately every 20 - 25 years. Remaining life based on current age.

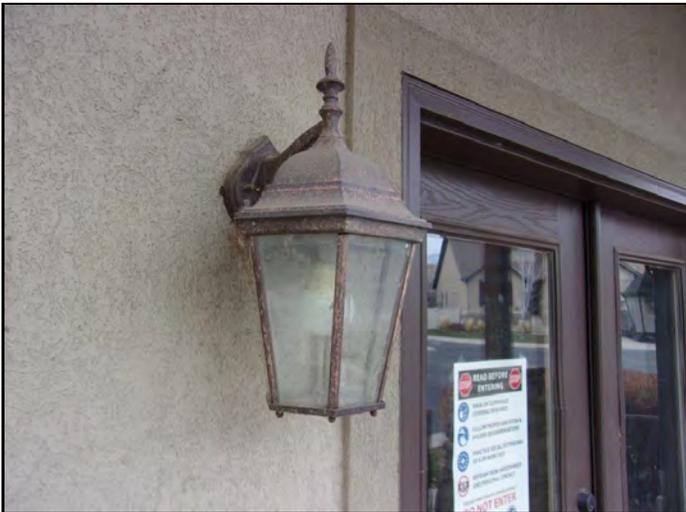
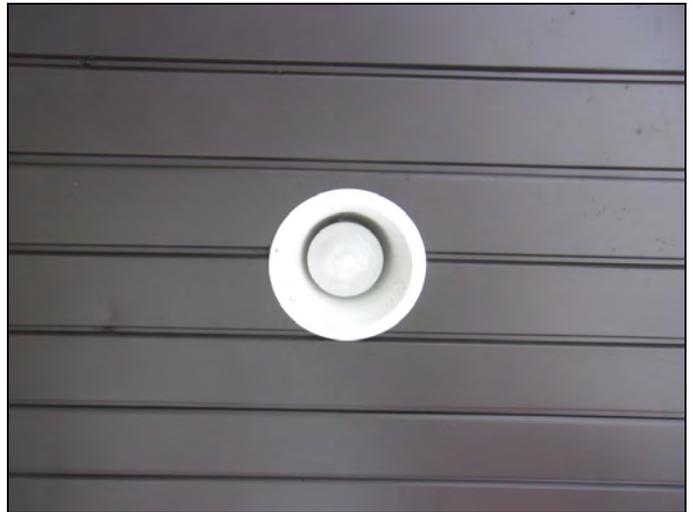
Comp #: 1602 Exterior Light Fixtures - Clubhouse - Replace

The exterior light fixtures are in good to fair condition. We recommend funding to replace this component approximately every 16 - 20 years. Remaining life based on current age.

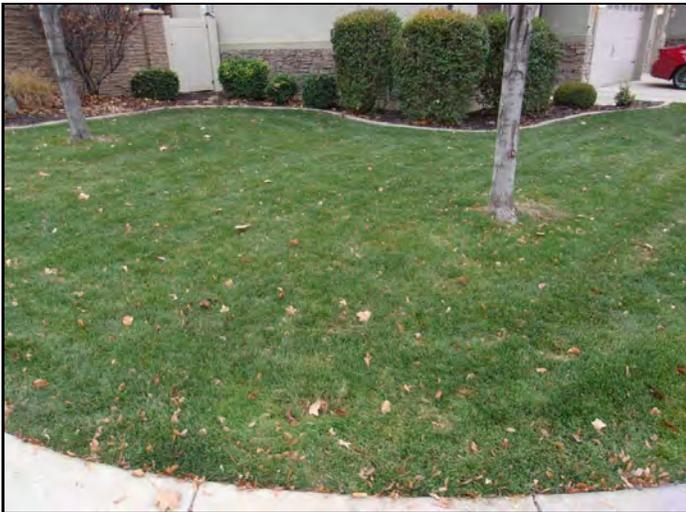
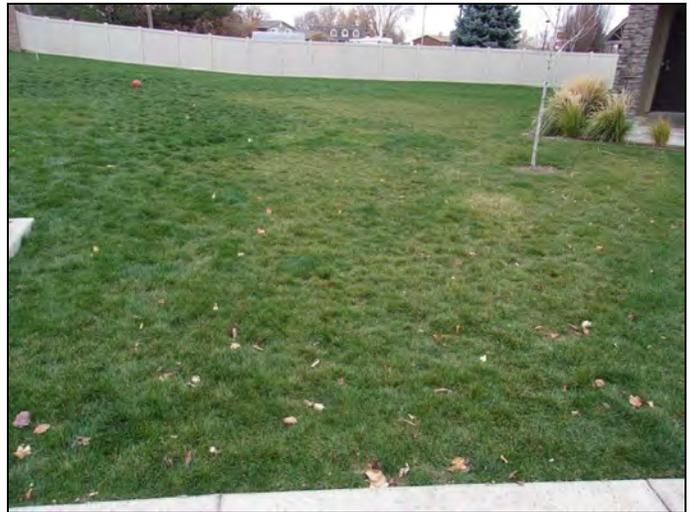
Comp #: 1812 Landscaping & Irrigation System - Renovate

The landscaping and irrigation system are in good to fair condition. We recommend funding for an allowance to renovate the landscaping and irrigation system approximately every 20 years. Remaining life based on average age.
