Stone Creek Canyon HOA

Level 2 Reserve Study

Report Period – 01/01/2025 – 12/31/2025

Type of Study	Update w/Site Visit
Date of Property Inspection	12/11/2024
Prepared By	Dale Gifford
Analysis Method	Cash Flow
Funding Goal	Full Funding

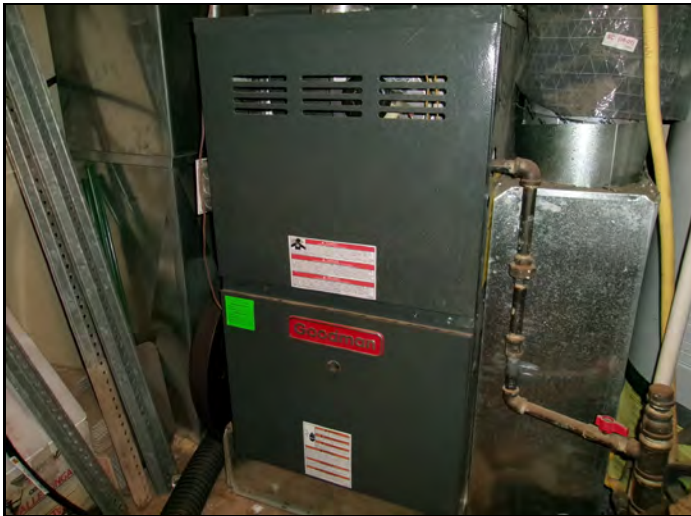
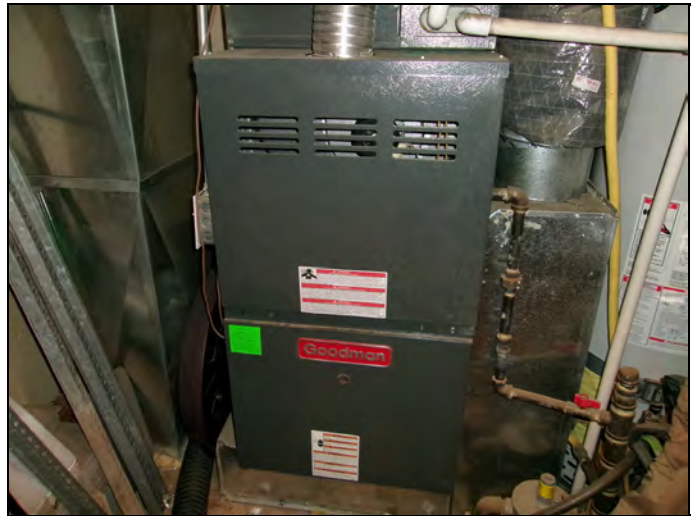
Comp #: 706 HVAC Furnace - Replace

The furnace is in working condition. We recommend funding to replace this component approximately every 20 years. Remaining life based on current age.

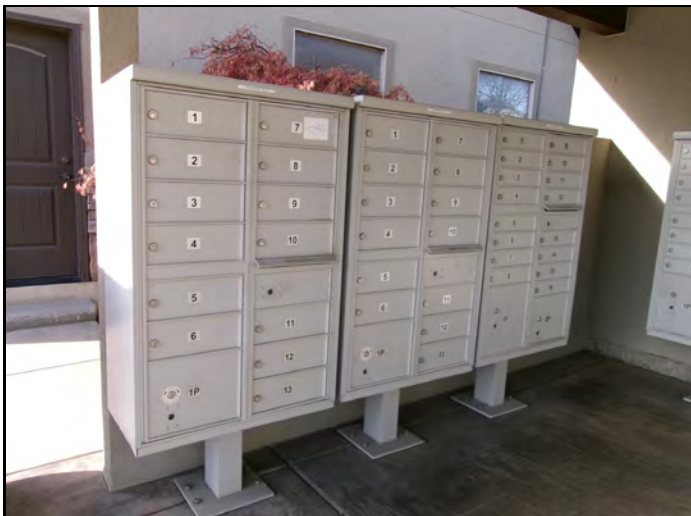
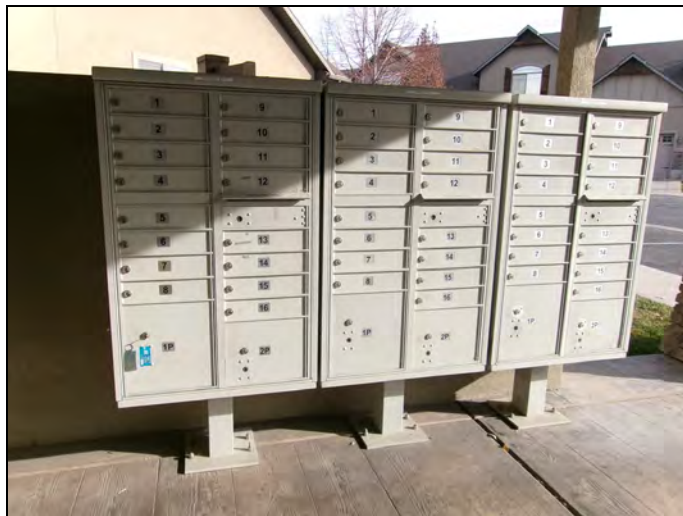
Comp #: 803 Mailboxes - Replace

The mailboxes are in good condition. We recommend funding to replace this component approximately every 20 - 25 years. Remaining life based on current age.

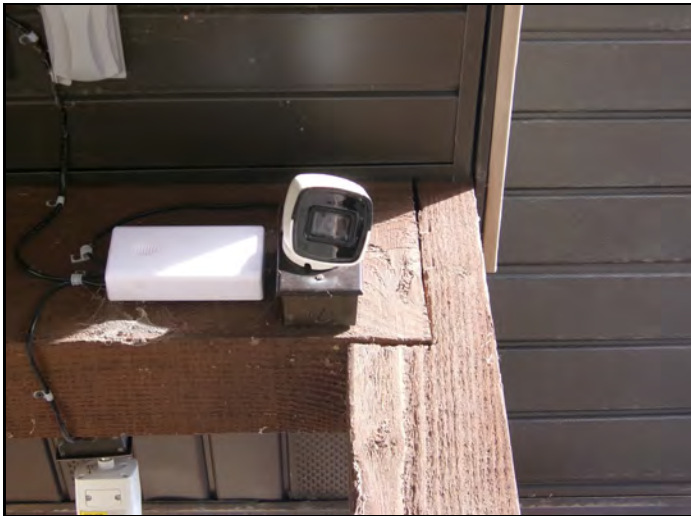
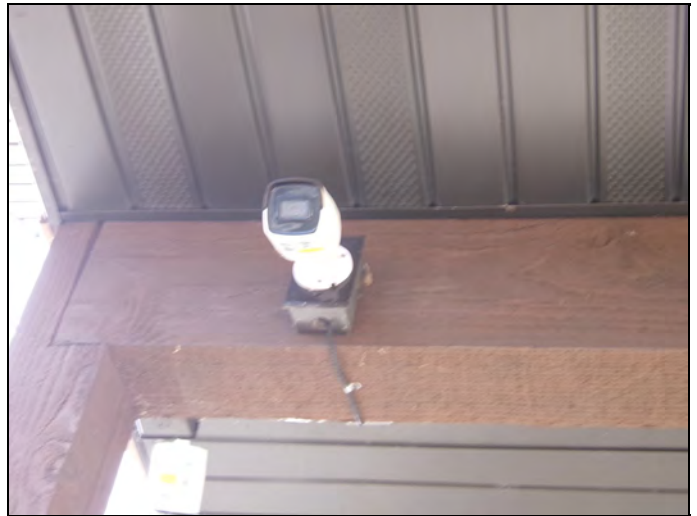
Comp #: 903 Security Camera System - Replace

The security camera system is in working condition. We recommend funding to replace this component approximately every 10 - 12 years. Remaining life based on current age and condition.

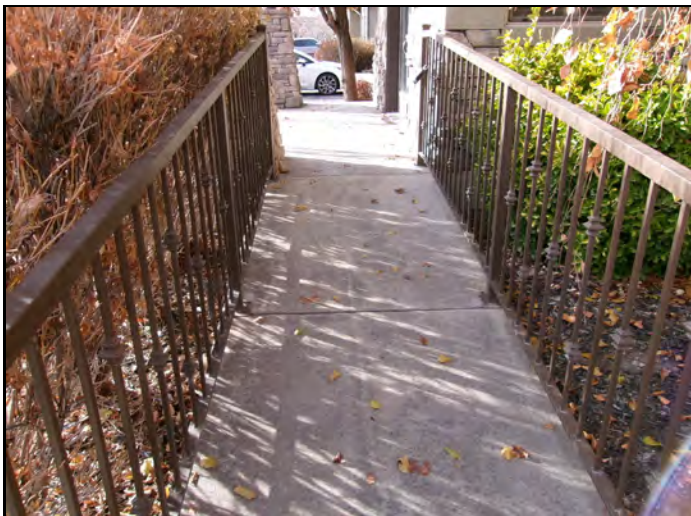
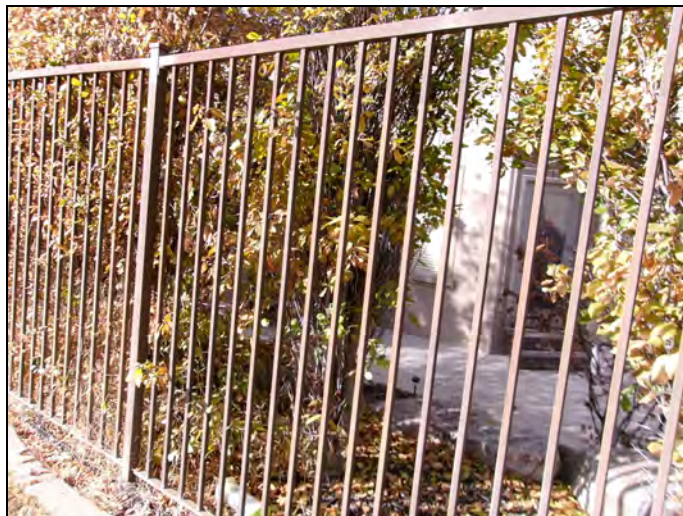
Comp #: 1002 Metal Fencing & Railing - Replace

The metal fencing and railing is in good condition. We recommend funding to replace this component approximately every 40 - 50 years. Remaining life based on current age.

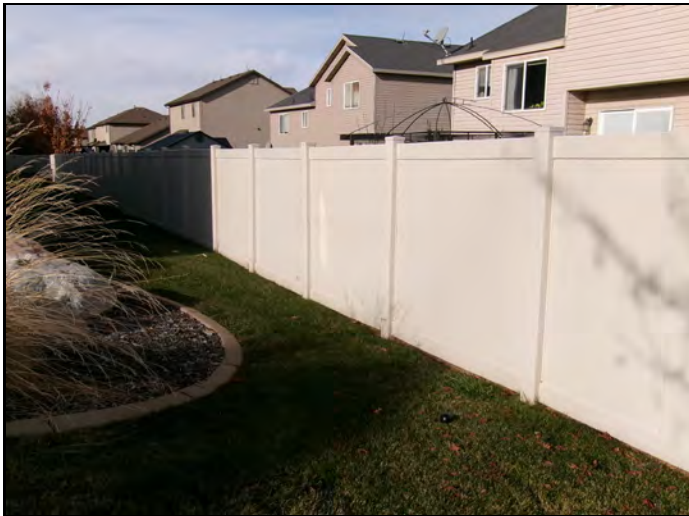
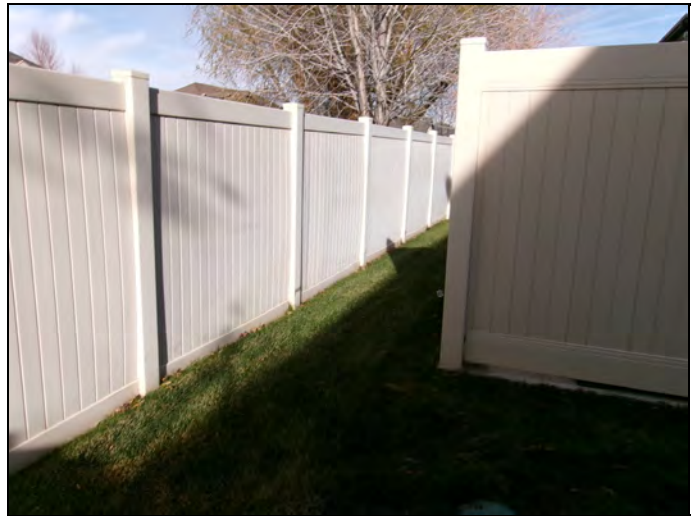
Comp #: 1008 Vinyl Fencing - Perimeter - Replace

The vinyl fencing is in good condition. We recommend funding to replace this component approximately every 25 - 30 years. Remaining life based on current age.

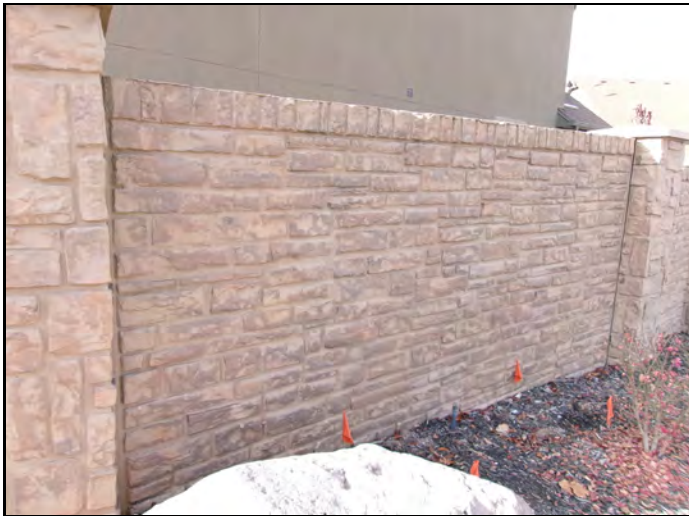
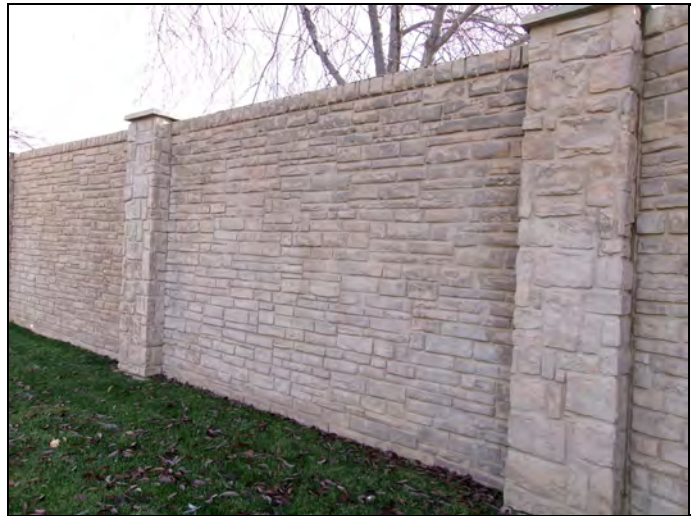
Comp #: 1012 Prefab Concrete Fence - Replace

This type of component should have an extended useful life under normal conditions. Reserve funding is not appropriate.

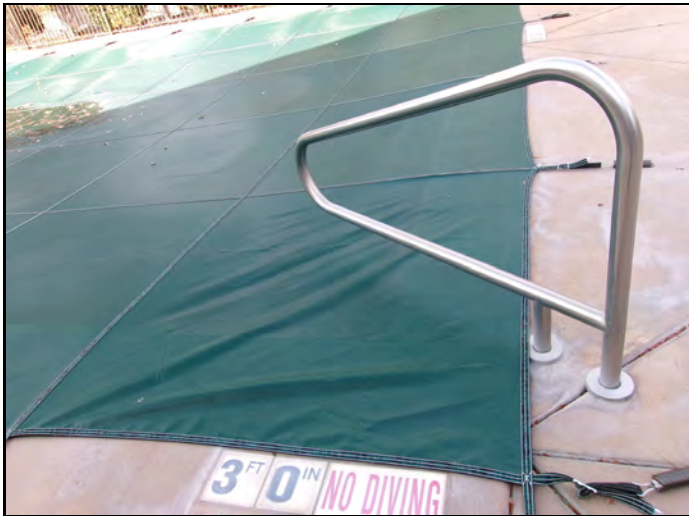
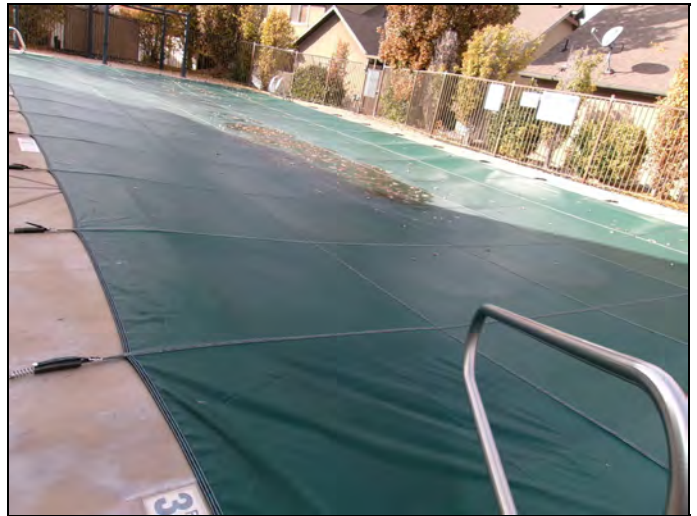
Comp #: 1101 Pool - Resurface

Unable to inspect this component at the time of the site visit. We recommend funding to resurface this component every 10 - 12 years. Remaining life based on current age.

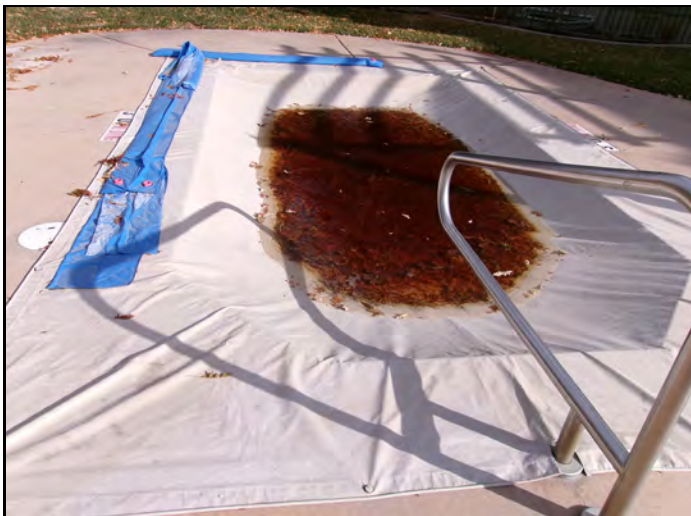
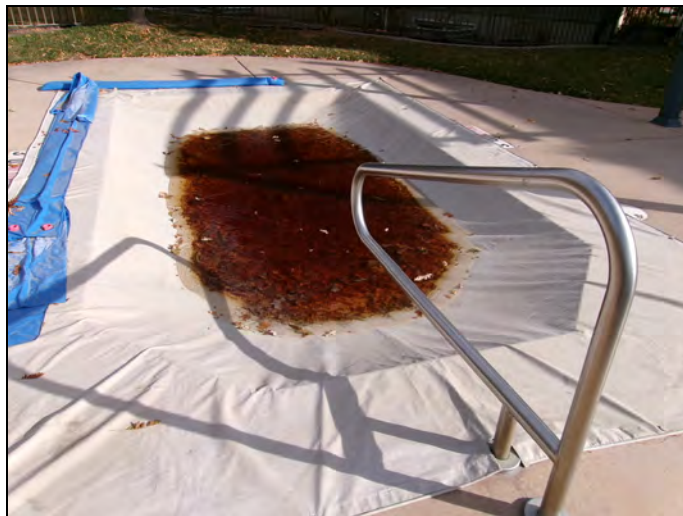
Comp #: 1102 Spa - Resurface

Unable to inspect this component at the time of the site visit. We recommend funding to resurface this component approximately every 10 - 12 years. Remaining life based on current age.

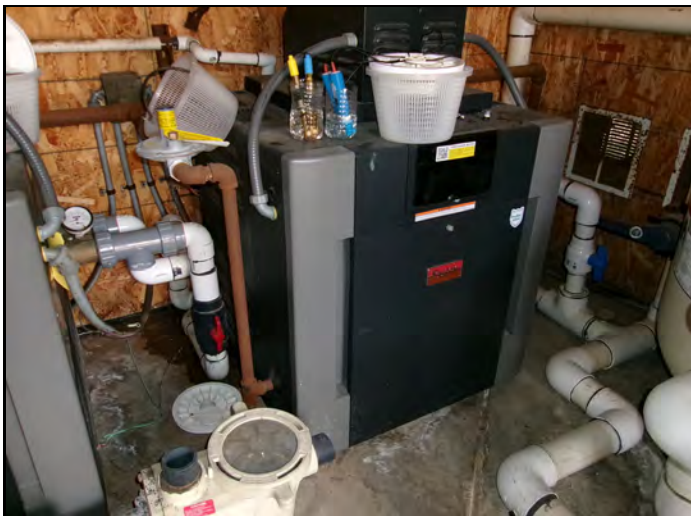
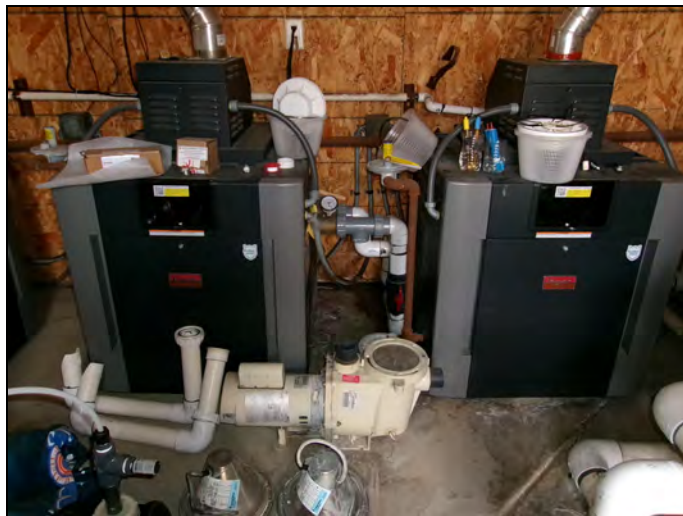
Comp #: 1104 Pool Heaters - Replace

The pool heaters are in working condition. We recommend funding to replace this component approximately every 12 years. Remaining life based on current age.

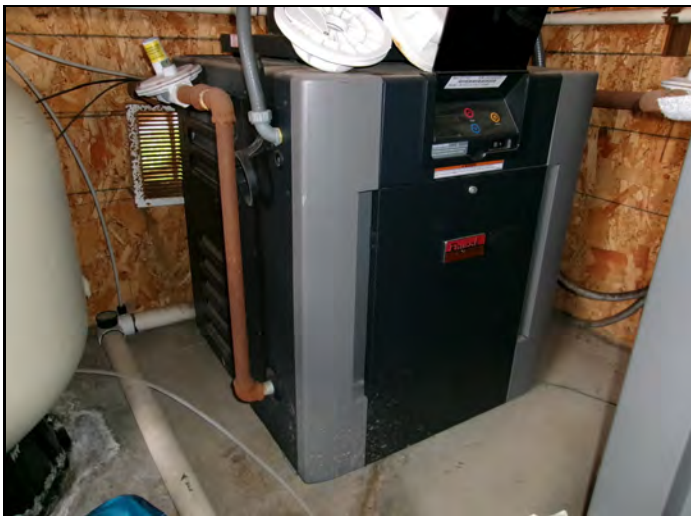
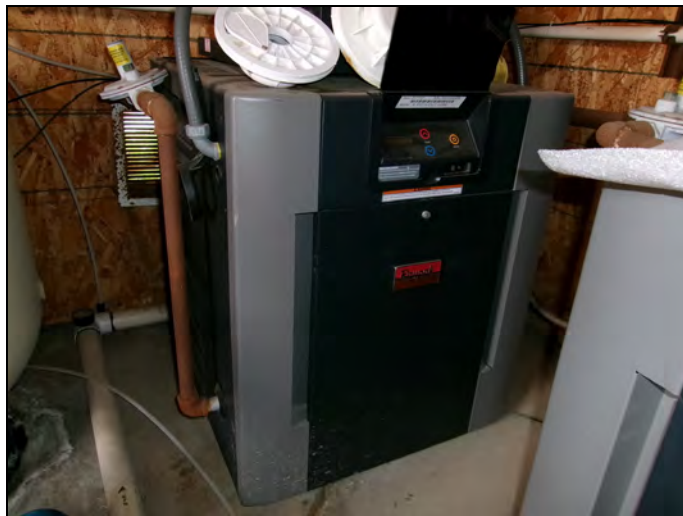
Comp #: 1105 Spa Heater - Replace

The spa heater is in working condition. We recommend funding to replace this component approximately every 12 years. Remaining life is based on current age.

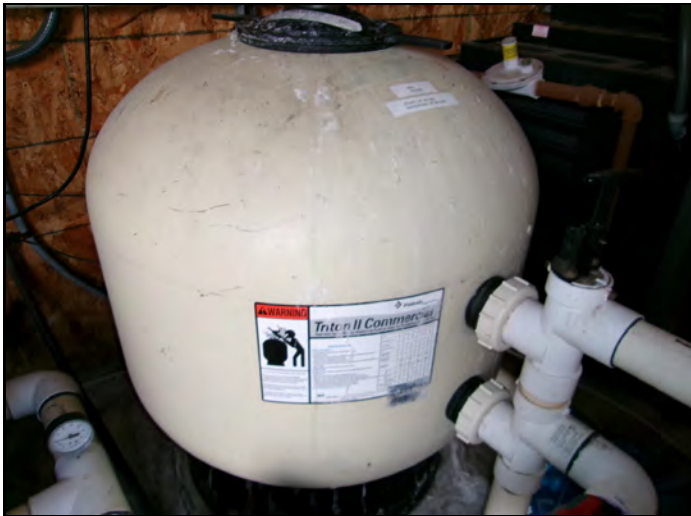
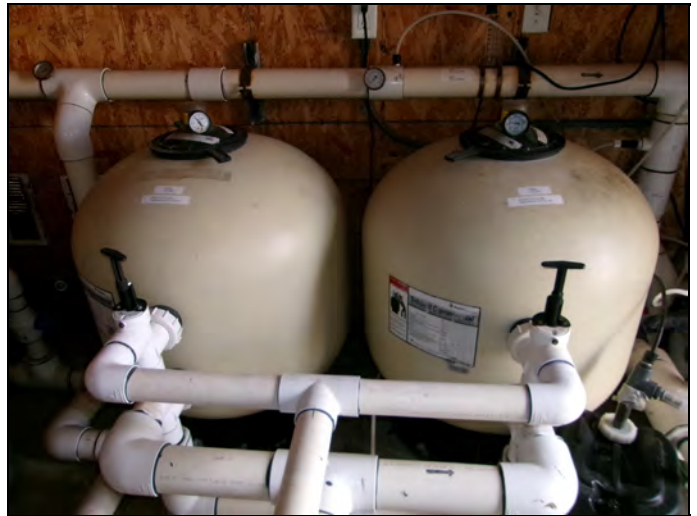
Comp #: 1107 Pool & Spa Filters - Replace

The filters are in working condition. We recommend funding to replace this component approximately every 12 - 15 years. Remaining life based on current age and condition.

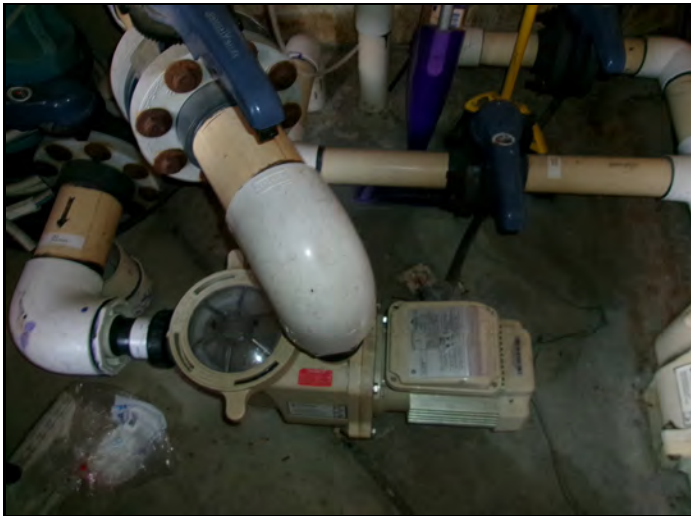
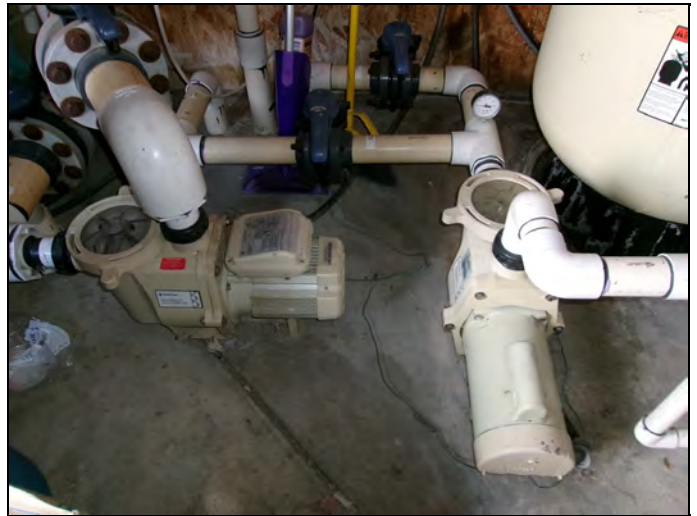
Comp #: 1110 Pool & Spa Pumps - Replace

The pumps are in working condition. We recommend funding to replace this component approximately every 8 - 10 years. Remaining life based on current age and condition.

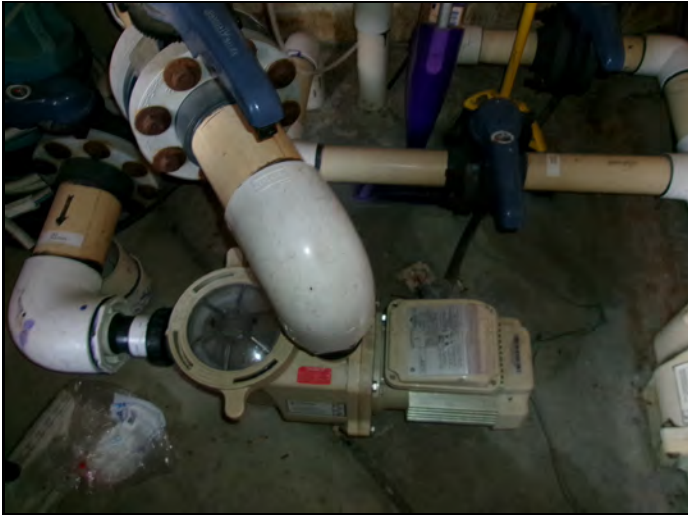
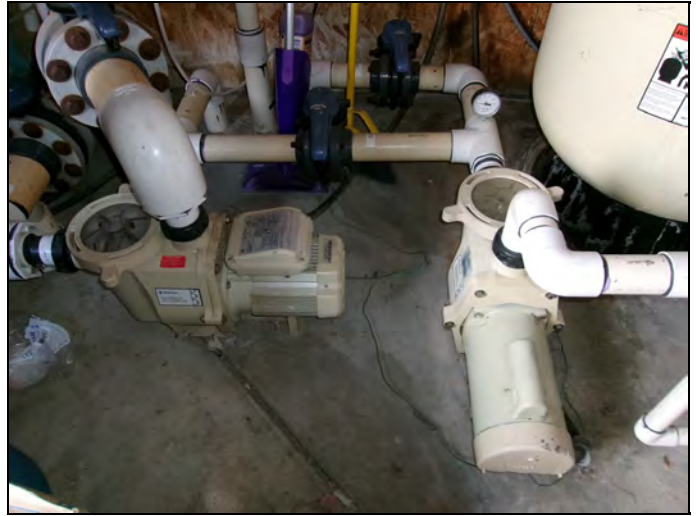
Comp #: 1110 Spa Pump - 2023 - Replace

The pool pump is in working condition. We recommend funding to replace this component approximately every 8 - 10 years. Remaining life based on current age.

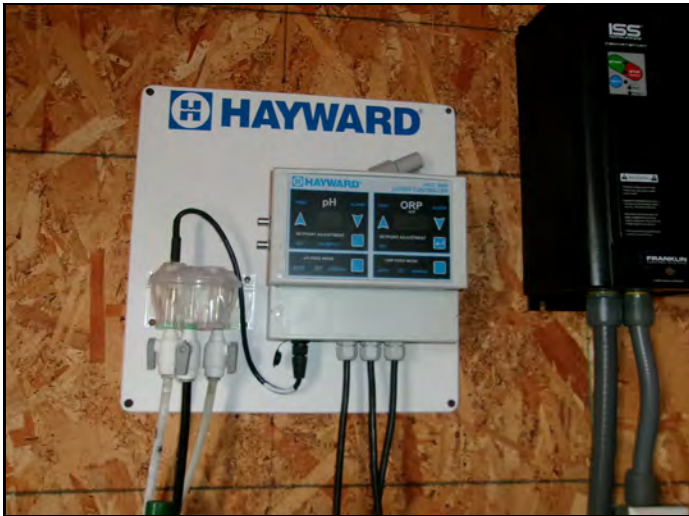
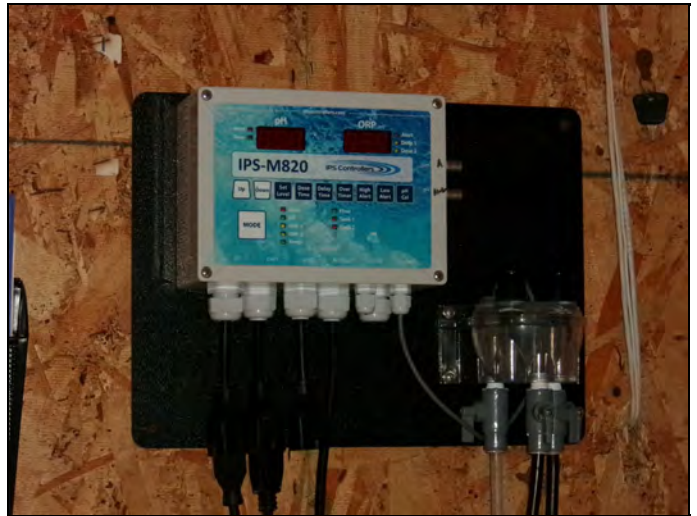
Comp #: 1111 Pool & Spa Chemical Systems - Replace

The chemical systems are in working condition. We recommend funding to replace this component approximately every 10 - 12 years. Remaining life based on current age.

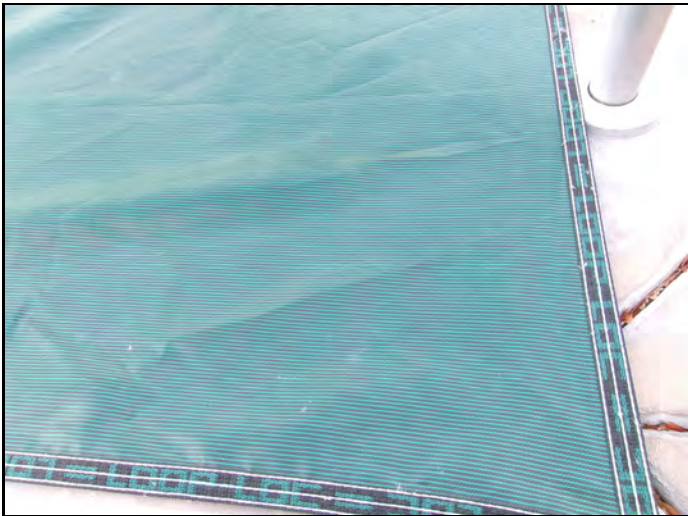
Comp #: 1112 Pool Cover - Replace

The pool cover appears to be in good condition. We recommend funding to replace this component approximately every 10 years. Remaining life based on current age.

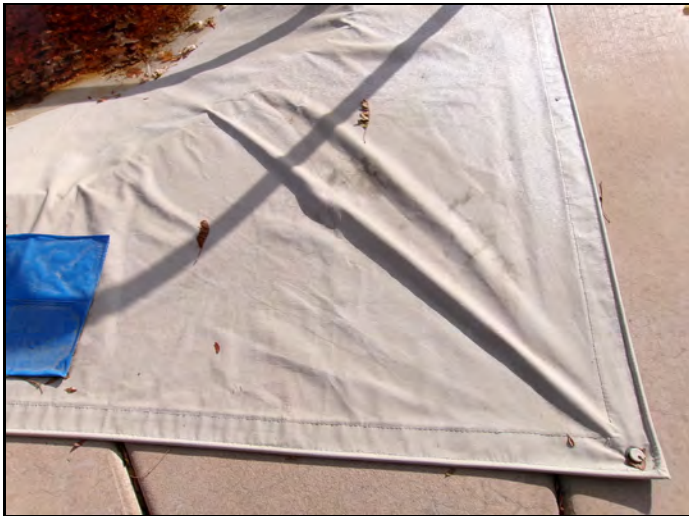
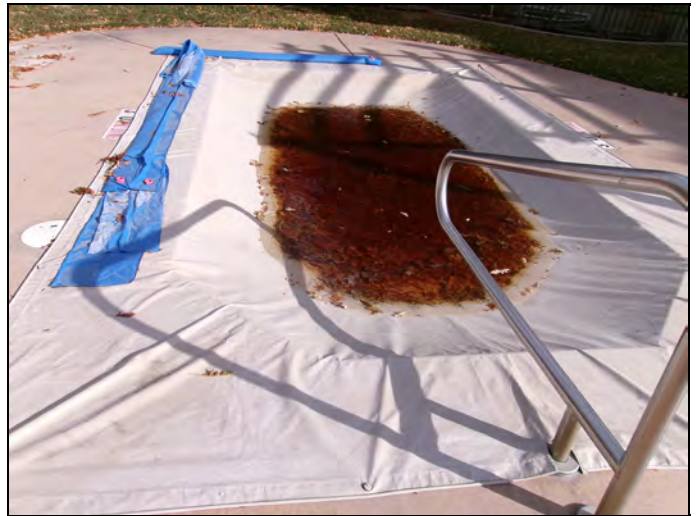
Comp #: 1113 Spa Cover - Replace

Due to the minimal cost of replacing this component, reserve funding is not appropriate. Replace as necessary as an operating expense.

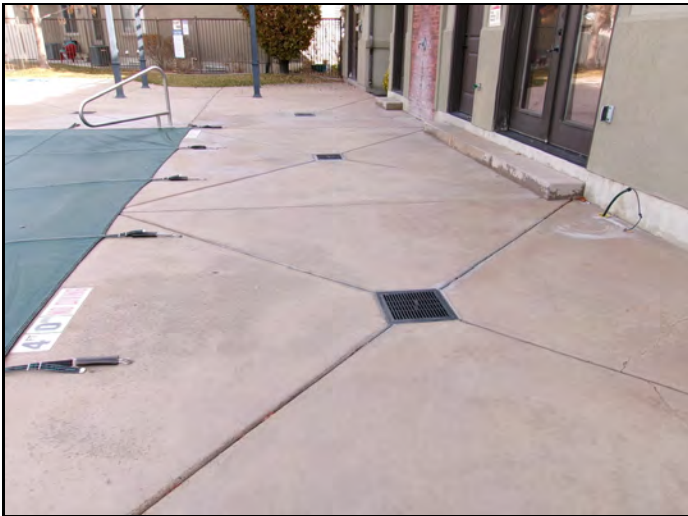
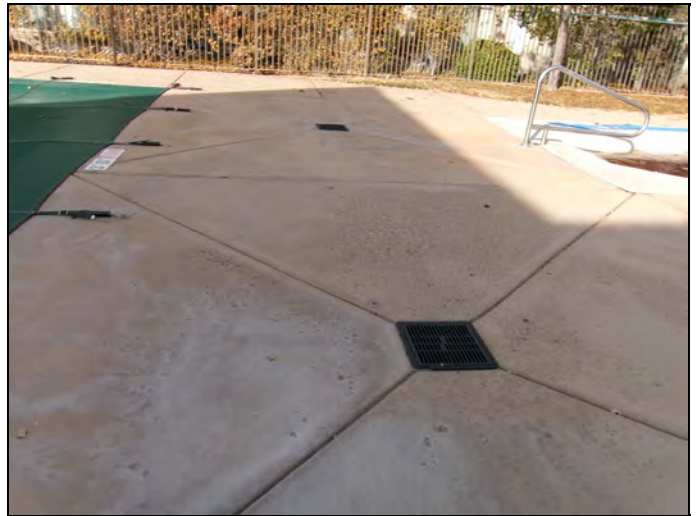
Comp #: 1116 Pool Deck - Replace

The pool deck is in good condition. We recommend funding to replace this component approximately every 40 - 50 years. Remaining life based on current age.

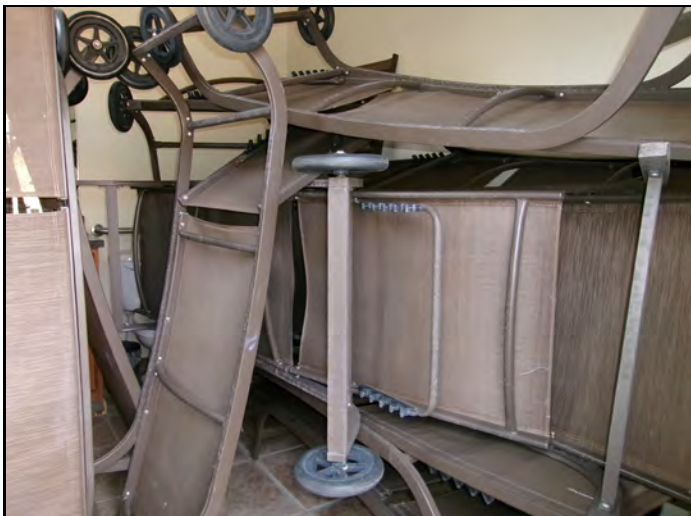
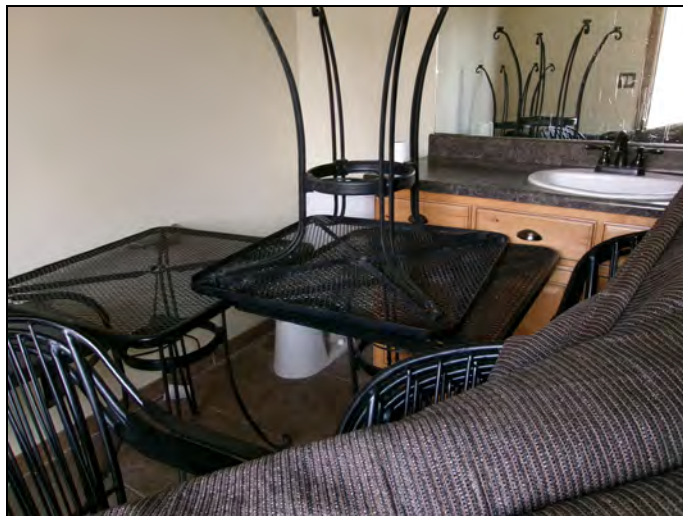
Comp #: 1121 Pool Furniture - Replace

The pool furniture is in good to fair condition. We recommend funding an allowance to make replacements to this component approximately every 6 years. Remaining life based on current age.

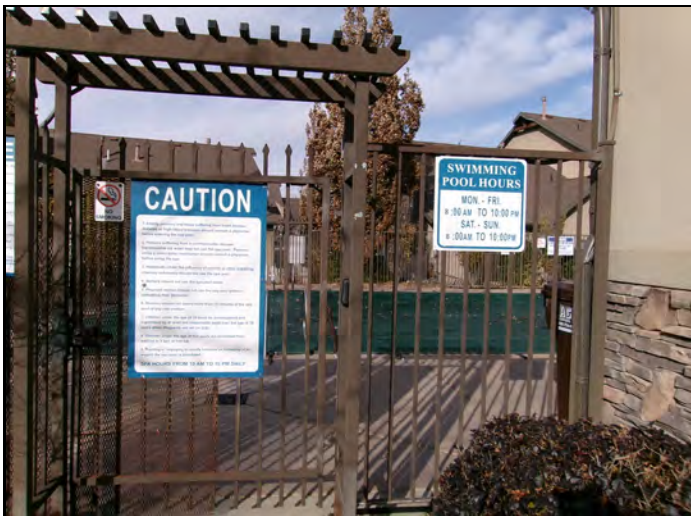
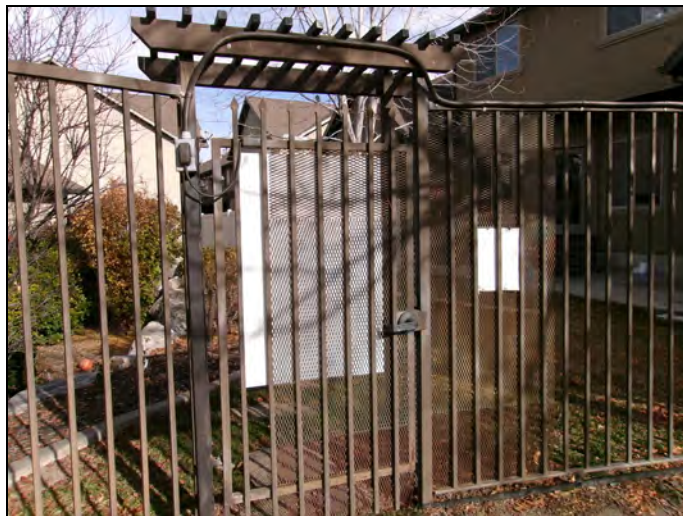
Comp #: 1190 Pool Gates - Replace

The pool gates are in good to fair condition. We recommend funding to completely replace this component approximately every 25 - 30 years. Remaining life based on current age.

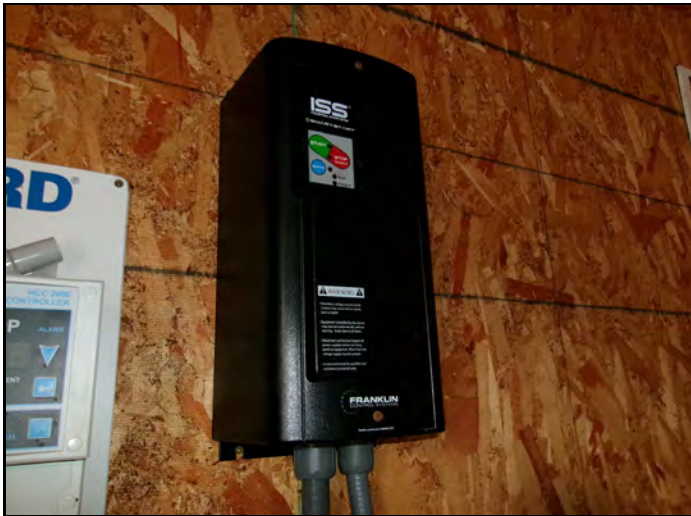
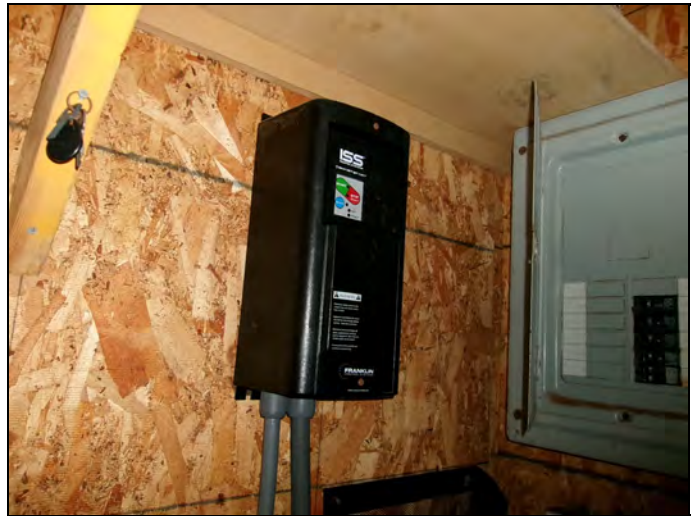
Comp #: 1190 Pump Controllers - Replace

The controllers are in working condition. NWe recommend funding to replace this system approximately every 10 - 15 years. Remaining life based on current age and condition.

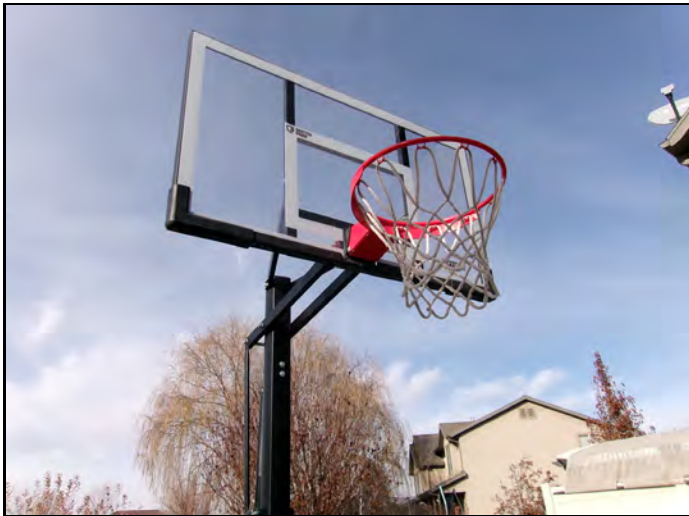
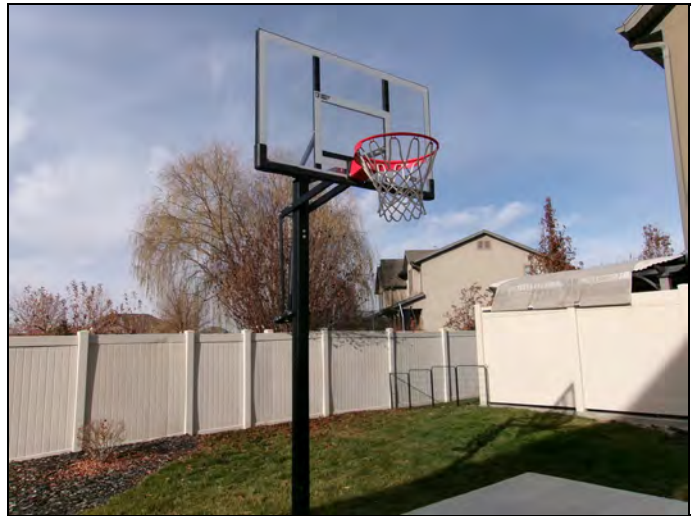
Comp #: 1207 Basketball Equipment - Replace

The basketball equipment is in good condition. We recommend funding to replace this component approximately every 10 - 15 years. Remaining life is based on current age.

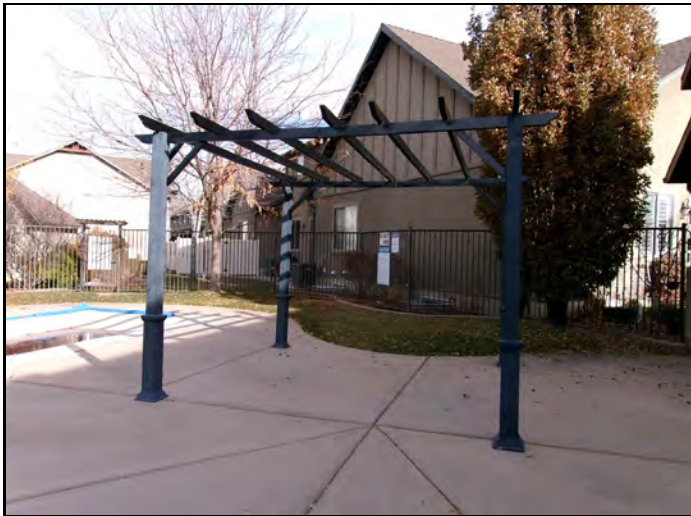
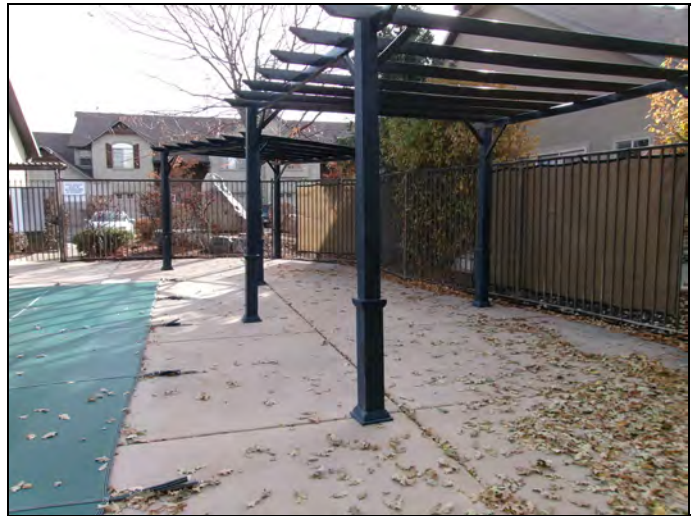
Comp #: 1309 Metal Pergola - Replace

The pergolas are in good to fair condition. We recommend funding to replace this component approximately every 30 - 40 years. Remaining life based on current age.

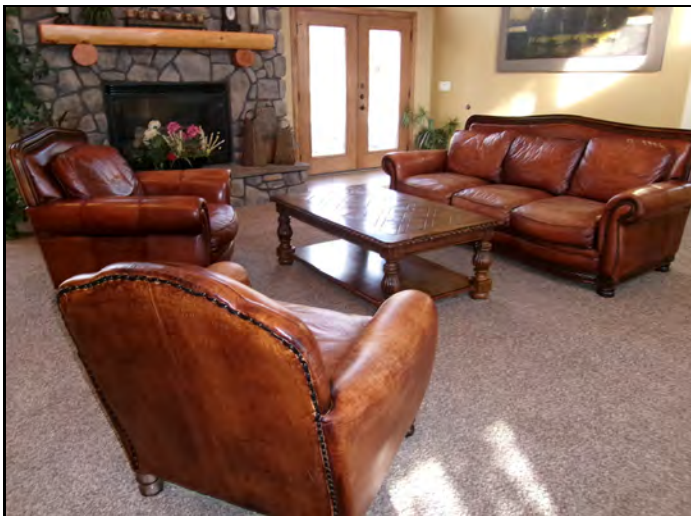
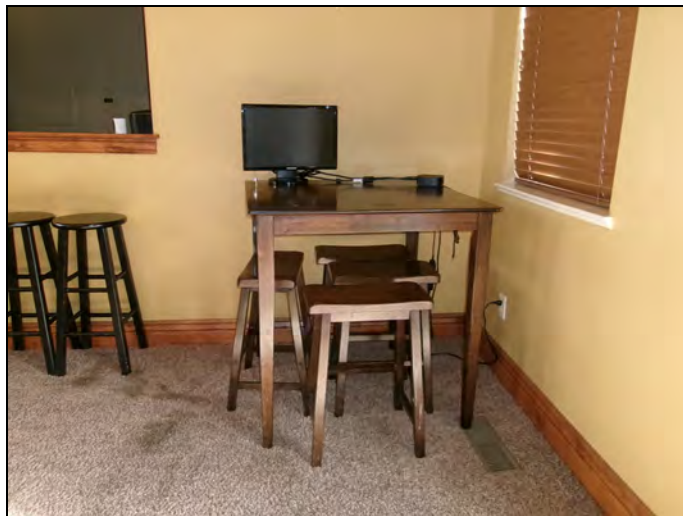
Comp #: 1405 Furniture - Replace

The furniture is in fair condition. We recommend funding an allowance to make replacements approximately every 10 years. Remaining life based on current age.

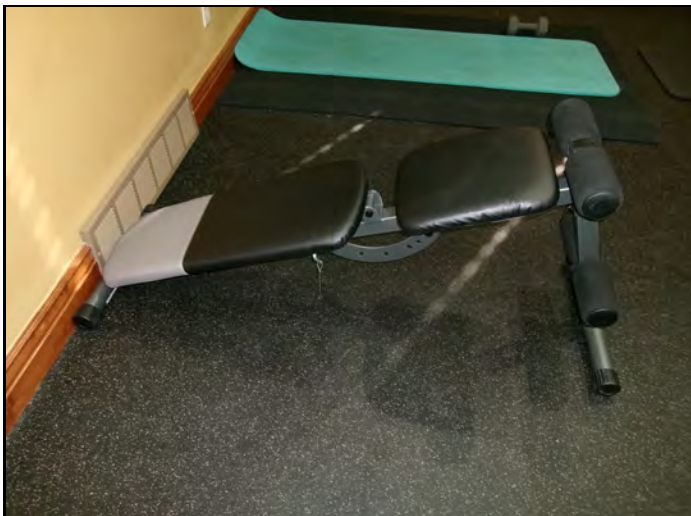
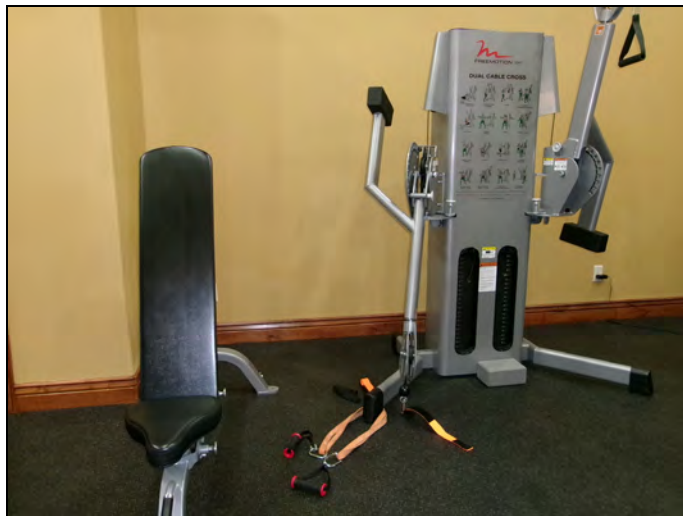
Comp #: 1406 Fitness Equipment - Replace

The fitness equipment is in working condition. We recommend funding to replace this component approximately every 15 years. Remaining life based on current age and condition.

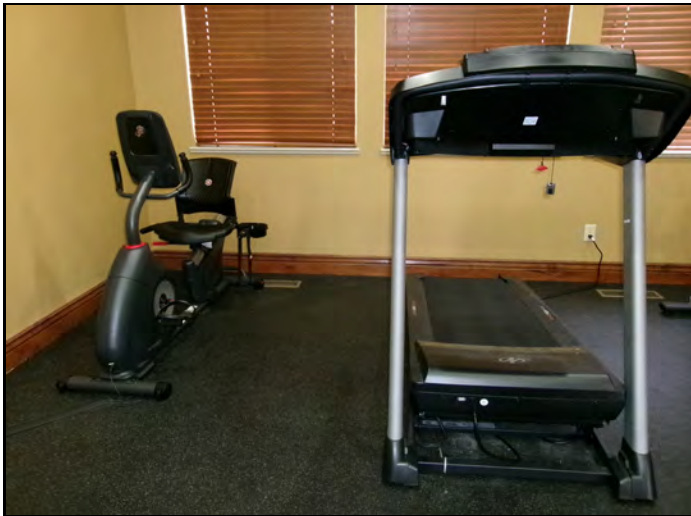
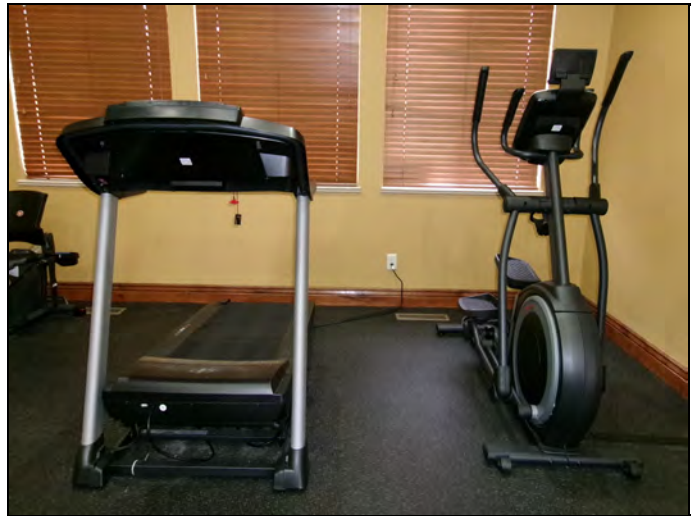
Comp #: 1407 Cardio Equipment - Replace

The cardio fitness equipment is in working condition. We recommend funding to replace this component approximately every 8 - 10 years. Remaining life based on current age and condition.

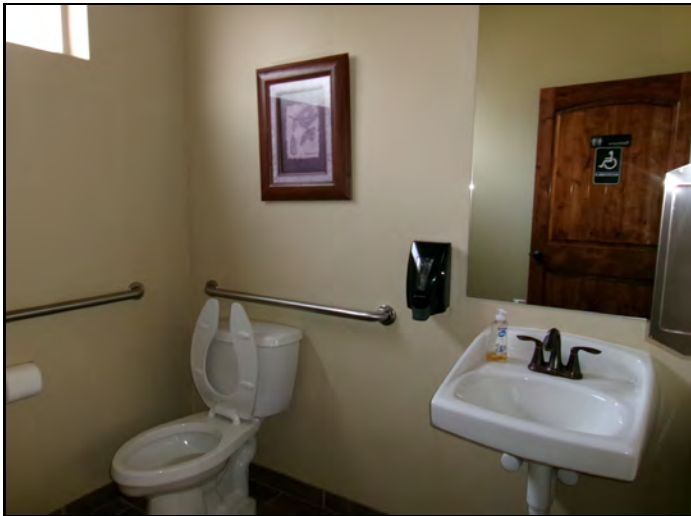
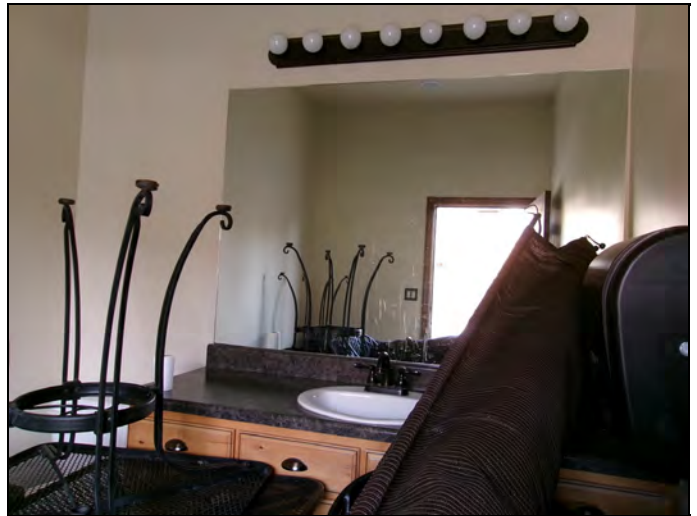
Comp #: 1413 Restrooms & Shower - Remodel

The restrooms and shower are in good to fair condition. We recommend funding to remodel this component approximately every 20 - 25 years. Remaining life based on current age.

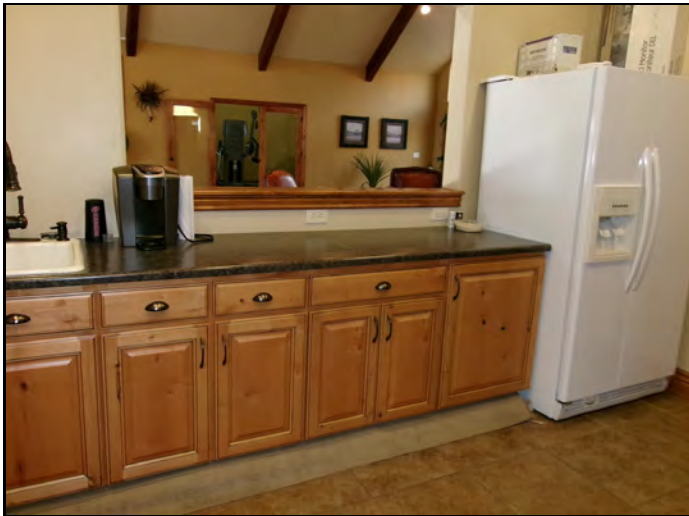
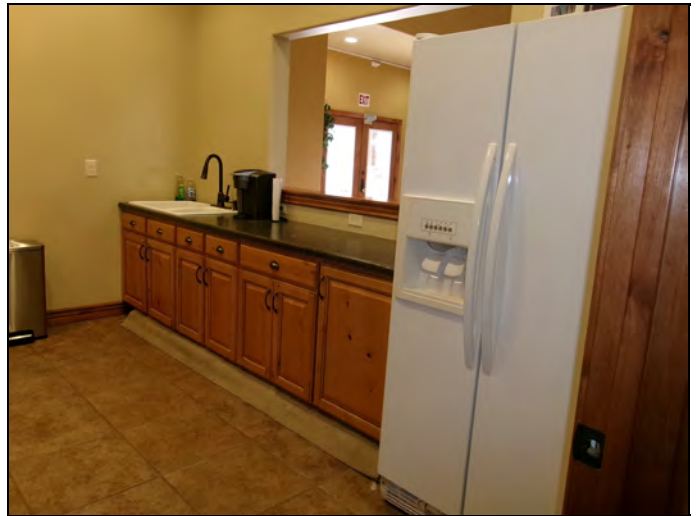
Comp #: 1417 Kitchen - Remodel

The kitchen is in good condition. We recommend funding to remodel this component approximately every 20 years. Remaining life based on current age.

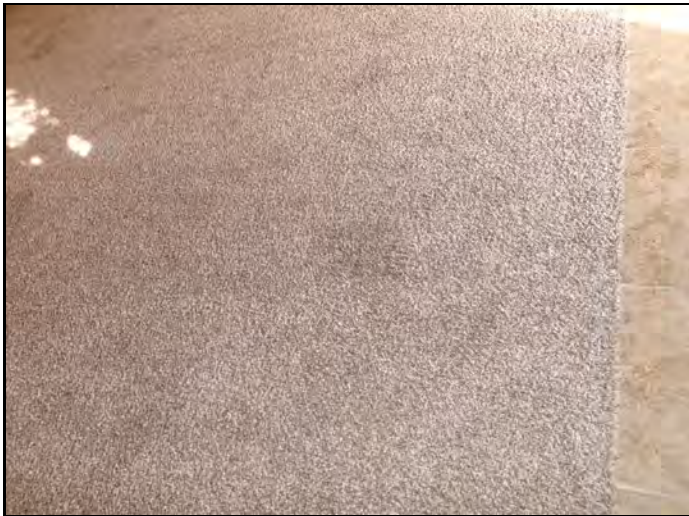
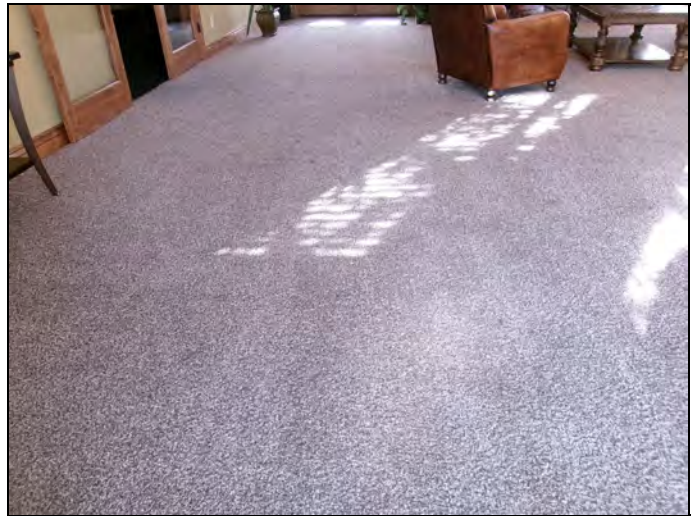
Comp #: 1501 Carpeting - Replace

The carpeting is in fair condition. We recommend funding to replace this component approximately every 8 - 10 years. Remaining life based on current age and condition.

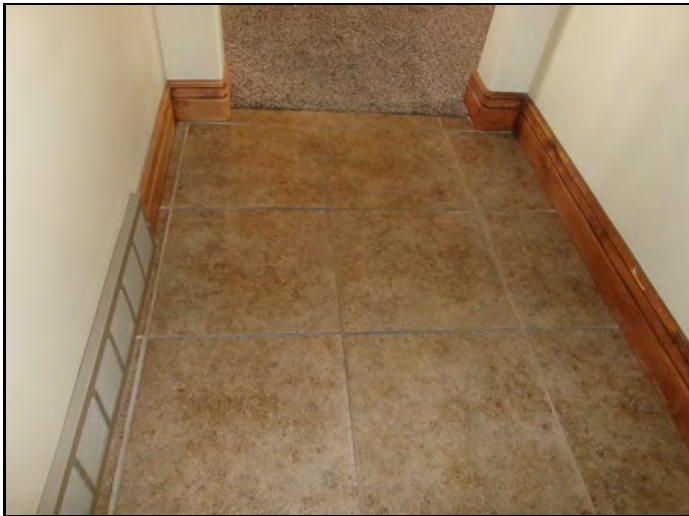
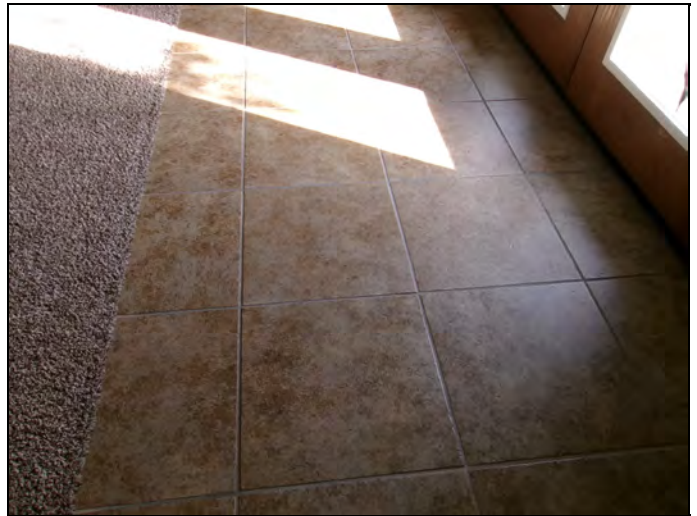
Comp #: 1503 Tile Flooring - Replace

The tile flooring is in good condition. We recommend funding to replace this component approximately every 30 years. Remaining life based on current age.

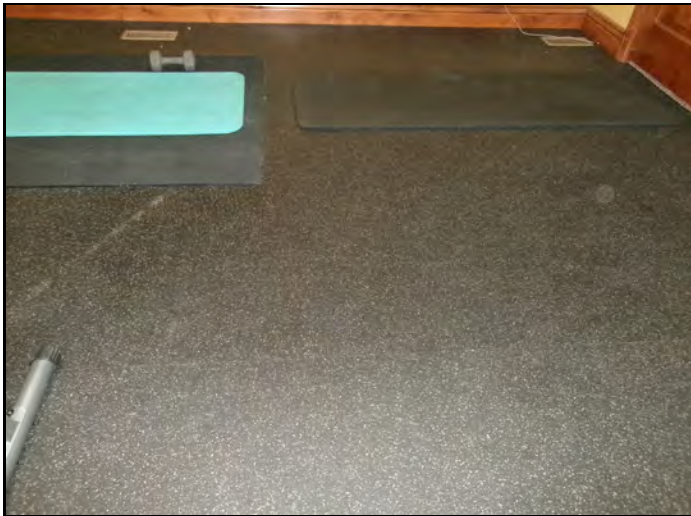
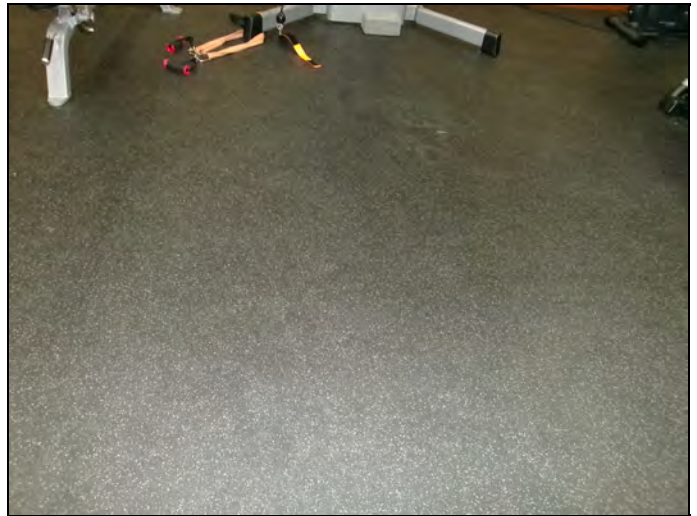
Comp #: 1590 Rubber Safety Flooring - Replace

The rubber safety flooring is in good condition. We recommend funding to replace this component approximately every 10 - 12 years. Remaining life based on current age and condition.
