Stone Creek Canyon HOA

Level 2 Reserve Study

Report Period – 01/01/2025 – 12/31/2025

Type of Study	Update w/Site Visit
Date of Property Inspection	12/11/2024
Prepared By	Dale Gifford
Analysis Method	Cash Flow
Funding Goal	Full Funding

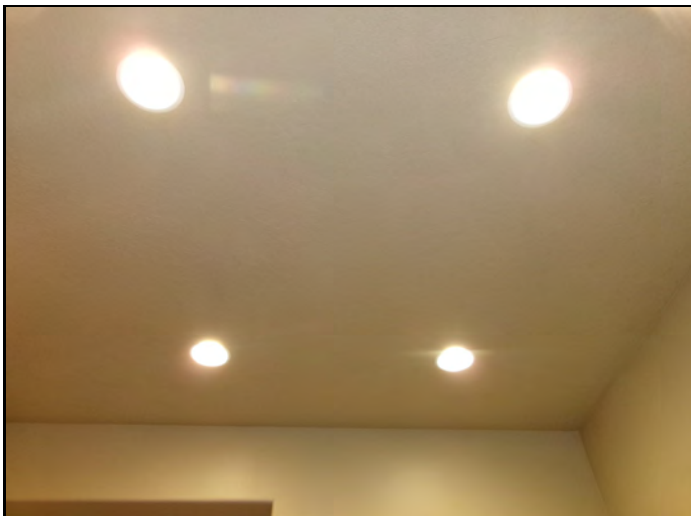
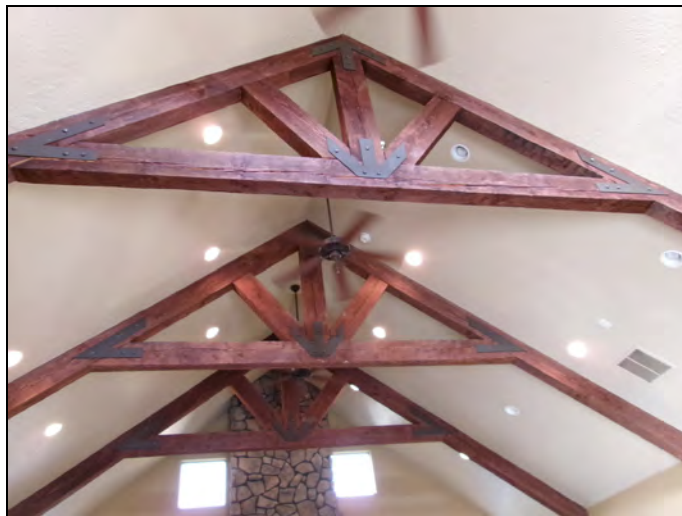
Comp #: 1601 Interior Light Fixtures - Replace

The interior light fixtures are in good condition. We recommend funding to replace this component approximately every 20 - 25 years. Remaining life based on current age.

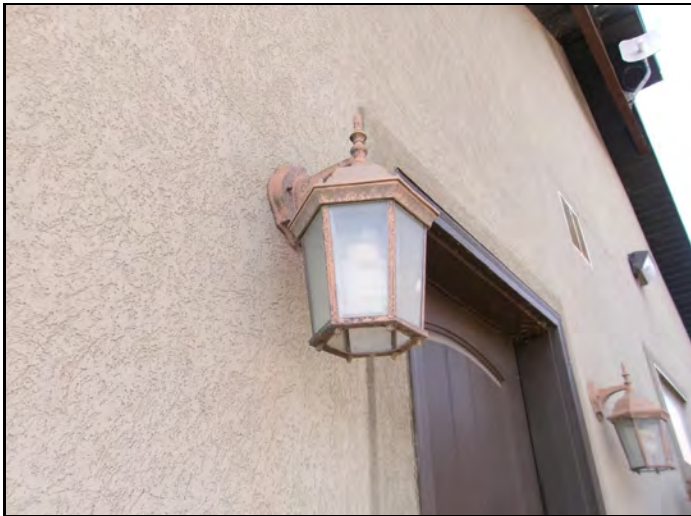
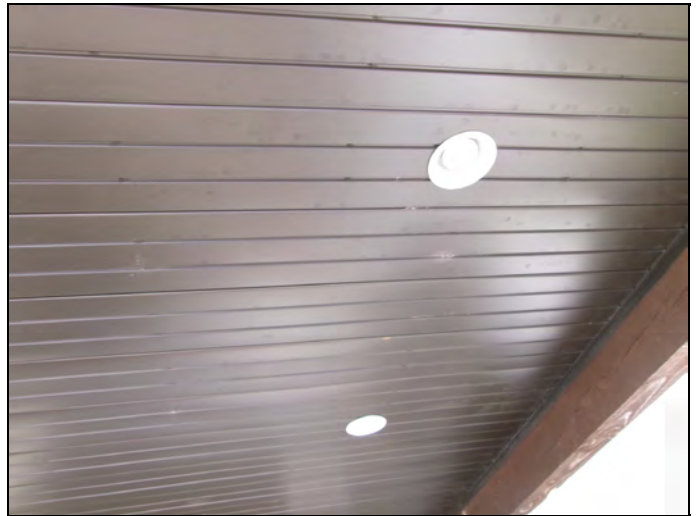
Comp #: 1602 Exterior Light Fixtures - Clubhouse - Replace

The exterior light fixtures are in fair condition. We recommend funding to replace this component approximately every 16 - 20 years. Remaining life based on current age.

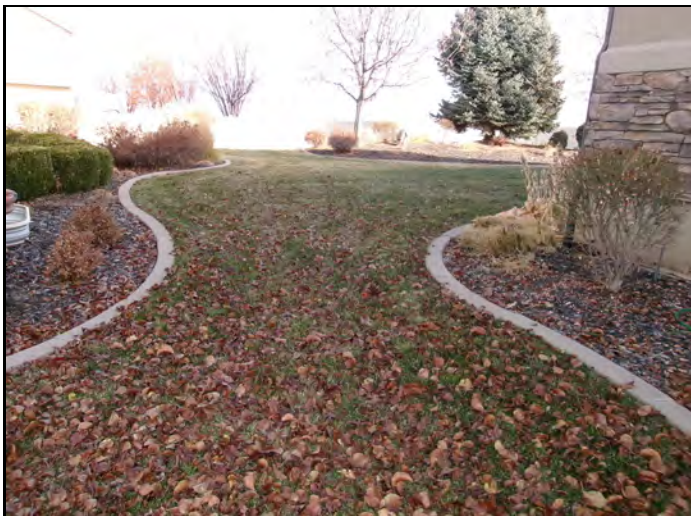
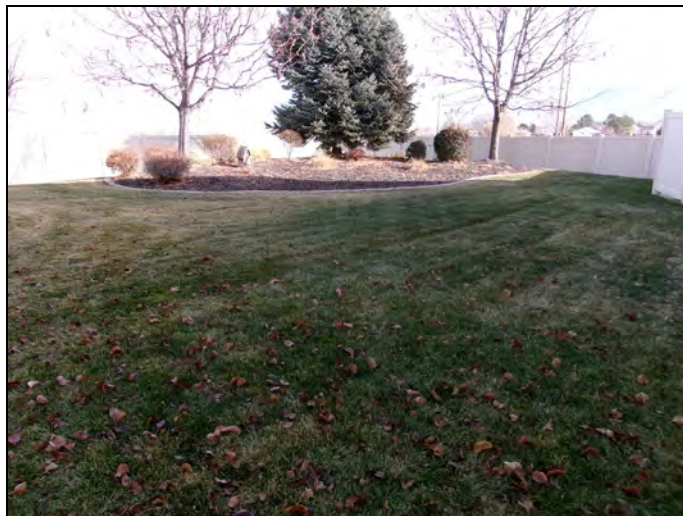
Comp #: 1812 Landscaping & Irrigation System - Renovate

The landscaping and irrigation system appear to be in good to fair condition. We recommend funding for an allowance to renovate this component approximately every 20 years. Remaining life based on current age.

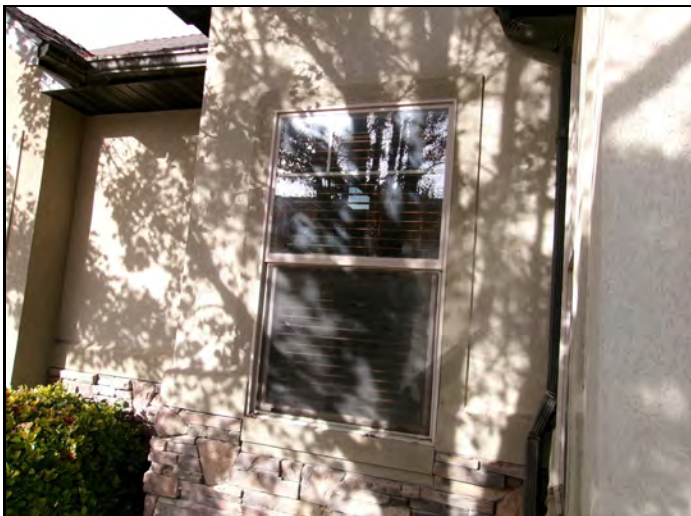
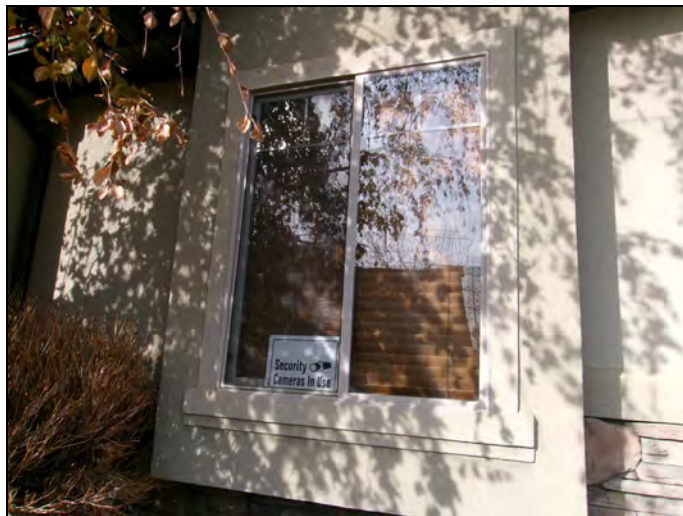
Comp #: 2303 Windows - Replace

The windows appear to be in good condition. We recommend funding to replace this component approximately every 40 - 50 years. Remaining life based on current age.

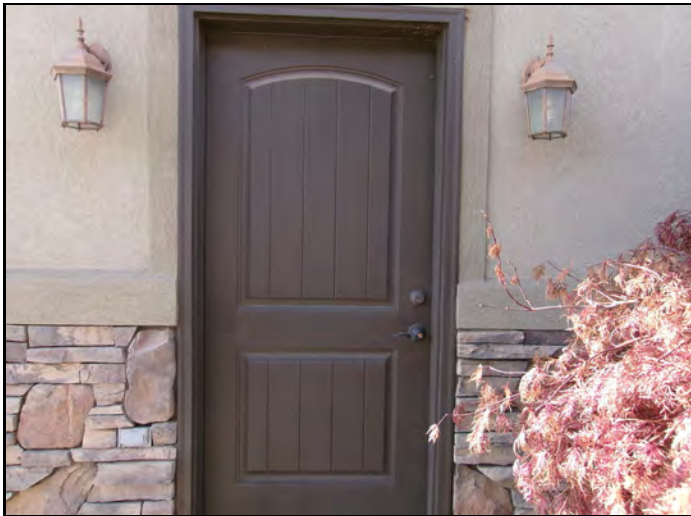
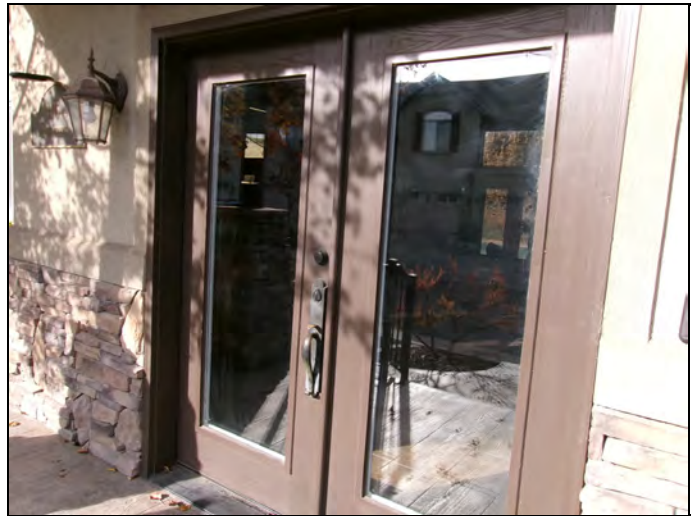
Comp #: 2304 Exterior Doors - Replace

The doors are in good to fair condition. We recommend funding to replace this component approximately every 40 - 50 years. Remaining life based on current age.
