Re: **Cormorant Lake Dam**  
**Dam Inspection Report**  
NID ID No.: LA00395  
St. Tammany Parish

# LADOTD DAM INSPECTION AND EVALUATION REPORT

Inspection Date: 12/15/2021

Name of Dam: Cormorant Lake  
Downstream Hazard: Low  
NID ID #: LA00395  
Parish: St. Tammany  
DOTD District: 62  
District Contact: Jennifer Branton, P.E.

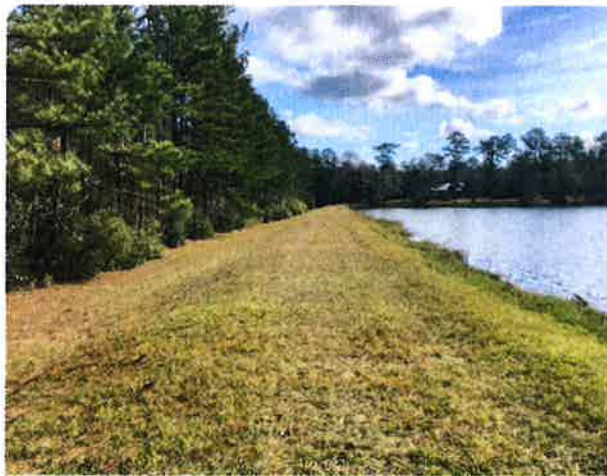
Embankment Crown Photo 1

*No deficiencies identified*

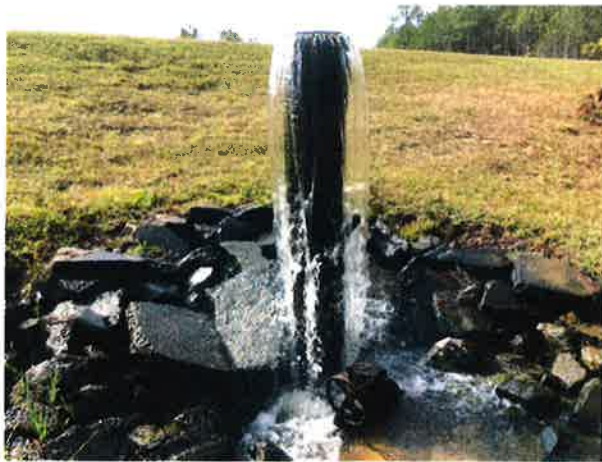
Primary Spillway Photo 1

<b>Spillway Classification:</b>	Primary
<b>Spillway Type:</b>	Uncontrolled
<b>Spillway Description:</b>	12-inch diameter steel riser pipe
<b>Crest Description:</b>	None
<b>Stilling Basin:</b>	The earthen stilling basin has some minor erosion.
<b>End Sill:</b>	None
<b>Approach Channel:</b>	None
<b>Discharge Channel:</b>	Earthen streambed to Simmons Creek
<b>Gates and Operations:</b>	None
<b>Spillway Drains:</b>	None
<b>Comments:</b>	No additional comments.

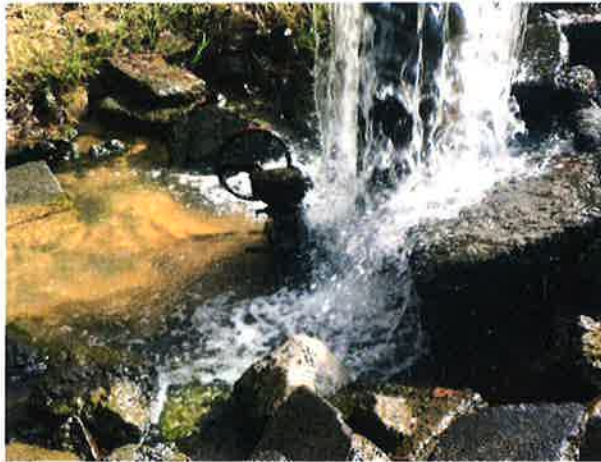
Outlet Works Photo 1

<b>Intake Structure:</b>	The upstream end of the steel riser pipe.
<b>Outlet Channel:</b>	Earthen channel that is a tributary to Simmons Creek
<b>Gates and Related Devices:</b>	None
<b>Comments:</b>	No additional comments.

*No deficiencies identified*

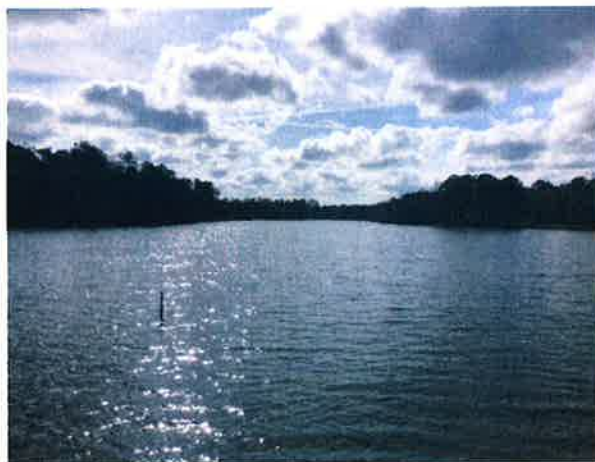
Reservoir Photo 1

The reservoir slopes appear to be in satisfactory condition and fulfilling their intended purpose.

The reservoir banks appear to be in satisfactory condition and fulfilling their intended purpose.

There were no visible areas of sedimentation occurring within the reservoir at the time of the inspection.
