Mill Pond Salt Marsh Restoration Alternatives Assessment Technical Memorandum

Town of Truro
Truro, MA

June 2022

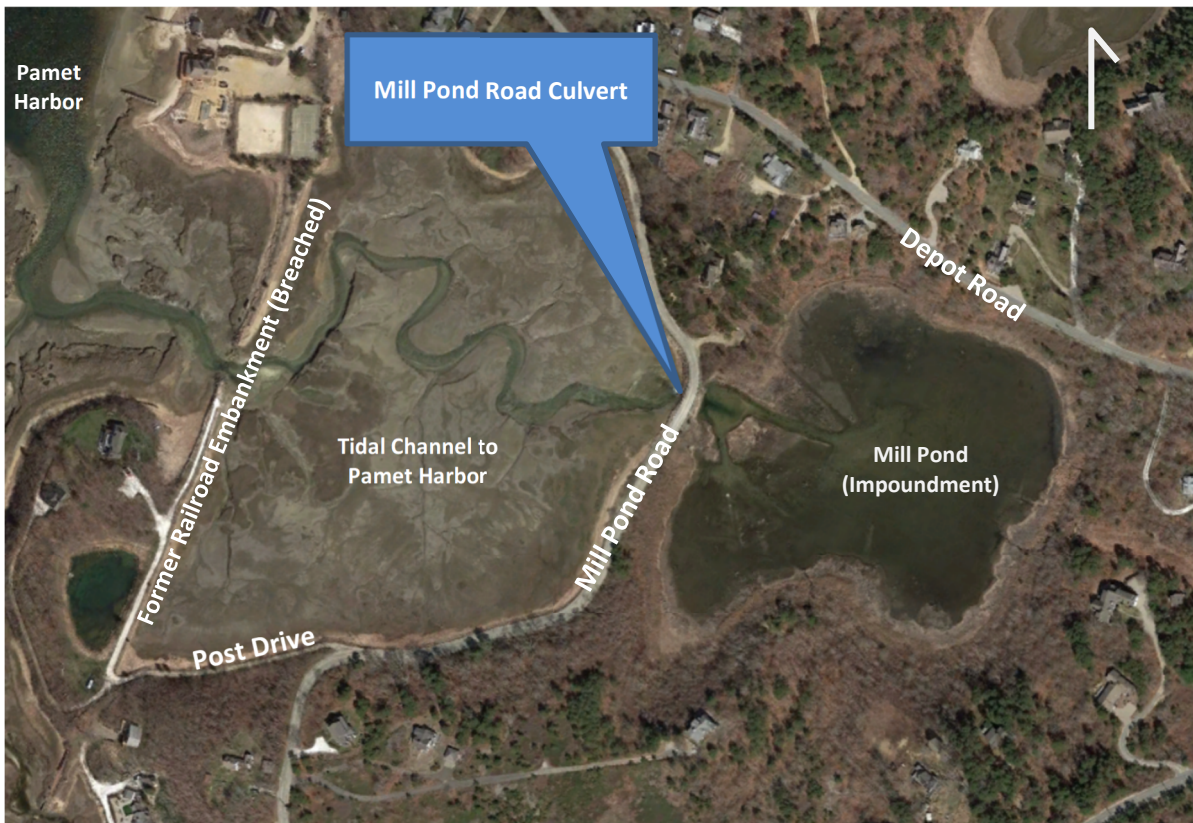
Figure 1 — Mill Pond Road Culvert Location

The earthen causeway supporting Mill Pond Road (MPR) effectively functions as a dike restricting tidal flows to, and drainage flows from, the Mill Pond impoundment. A 36-inch corrugated polyethylene pipe (CPP) conveys drainage from Mill Pond to the Pamet River (Figure 1).

The freshwater condition remained until large storm events in 1978 and 1991 completely breached the former railroad embankment. The existing 36-inch CPP pipe was installed after the 1991 storm as a temporary measure, with the intent to subsequently install a larger timber bridge as a permanent structure. The bridge was never constructed and the 36-inch CPP remains today.

The roadway embankment covering over the culvert is subject to wave and roadway runoff erosion, resulting in a narrowing of the roadway shoulders over the culvert, and requiring regular repair and replenishment of stone armor scour protection.

The purpose of this project is to replace the undersized culvert that tidally restricts Mill Pond with a larger structure or channel breach alternative that will allow increased tidal flushing to restore degraded salt marsh resources, provide water quality improvements, and improve drainage runoff flows from the impounded system under both normal and storm flow conditions.

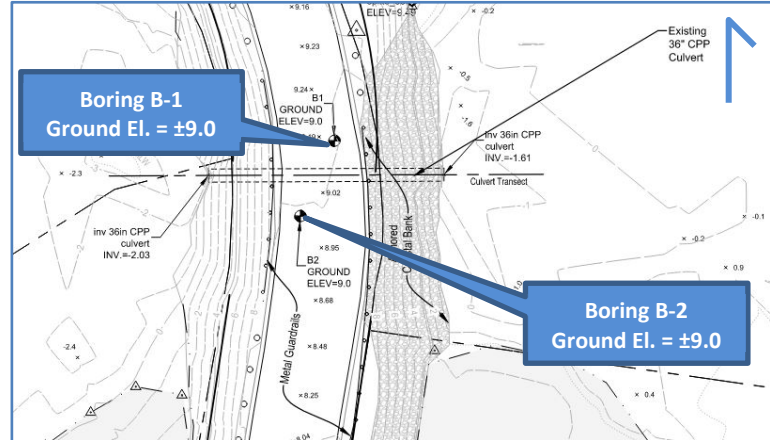
Figure 7 — Subsurface Boring Locations

approximate locations of the borings are depicted in [Figure 7](#). All borings were observed and logged by a Fuss & O'Neill engineer. Boring logs are provided as [Attachment D](#).

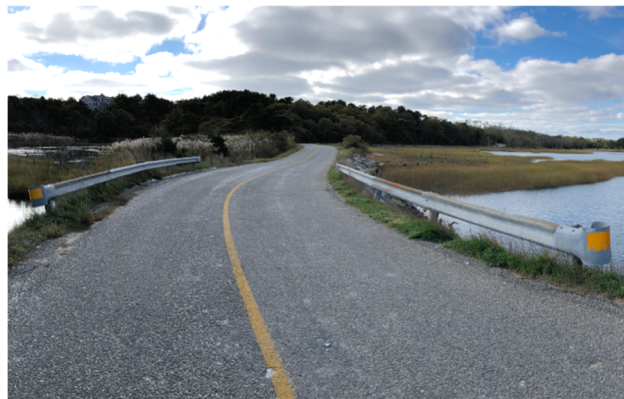
Figure 8 — Mill Pond Road Layout (facing south)

Mill Pond Road's cross-section over the embankment and culvert currently consists of two approximately 9-foot wide travel lanes (no outer stripes) with approximate 12-inch wide grassed shoulders inside the face of metal beam guardrails bordering the embankment over the tidal channel, as shown on [Figure 8](#). The conceptual roadway section depicted on drawings included in [Attachment F](#) maintains existing travel lane widths within the limits of excavation required to construct the culvert, which conforms to the Town's requirements for a "Type B" roadway (defined as a road serving 5-10 residential properties).

Steel-backed timber guardrails are conceptually proposed to replace the existing metal beam guardrails. Standard MassDOT guardrail section requirements including a minimum of 24-inches of compacted soil behind guardrails to provide lateral support for driven posts, as shown on [Figure 9](#). Guardrails are conceptually depicted along both lanes within the limits of excavation associated with the culvert, and would be evaluated in future design phases to adjacent the extent required along both lanes to provide adequate protection to prevent errant vehicles from striking the bridge's wingwalls or entering the steeply sloped banks and open water.
