Jun 20th, 2023

1234 Skywalker Drive, Tampa, 34654

Home Inspection Report

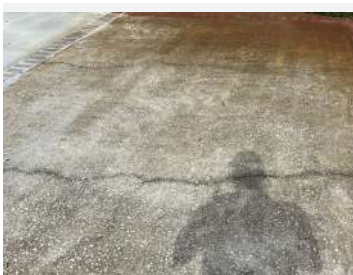
LOCATION: North

- Typical cracking noted

- Common cracks and stains present
Recommend sealing crack(s) and resurfacing as needed

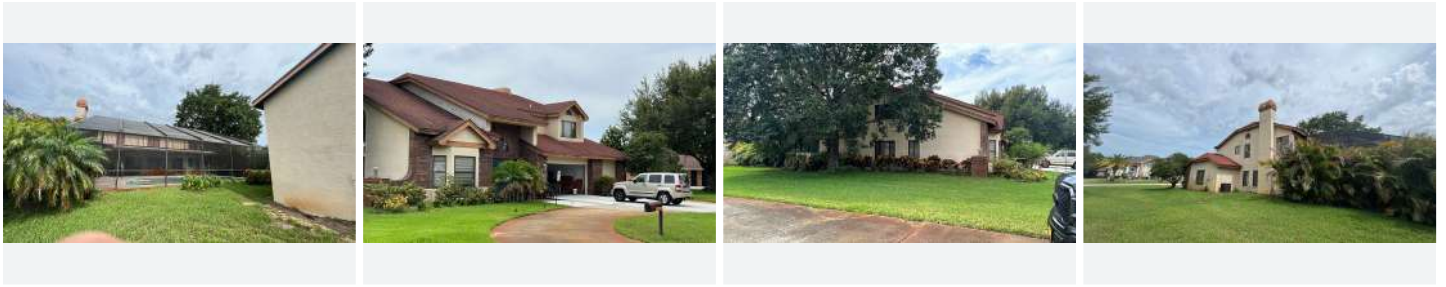
TRIM: Wood

- Water damaged/deteriorated trim

- Wood rot was noted at portions of the fascia trim. See a licensed contractor for evaluation and repair/replacement as needed.

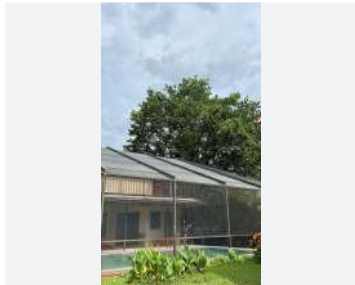
2.5 TREES AND VEGETATION

- **Overgrown/Overhanging Tree Limbs**

Tree limbs are overhanging the roof and could damage roofing material. Recommend evaluation by an arborist.

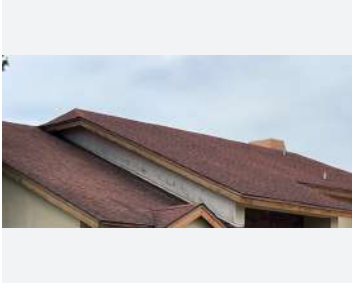
MATERIAL: Architectural Shingle

- **Roof at/near end of useful life**

life expectancy. Recommend evaluation and saving for replacement by a licensed/qualified roofer.

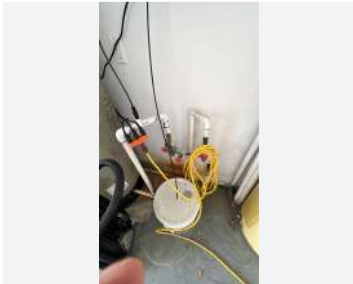
7.2 MAIN WATER SHUTOFF

- **Filtration System Not Inspected**

Inspection of the water filtration system goes beyond the scope of the inspection. Recommend servicing as needed by a licensed plumber.

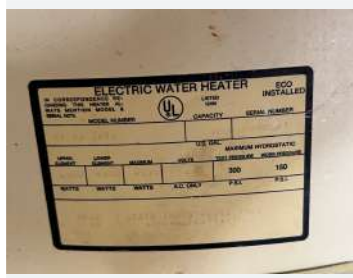
LOCATION: Garage

- Water heater has exceeded design life

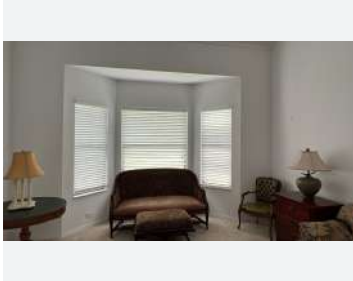
12.6 WINDOWS

- **Cracked Living Room Window**
Cracked, broken, or missing glass
