Jun 20th, 2023

123 Easy St, Tampa, 33647

Home Inspection Report

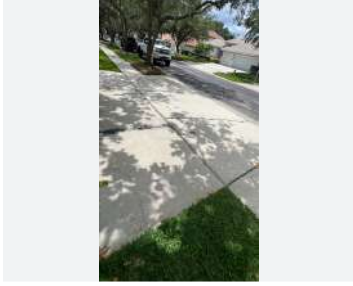
- **Raised Sections of Driveway Noted**

Heave(s) in concrete causing a trip hazard were noted at the driveway. Recommend evaluation and repair by a paving specialist.

- Recommend sealing crack(s) and resurfacing as needed

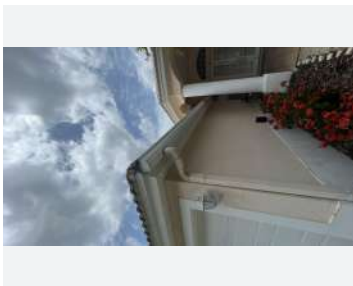
3.2 GUTTERS

- Need Cleaning

- Extend drain(s) to move water away from foundation

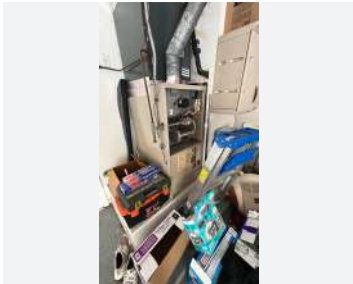
- Furnace nearing the end of its design life

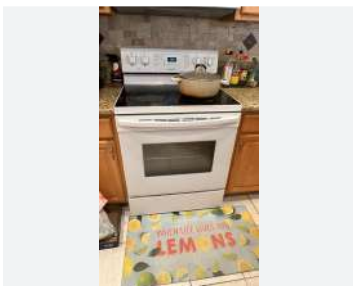
11.8 RANGE/OVEN

- Scorching on Control Board

Scorching was noted on the control board of the kitchen range. This did not appear to effect function at the time of inspection. Recommend monitoring for further issues.

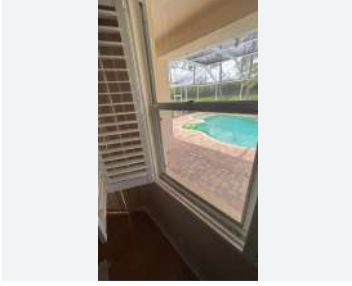
- **Mold Like Substance**

Suspected mold/mildew growth was noted on several of the windows and treatments. Recommend evaluation and cleaning by a mold abatement professional.
