Coastal Home Inspections LLC

Property Inspection Report

309 Elwood Pl., Gulfport, MS 39507
Inspection prepared for: Ken Lefebvre
Date of Inspection: 3/10/2018 Time: 1:00pm
Age of Home: 51yrs Size: 2104 sq ft
Weather: Partly Cloudy

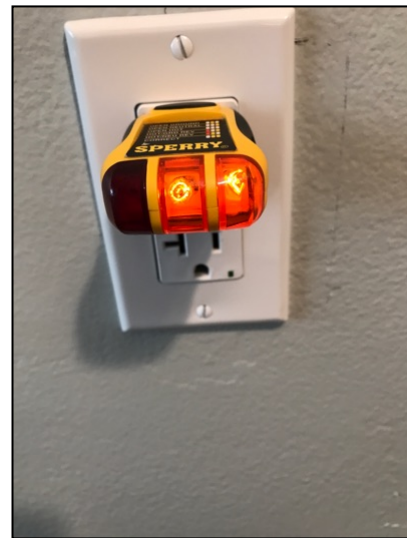
Hot-neutral reversed outlets present. This means that the black and white wires in the circuit have been reversed.

Look of tester when outlet is wired correctly.

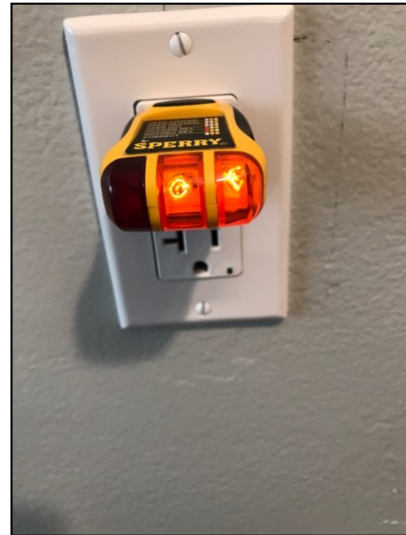
- Hot-neutral reversed outlets present. This means that the black and white wires in the circuit have been reversed.

Hot-neutral reversed outlets present. This means that the black and white wires in the circuit have been reversed.

Look of tester when outlet is wired correctly.

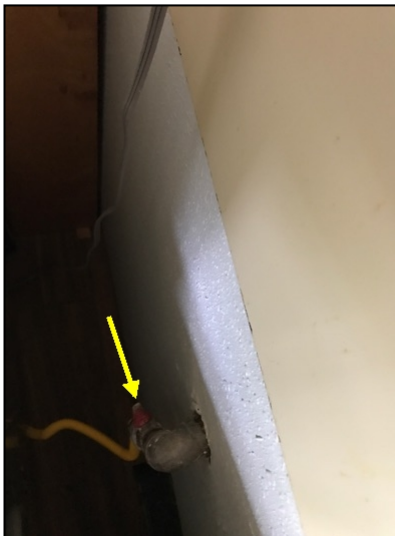
- Meter located at exterior. All gas appliances have cut-off valves in line at each unit. No gas odors detected.

Meter located at exterior. All gas appliances have cut-off valves in line at each unit. No gas odors detected.
