### Statement of Conditions that Affect EIFS Homes

The following is a case study of three homes. Two of these homes underwent the typical repairs as described previously. The third home shows what can happen even with proper sealant joints installed.

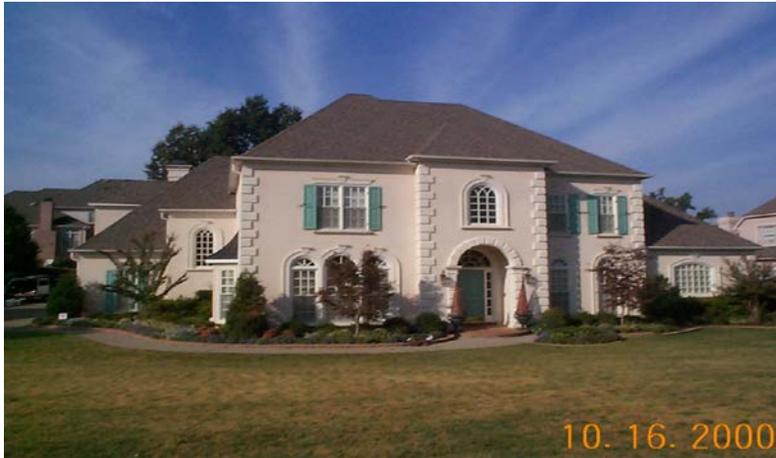
Above is a photo of a well-kept EIFS home. This home was constructed in the mid-south approximately four years ago. While talking with the owner, we realized that this home was retrofitted within the last year and a half.

On inspection of this home we found the EIFS details to be up to standard in every aspect with the exception of metal head flashing over the windows and doors.

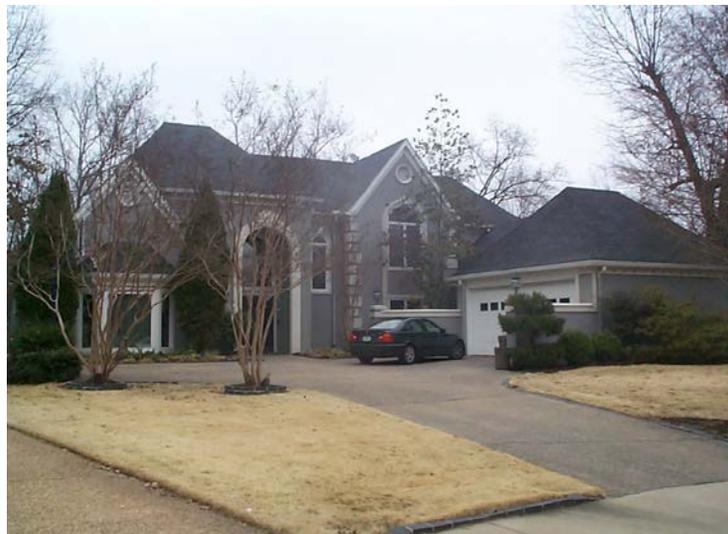
The second home is nine years old. It was custom built and the EIFS was installed by a large commercial plastering contractor.

In the fifth year, ten of the windows on this home were replaced due to rot. The same plastering contractor also brought the home into specification by installing expansion joints, proper window

and door sealant joints, metal head flashing and diverter flashings. The repair costs were over \$40,000.00.

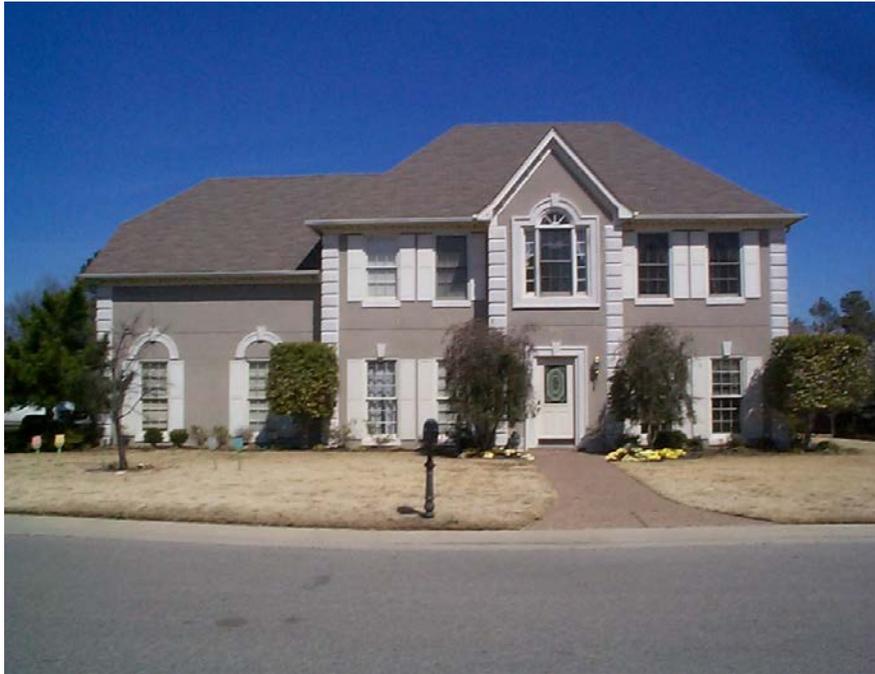
The last home in the study is slightly over four years old and has an EIFS polymer based system. This home was also constructed with proper sealant joints.
