LISCOTT CUSTOM HOMES, LTD.
PROPOSED RESIDENCE
LOT 5, BLOCK 16, WHISPERING PINES RANCH SUB #8
CTL | THOMPSON PROJECT NO. SU01733.000-120
C:\Users\briggeler\AppData\Local\Box\Box Edit\Documents\DD1R3HfME+YwHUzVwXGvg==\SU01733.000 - 120 - R1.docx

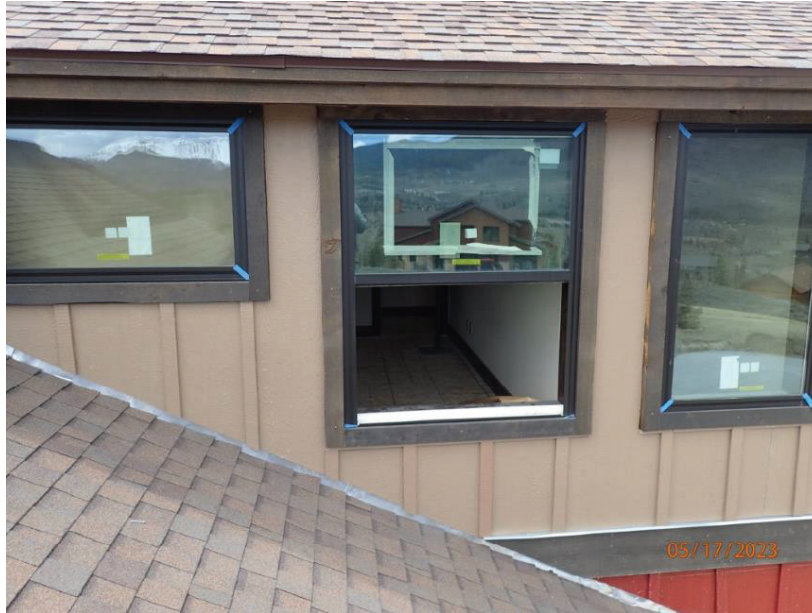
As constructed, the siding and trim at the Property contain untreated cut ends that are in violation of the manufacturers' requirements. The as-built untreated edges will promote moisture absorption and result in premature deterioration of the products in the forms of swelling, delamination, strength loss, and probable biogrowth. These issues are compounded where untreated cut ends are placed without compliant clearance to adjacent surfaces and flashings, as may be discussed in other sections of this report.

May 17, 2023, Disc OBS1, Photograph 271, DLC, 101 Mule Deer Court, looking west from garage roof.

It is CTETS's opinion that, due to this condition being present at all locations where the siding and trim have been installed, the only reasonable remedy to these conditions would be to fully remove and replace all siding and trim installed on the Project.

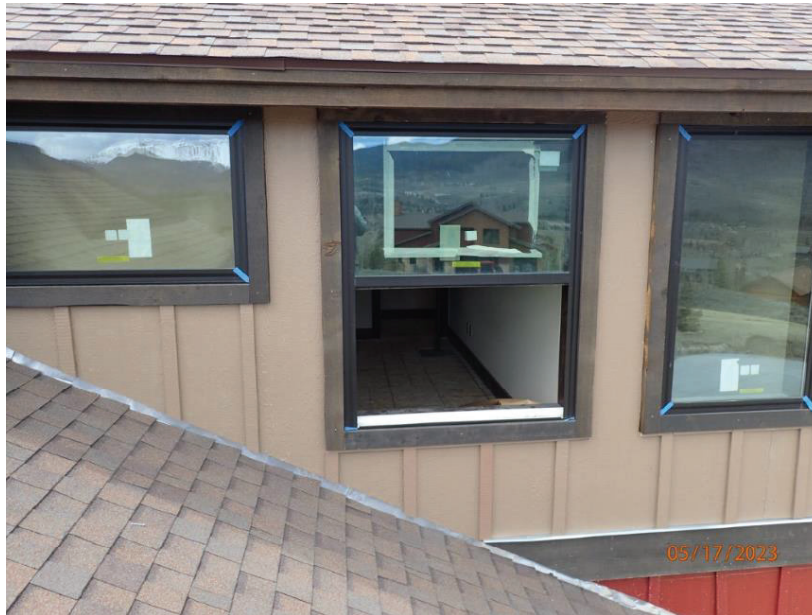
Where non-compliant clearance between claddings and flashings exists, the as-built condition falls short of the prescriptive requirements of the relevant codes, design, industry standards, and manufacturer requirements, and therefore, the contractor and subcontractors who performed the work are responsible for any costs associated with the repairs required to resolve these conditions.

May 17, 2023, Disc OBS1, Photograph 271, DLC, 101 Mule Deer Court, looking west from garage roof.
