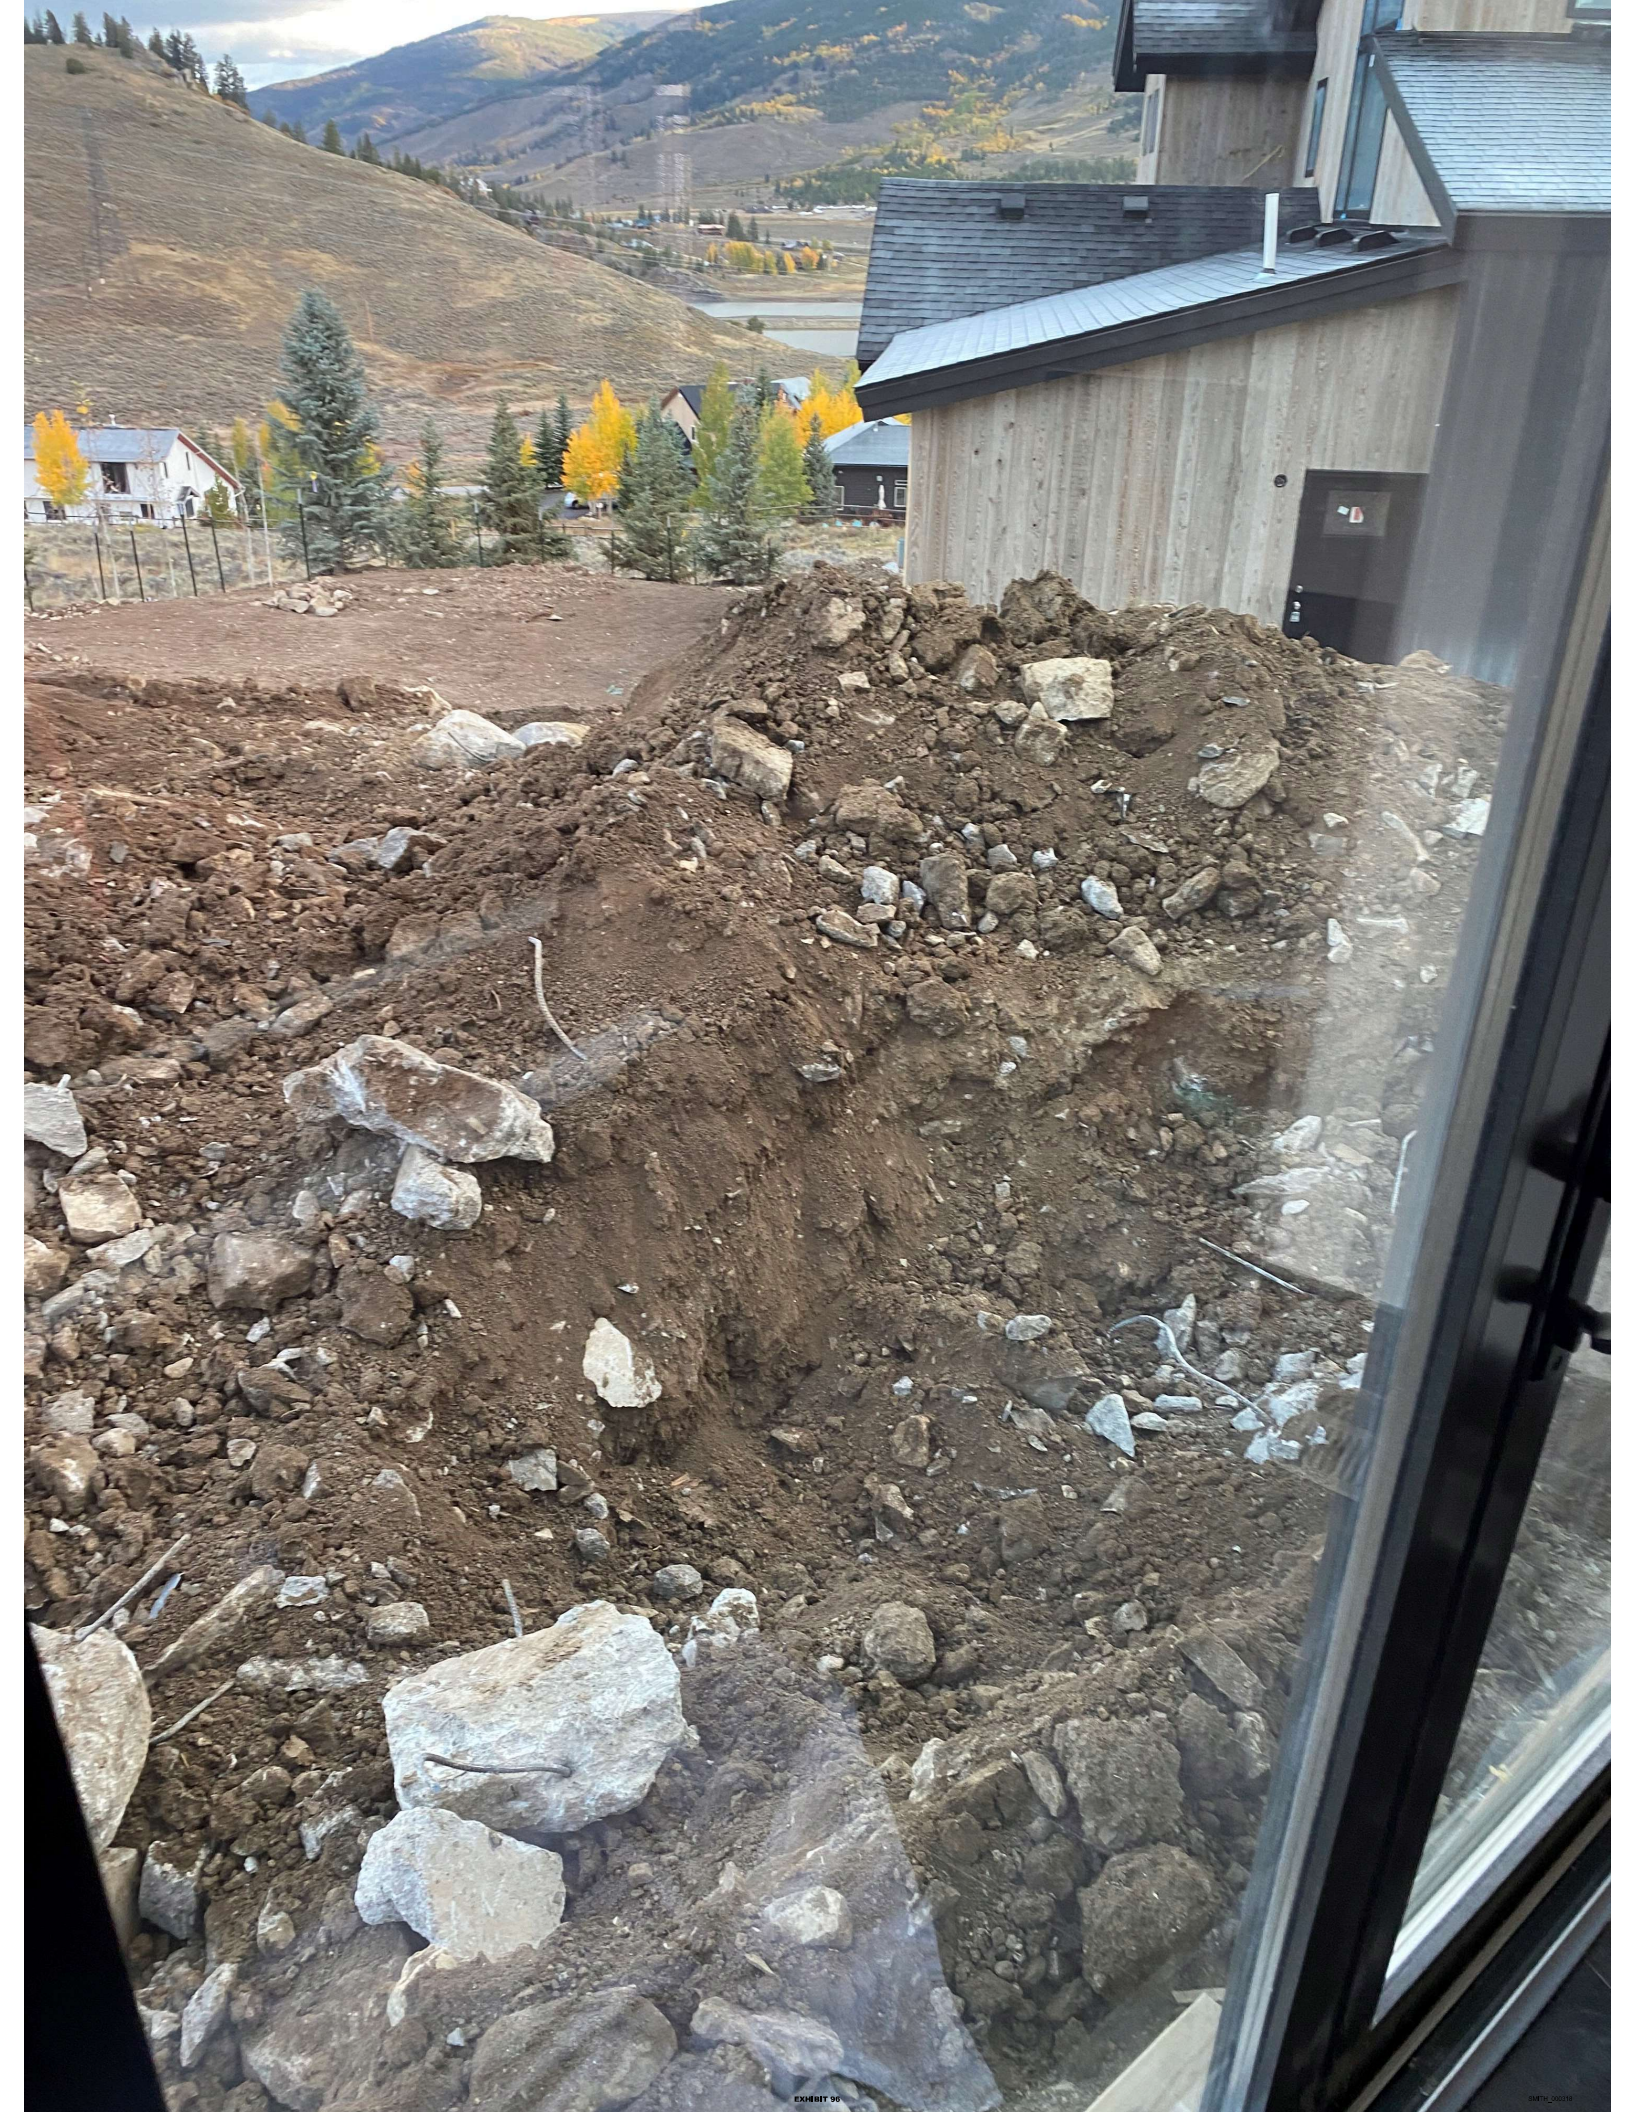
Note the large rocks and native soil in the backfill. This led to poor compaction and every concrete footing for exterior structures sinking and breaking away from the home.

Liscott never had a geotechnical engineer visit the site after the initial soil report was issued. They also didn't follow the guidelines in the report for proper back fill. Liscott simply dumped native soils back into the trenches.
