# PROPERTY INSPECTION REPORT

**Any Street, Any City, 44444**

**Report ID: Example Seller Home Inspection**

**Inspector: John Scaparo**

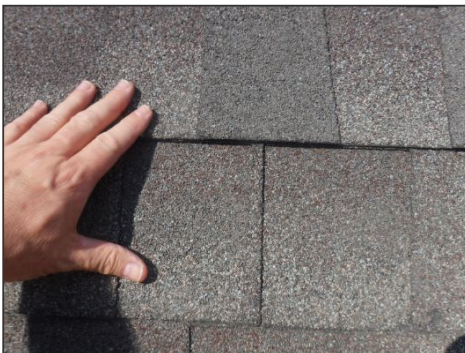
1.1. Age of roof covering estimated at its midpoint of its useful life. I observed a few lifted tabs from nails backing out of the decking (back side). The lifted tabs are potential water entry points and vulnerable to wind damage and wind driven rain. Recommend correction by a qualified and licensed roof contractor evaluate and provide estimate of repair.

Example Of Roof Covering

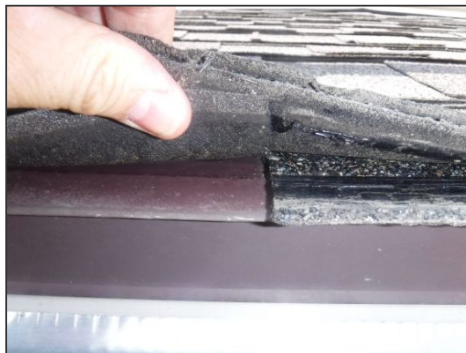
Example Of Roof Covering (Single Layer)

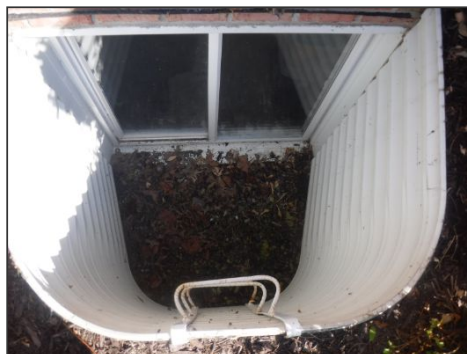
2.1. The exterior doors/below grade egress were in good condition and operated properly during the inspection.

Example Of Egress

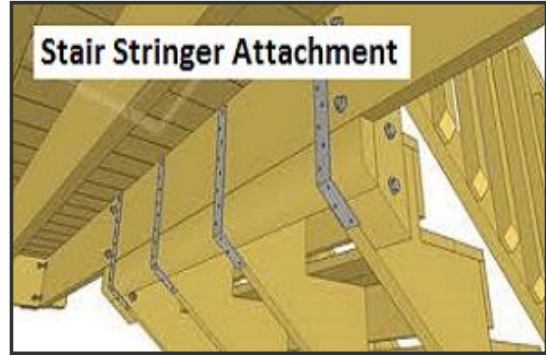
Example Of Stringer Straps

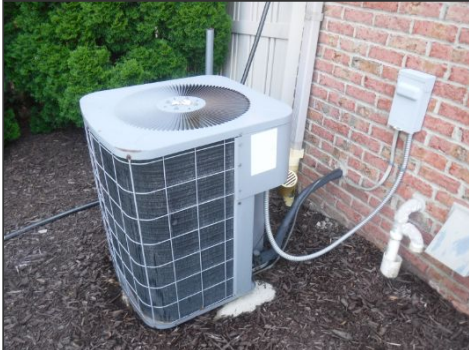
3.1. Even though the A/C system responded and provided cooling when turned on by the wall thermostat, the exterior condenser unit fins were damaged and folded over. This will reduce the overall cooling efficiency. Recommend service check-up and cleaning to ensure proper operation. Servicing can also uncover problems not discovered or that are beyond the scope of home inspection standards. Budget for replacement.

Example Of A/C Unit

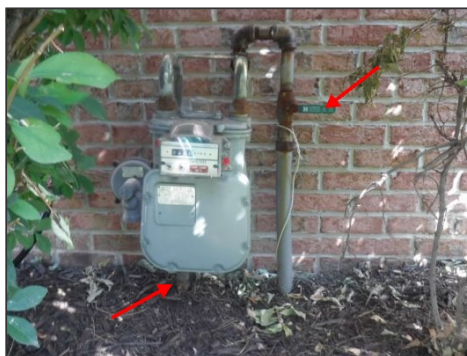
1.1. I did not smell any gas odors (Sulfur - similar to rotten egg odor) which is an indication of a leak. No evidence of damage was observed with the accessible gas piping today (concealed plumbing can not be inspected).

Example Of Gas Service Meter And Shut Off Valve

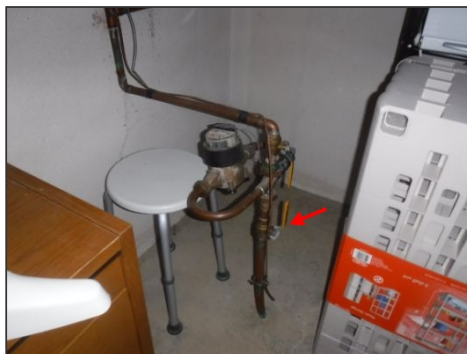
3.1. Good water flow, no visible drop in water flow when tested with two fixtures running water simultaneously. As part of my inspection, I ran the water from the plumbing fixtures for an extended period. No active leaks were observed during the inspection. Recommend annual maintenance inspection and repair any as needed and reviewing seller disclosure statement for history of leak/repair.

Example Of Water Service Meter And Shut Off Valve

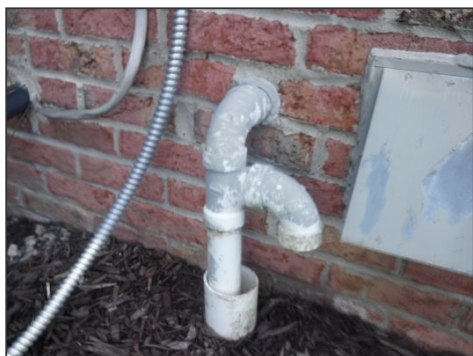
9.2. The check valve was missing from the sump pump discharge pipe. While not every installation requires a check valve, they are recommended where the discharge pipe is long, the vertical discharge is more than seven or eight feet, or the sump pump has a small pit. Check valves prevent water in the discharge pipe from flowing back down into the sump pit after the pump shuts off. Recommend having a qualified contractor install a check valve.

Example Of Sump Pump Exterior Discharge

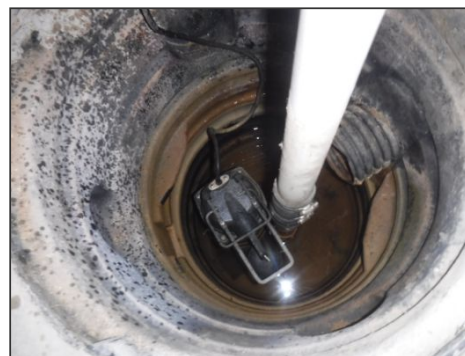
9.1. The sump pump(s) responded when tested. Recommend including inspection of sump pump and its exterior discharge pipe for proper drainage as part of annual maintenance to ensure proper operation and flood prevention.

Example Of Sump Pump And Basin

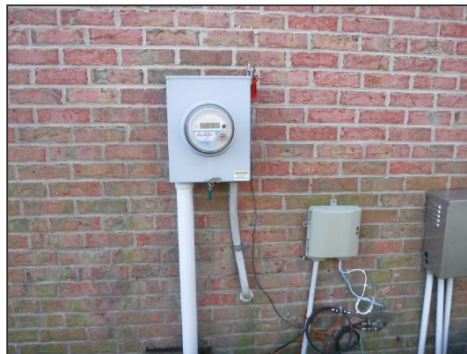
- 1.1. The exterior meter box was in good condition. No major rust or damage. Not loose.

Example Of Service Meter

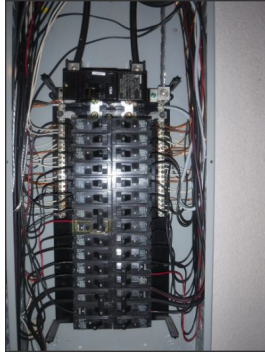
2.3. I saw (1) double tapped breaker within the service panel. A double tap is the connection of two wires (circuits) to one circuit breaker. It can add to the load of the circuit causing a possible overload that trips the breakers. Recommend an electrician properly separate the circuits to bring the home up to standards and enhance the safety of the occupants. Service can also uncover problems not discovered or that are beyond the scope of home inspection standards.

Example Of Service Panel With Cover Removed

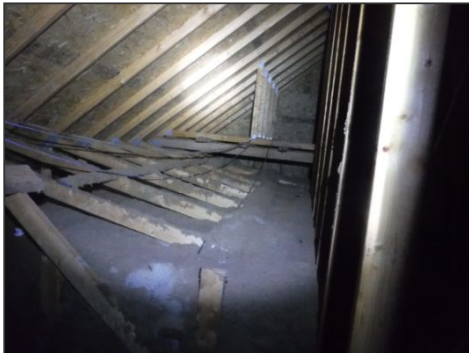
1.1. Estimate thickness between 8 - 12 inches. Attic insulation, where visible was evenly distributed.

Example Of Attic Insulation

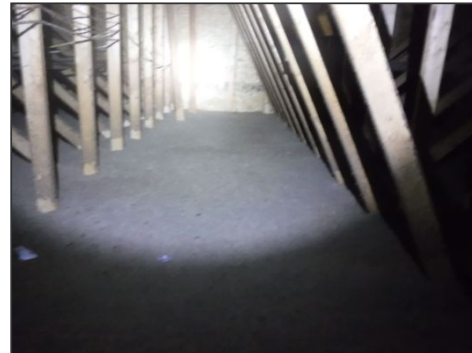
Example Of Attic Insulation

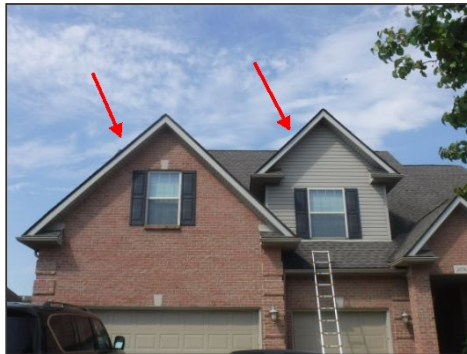
No access to roof cavities

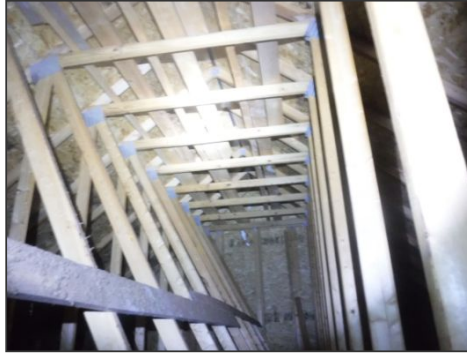
- 2.1. Exposed roof structures, I did not observe any indication of structural concerns such as damaged or unprofessional repairs to the exposed and accessible attic/roof structures during inspection today. Recommend annual preventive maintenance inspection to maintain the structural integrity of the roof system. If damage should appear or worsen, a professional should evaluate and repair to help prevent potential of material damage to the home.

Example Of Roof Structure Within Attic
