## Leaks Report -Level 0 and 1 East

Site Inspection 16.03.23  
Rainy Condition  
Prepare by P. Mazur

### Leaks Observation Report

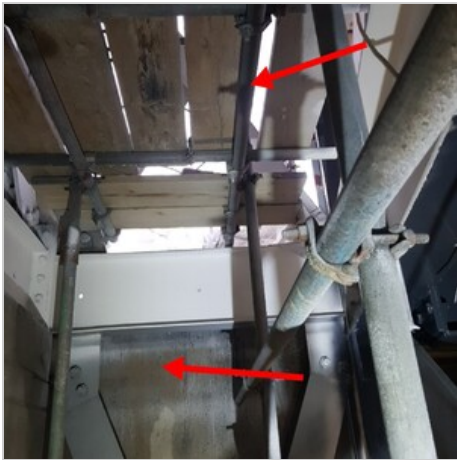
WET CONCRETE
