Project Name Removed - All Remedials works has been completed and no leaks observed by date - copyright to FTC

MSCP - Swansea - Leaks - Water Test Link Bridge and Weatherproof preparation for Ramp Cornerp

Created: 04-04-2023  
Creator: Peter Mazur (@PMA)  
Status:  
Dates: 02-20-2023 - 04-04-2023

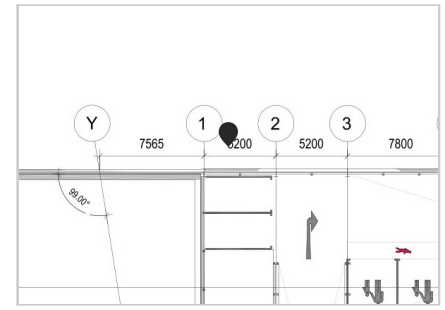
● #50 - Corner to be exposed , clean off to check horizontal details as build

#29 | Leaks | Heavy leak behind Corner Column and Blockwork Damp/Wet .Leaks - Footpath Movement Weatherproof Joint, Drainage outlets TBC . Missing Weatherproof tests - To be investigate . Outstanding works along grid A

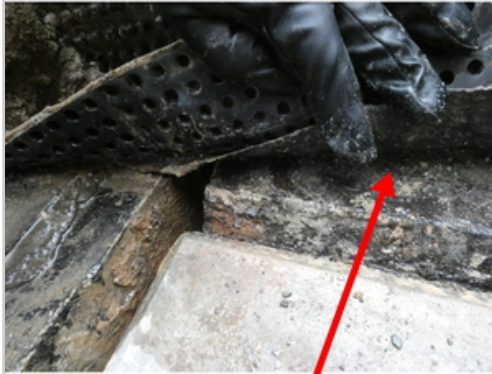
8

Membrane not stick to concrete

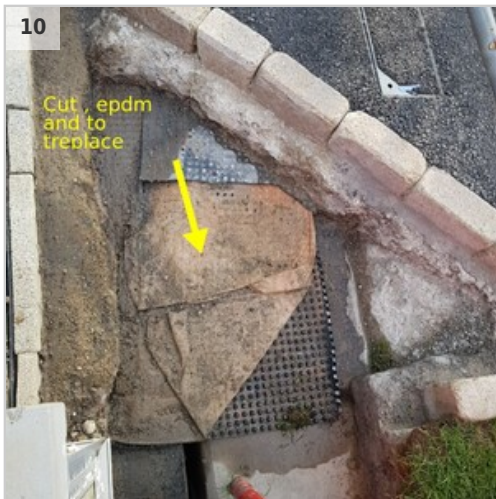
Cut, epdm and to replace

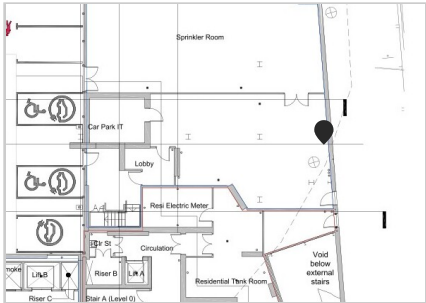
● **#63 - 1. Water Test Failed - Drain Pipe Infilled 60liter water. Leak Ingress . 2. Water Test - Gap Between Concrete Uprstand Failed. Phase 1 Area to be excavated and repair - drain connection to seal**

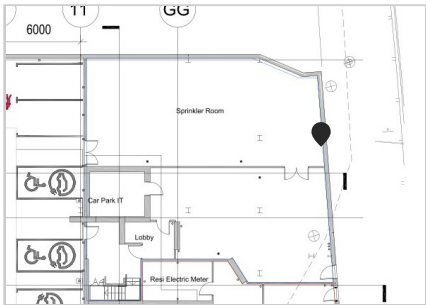
● **#64 - 1. Water Test Failed - Drain Pipe Infilled 60liter water. Leak Ingress . 2. Water Test - Gap Between Concrete Upstand Passed. Phase 1 Area to be excavated and repair - drain connection to seal**

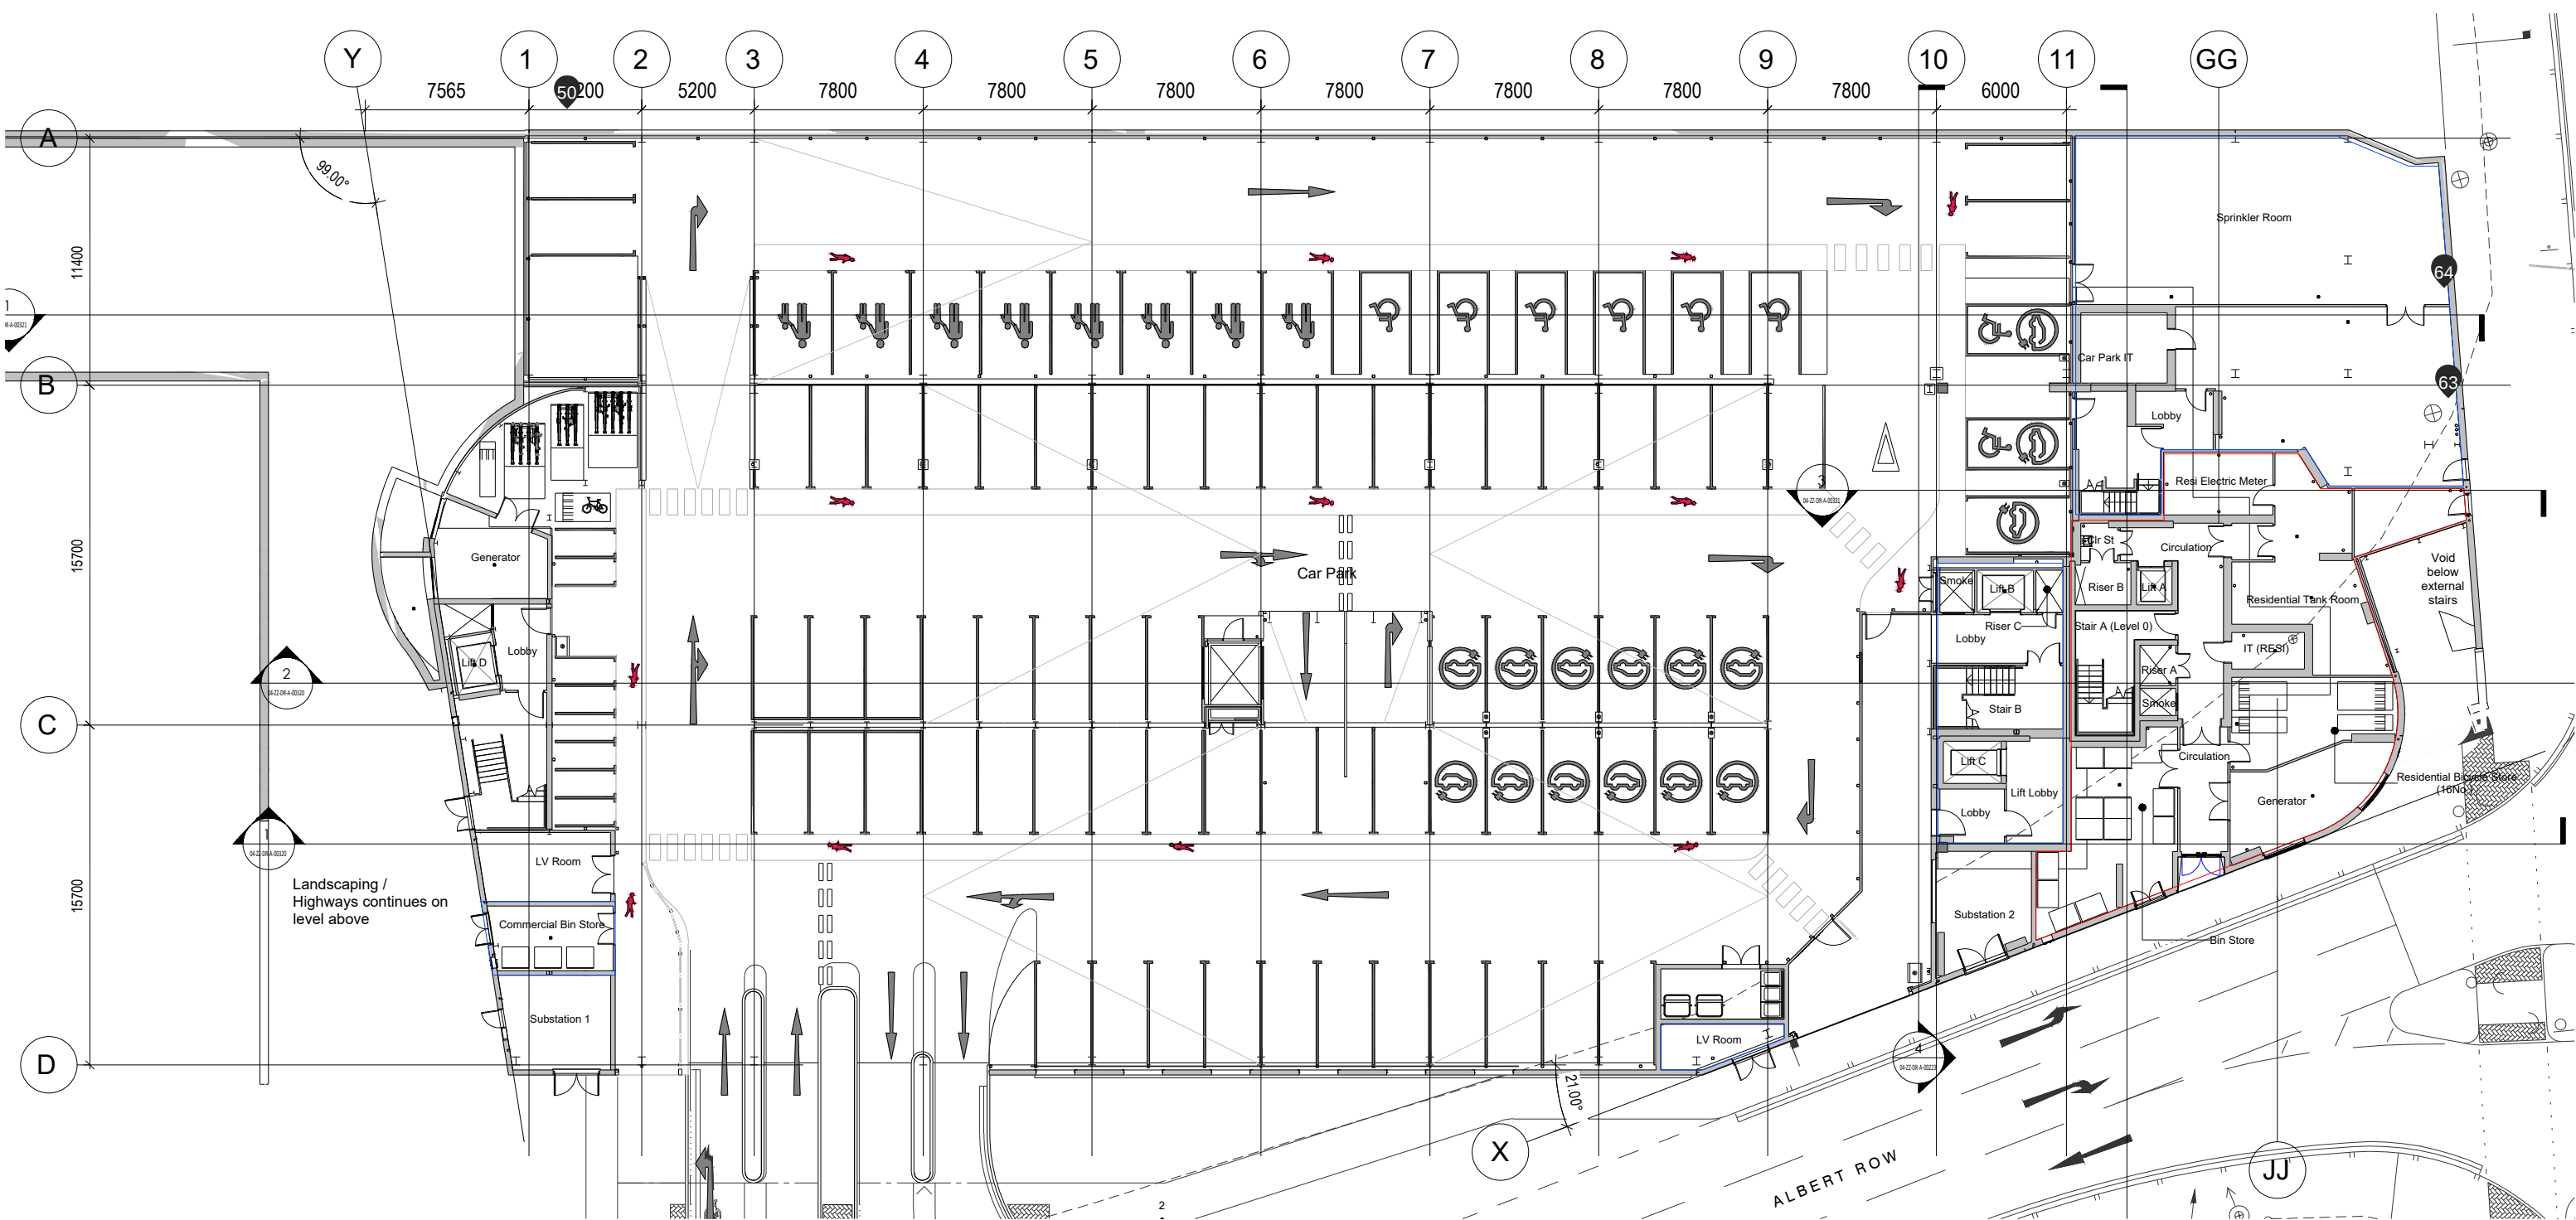
Wet Gaps , water  
flush out grout
