## Indian Lake Dam Inspection Report

Dam Identification No.: 687

Date of Inspection: November 18, 2013

Date of Final Report: December 31, 2013

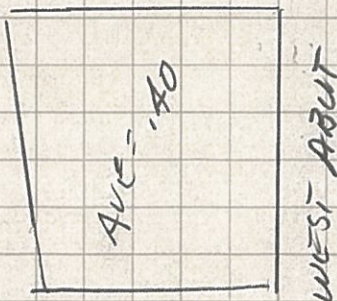
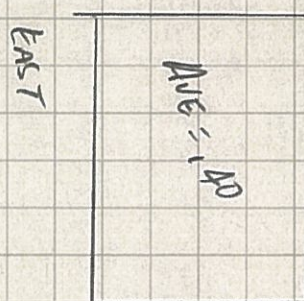
IN GENERAL THIS  
AREA IS DEFINED BY UPPER POUR COLOR PYRAMID  
RUST AREA DUE TO ISSUES WITH CONSOLIDATION.  
NO SPALLING SUGGESTS MINIMAL IF ANY  
WATER LEAKING.

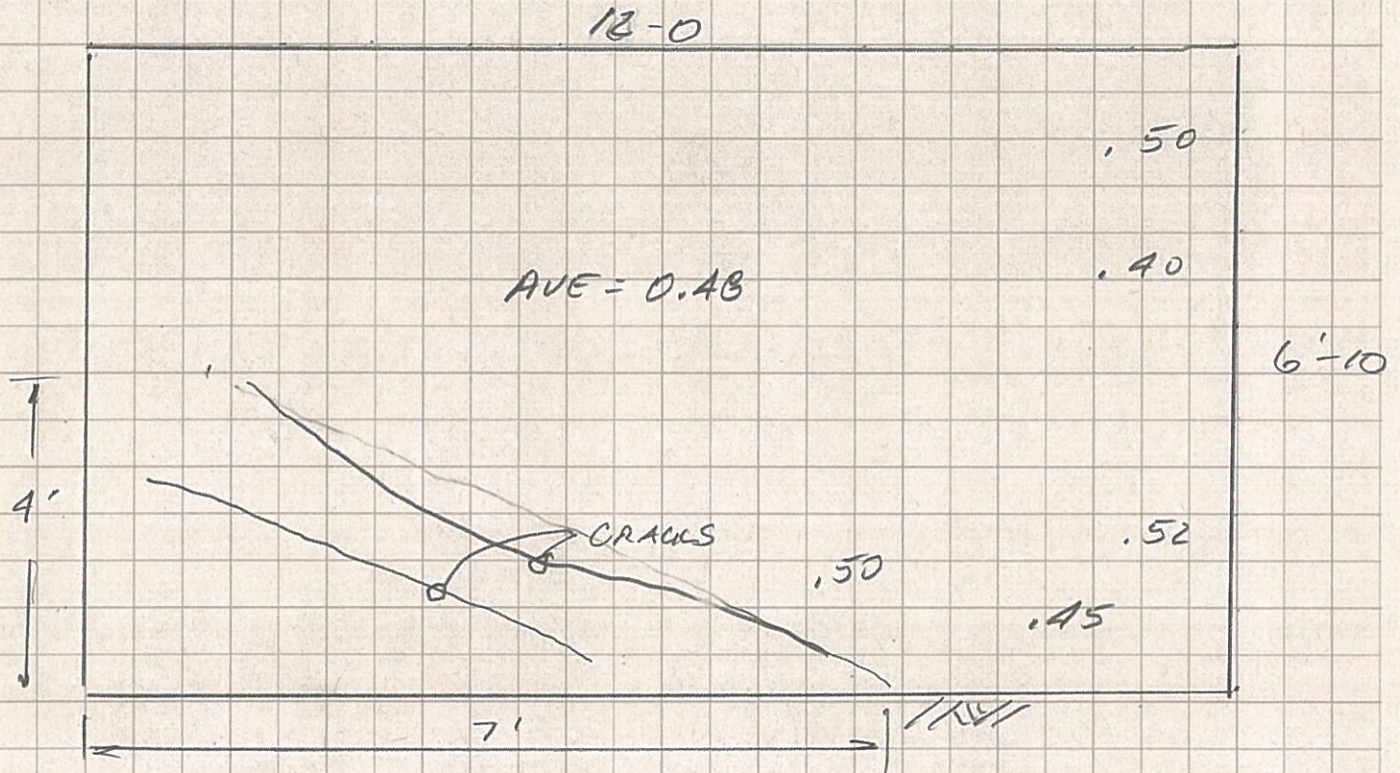
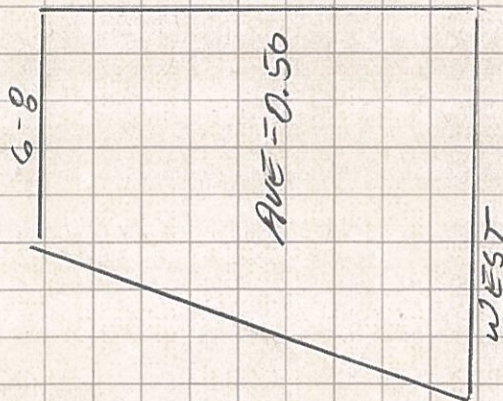
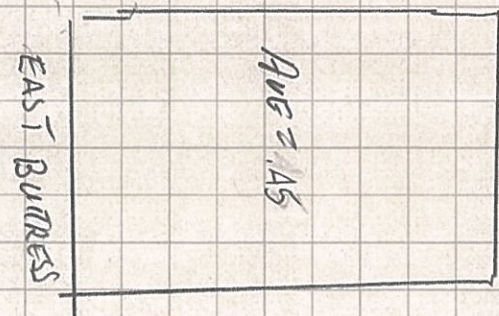
BAY 5

CEILING = .50 +

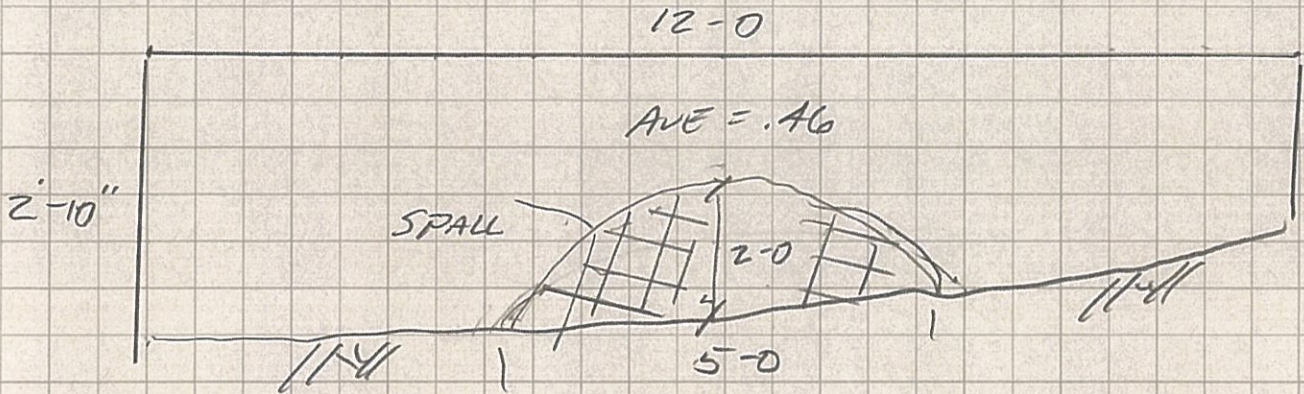
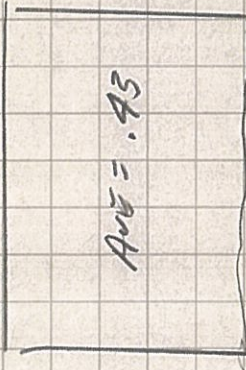
BAY 6

- a. Monitor seepage adjacent to the newly constructed walls of Bay 2, 3, 4 and 5.
  - b. Bay 6 has evidence of spalling and seepage at the contact point of the ground and concrete.
