THE IVATT INFORMER

Recording progress with LMS 10000

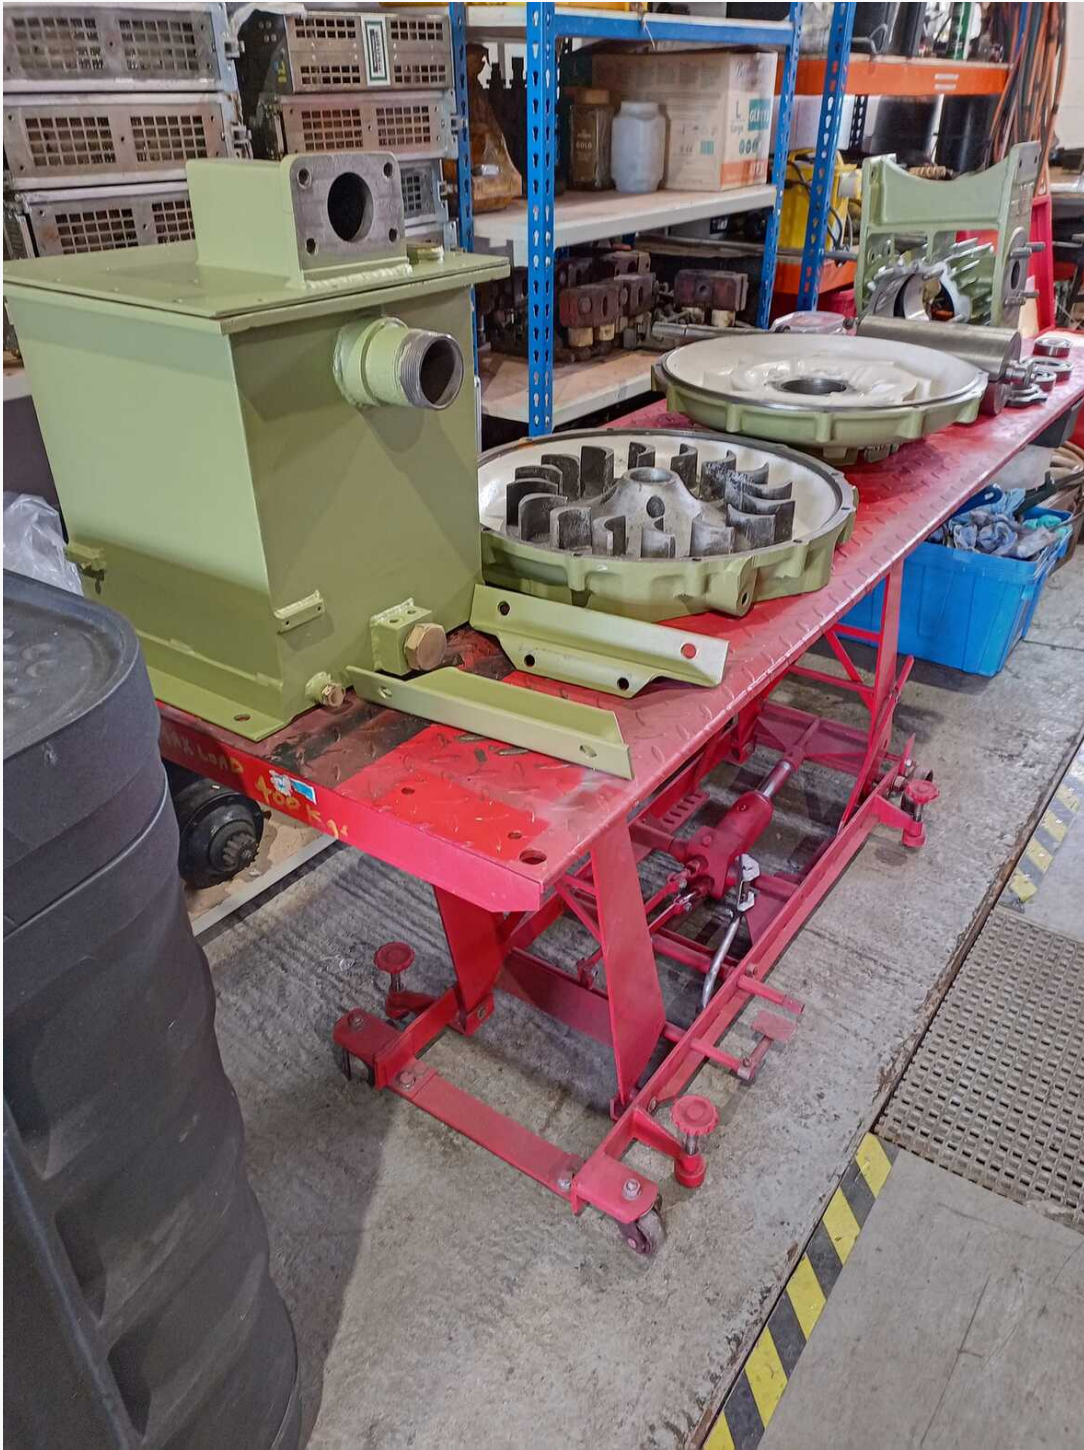
My main task was in delivering and unloading with assistance from Tony my hydraulic motorcycle table lift to use as a workbench, and thank you Les for the loan of the trailer. I also returned all the Exhauster components that I took home to clean and paint. Assembly will commence in slow time once I have collected together all the replacement parts. For our open days and as a guide to a complete exhauster I will be setting out the components on the bench in order as they appear once assembled. Looking at the pictures I think it needs a white tablecloth, I might have something suitable in the garage.

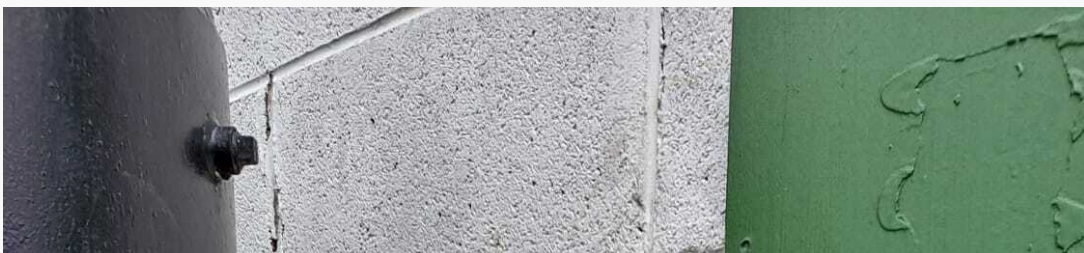
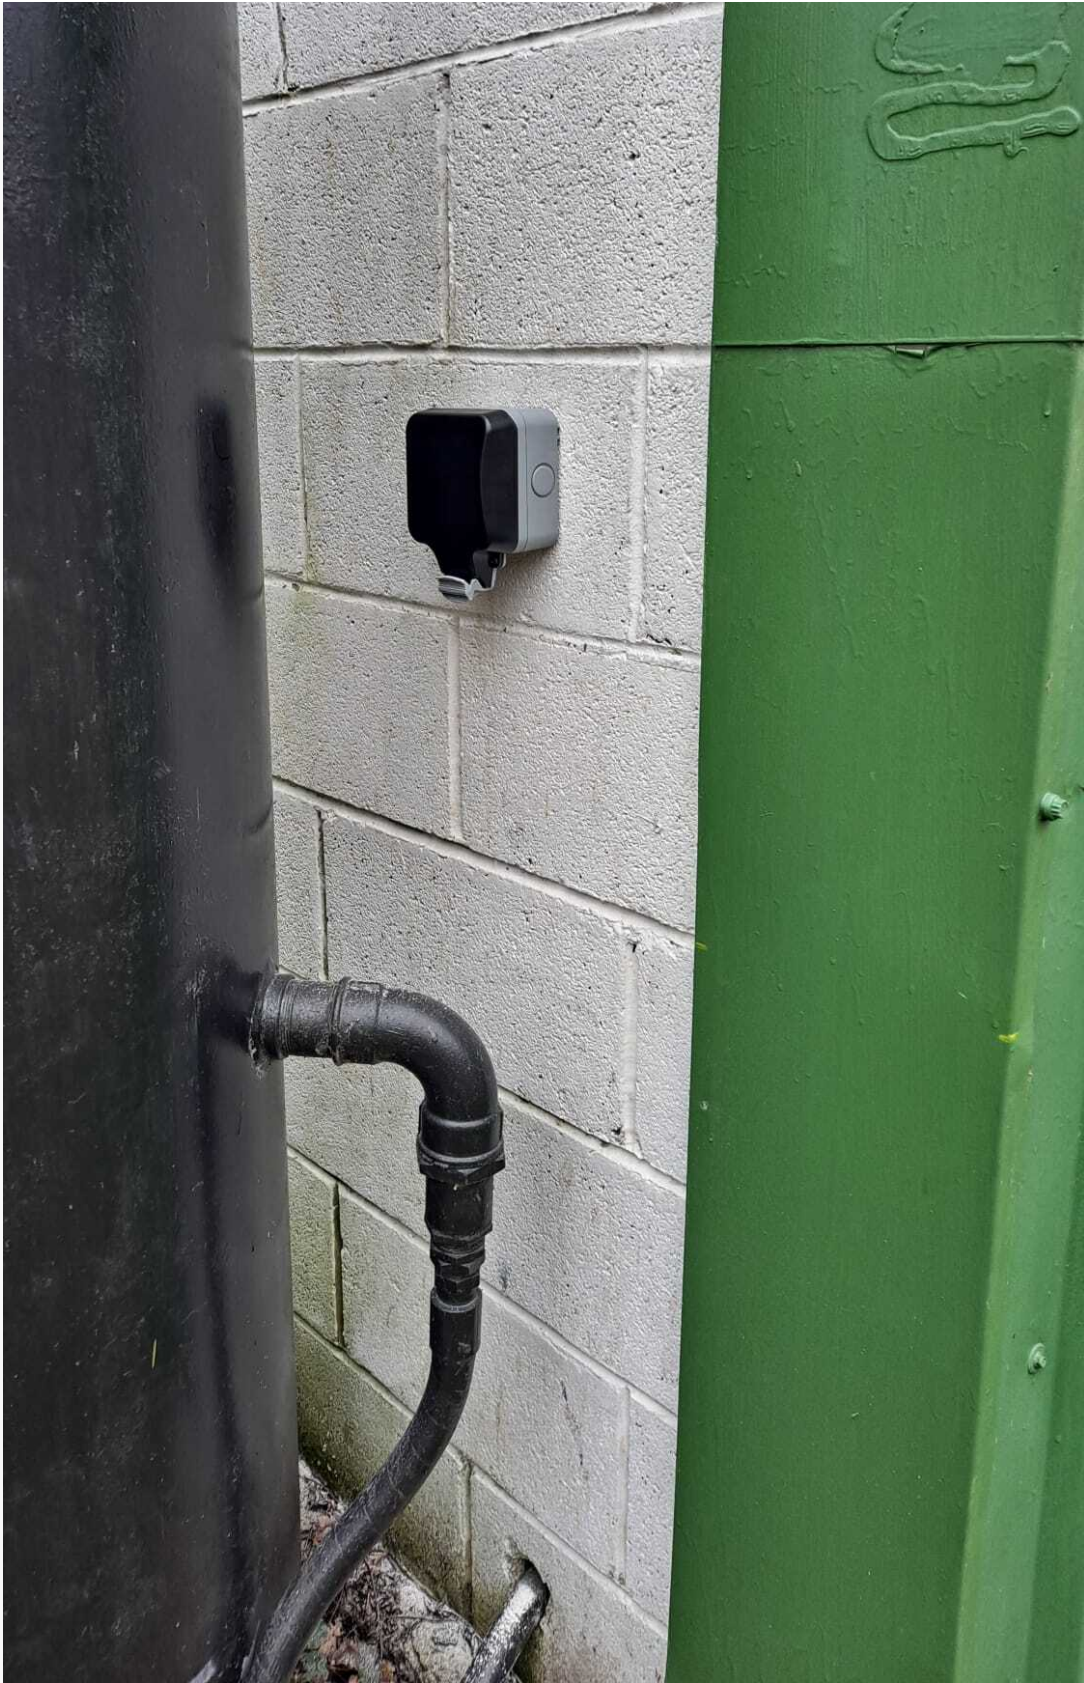
Tony reported that on the 29th an outside power socket has been fitted to aid work at the rear of the workshop. It is situated behind the workshop's external air tank.

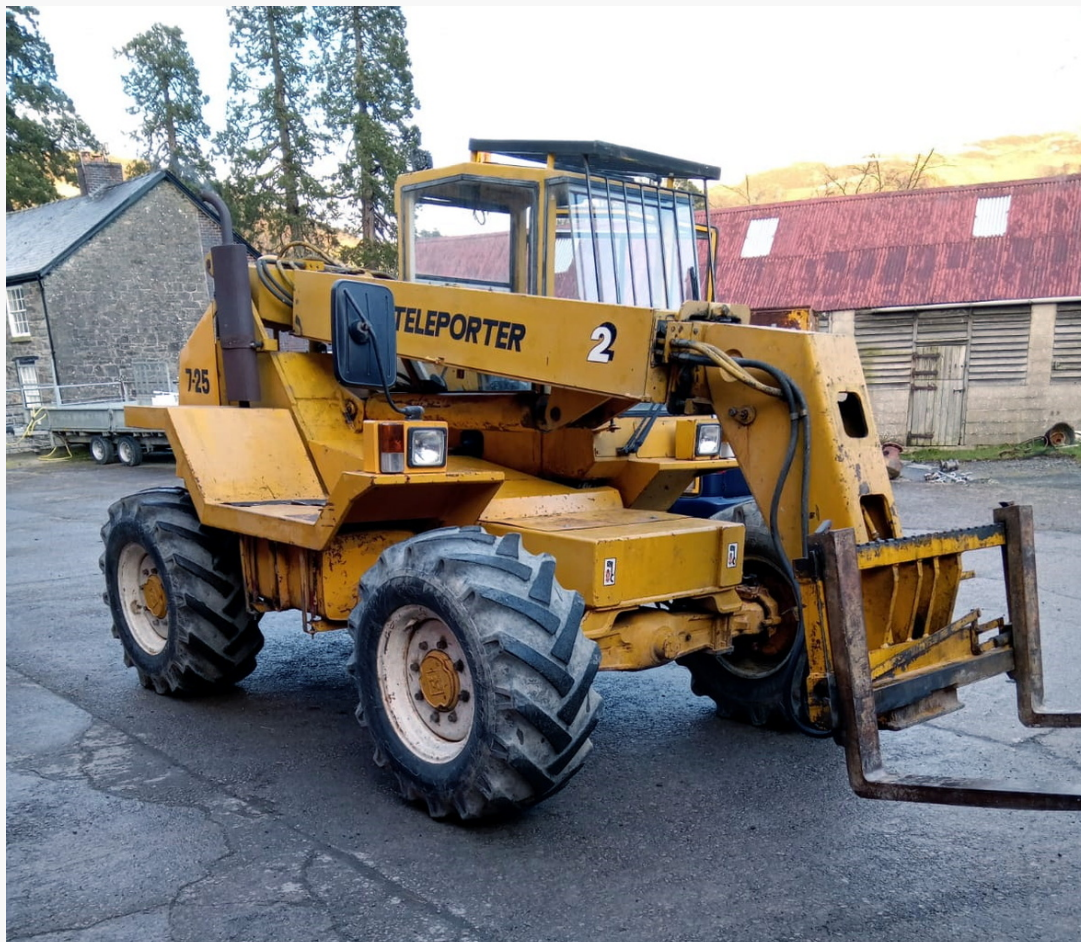
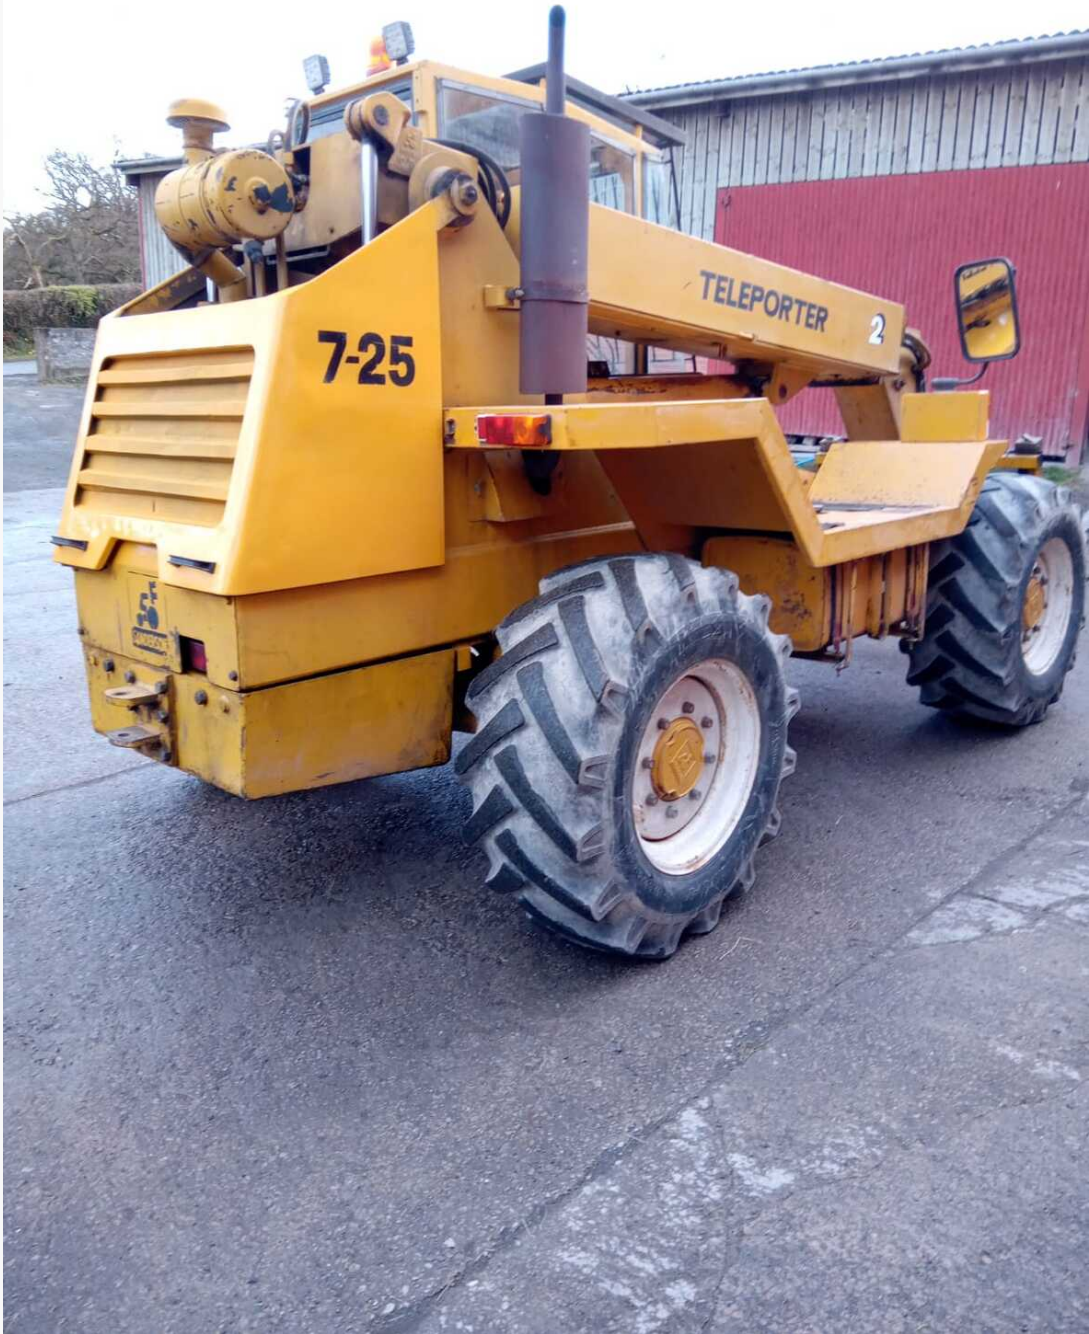
"It was a long shift yesterday. I got in at 1am after hitting every road closures going. It's a Sanderson 725 1989 model with manual gearshift and a proper clutch, it has had a very low hours Ford 400 series engine fitted by the owner two years ago (better engine) which was serviced in November. He has attended to everything over his tenure so it drives and works better than a much younger machine Well worth the effort and money.
