Interim Report on the capsizing of “The Big Hairy”

- 56) On the 2 August 2024 Mr Lyons inspected *The Big Hairy*, at Bundaberg Port Marina.
- 57) On 23 August 2024 Mr Lyons issued a comprehensive Expert Naval Architect's Interim Report titled: Inspection of failed ballast keel on the yacht "The Big Hairy" HIN AU-WWA187638/TIM01Q/ON 857223. Attached at Annex A.

**INSPECTION OF FAILED BALLAST KEEL
ON THE YACHT
THE BIG HAIRY
HIN AU-WWA187638 / TIM01Q / ON 857223**

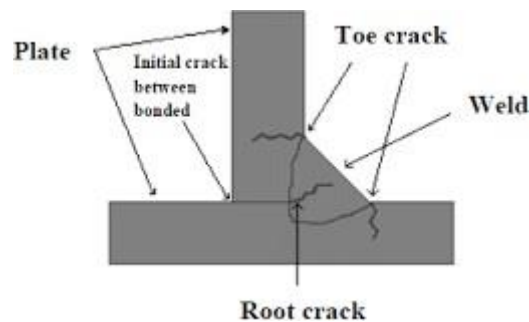
- 22 The fracture surfaces are co-incident with, or in very close proximity to the welds (no more than the keel sides' plate thickness of 10 mm and mostly less).
- 23 Cracking at the boundaries of the fracture surface closest to the welds appears to be co-incident with the **toes** of the welds. The toes are the junction of the weld face and the base metal:

Fig.8– Typical weld geometry shown in cross-section (https://www.researchgate.net/figure/Cracks-initiation-at-weld-toes_fig2_353287193)

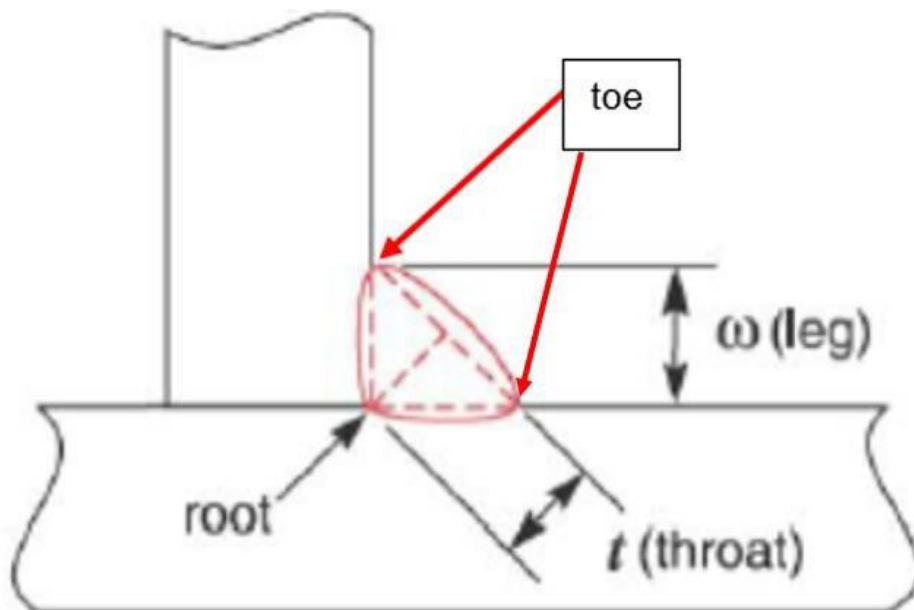
Fig.9 – Weld throat and leg dimensions, with toe indicated (adapted from https://www.researchgate.net/figure/Dimensions-of-the-fillet-weld_fig1_264036794).

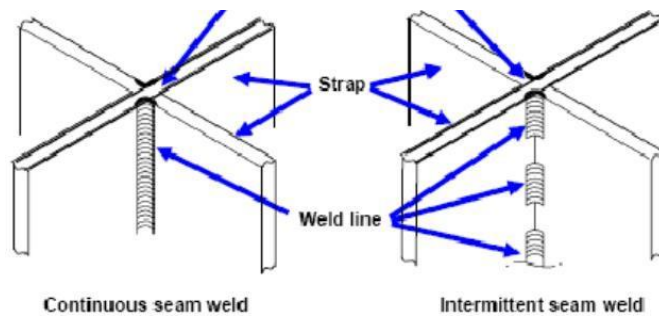
Fig.10– Continuous and intermittent welds (https://www.researchgate.net/figure/Continuous-weld-line-of-the-specimen-welded-by-the-proposed-LASER-welding-method_fig7_298897430).

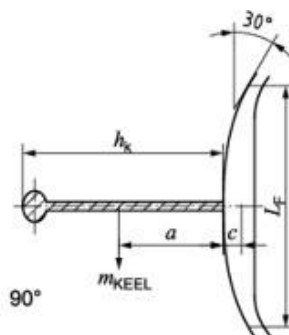
a) Craft with axial keel heeled at 90°

Fig.15 – taken from ISO/DIS12215-9 Fig. 1 a)

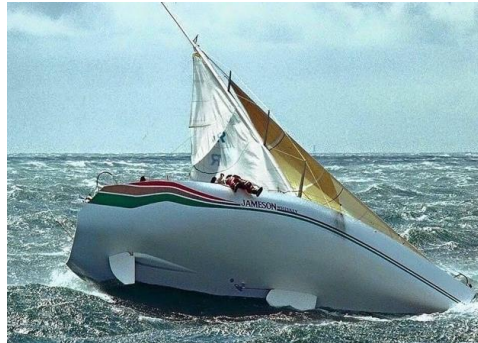
Fig.16 – A near-90° ‘knock-down’ of a similar yacht. Although such behaviour may seem ‘spectacular’, sailing yachts and their keels are expected to be designed and built to cater for such a scenario, and account for some movement during the event, that designers treat as “quasi-static”. This is not an instance of fatigue loading, which must be accounted for separately (<https://www.alamy.com/stock-photo-jameson-whisky-the-irish-entry-for-the-admirals-cup-broaches-in-breezy-31503836.html>)
