PAŃSTWOWA KOMISJA BADANIA  
WYPADKÓW MORSKICH

**PRODIGY 2  
SAILING YACHT**

Sinking of the yacht due to the ballast fin breaking off on  
the North Sea on 13 October 2017

**FINAL REPORT**

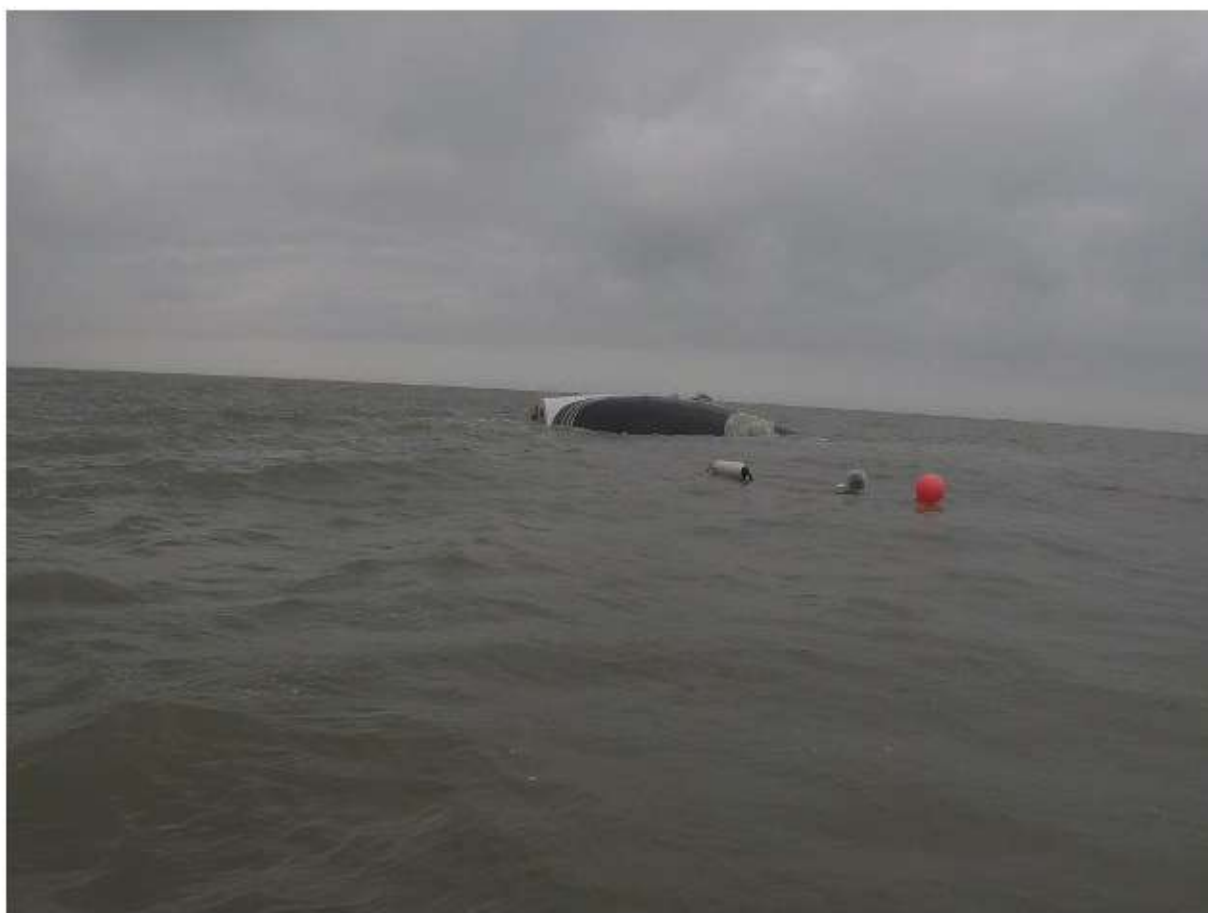
On 15.10.2017, at 13:08 hours “Mellum” transferred securing of the “Prodigy 2” yacht to the “Ems Server” vessel from the Ems Marine Offshore company. At that time, the yacht was drifting to the north of Drehbargen, along the 1m isobath. On 16.10.2017, at 11:10 hours the wreck was lying on the sea bottom near the Langeoog beach, at the position of 53°45.73’N and 007°34.58’E.

*Photograph 2. Wreck of the “Prodigy 2” yacht, drifting after the accident*

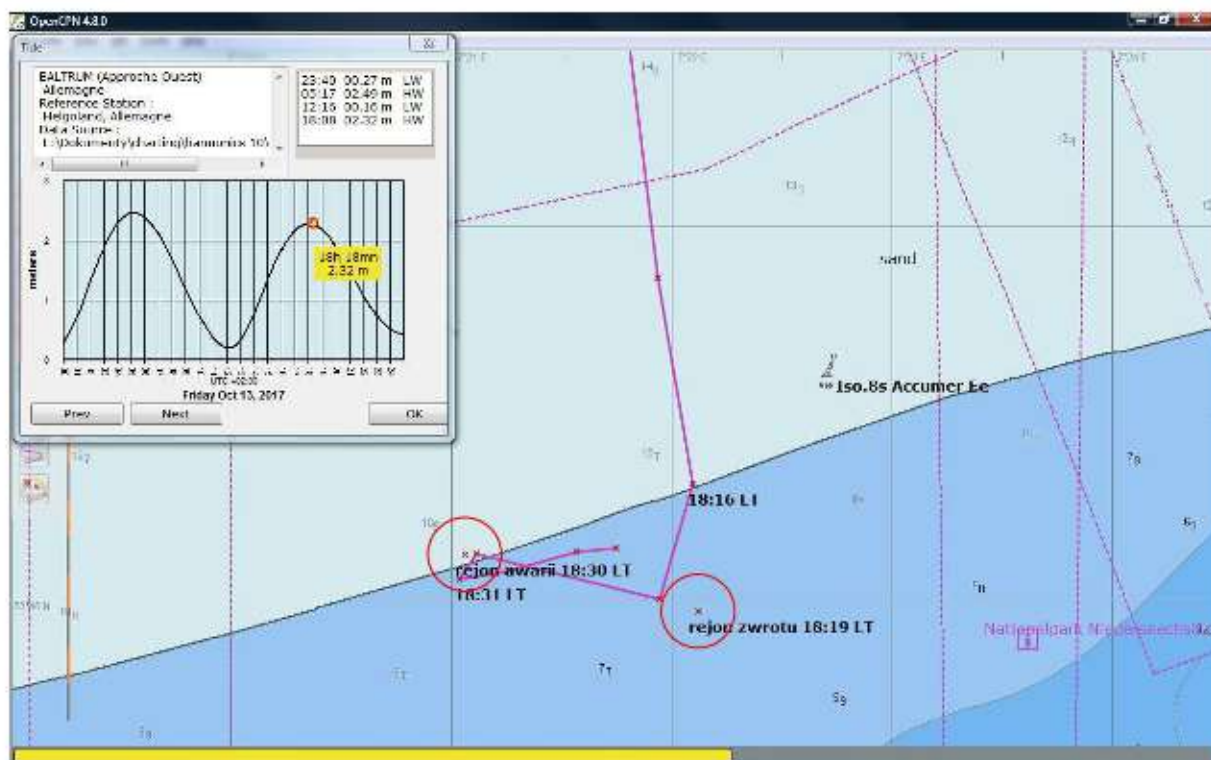
At 18:19 hours the yacht, approaching to the Baltrum Island coast on a southern course, made a turn to the port tack at the position of  $\varphi = 53^{\circ} 45,97' N$   $\lambda = 007^{\circ} 22,12' E$ . Before the turn, the yacht was sailing with partially reefed mainsail and gennoa at the speed of 6 - 7 kn, and an angle of heel ca  $12^{\circ}$  (according to the captain's estimation). The watch was held by the boatswain, who carried out the turn in the assistance of the captain, who had entered the cockpit for that purpose. After the turn, the yacht in a few minutes' time gained speed to over 6 kn, continuing sailing in the direction of  $KD=284^{\circ}$ .

*Illustration 2: Detailed recording of the route in the failure region<sup>2</sup>*

At about 18:25 hours, the boatswain holding the watch and the captain staying inside the yacht felt a tremor and heard a loud crack. The third crew member, sleeping in the bow cabin, did not wake up, and was only called later, to abandon the vessel. At the first moment, the crew thought that the reason for the tremor or noise was a door or hatch banging shut, or a heavy object falling. They did not feel the slowing down of the yacht's movement or any disturbance in it. The captain and the boatswain speedily inspected the yacht rooms on the stern and amidships, failing to discover anything unexpected.

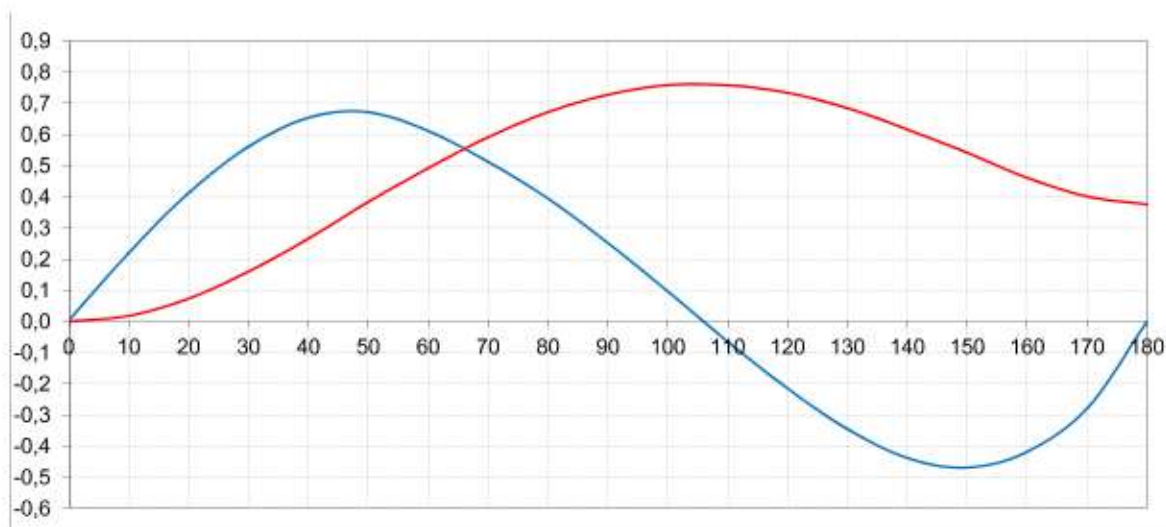
*Fig 3 Diagram of the righting lever curve for “Prodigy 2” for the following loading condition – for going out to sea, i.e. 10 persons + 100% supplies (15.06.2017)*

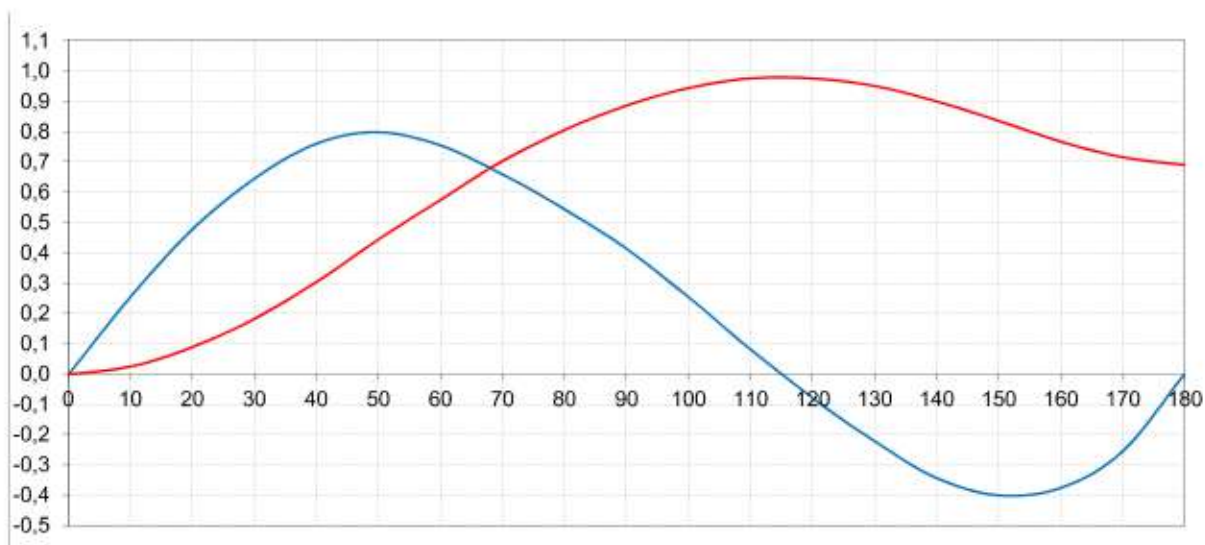
After completing the operation of extending the ballast fin and moving the battery, another inclining test was carried out on 22 August 2017.

The notified body did not supervise the ballast fin extension and only approved the change in documentation.

*Fig 4 Diagram of the righting lever curve for “Prodigy 2” for the following loading condition – for going out to sea, i.e. 10 crew members + 100% supplies (22.08.2017)*

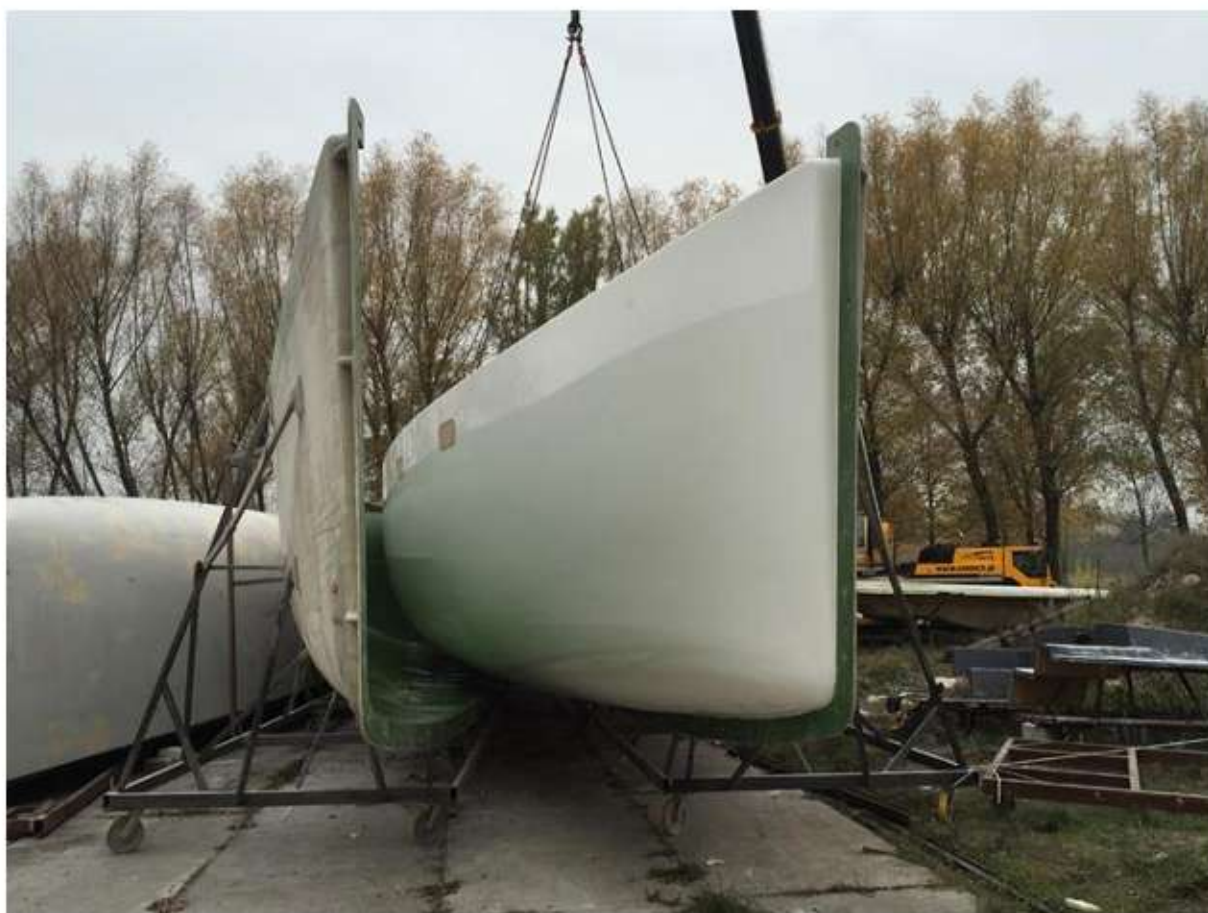
*Photograph 12. Stripping of the yacht's hull (source: <http://kalifyacht.eu/projekty.php>)*

The process had been documented photographically. No records of the environmental conditions during the construction process were retained<sup>15</sup> and neither a control plate had been prepared nor any strength testing carried out.<sup>16</sup> After transporting the laminates to the new hall situated at Polna Street in Toruń, the yacht's construction continued for around 15 months with the participation of subcontractors. No compliance assurance procedure<sup>17</sup> nor work instructions for the individual stages of the yacht's construction had been drafted. No final inspection report had not been prepared at the completion of the yacht's construction<sup>18</sup>.

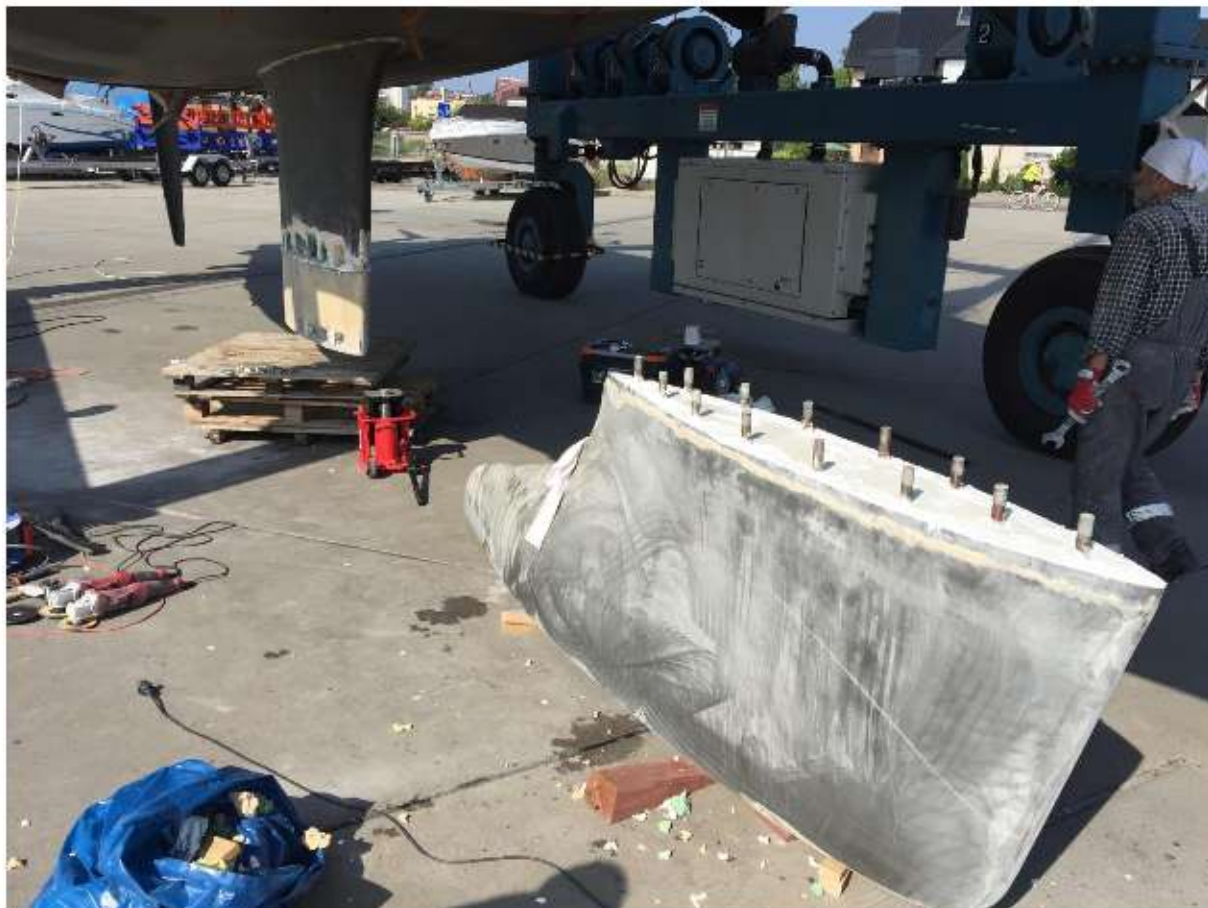
*Photograph 14. Connection of the insert with the fin (source: yacht builder)*

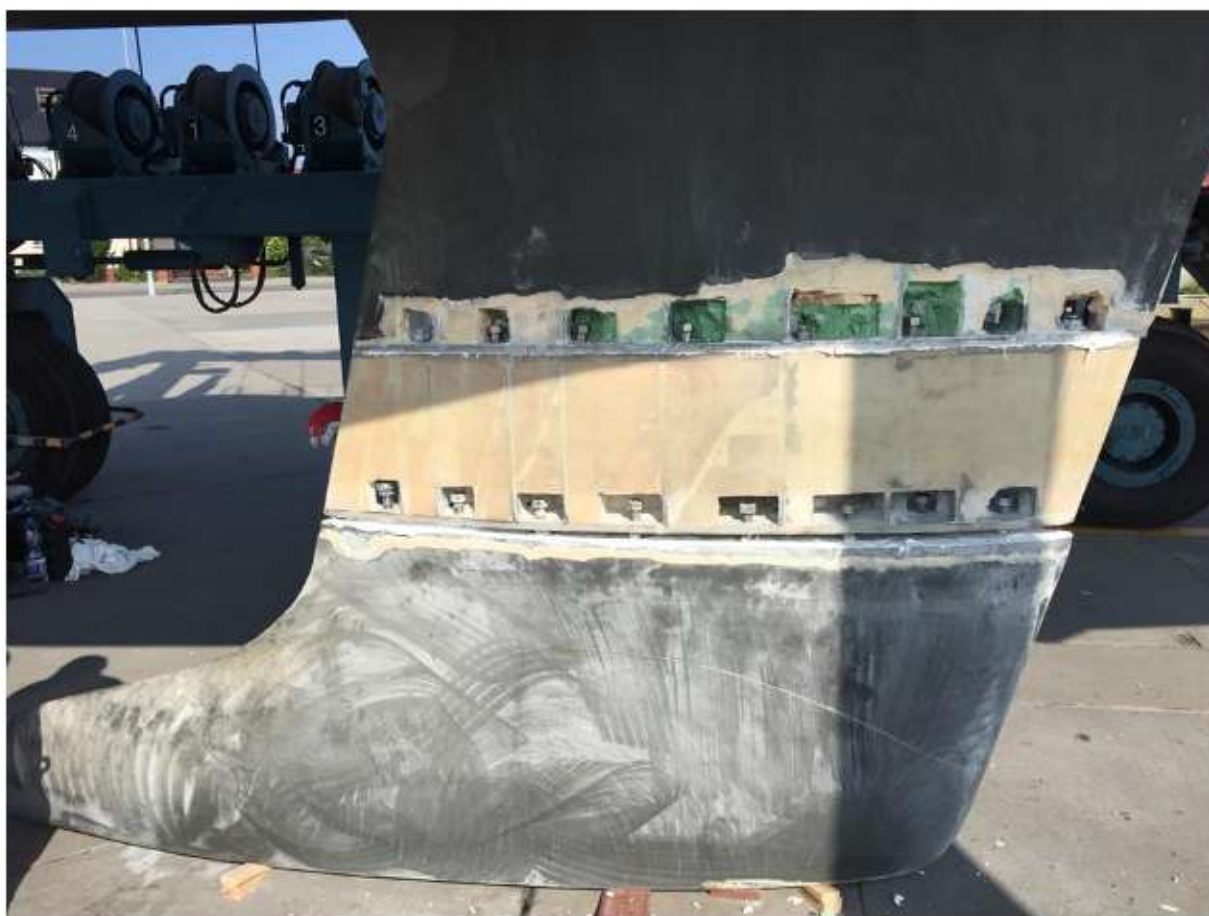
*Photograph 15. Mounting of the bulb keel to the insert (source: yacht builder)*
