**MARINE INVESTIGATION REPORT
M10F0003**

KNOCKDOWN AND CAPSIZING

**SAIL TRAINING YACHT *CONCORDIA*
300 MILES SSE OFF RIO DE JANEIRO, BRAZIL
17 FEBRUARY 2010**

Report Number M10F0003

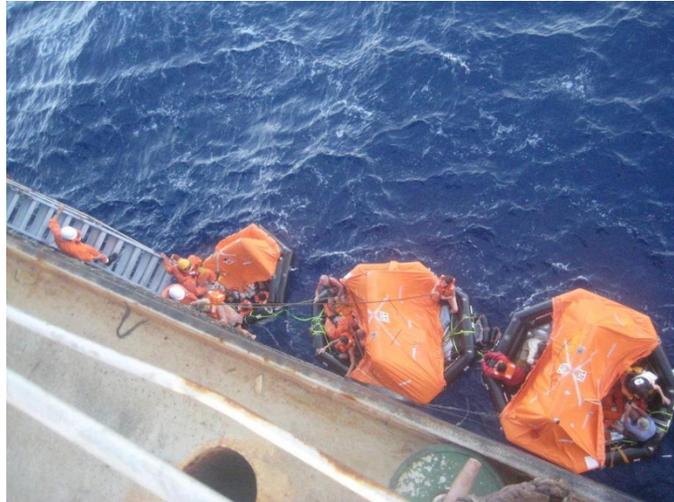
One of the 4 rafts was retrieved from the water. This raft and its associated equipment were not available for examination during the investigation.

Photo 2. Liferafts alongside *Hokuetsu Delight*

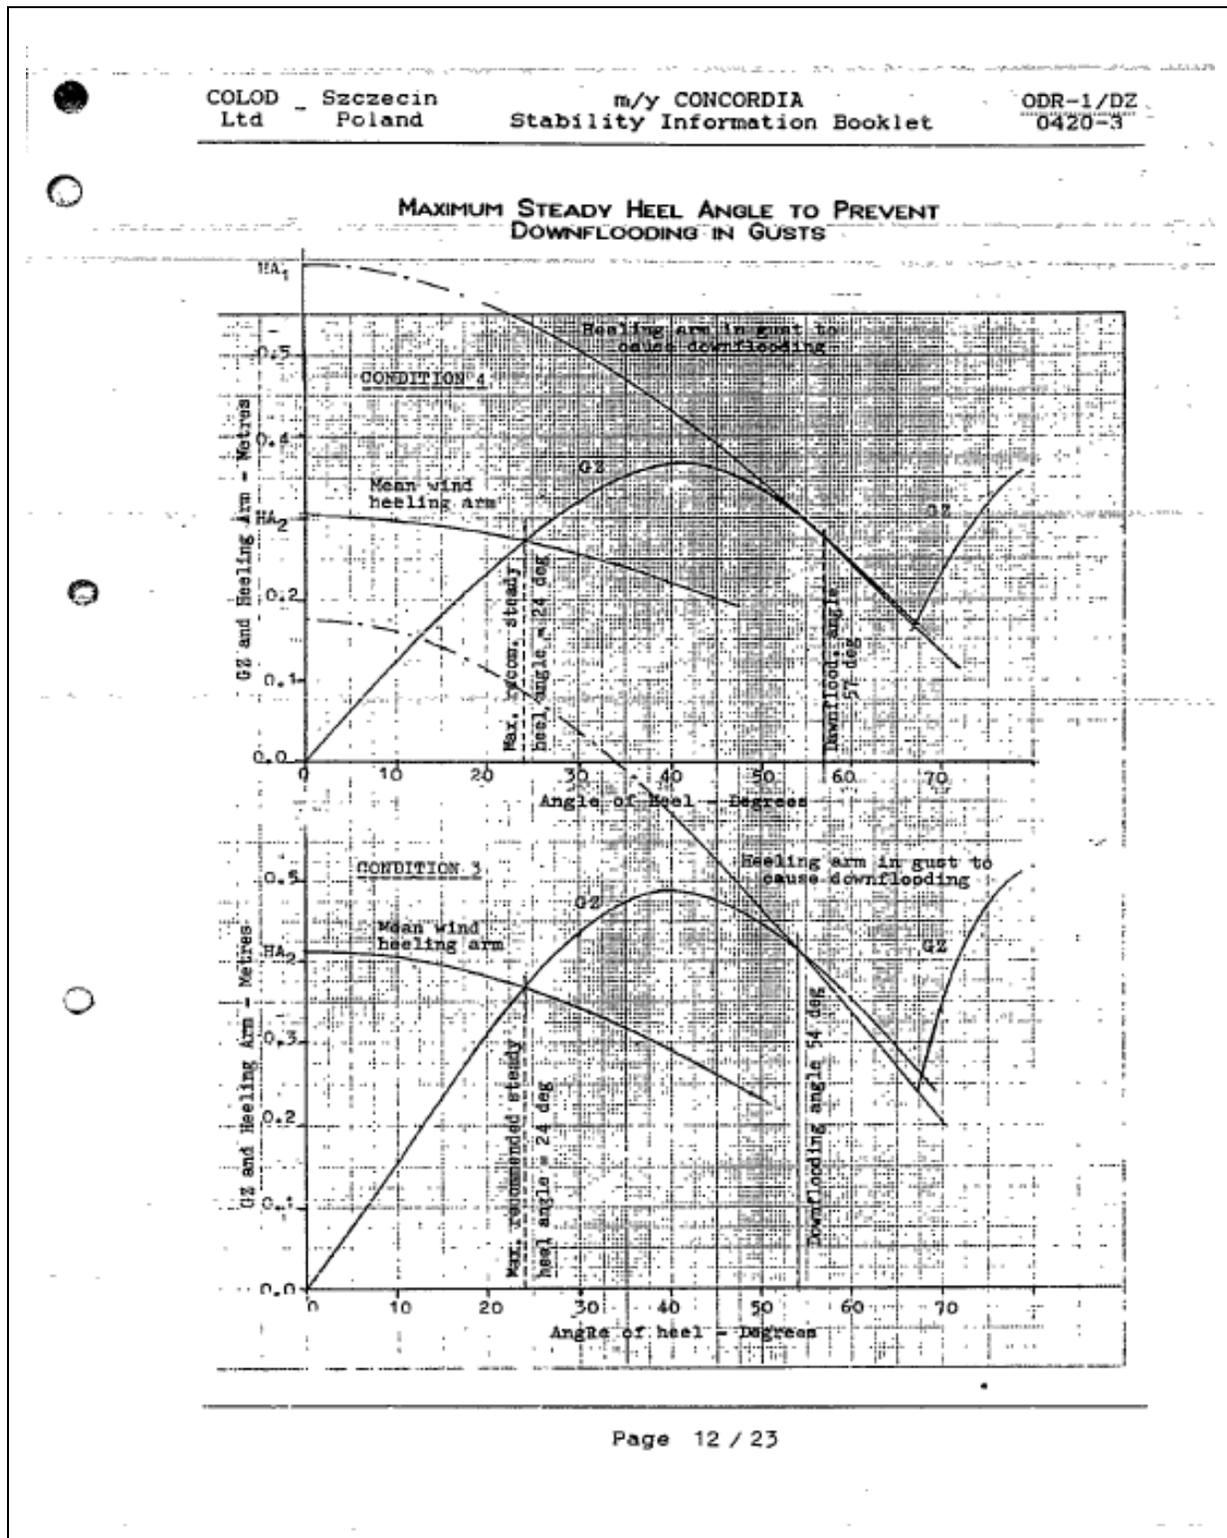
Appendix F – Maximum Steady Heel Angle to Prevent Downflooding in Gusts and Squalls

Curves of maximum steady heel angle indicate the range of mean or steady heel angles beyond which the vessel will suffer downflooding in the event of a squall.

Operation of the vessel in cyclonic conditions particularly in the hours of darkness, where severe squalls are imminent requires the recommended maximum steady heel angle to be reduced depending on the mean apparent wind speed in accordance with the curves presented above.

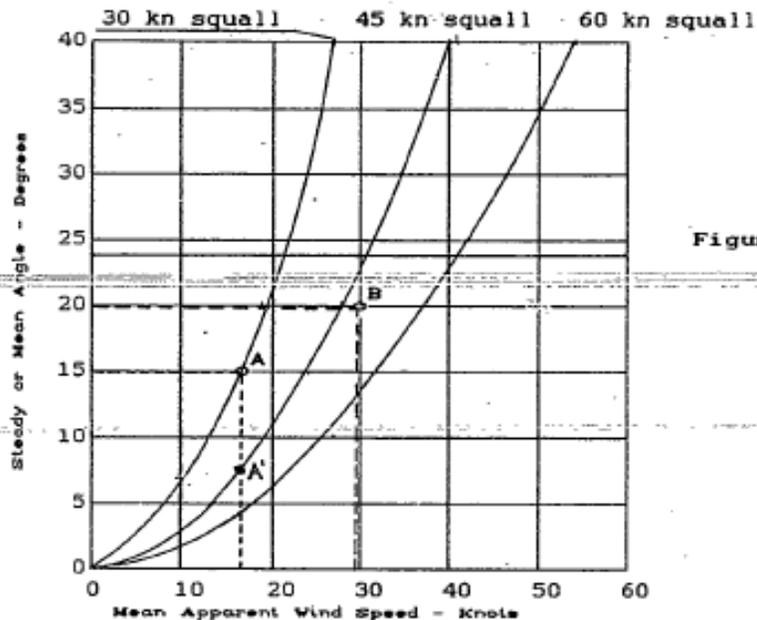
Figure 1

Example A The yacht is reaching, with a steady apparent wind speed of 16 knots. The mean heel angle is 15 degrees. Forecasts and visible cumulo-nimbus clouds suggest squalls may be imminent. By plotting the heel angle and wind speed (point A in Figure 1) the indication is that the vessel will be in danger of heeling to the downflooding angle in squalls of 30 knots. In order to increase safety from downflooding, say, to withstand squalls of up to 45 knots, sails should be handed or reefed to reduce the mean heel angle to 7 degrees (point A' in Figure 1) or less.

Example B The yacht is beating in gusty conditions with a mean apparent wind speed of 30 knots. The mean heel angle is 20 degrees. No squalls are expected. The heel angle is significantly less than 24 degrees, the maximum recommended steady heel angle, and there is therefore a good safety margin against downflooding in a strong gust. Plotting these values of wind speed and heel angle (point B in Figure 1) also indicates that the vessel would not be vulnerable to downflooding in a squall unless it resulted in a wind speed in excess of about 50 knots. There is thus no need to reduce sail area on the grounds of stability.

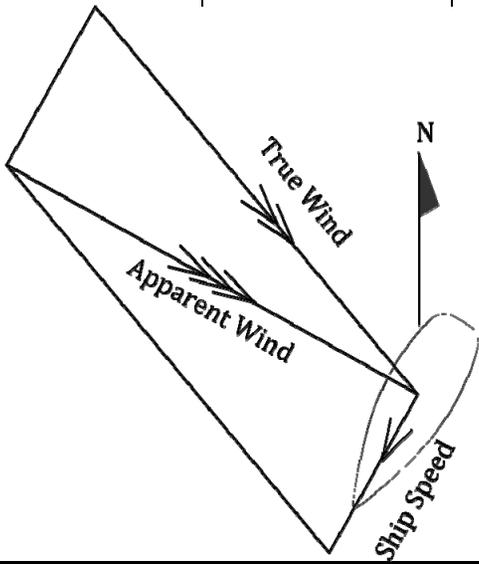
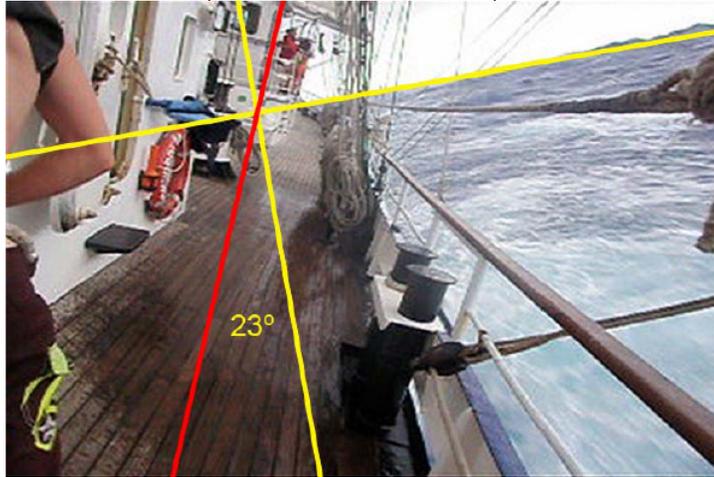
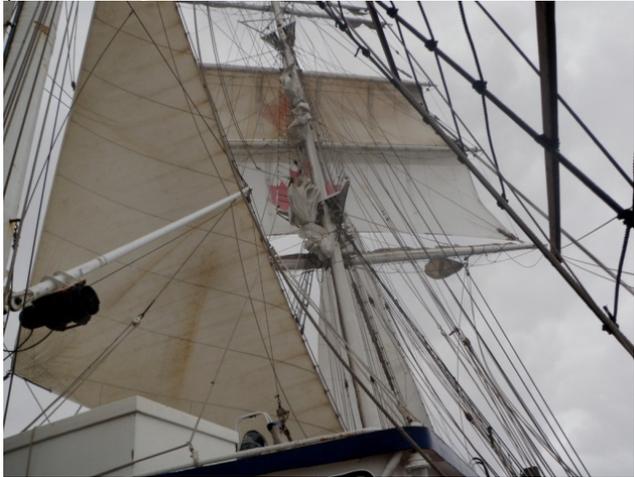
Time Period (Approx)	Ship Speed /Heading	True Wind	Apparent Wind	Heel	Notes
<p>1420</p> <p>2 to 3 minutes - Student takes video (57 sec) showing conditions on deck and some still photos</p>	<p>Approximation: 9 knots at 210°</p>	<p>Approximation: 25 knots at 320°</p>	<p>Investigation Info: 23 knots</p> <p>Derived Using Approximations for Ship and True Wind Info: 23.5 knots at 88.9°</p> <p>* See notes</p>	<p>Investigation Info: 23° min</p> <p>Calculated range of apparent wind speed for this heel is 20 to 28 knots</p> <p>* See notes</p>	<ul style="list-style-type: none"> Analysis of video footage determined that the minimum angle of inclination of the vessel which could be discerned from the video was 23°. [See photo, below] Video shows inner jib with leading edge full but trailing edge flapping; likely due to blanketing effect of forestaysail. Main staysail and main also appear full, indicating a likely apparent wind angle at least at the beam or aft of that Square sails full, indicating likely apparent wind angle at least at the beam or aft of that [see photo below]
