**Report**

# The loss of the sailing vessel, *Essence* 22 July 2021

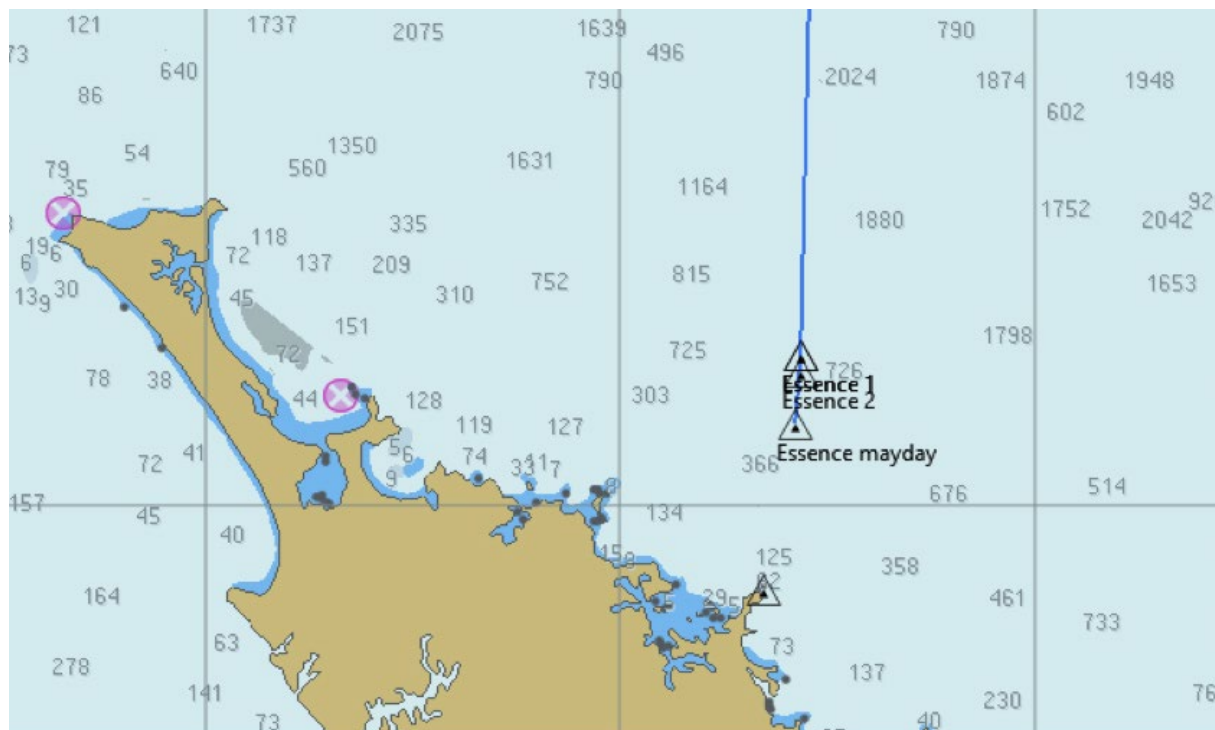
**Diagram 2: Approximate track of *Essence***

At 1229 hours, a Mayday was issued on VHF Channel 16 to Maritime Radio from a position of 34° 50.3156S, 174° 25.208 E advising that the vessel was full of water and likely to sink. One of the crew went forward to find his personal PLB which he then activated. He observed that the forward hatch that had earlier been closed was now open, and closed it. A decision was then made to abandon ship to the liferaft, however, the liferaft had been washed off the aft deck.

The crew then assembled in the cockpit area with a grab bag containing emergency equipment, and discussed their predicament. The hand-operated bilge pump at the helm was operated in an attempt to remove water from the cabin, but it proved ineffectual. After approximately 15 to 20 minutes **Essence** began to settle and sank bow first as the crew disembarked into the sea through the port aft rails, with a danbuoy and the grab bag containing a waterproof handheld VHF radio.

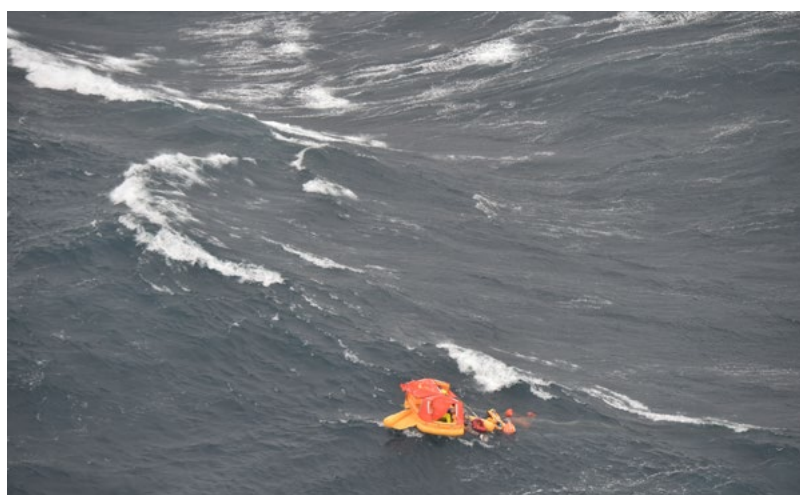
### Photograph 2: Liferaft dropped by NZDF Orion with crew on board and in the sea

At approximately 1521 hours, **Westpac Rescue 1** arrived on the scene and, in challenging conditions, a rescue diver was able to carry out four lifts of the crew from the liferaft and surrounding seas. The skipper was first to be lifted but was deceased when pulled into **Westpac Rescue 1**.
