Report on the investigations of two fatal accidents

on board the UK registered yacht

CV21

122nm west of Porto, Portugal

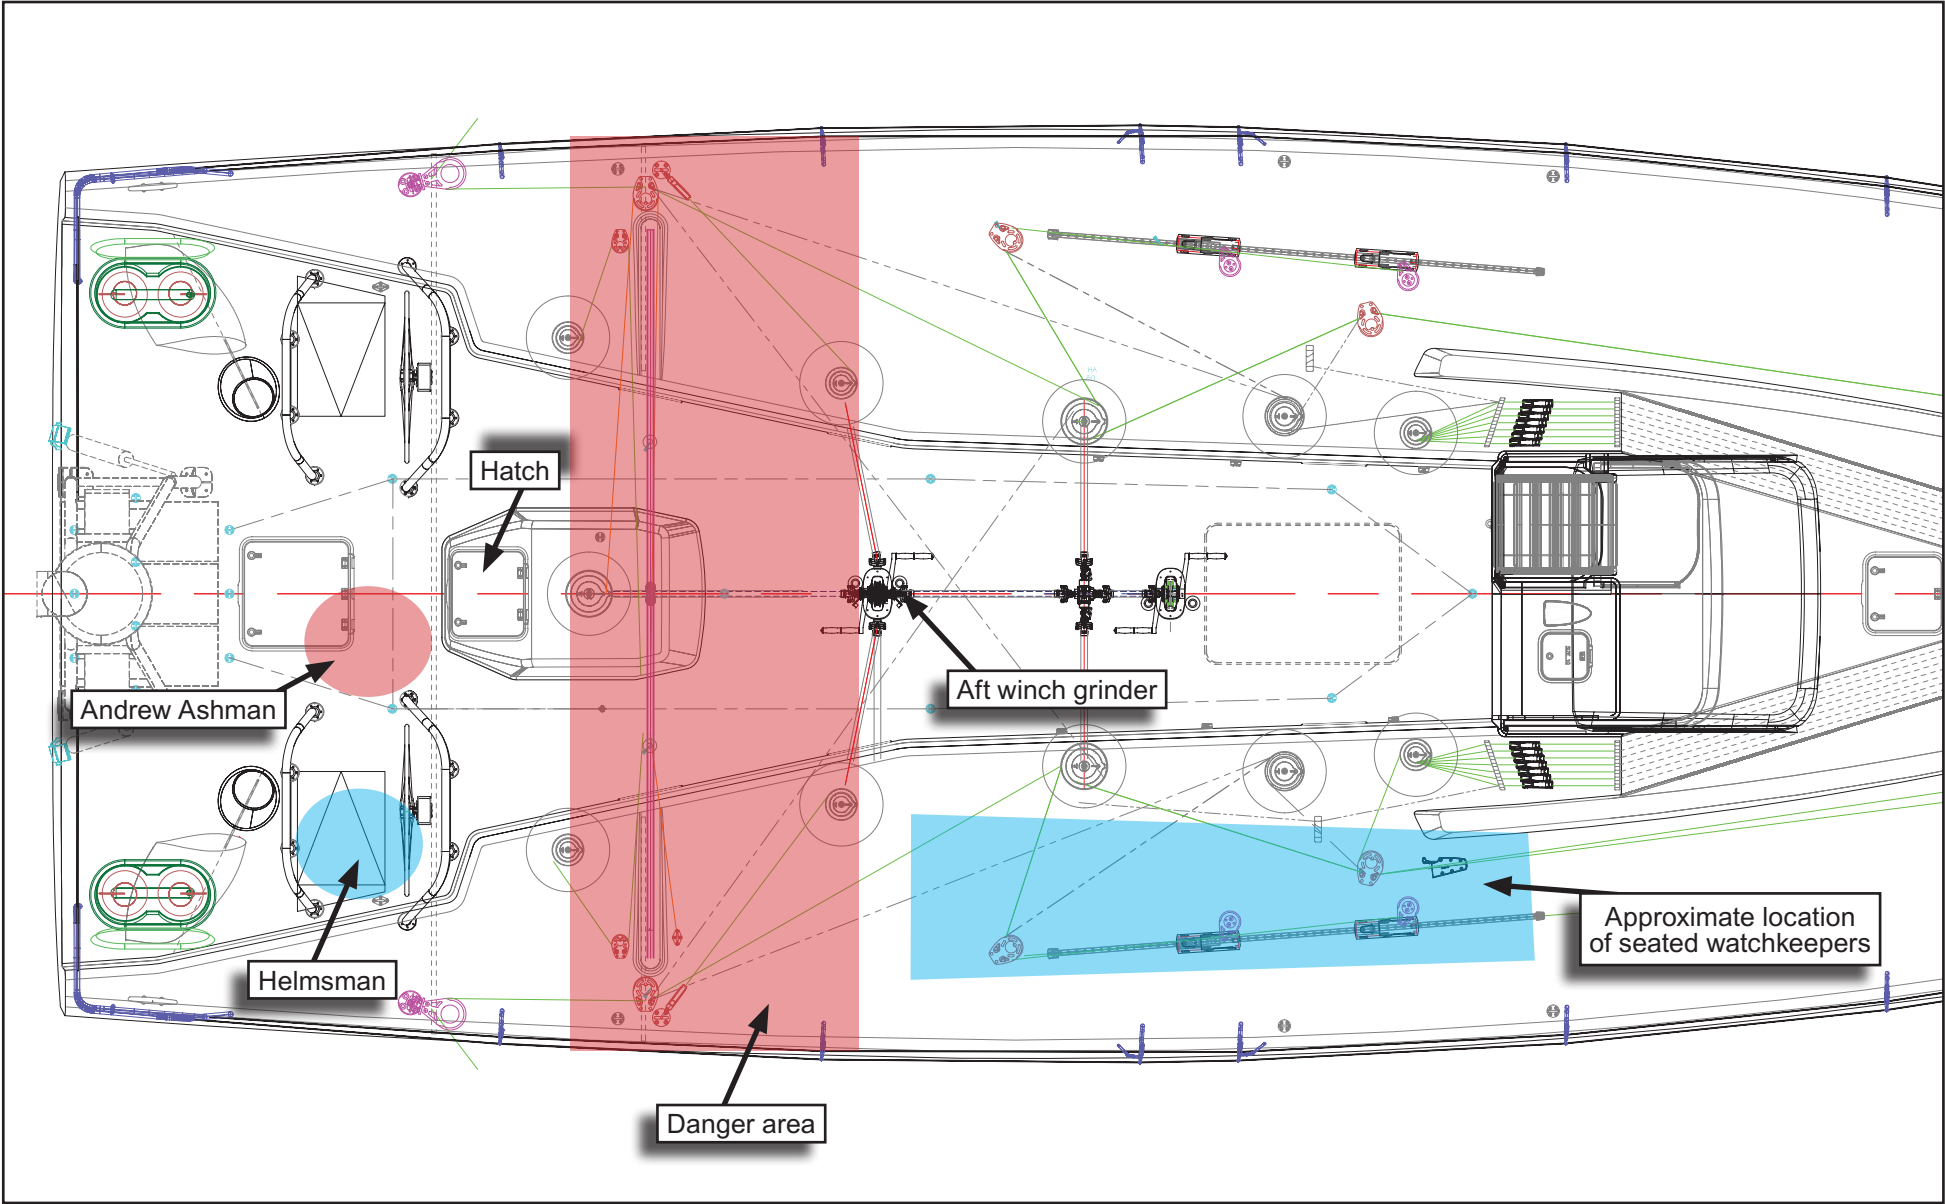
Figure 11: Position of crew prior to accident

At 2330, the helm was passed to one of the least experienced helmsmen, with Andrew monitoring him. Andrew was standing aft of the traveller and to port of the helmsman (**Figure 11**), with his tether fixed to a D-ring to starboard of the navigation station hatch.

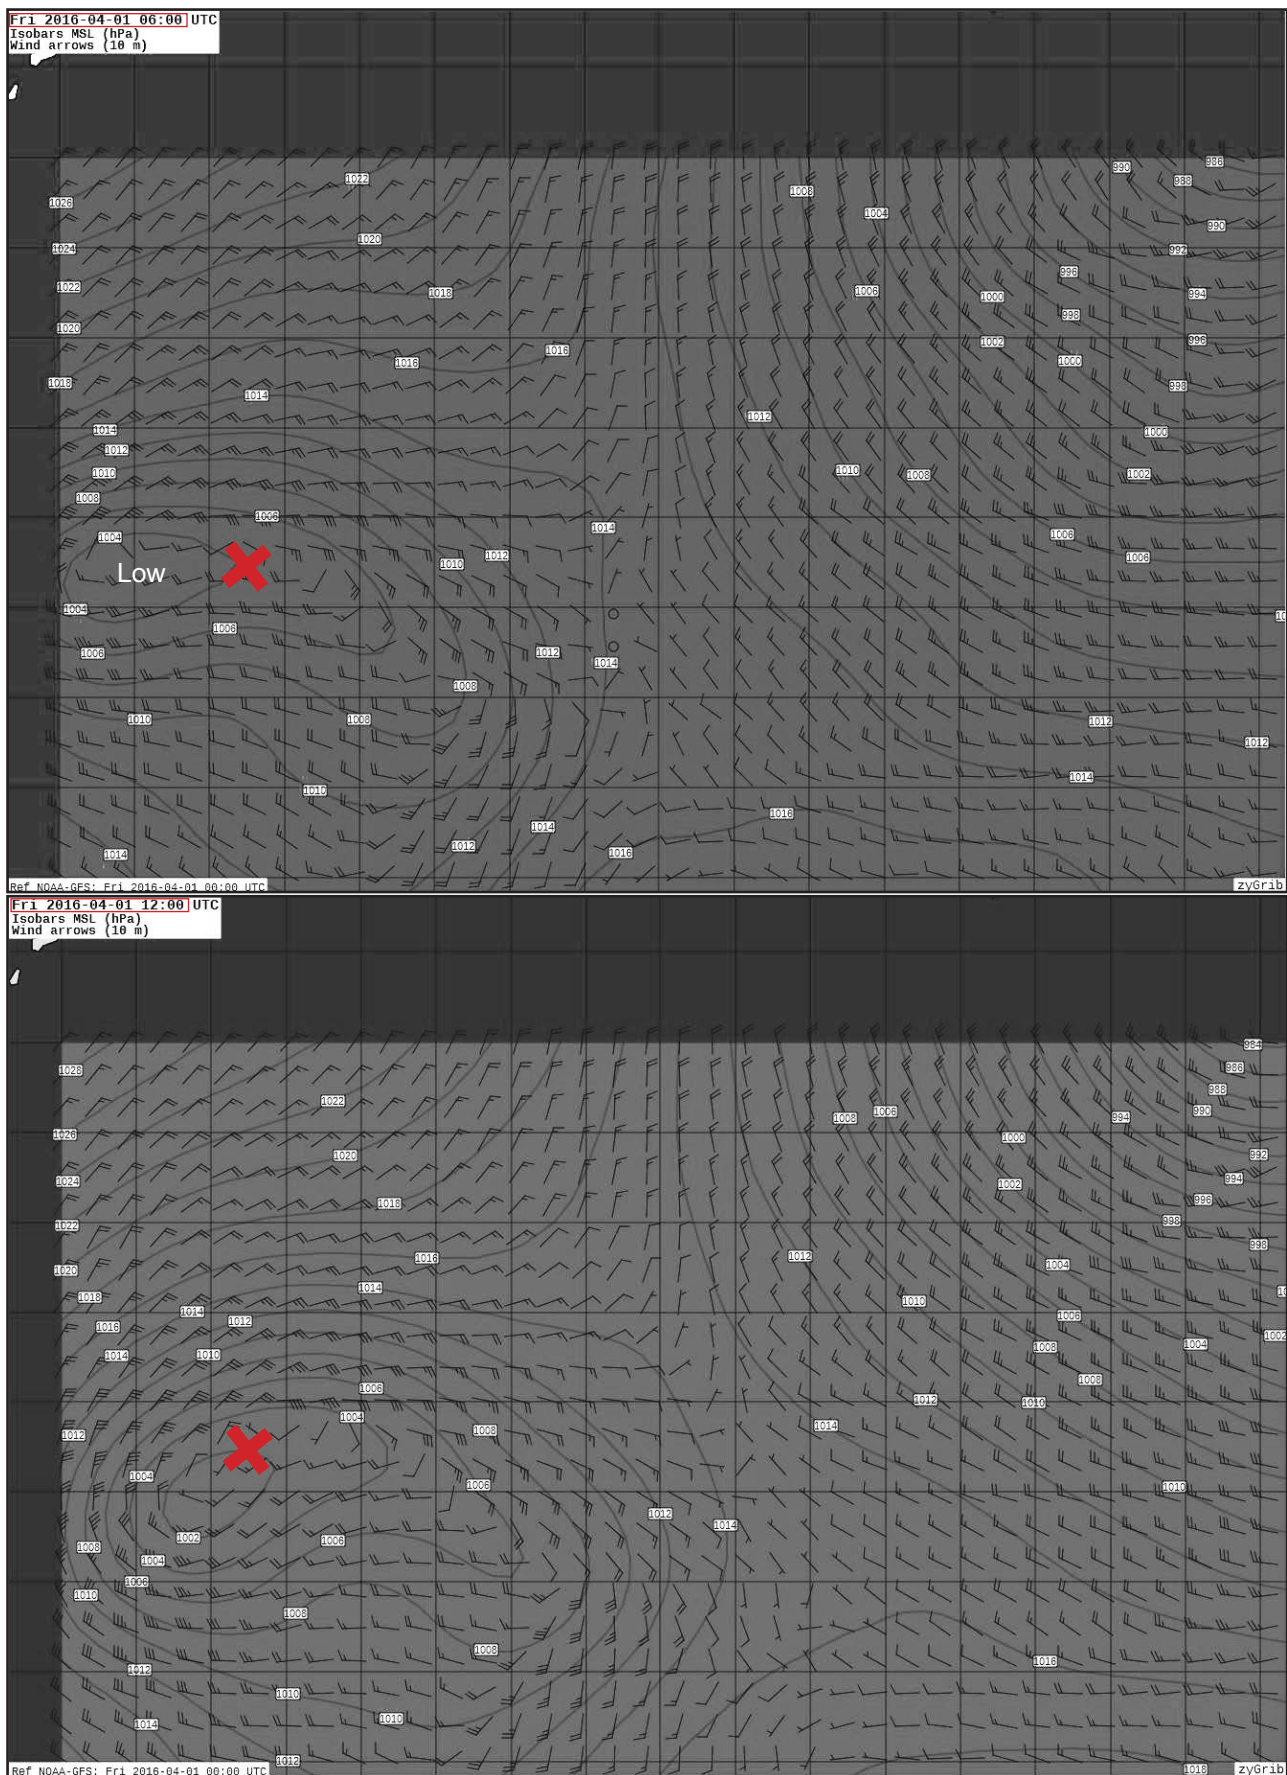
Figure 15: Zygrib weather forecast issued at 0900 (UTC) on 1 April 2016 with MOB position marked

At 2100 (UTC+12) on 1 April, the skipper received the daily weather report (**Figure 15**). At 2116, the yacht gybed on to a starboard tack (**Figure 16**), the wind having been backing since 1700, to maintain an easterly course. From examining the data, he anticipated the wind would increase early the following morning as a weather system moved through from west to east. He briefed the ongoing watch leader prior to the starboard watch taking over at 2200. The port watch leader completed a handover with the starboard watch leader before the port watch then went below.

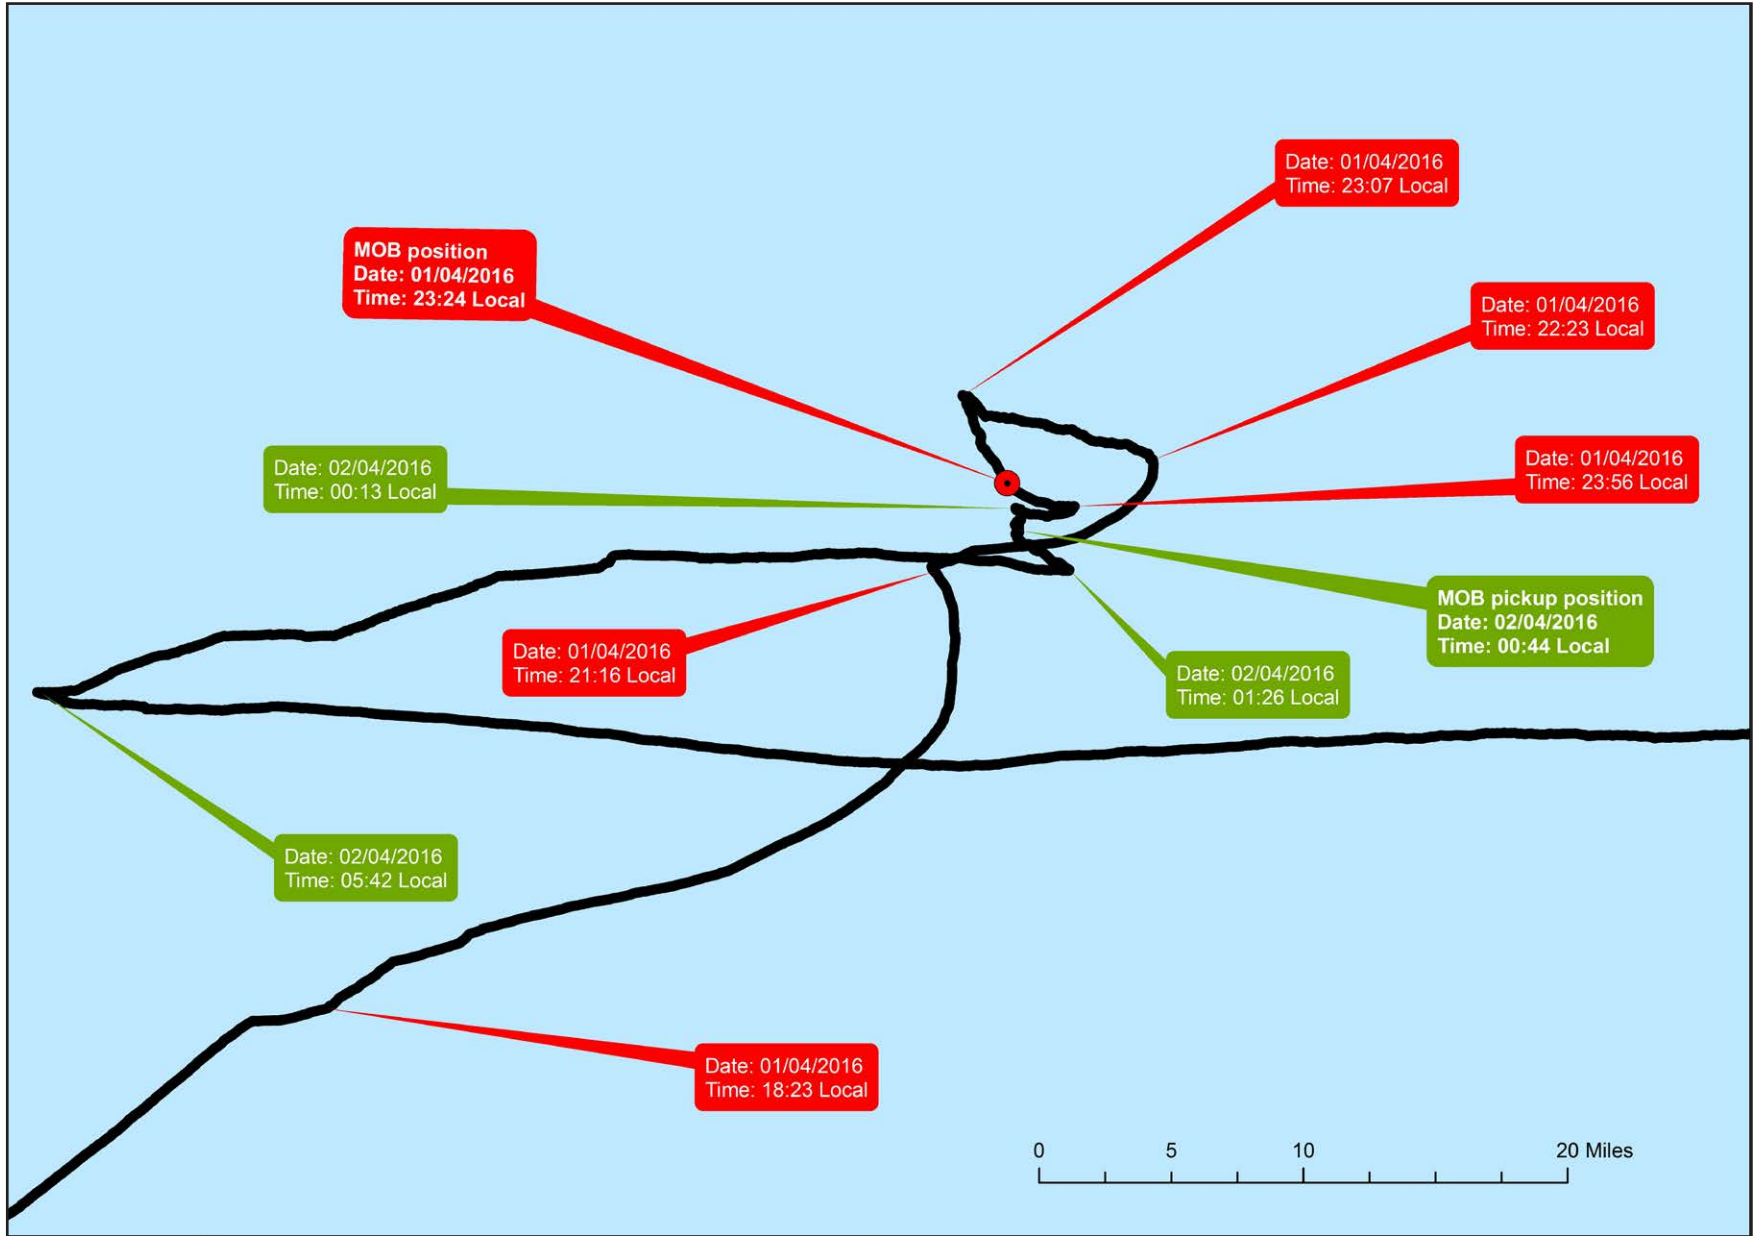
Figure 16: Track of CV21

At 2307, the skipper finally managed to turn CV21 onto a port tack on a south-easterly heading. The boom was on the starboard side and the yacht was heeling to starboard. The assistant watch leader had gone below to warm up, having become wet during the reefing process. The crew on deck tidied the lines and

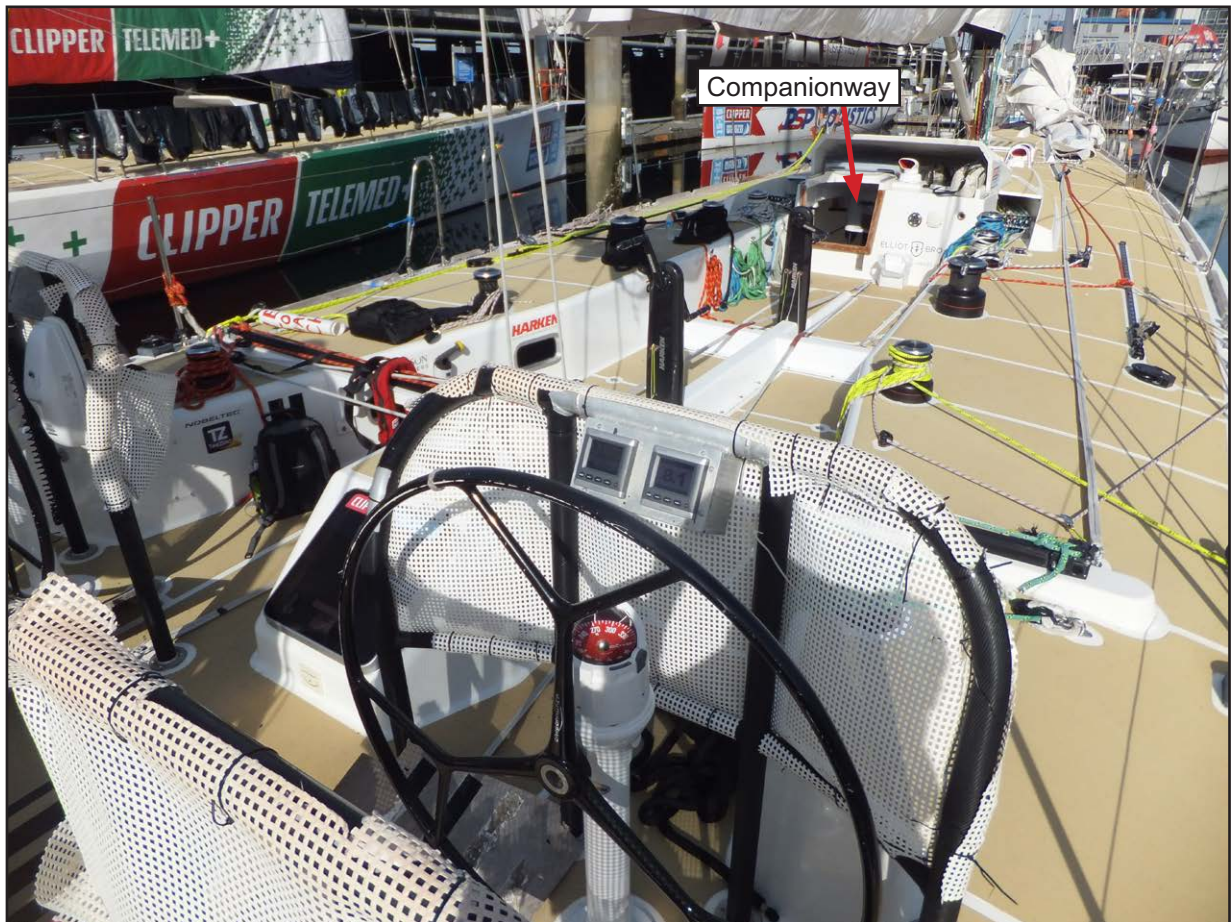
Figure 17: Cockpit showing companionway

Leaving the three crew below to get ready, Sarah climbed back up the companionway steps into the cockpit (**Figure 17**). Without first clipping on her tether, she assisted another crew member in reattaching a winch handle pocket (**Figure 18**) onto the port forward side of the cockpit. The combination of a wave breaking over the deck from the port side and CV21 heeling further to starboard led to Sarah losing her footing, and falling over and down the deck, ending up lying next to the starboard guardrail with a winch handle in her hand. The watch leader, who was sitting on the starboard side of the cockpit, tried to grab her, but before he was able to do so another wave washed down the starboard side, forcing Sarah over the side.

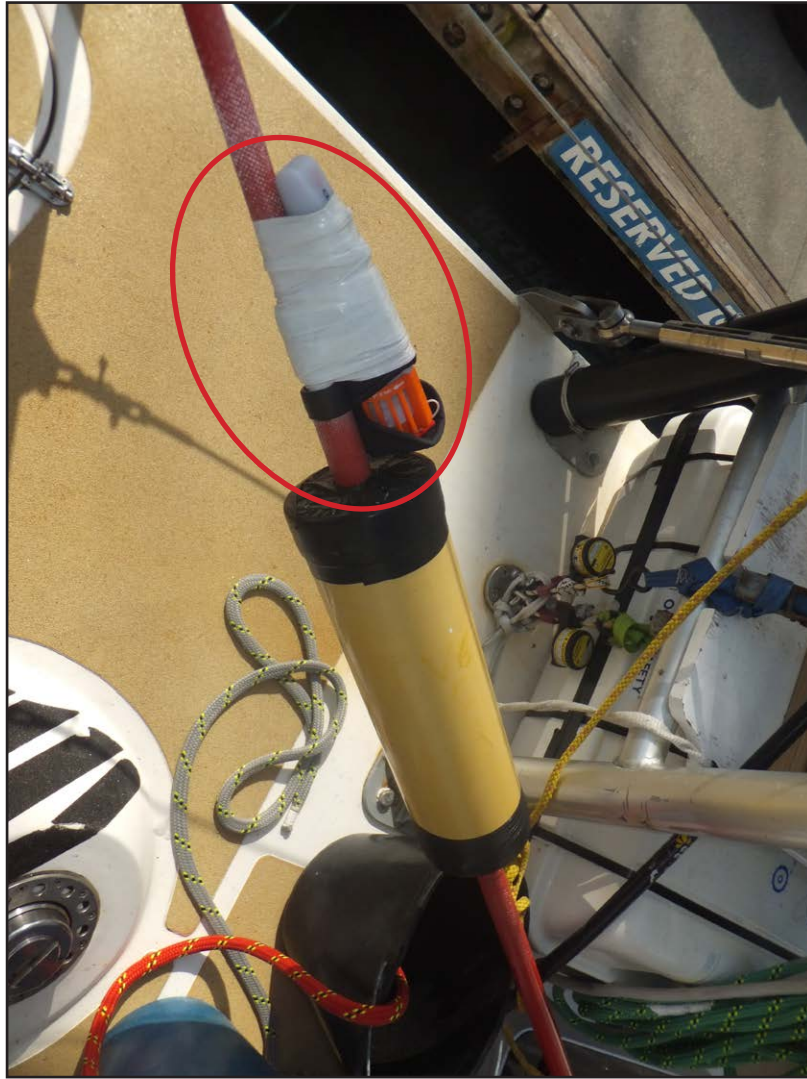
Figure 23: McMurdo S10 AIS beacon mounted on dan buoy

The dan buoy had taped to it an AIS beacon, which was a different model to that fitted to the lifejackets. This AIS beacon was submersible to 60m water depth and had a typical reception range of 4nm at sea level (**Figure 23**).

The AIS beacon needed to be activated prior to the dan buoy being thrown overboard. This required a crew member to remove the base pin, twist the bottom of the unit clockwise, and then push the base upwards. To check the battery, the base pin was left in place and the bottom twisted anticlockwise and released. The resulting flashing light sequence then indicated the residual battery life. To conduct a full system check, the bottom was twisted anticlockwise and held for 10 seconds, which caused a test message to be transmitted.

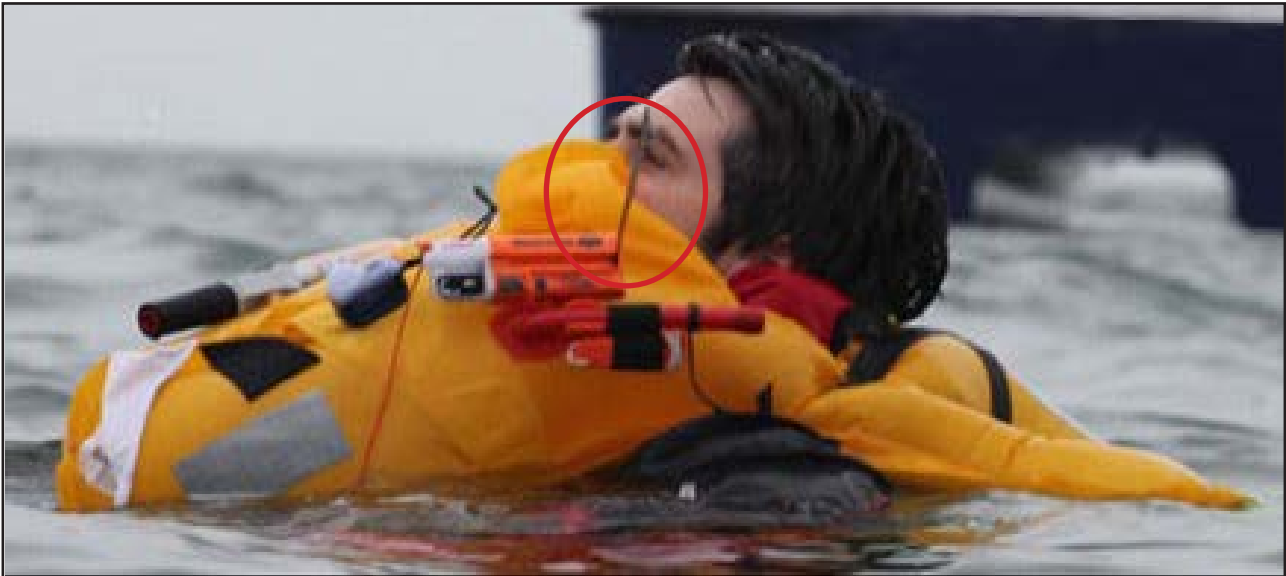
Figure 27: AIS beacon with antenna deployed on inflated lifejacket

beacon not in a vertical orientation its reception range would have been reduced significantly. The effectiveness of fitting an AIS beacon to the dan buoy needs further consideration.

As demonstrated in this accident, the fitting of personal AIS beacons to individual crew members would appear to offer a more reliable option. Firstly, it locates the person, not a dan buoy thrown over at some stage after the MOB. Secondly, because the orientation of the AIS beacon antenna when deployed will maximise the AIS transmission (**Figure 27**). Thirdly, it is small enough to be carried on a person and be immediately available at all times.

Ideally, AIS beacons should auto-activate. However, the AIS beacons that were voluntarily fitted to the lifejackets of the majority of participants in the Race were manually activated, therefore requiring the casualty to be conscious when in the water. However, the current lack of availability of an auto-activating AIS beacon should not prevent Clipper requiring the compulsory carriage of personal AIS beacons for all Clipper crew in future races.
