Report of Marine Survey

Vessel: 2013 Cobalt 24 SD

Purpose: Pre-purchase and Evaluation

Date of Survey: September, 9th 2017

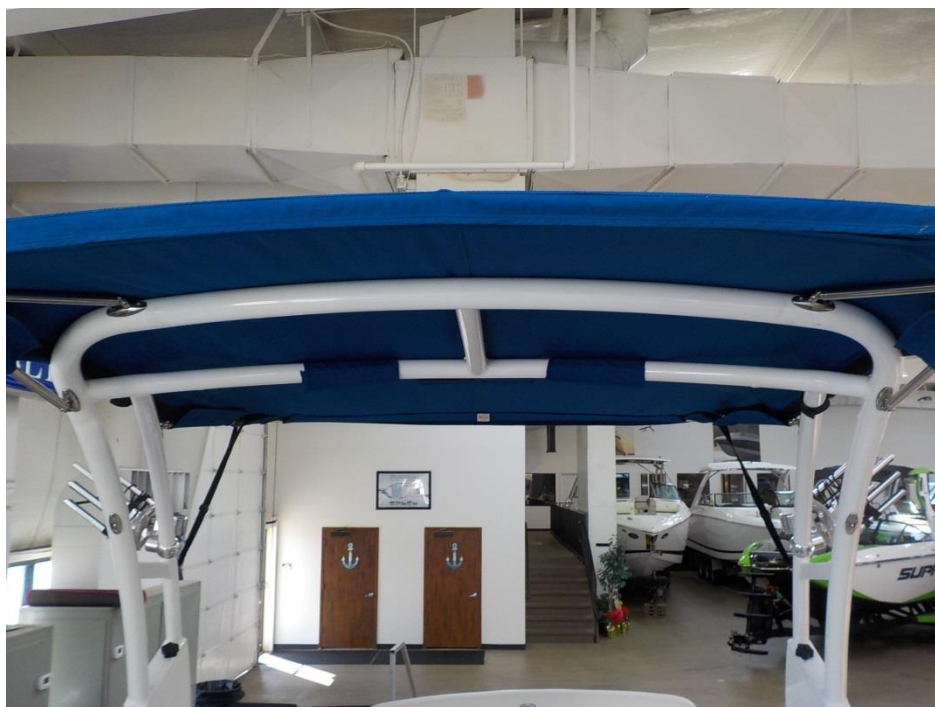
Yes. Blue canvas bimini sighted on vessel above wake-board tower. Canvas is clean and in good condition. No damage, rips or tears sighted.

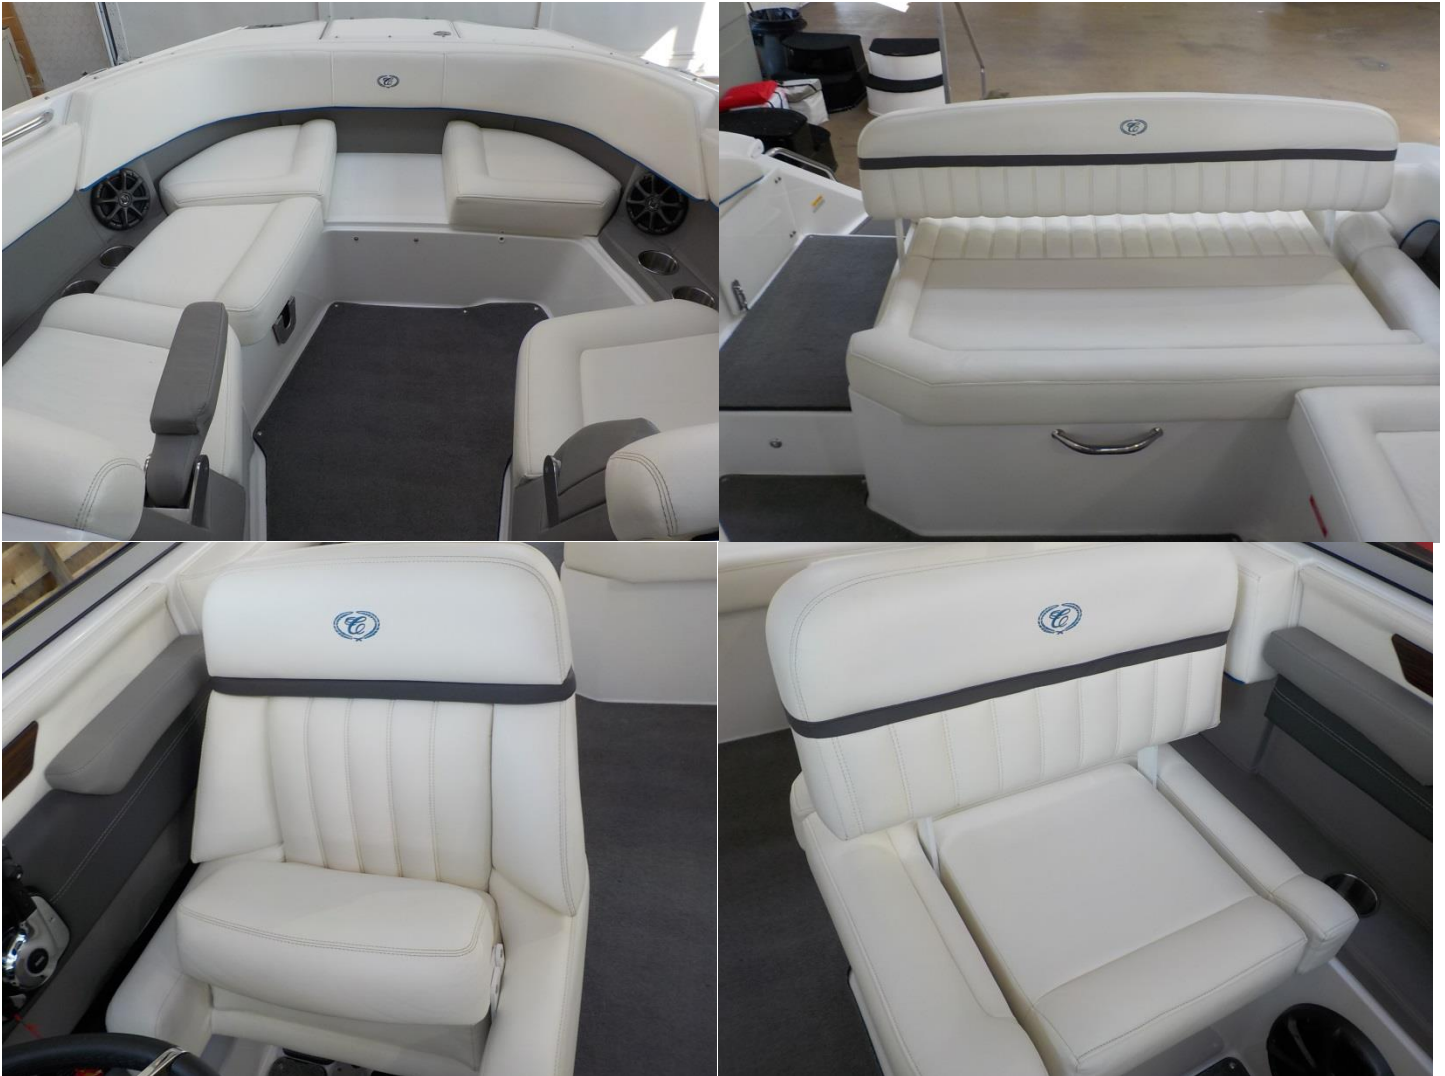
Single fold-down white vinyl covered seat on port side of cockpit. "L" shaped vinyl covered seating behind, with additional vinyl seat aft of cockpit on starboard side. Forward of the cockpit there is an open bow area with C-shaped wrap around seating. White in color with blue piping and silver highlights. Vinyl is in very good condition. Clean, with no rips or tears sighted.

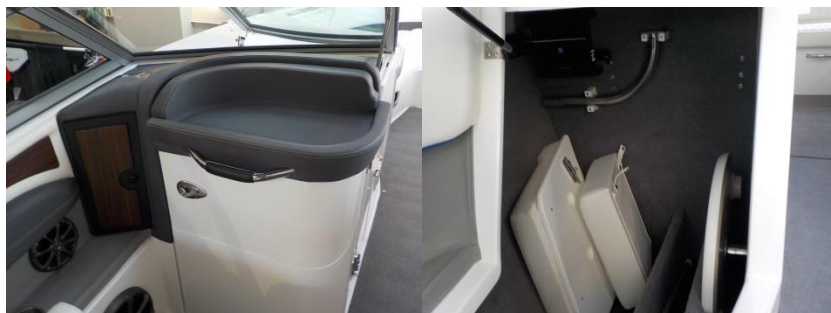
Porta-pottie located in head compartment on port side of cockpit. NOTE: Not tested for functionality.

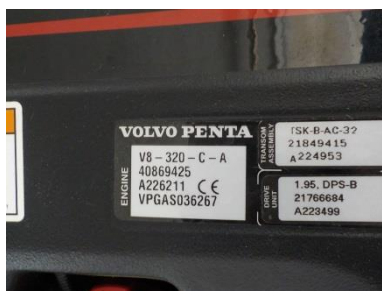
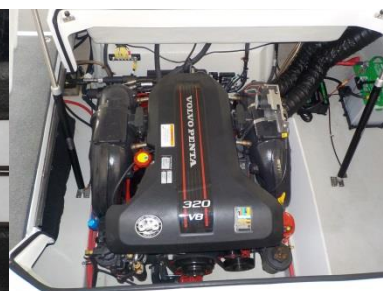
Volvo Penta 320 V8
Serial: 40869425-A226211-VPGASO36267

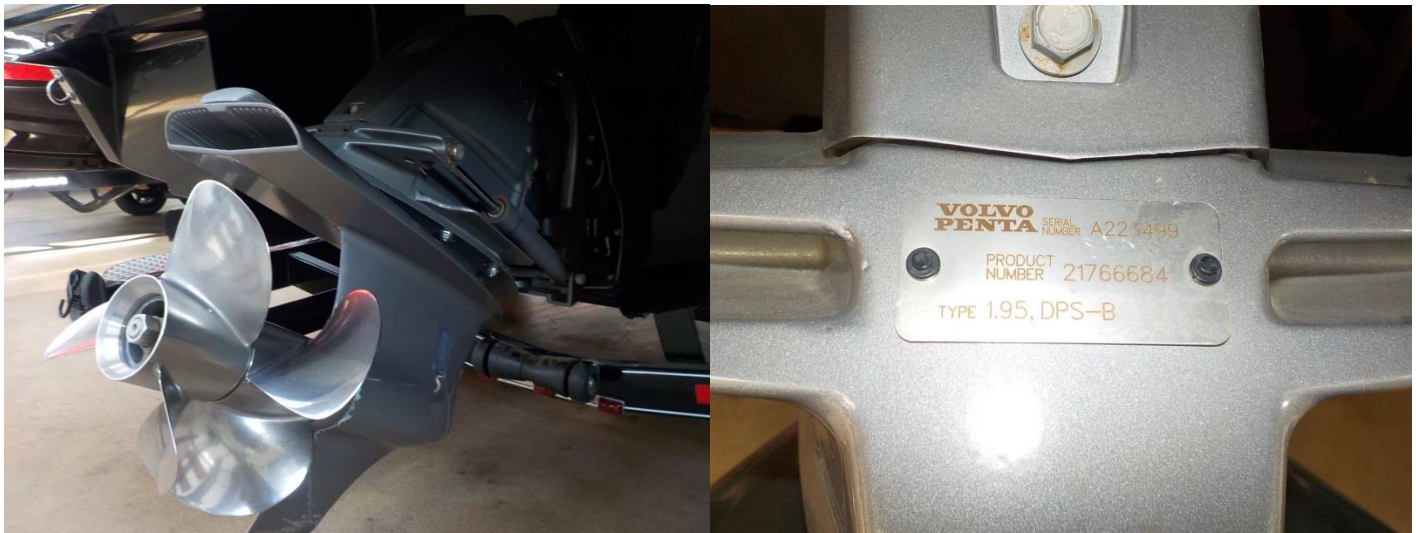
NOTE: Plug was not pulled to check gear oil. Have outdrive oil condition checked for excess gear wear and replace gear oil. Monitor condition frequently.

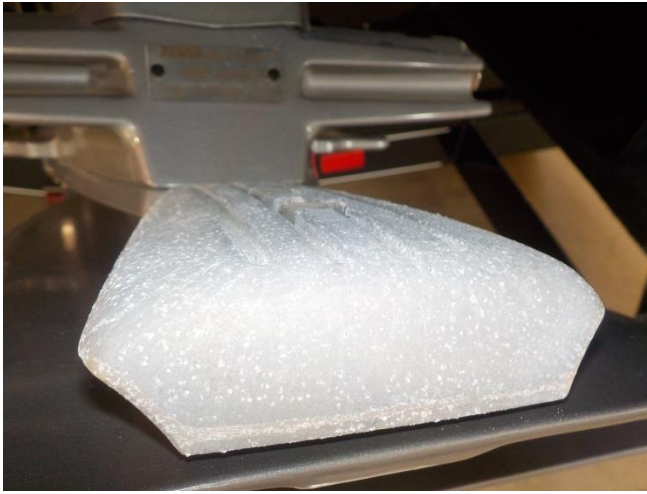
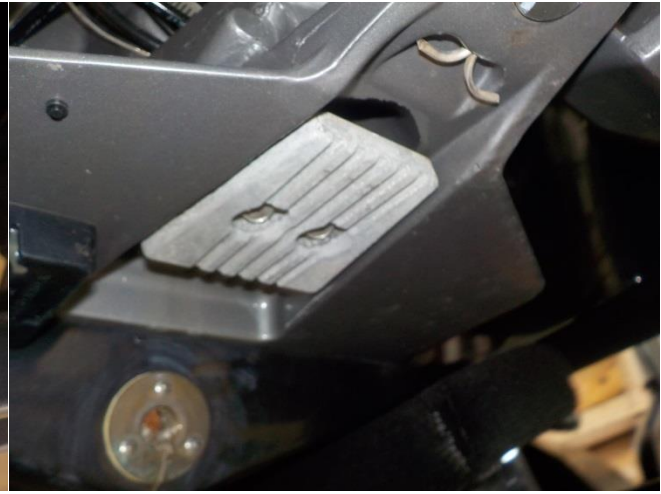
Two total anodes: (1) on outdrive lower unit, (1) on bottom of out-drive transom assembly. Both anodes are in good condition and serviceable.
