Report of Marine Survey

Vessel: 2017 Mastercraft X23

Purpose: Pre-Purchase Condition & Valuation

Date of Survey: November 26th, 2025

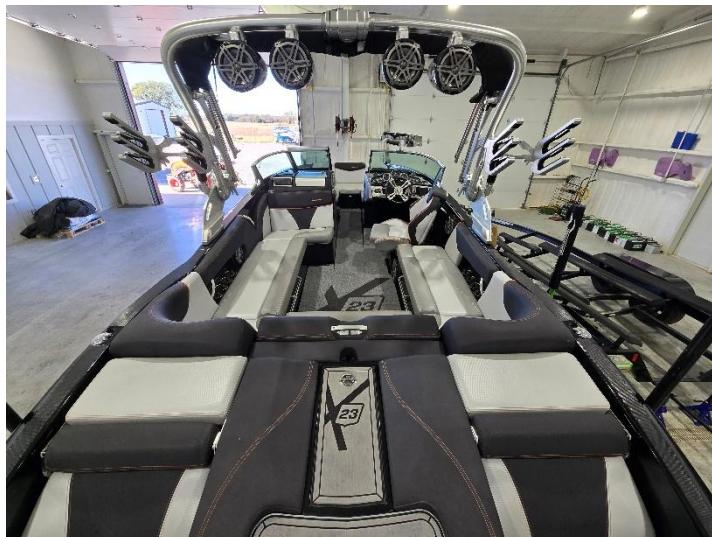
Cockpit

Component	Description	Condition/Notes
Helm Station	Dual console type design with helm station on the starboard side and equipped with instrument dash, seating, controls and accessory switches.	Clean, no damages sighted.
Deck/Sole Covering	Bare gelcoat with removeable foam type padding throughout the cockpit.	Good overall condition.
Bimini Top	Stainless framed bimini top with black colored canvas integrated into the ski tower.	Good overall condition, well secured, no damages sighted. NOTE: Underside of bimini top – canvas is dirty. Clean as needed for cosmetic purposes.
Windshield	Aluminum framed three piece glass windshield with opening walk-thru center pane.	No damages sighted. Center door opens and closes properly.
Storage Hatch(s)	Storage compartments located under the forward and aft seat cushions.	Clean and dry where sighted.

Exterior Seating	Helm station equipped a swiveling captains chair. Bow area and aft cockpit equipped with "U" shaped bench type seating. Sunpad cushion on each side of the engine hatch.	Vinyl cushions are grey/black in color with orange piping and are in good overall condition. NOTE: Starboard aft seat cushion in the cockpit has a 6" black scuff mark. Clean as needed for cosmetic purposes.
Engine Hatch	Manually opening engine hatch on the aft deck.	Opens and closes properly. No damages sighted.

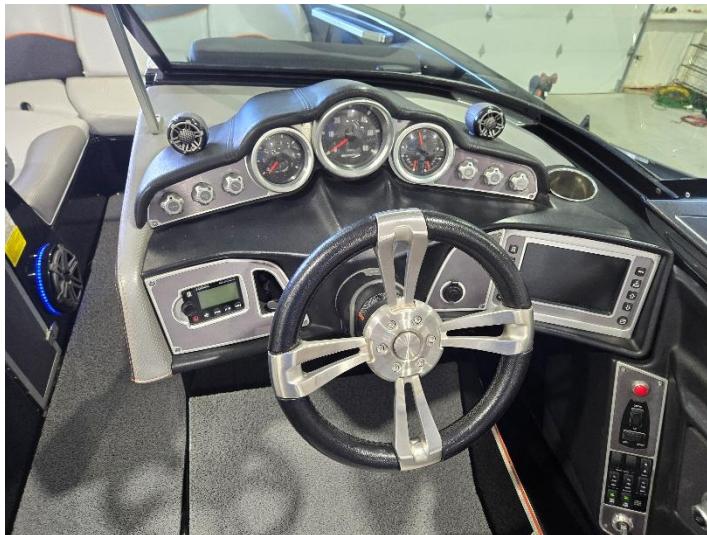
Helm Station

Component	Description	Condition/Notes
Throttles & Shifter	DTS (Digital Throttle & Shifter)	Controls were shifted back and forth and operated smoothly.

Engine & Status Gauges	Engine and status information displayed via digital display screen and analogue gauges for speed, RPM, fuel level, oil pressure and engine temperature.	All gauges were found to be operational.
Multi-Function Control Panel	Digital control panel for viewing engine information and deploying the ballast system, surf gate, power wedge and cruise control settings.	Operational. Screen is in good condition with no delamination or damages.
Ballast Controls	Ballast control settings operated via the digital display screen and the analogue switches next to the helm seat.	Operational.
Bilge Pump Switch	Analogue rotary type switch to manually power on the bilge pump.	Operational.
Blower Control Switch	Analogue rotary type switch to manually power on the bilge blower.	Operational.
Accessory Switches	Accessories and lighting are controlled via rotary type switches.	All are in serviceable condition.
