# **Report of Marine Survey**

**Vessel: 2021 Axis T22**

**Purpose: Pre-Purchase Condition & Valuation Survey**

**Date of Survey: October 23rd, 2023**

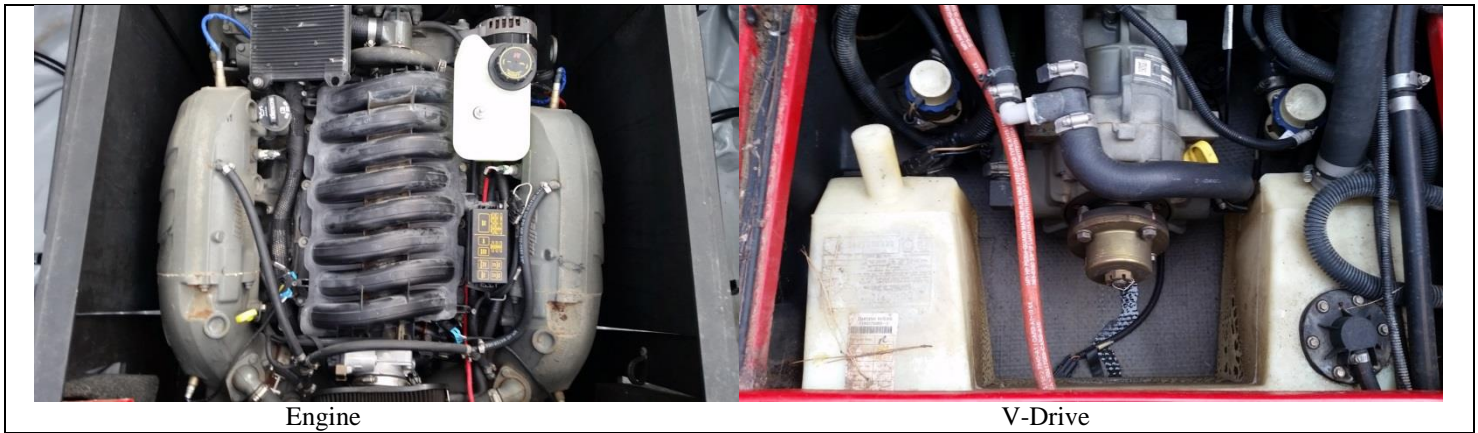
**Exhaust System**

<b>Discharge Location:</b>	Underwater via stainless downpipe at transom
<b>Piping/Clamps:</b>	Metal piping and marine grade wet exhaust hose. Securely double clamped as required by ABYC P-1. No cracks or damages sighted where accessible for
<b>Manifold/Risers:</b>	Serviceable condition, no cracks or leakage sighted where accessible for inspection. <b>NOTE: Exhaust manifold fasteners/bolts are heavily corroded in places. Recommend having mechanic inspect interior passages of exhaust manifolds for corrosion and servicing system with fresh gaskets and stainless steel fasteners.</b>
