Report of Marine Survey

Vessel: 1996 Catalina 320 Sailboat

Purpose: Pre-Purchase Condition & Valuation

Date of Survey: September 28th, 2023

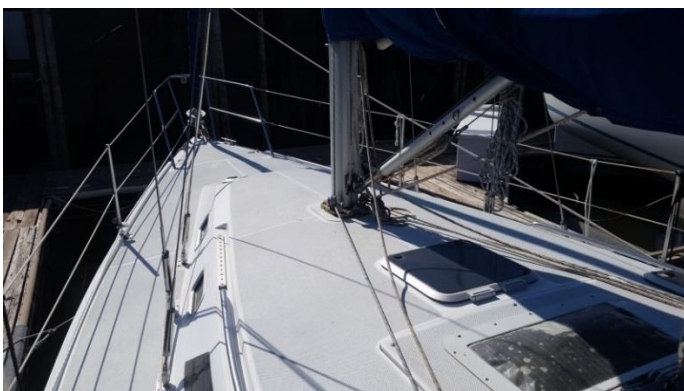
Forward Deck

Two lexan square shaped deck hatches on forward deck. No damages or leakage sighted. Both open and close properly.

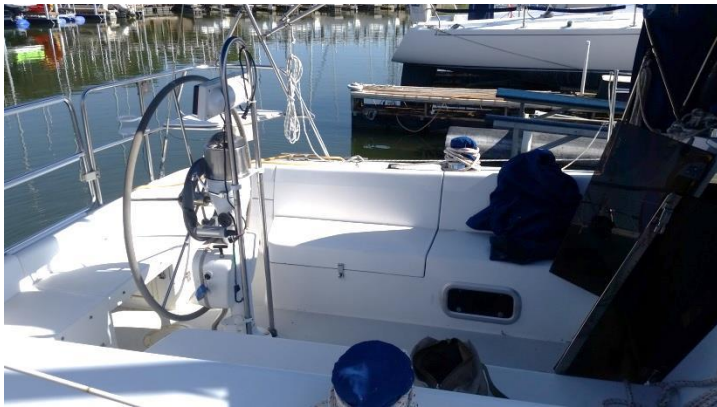
Cockpit

Stainless framed bimini top with blue sunbrella covering cockpit. **NOTE: Bimini fabric is ripped/torn in places and several threads are torn. Repair/replace as needed.**

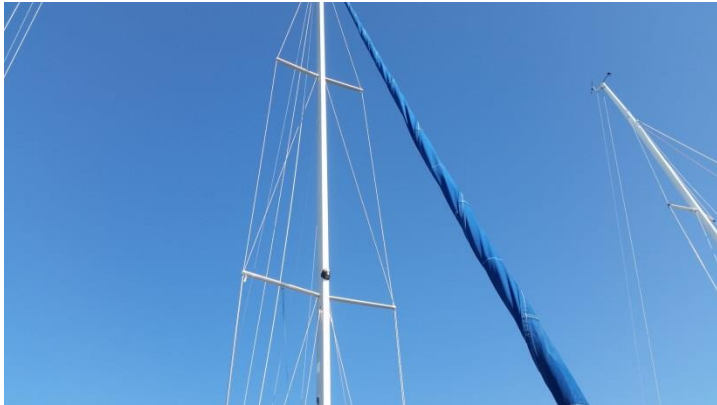
Mast

Deck stepped with compression post. FRP surrounding mast was percussion tested with a phenolic hammer, no delamination was detected or stress cracks sighted.

NOTE: Rigging must be inspected by a qualified/certified rigger. Surveyor is not qualified to inspect rigging. Be advised.

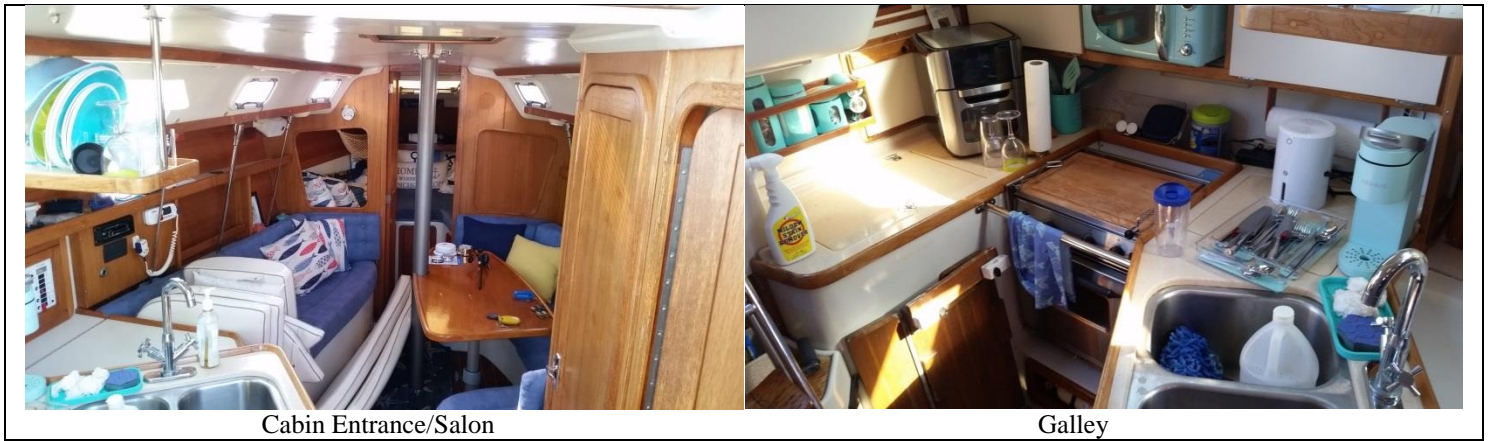
Cabin Entrance/Salon

Nav Station:	Navigation station with built-in chart table on port midships side of salon just forward of galley.
Notes:	NOTE: Forward cabin door (for V-berth) is broken. Repair.

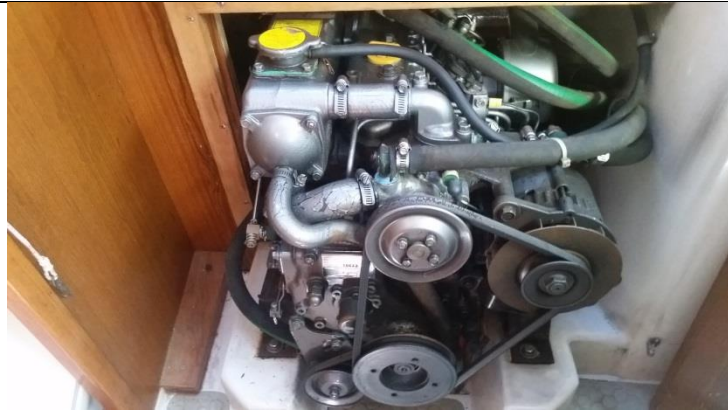
Propulsion Type:	Inboard Diesel
NO#/Type/Cylinders:	<i>NO#:</i> One <i>Type:</i> 4-stroke Diesel Engine <i>Cylinders:</i> 3
Make/Model/Serial:	<i>Make:</i> Yanmar <i>Model:</i> 3GM30F <i>Serial#</i> 16833
Horsepower:	27
Engine Hours:	Unable to determine, no hour meter sighted.
Hoses/Clamps:	Serviceable condition.
Belts/Pulleys:	Serviceable condition.
Cooling System:	Closed cooled with heat exchanger. Coolant level full as per expansion tank markings.
Oil Condition:	NOTE: Engine oil appears dirty. Service engine with fresh oil and filters.
Fuel Line(s):	USCG type A15 fuel hose from tank to engine. Serviceable condition, no leakage, cracks or splitting sighted where accessible for inspection.
Fuel Filter:	Remote mounted fuel water separator next to engine. No leakage sighted. Equipped with metal bowl as per ABYC recommendations.
Mounts/Beds:	Engine mounts are well secured to the support stringers with minimal corrosion sighted.

Flame Arrestor:	Engine is diesel powered, flame arrestor not required.
Engine Started:	Yes, engine was started and ran for approximately fifteen minutes and transmission was shifted in and out of gears. No issues observed.
Notes:	N/A
