Report of Marine Survey

Vessel: 2003 Cobalt 246

Purpose: Inspection and Valuation

Date of Survey: January 7th, 2020

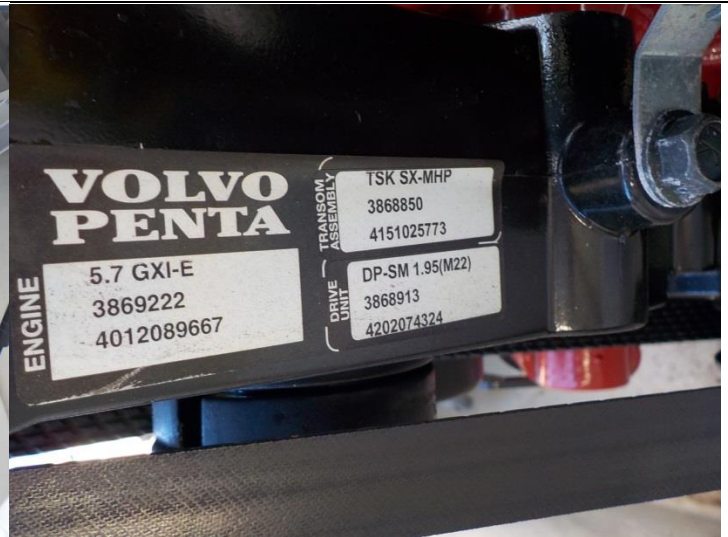
Engine Serial#

Propulsion Type:	Inboard Outboard.
NO#/Type/Cylinders:	One gasoline fuel injected V8 engine. 320 horsepower.
Make/Model/Serial:	<i>Make:</i> Volvo Penta <i>Model#</i> 5.7 GXI-E 3869222 <i>Serial#</i> 4012089667
Engine Hours:	359 hours as per meter inside engine compartment.
Hoses and Clamps:	Average condition, no cracks sighted. Hoses are double clamp where required.
Belts and Pulleys:	Belts are serviceable. No cracks or splits sighted. Pulleys/belts appear to be in line.
Cooling System(s):	Raw water cooled with raw water intake through lower out drive unit, circulated through engine and combined with engine exhaust and routed through out drive props.
Oil Level/Condition:	Full and clean on dipstick. No evidence of water in lube oil.
Flame Arrestor(s):	USCG approved. Clean.
Engine Ventilation:	Blowers and natural ventilation. See safety section of survey for details.
Engine Fuel Pump:	Engine mounted fuel pump. Ignition protected. No leakage sighted.
