# **Report of Marine Survey**

**Vessel: 2007 Sea Ray 320 Sundancer**

**Purpose: Pre-Purchase Condition & Valuation**

**Date of Survey: December 15th, 2023**

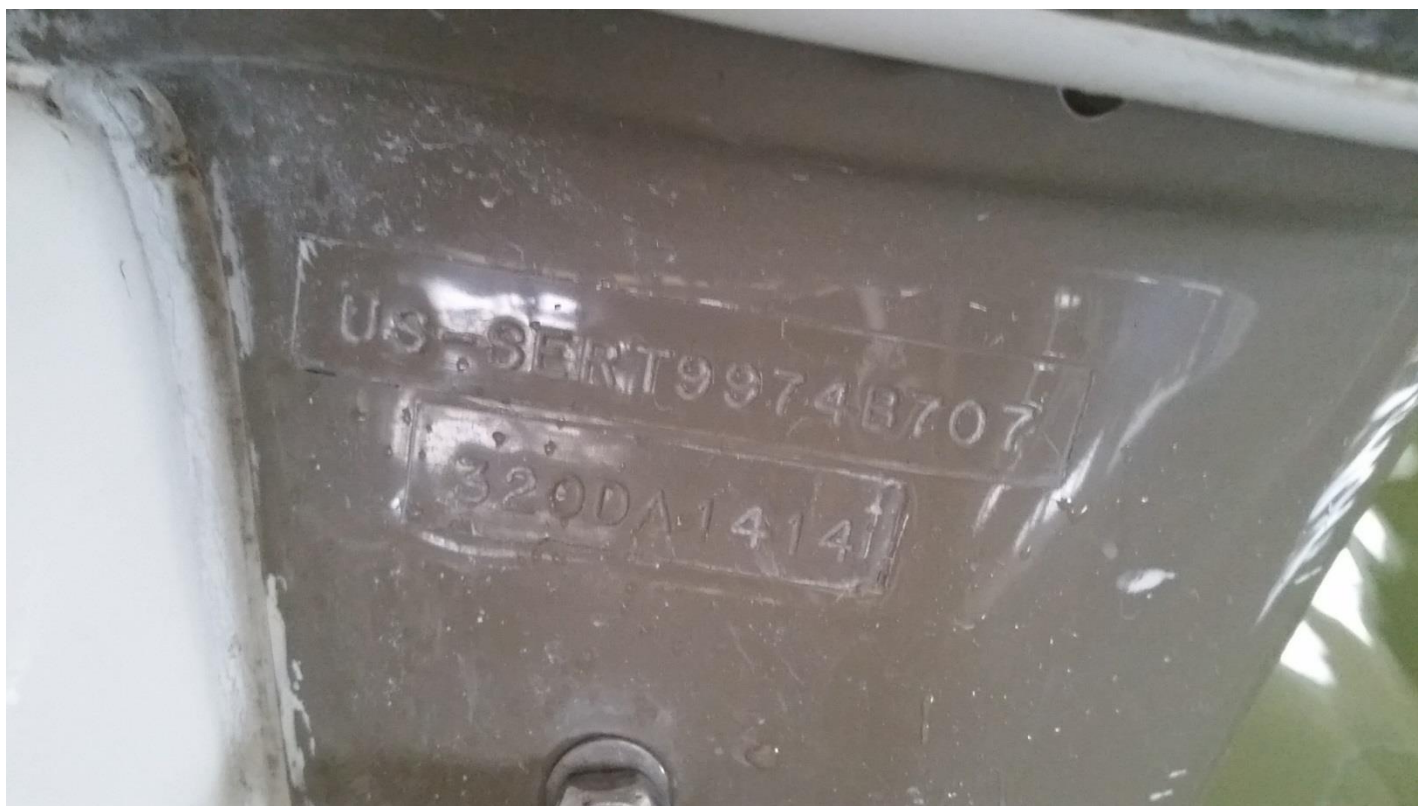
Hull Identification Number (Starboard Aft Corner)

<b>State Registration NO#:</b>	NOTE: State registration numbers not sighted. Register vessel.
<b>State Validation Sticker:</b>	NOTE: State validation sticker not sighted. Register vessel.
<b>Registration valid and sighted on hull as per regulations:</b>	No. See above finding.
<b>Vessel Type:</b>	Fiberglass Express Cruiser w/ Deep-Vee Hull Configuration
<b>Manufacturer:</b>	Sea Ray Boats, Knoxville TN (Div of Brunswick Corp)
<b>Year of Vessel:</b>	2007
<b>Vessel Length:</b>	<i>Length Overall:</i> 35' 6" <i>Length on Deck:</i> 32'
<b>Vessel Draft:</b>	2' 9"
<b>Vessel Beam:</b>	11' 5"
<b>Vessel Weight:</b>	14,150 pounds
